# Appendix A

## Facility Overviews

This appendix profiles 21 existing State-owned and -operated facilities in detail and also describes the proposed Baltimore County Juvenile Detention Center. Our recommendations for each of these facilities can be summarized, briefly, as follows:

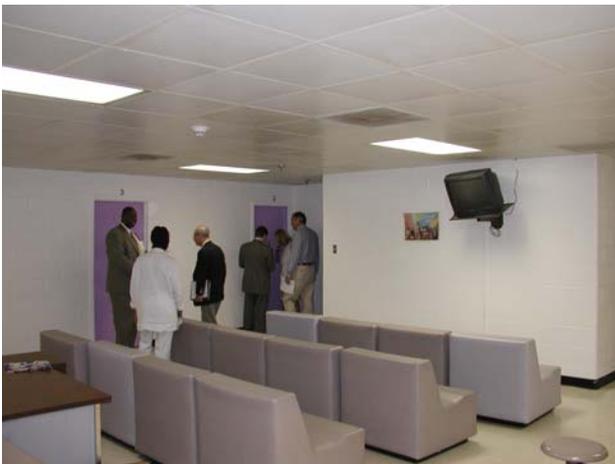
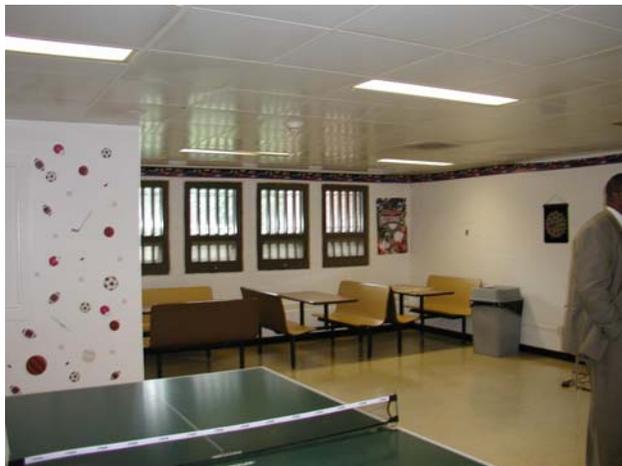
Some systems have undergone upgrades. Heat is provided by an oil-fueled boiler, replaced in 1997. And a new chiller and air-handling units were installed in 1992. But the controls are original and outdated, and it is difficult to obtain parts. The system also does not meet current ventilation standards. No major code or life-safety deficiencies were observed. The building is partially sprinklered, and the fire alarm system was upgraded in the last few years. The original underground fuel storage tank is still in use.

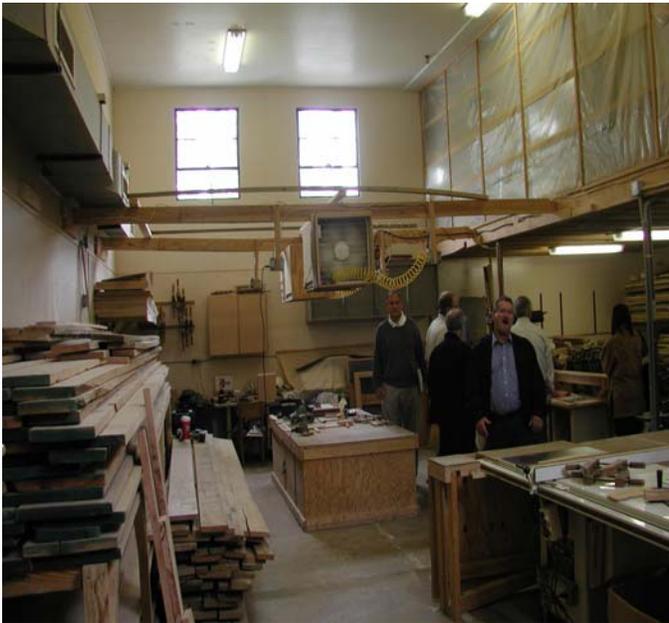
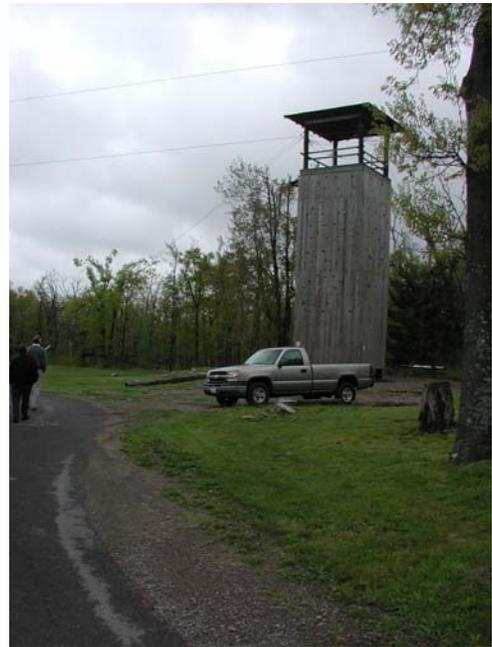
The dormitory is a wood-framed building built over a crawlspace. The toilet, shower, and laundry areas are in an adjoining building area several steps lower, of concrete masonry construction on a concrete slab. There are moisture problems at the base of this building. The dining area had a significant interior humidity problem when the facility was visited in late spring, possibly caused by inadequate ventilation of moisture from cooking operations. The school is a leased modular building

containing three classrooms. A pole shed houses vocational education (woodworking) programs. A tower equipped for ropes courses is onsite.

As at Meadow Mountain, the construction of some of the buildings at Backbone is insubstantial and not well suited to the harsher environment of Garrett County. Thus, there is deterioration of some of the structures despite the efforts of the maintenance staff.

A diligent maintenance staff keeps things running, but replacement of older buildings such as the kitchen/dining facility and the dormitory building will likely be required in the next decade or so. One modular classroom should also be added to this facility.

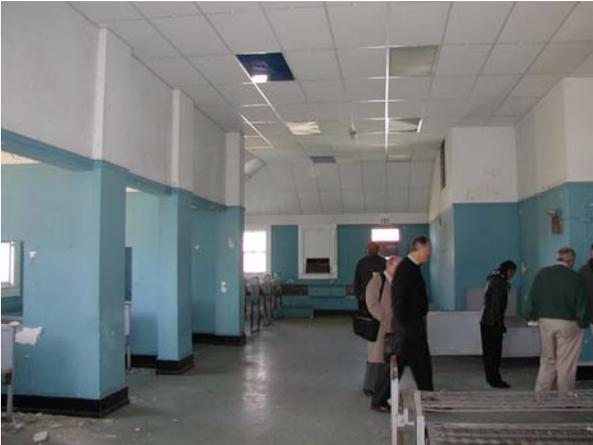
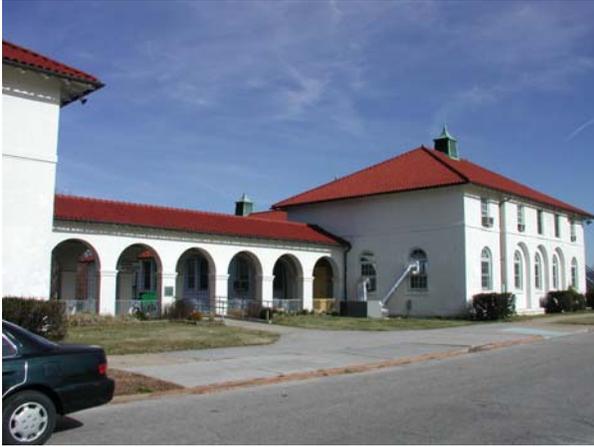
The residential buildings on the Pratt campus are vacant. The oldest seven buildings, dating from the early 1930s, are two-story structures with basements, containing just less than 10,000 square feet and oriented around a central open green space. The main level of each building housed common areas, with large dormitory-style rooms on the upper level. Most of these buildings are in poor condition owing to their age and their abandonment for the past 10–12 years.

The structures are concrete and masonry, with stucco exteriors and mission-style, clay tile roofs. In addition to the historic residential buildings, there are four cottage-style residential buildings on the Pratt campus dating from the 1980s that recently housed committed youths in a nonsecure setting. These structures are similar in layout and size to the cottages on the Victor Cullen campus (see Chapter 4) from the same era.

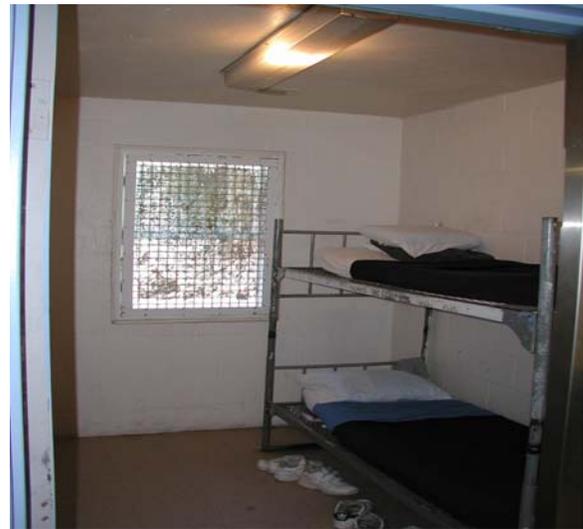
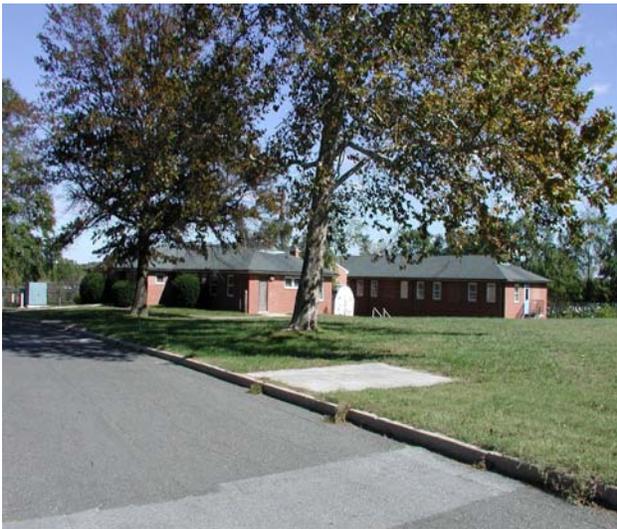
There are seven residential buildings on the Fletcher campus, dating from the 1950 and 1960s. Four contain just less than 10,000 square feet each and three contain from 11,000 to nearly 13,000 square feet. All are constructed on a similar model, very much like the residential buildings at Cheltenham, with a modified H-shaped footprint with common areas in wings to each side of the entry, a connecting corridor serving a dorm-style bathroom and locker areas, and a rear wing containing sleeping rooms arranged along a double-loaded corridor. There is no plumbing in bedrooms.

The residential buildings on the Fletcher campus are assigned to either detained or committed youths, including those in the sex offender treatment program. The Fletcher campus residential detention buildings are in poor condition, with antiquated systems and deteriorating conditions owing to limited maintenance. The gas-fired boilers are in fair to poor condition, with control systems almost nonexistent. There are numerous leaks in boilers rooms, with moisture and mold

problems ongoing. A lower level of rooms and a dayroom at the rear of the buildings is not used because of moisture problems and difficulty of supervision. Public water and sewers serving the buildings are old and barely adequate. Many rooms have non-security-grade, hollow metal doors. Because of damage, some have been retrofitted. Light fixtures are not abuse resistant. Sprinkler heads are not tamper resistant, and are frequently activated by detainees. The buildings

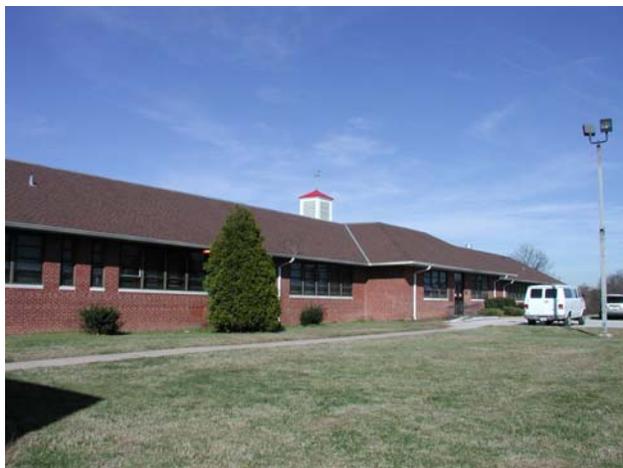
The Master Control building on the Pratt campus also serves the entire facility, serving as intake. Specialized space for intake functions, disciplinary seclusion, an infirmary, and overflow sleeping capacity are housed in a locked building on the Pratt campus outside of the security perimeter (and referred to as Master Control). Youths who are transported in and out of the Hickey facility must travel through this building—shackled, handcuffed, and transported in a security vehicle. The seclusion rooms have bars on the doors, which present a suicide risk. Further, they are not

equipped with toilets. The locked staff control room within the building has poor auditory and minimal sightline supervision, requiring staff to be stationed in hallways throughout the building to maintain supervision of detainees. Nursing and infirmary rooms are in poor condition but appear to be adequately sized. Youths needing to see a nurse or a doctor must be shackled when transported for their visit. Building walls are concrete masonry units. The physical condition of

this building is poor. The heating system in the room area is antiquated, with poor control over the system. Heating in intake room areas is so poorly distributed that the area near the floor is unbearably cold, while air near the ceiling is warm. Ceilings are nonsecure. Exterior steel lintels are rusted. Exterior louvers are damaged. The Master Control area is also used for overflow sleeping, which again requires transporting youths in shackles for the routine activity of sleeping.

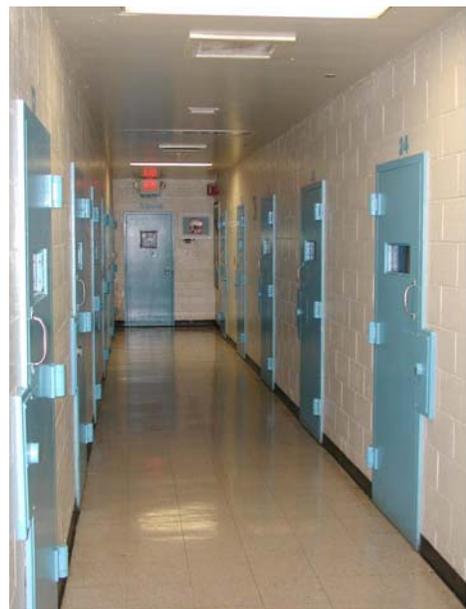
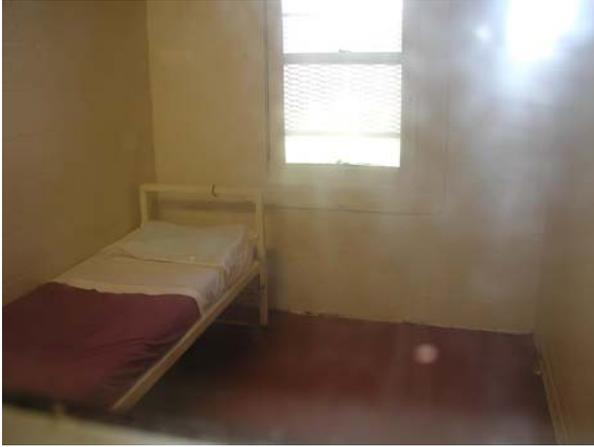
The eight residential cottages were constructed from 1947 to 1961 and range in size from just over 8,000 square feet to over 12,000 square feet. All cottages have a similar H-shaped building footprint, with common areas in the wings to each side of the entry, a connecting corridor serving a dorm-style bathroom and locker areas, and a rear wing that contains sleeping areas. In two of the cottages, the rear wing consists of two dormitory rooms, each containing 12 or 13 beds. Only one of these dormitory cottages, Murphy Cottage, is occupied; it serves as the shelter. In the remaining six cottages, the sleeping wing is configured as a double-loaded corridor serving individual bedrooms. The bedrooms have no plumbing. Three cottages are occupied and contain 17, 29, and 32 rooms.

The cottage structures are slab-on-grade with masonry bearing walls. Building systems are mostly original and inadequate by modern standards. Heating systems are hydronic, served by an oil-fired boiler in each building. The lack of control zones results in uneven temperatures throughout the building. Electrical service is also outmoded, with antiquated wiring, and is inadequate for air conditioning and new lighting. Two of the cottages, Rennie and Henry, are designated to house detained youth and are equipped with automatic sprinkler systems and electronic locking hardware on the doors. Most

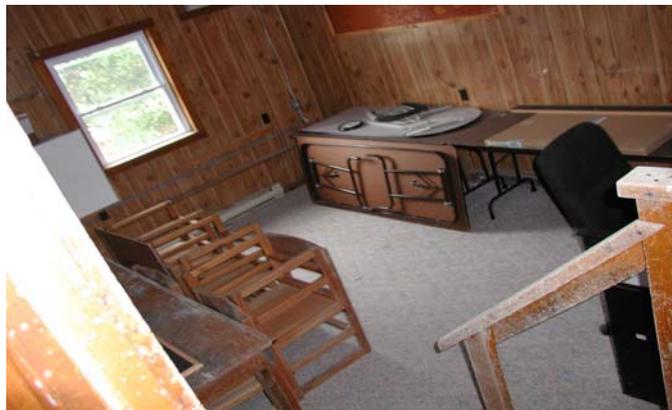
The building is in generally good condition. There is water damage to the second floor ceiling at the rear of the house from an apparent roof leak. There is also damage to the first floor bedroom closet ceiling from a second floor bathroom-plumbing leak. The exterior stair contains some damaged and rotting wood. No code deficiencies were observed. With classification as a residential occupancy

because of the small number of residents housed, the building appears to have proper egress, exit light signage, smoke detectors, and fire alarm devices. The building is not sprinklered.

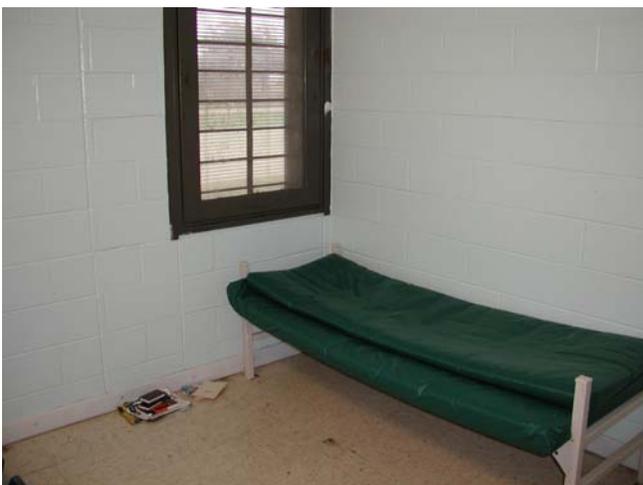
The detention center's mechanical room houses an air-handling unit served by chilled and hot water piped from the hospital. The hospital also houses the emergency generator and fire pump for the entire campus. The configuration of the mechanical system allows only limited control through the 20 variable-air-volume-unit boxes in the building. The system provides only heat or cooling to the entire building. Fresh air ventilation is inadequate. Humidity control is a problem, particularly in the dining area, where condensation on the floor creates a slippery and hazardous condition.

The amount of common spaces available for the number of detainees is limited, resulting in youths spending most of their time in extremely close quarters. There is no dedicated classroom. Metal beds create a suicide risk.

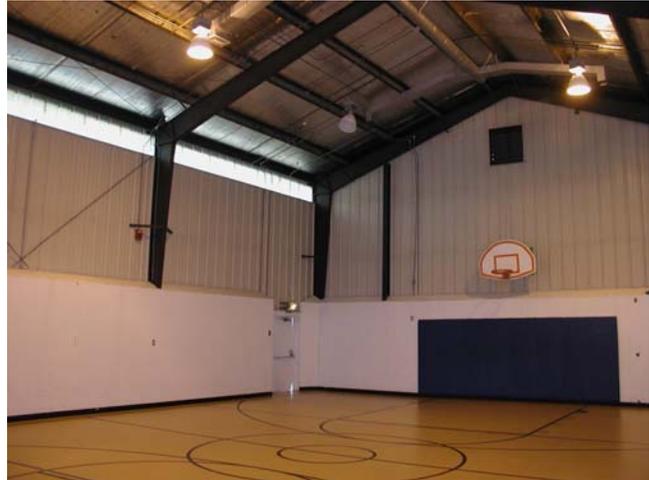
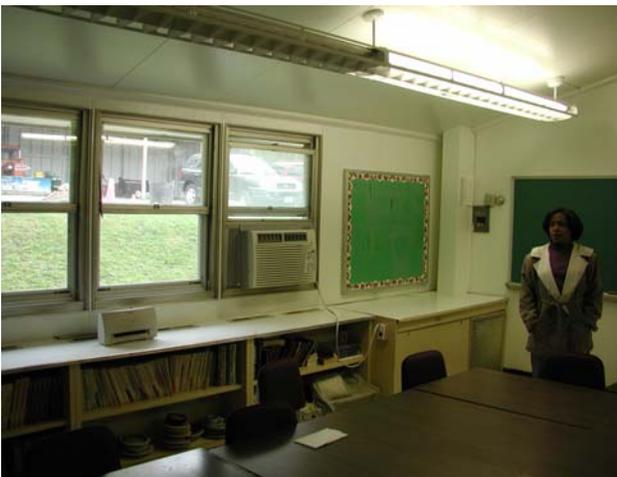
The modular classroom building is in poor condition: its thin walls and poorly insulated roof are hot in summer and cold in winter. The metal roof is noisy in the rain, but the flimsy structure likely cannot support a more substantial roof.

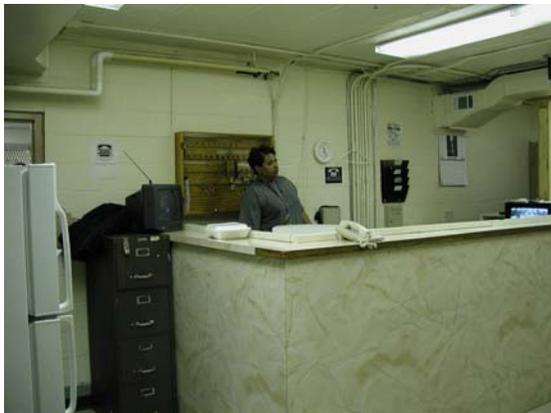
The building suffers from deferred maintenance in many areas. The configuration of the residential units does not allow appropriate sightlines for supervision of both units and is inappropriate for housing committed youths. The number of toilet and bathing fixtures is inadequate for the occupant load of the building. Apparently constructed to house boy detainees, the bathrooms are undergoing renovation to remove urinals.

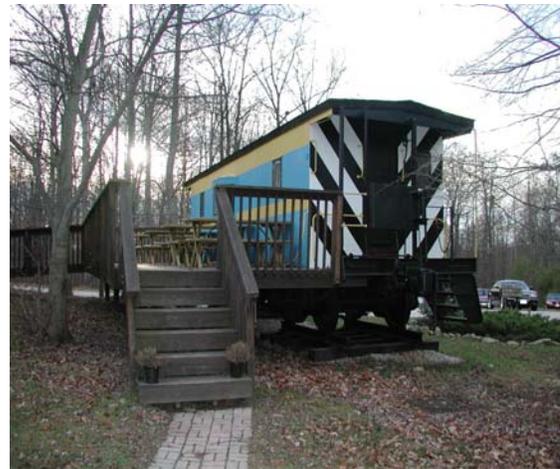
constant need or repair. As such, maintenance is an ongoing concern. Toilets and showers are in poor condition. The portable classrooms have undergone upgrades to meet Maryland State Department of Education standards, including modifications to heating-ventilation-and-air-conditioning problems systems.
