CA 94-05 White, William  
Bldg. Permit

Re: Modification to Building and Grading Permit-White Property

## SEARIDER INC.

- Attachments:
- a. Pictures of Storm Damage Cliff Slope Area Erosion taken December 2004
  - b. Storm Damage Plan of Storm Damage to Property, dwg No. DPSS Plan 1 rev F of 1 Jan 2005 (overview)

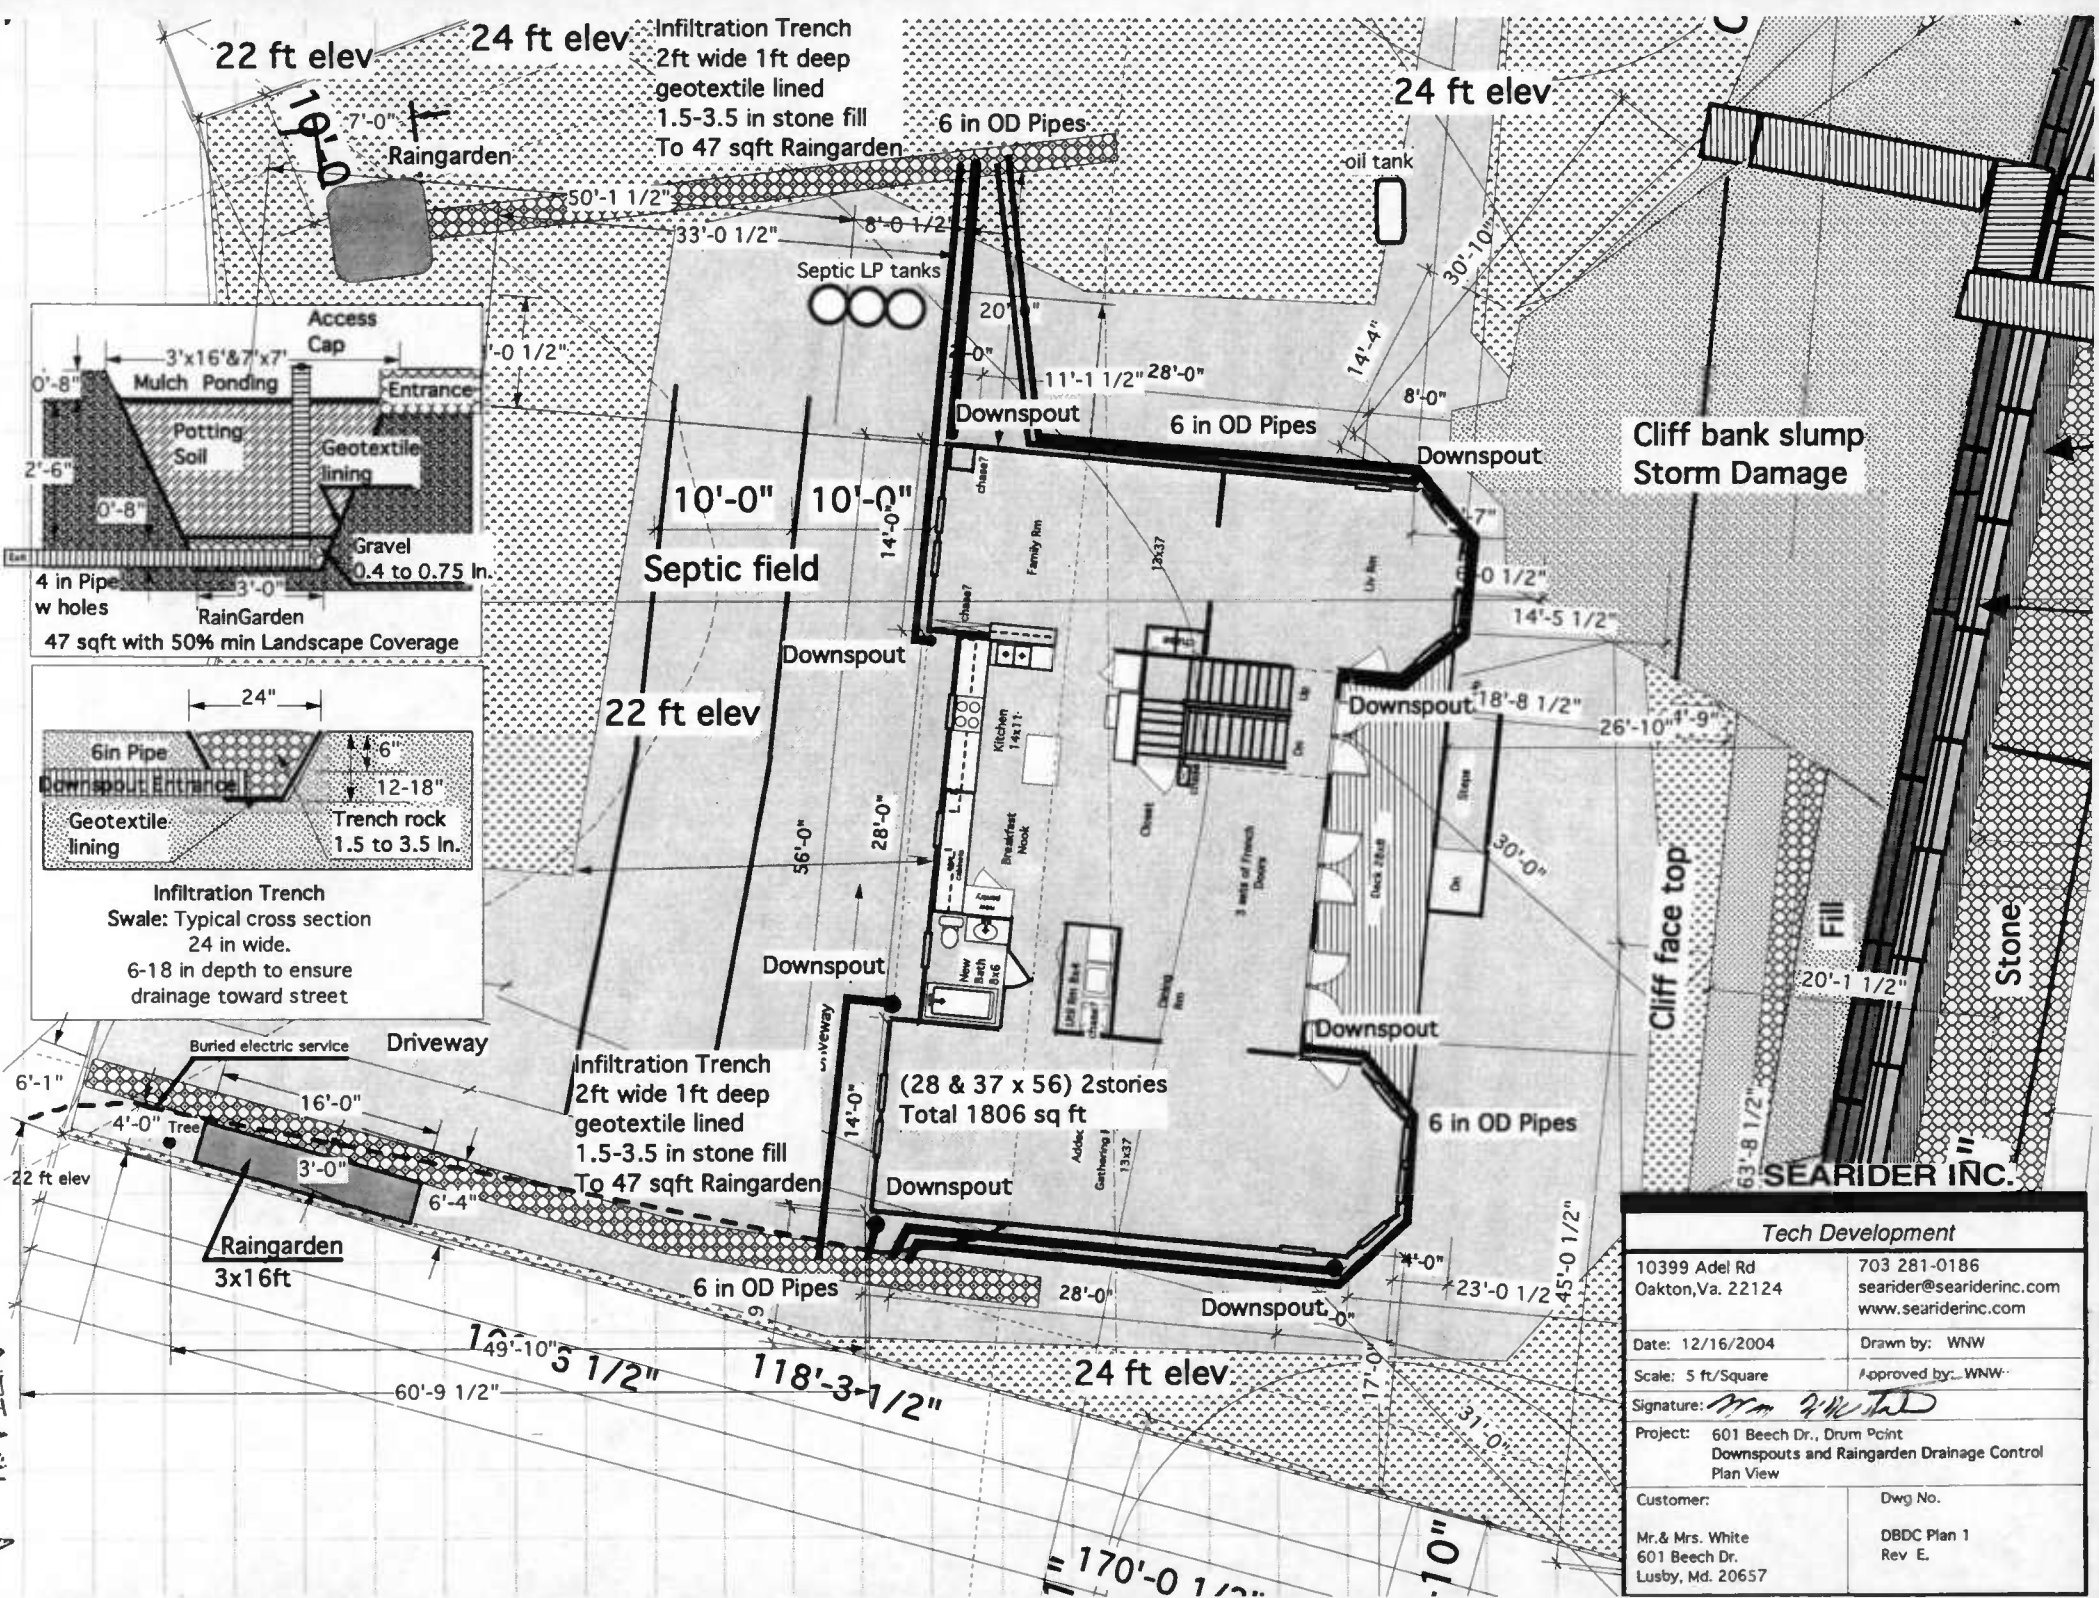
This letter provides details of our analysis of the water runoff mitigation approach developed for the property identified as 601 Beech Dr., Lusby Md. in Calvert County on the Chesapeake Bay. At the owners request we have developed an approach to control the roof runoff from the eight (8) downspouts currently on the house as shown on the attached drawing (attach a).

Three of four downspouts on the street side of the house discharge onto plastic splash blocks and run from there onto the lawn and then down-slope toward the street. The fourth front downspout (south west corner) has been connected into a buried 6 inch PVC pipe that discharges into a stone filled infiltration trench along the house side. Three of four downspouts at the rear of the house (bayside) discharge into buried 6 inch OD PVC pipe. It is suspected that those three pipes end in the soil at the rear of the house and may contribute to soil saturation in that area near the cliff situated approximately 24 feet from the rear of the house. The fourth rear downspout (North East corner) discharges above ground to the house side.

Attachment a. shows the layout of the two infiltration trenches that were designed to lead surface rain water away from the cliff face and collect piped downspout rain outputs initially to the sides of the house and then toward the street and into two raingardens. To control the water flow direction within each trench, the bottom of the trench is dug deeper as it moves from the rear of the house to the street side at a rate of 1 inch per 10 feet of run (>0.5%). For the 50 ft run alongside the house to the raingarden, the trench depth increases from 6 inches to 14 inches. For the rest of the trench toward the street the natural slope of the property is sufficient.

On the northern side of the house the trench runs a path along a natural swale located 15-20 feet from the house side. This also misses the low pressure dose Septic tanks and Oil storage tank on the northern part of the property. On the southern side of the house, the other trench follows a similar swale located 4-6 feet from the house side and 10-5 feet from the property line. Finally, both trenches on the street side are outside of the septic field area to minimize potential cross communication.

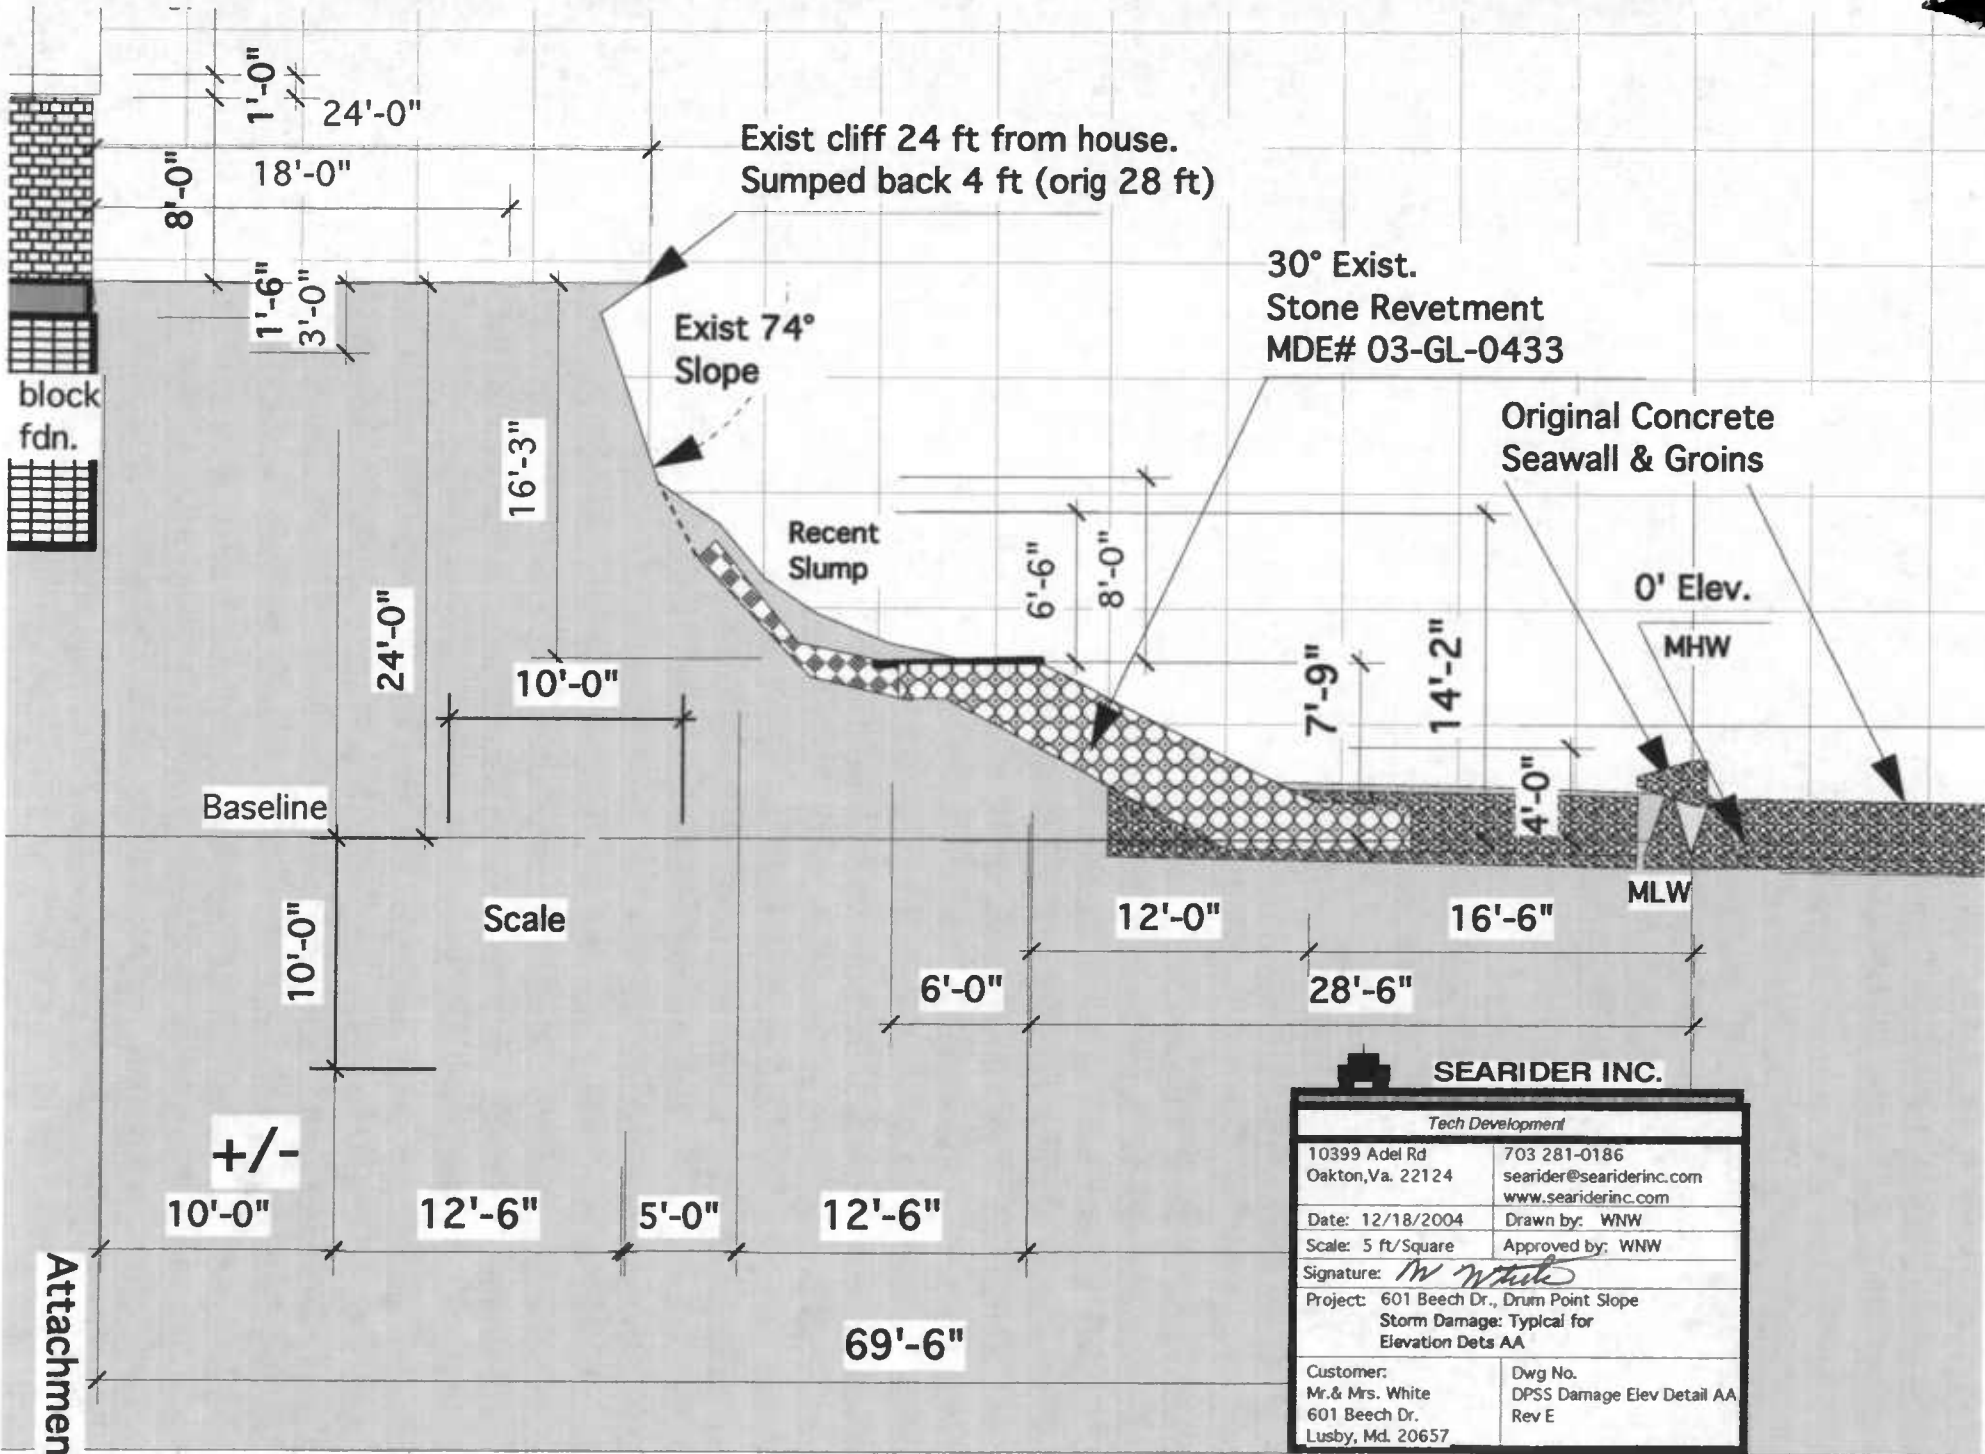
Attachment c.

The southern third of the cliff slumped first (in the Spring of 2004) cutting away the upper cliff edge approximately four feet back at the boundary with the neighbor's property. The resulting cliff face of slump covers over the stone revetment to approximately one-foot depth over the upper stone and the cliff is also severely undercut along 60 feet at the top cliff edge. Some of this slump has washed into the Bay due to the 80-degree steepness of the cliff face slope in this area. This steep slope continues to erode and during the Thanksgiving weekend (Nov. 24, 2004) a holly tree at the cliff edge toppled over with additional slumping also occurring. This additional damage is shown

in the four photographs included as attachment a. and indicated on the Plan of attachment b. by shading and is highlighted by Elevation, AA, on attachment c.

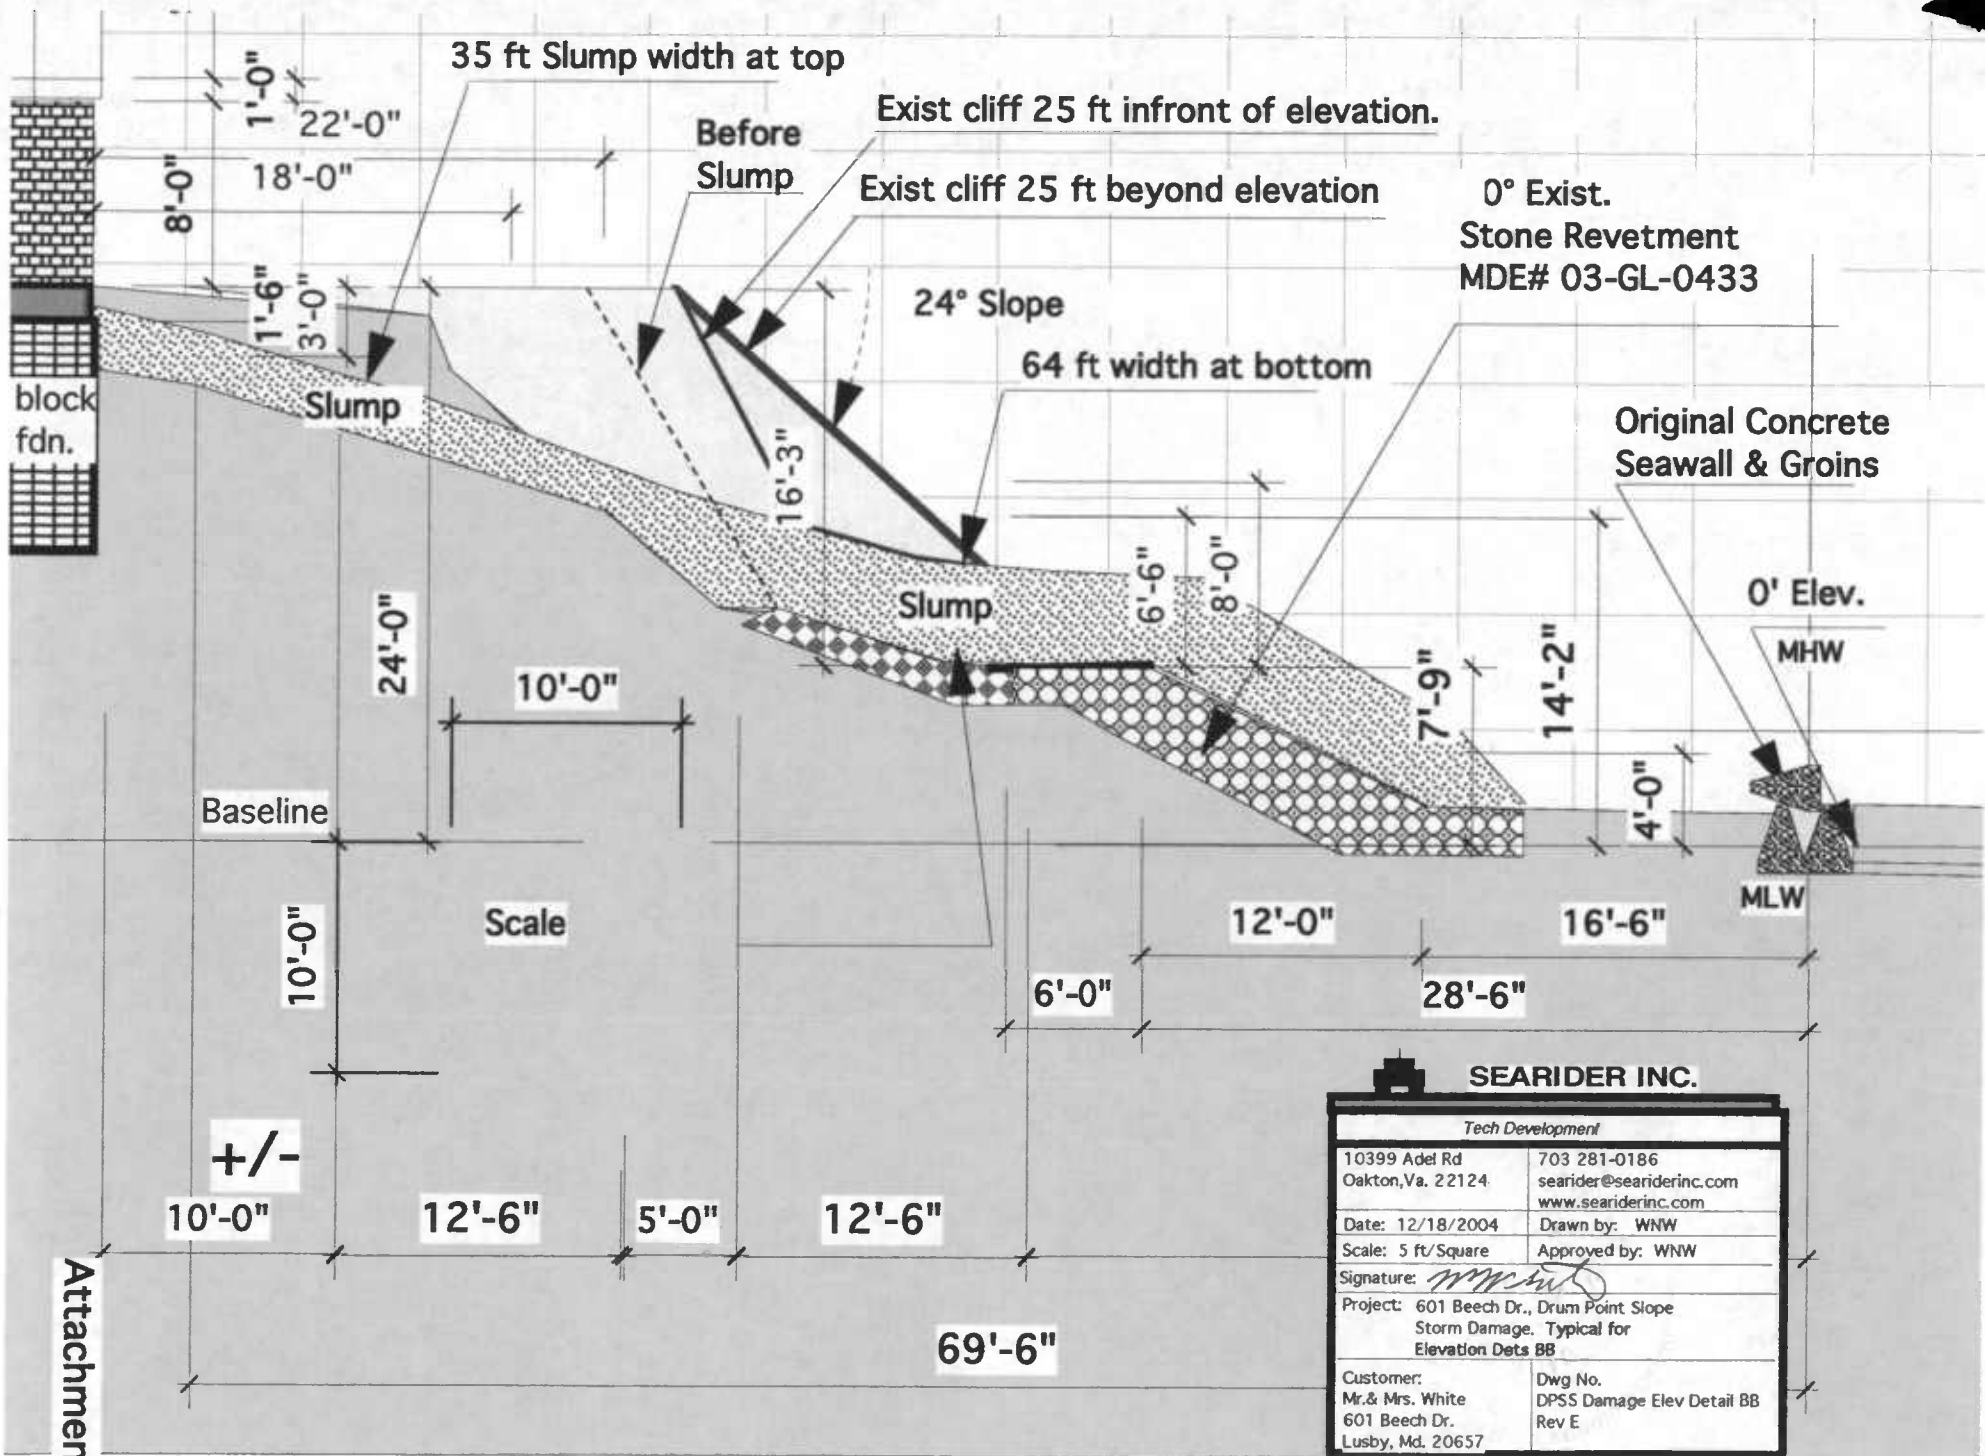
Attachment d.

The middle section of the cliff face at the rear North East corner of the house at 601 Beech Dr. Lusby, Md. has also severely slumped. The damage has come dangerously close to the house foundation during the July-August 2004 storms. The storms moved the cliff edge approximately 15 - 20 feet back and it is now past the rear house line and currently is within four feet of the house foundation. The resulting slump covered approximately 80 ft length of the recently installed stone revetment and was close to five feet deep over most of it. This is indicated on Plan 1 of attachment b. by shading and is highlighted by Elevation BB see attachment d.

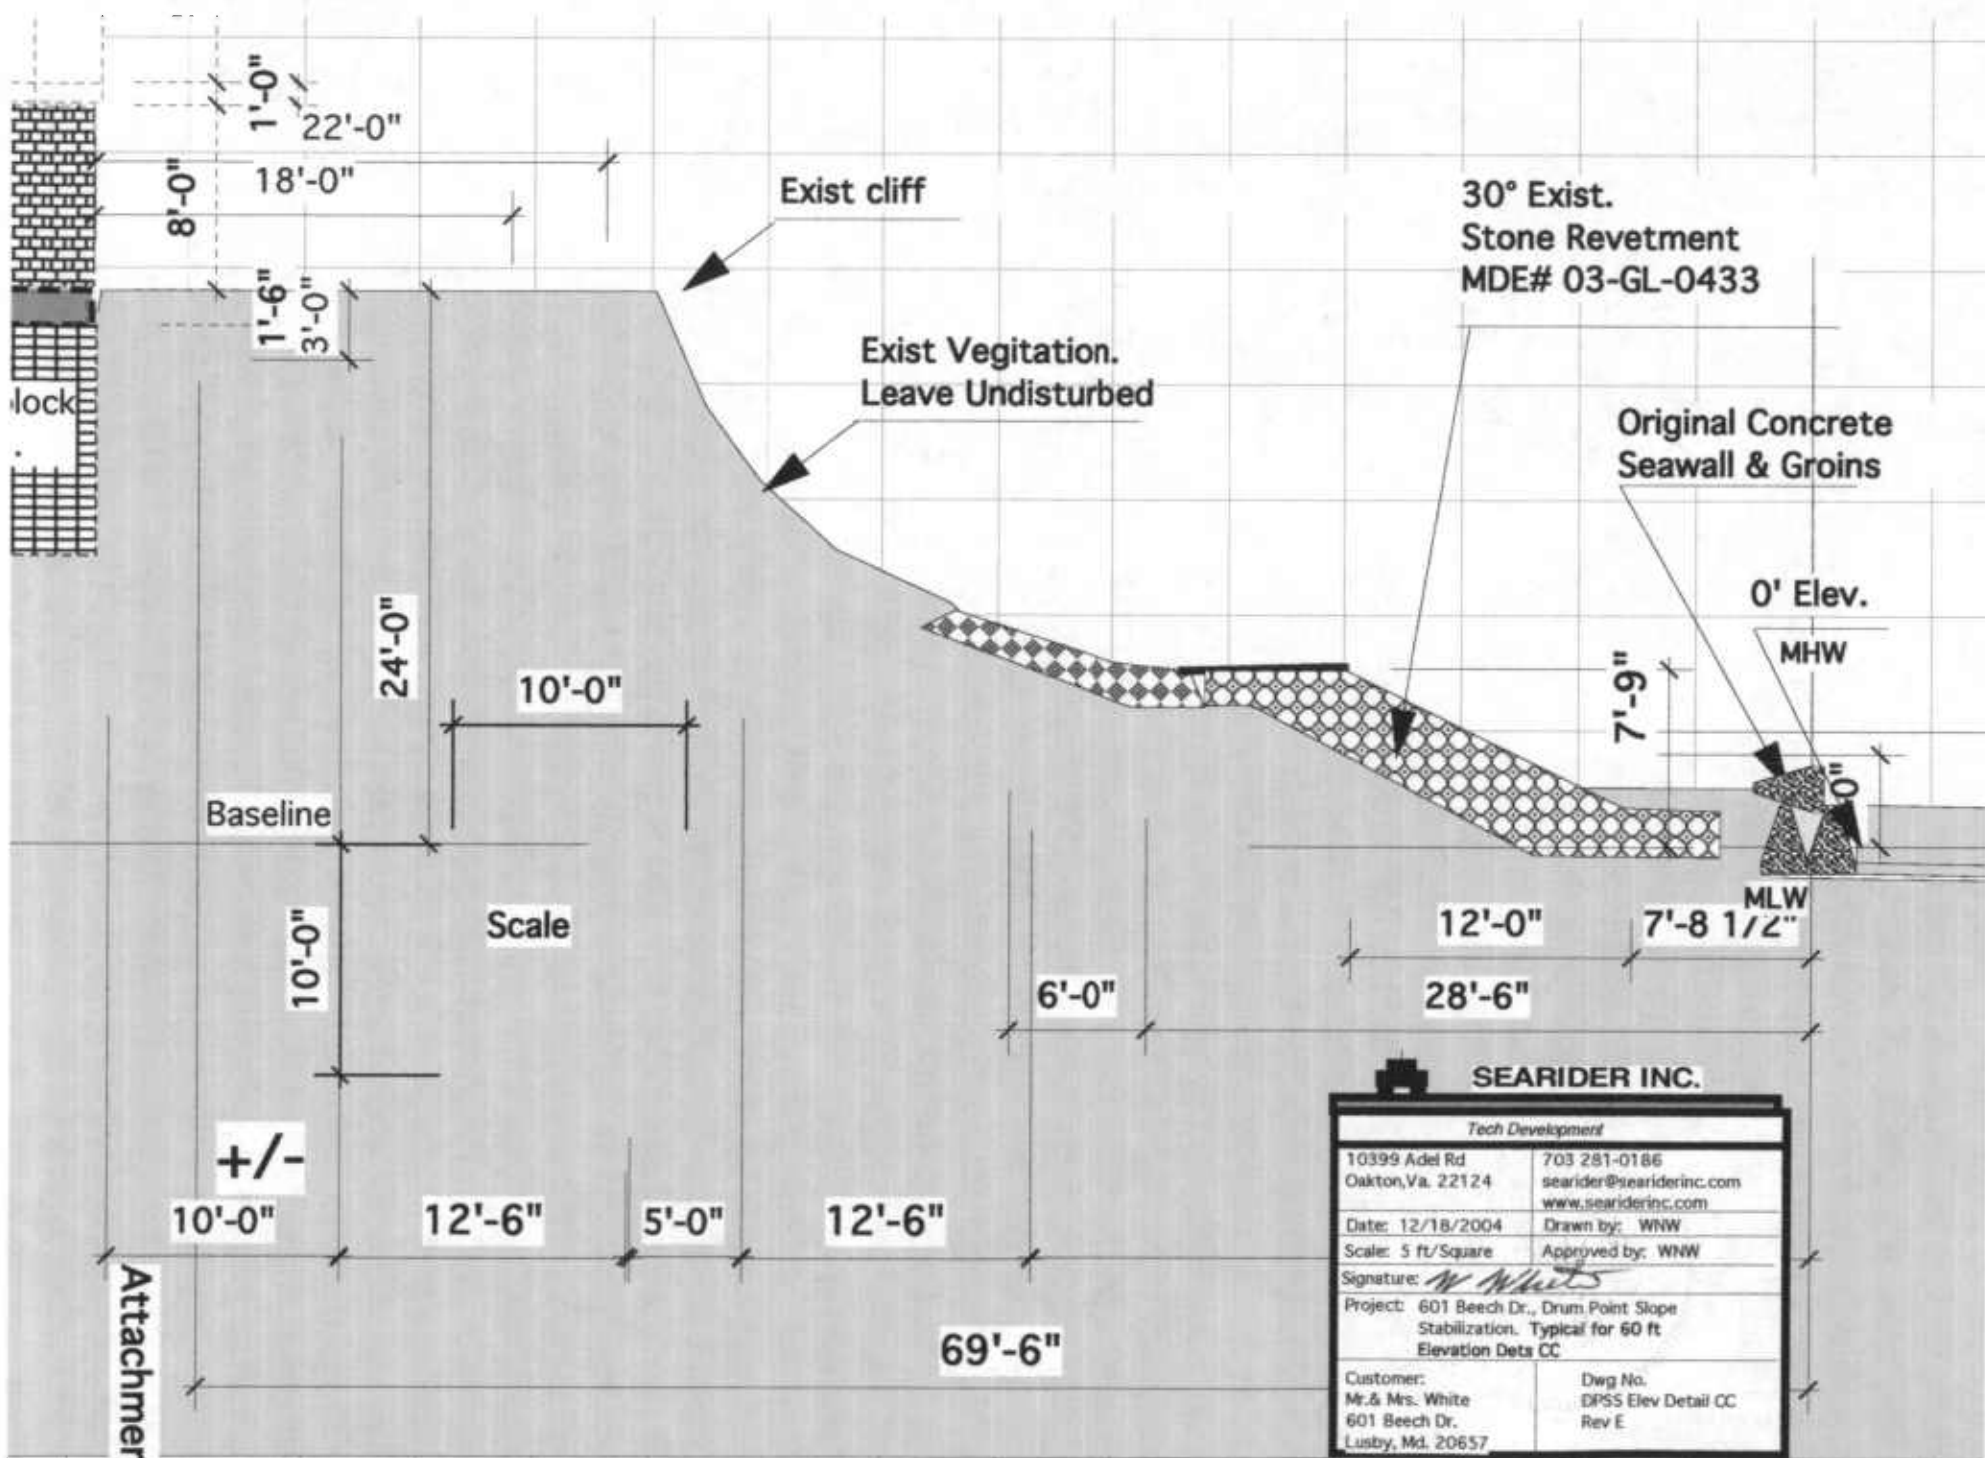
The northernmost third section of the revetment and cliff has not experienced significant damage and no repairs are contemplated in this area as indicated on the plan of attachment b. by shading and highlighted by Elevation, CC, see attachments e.

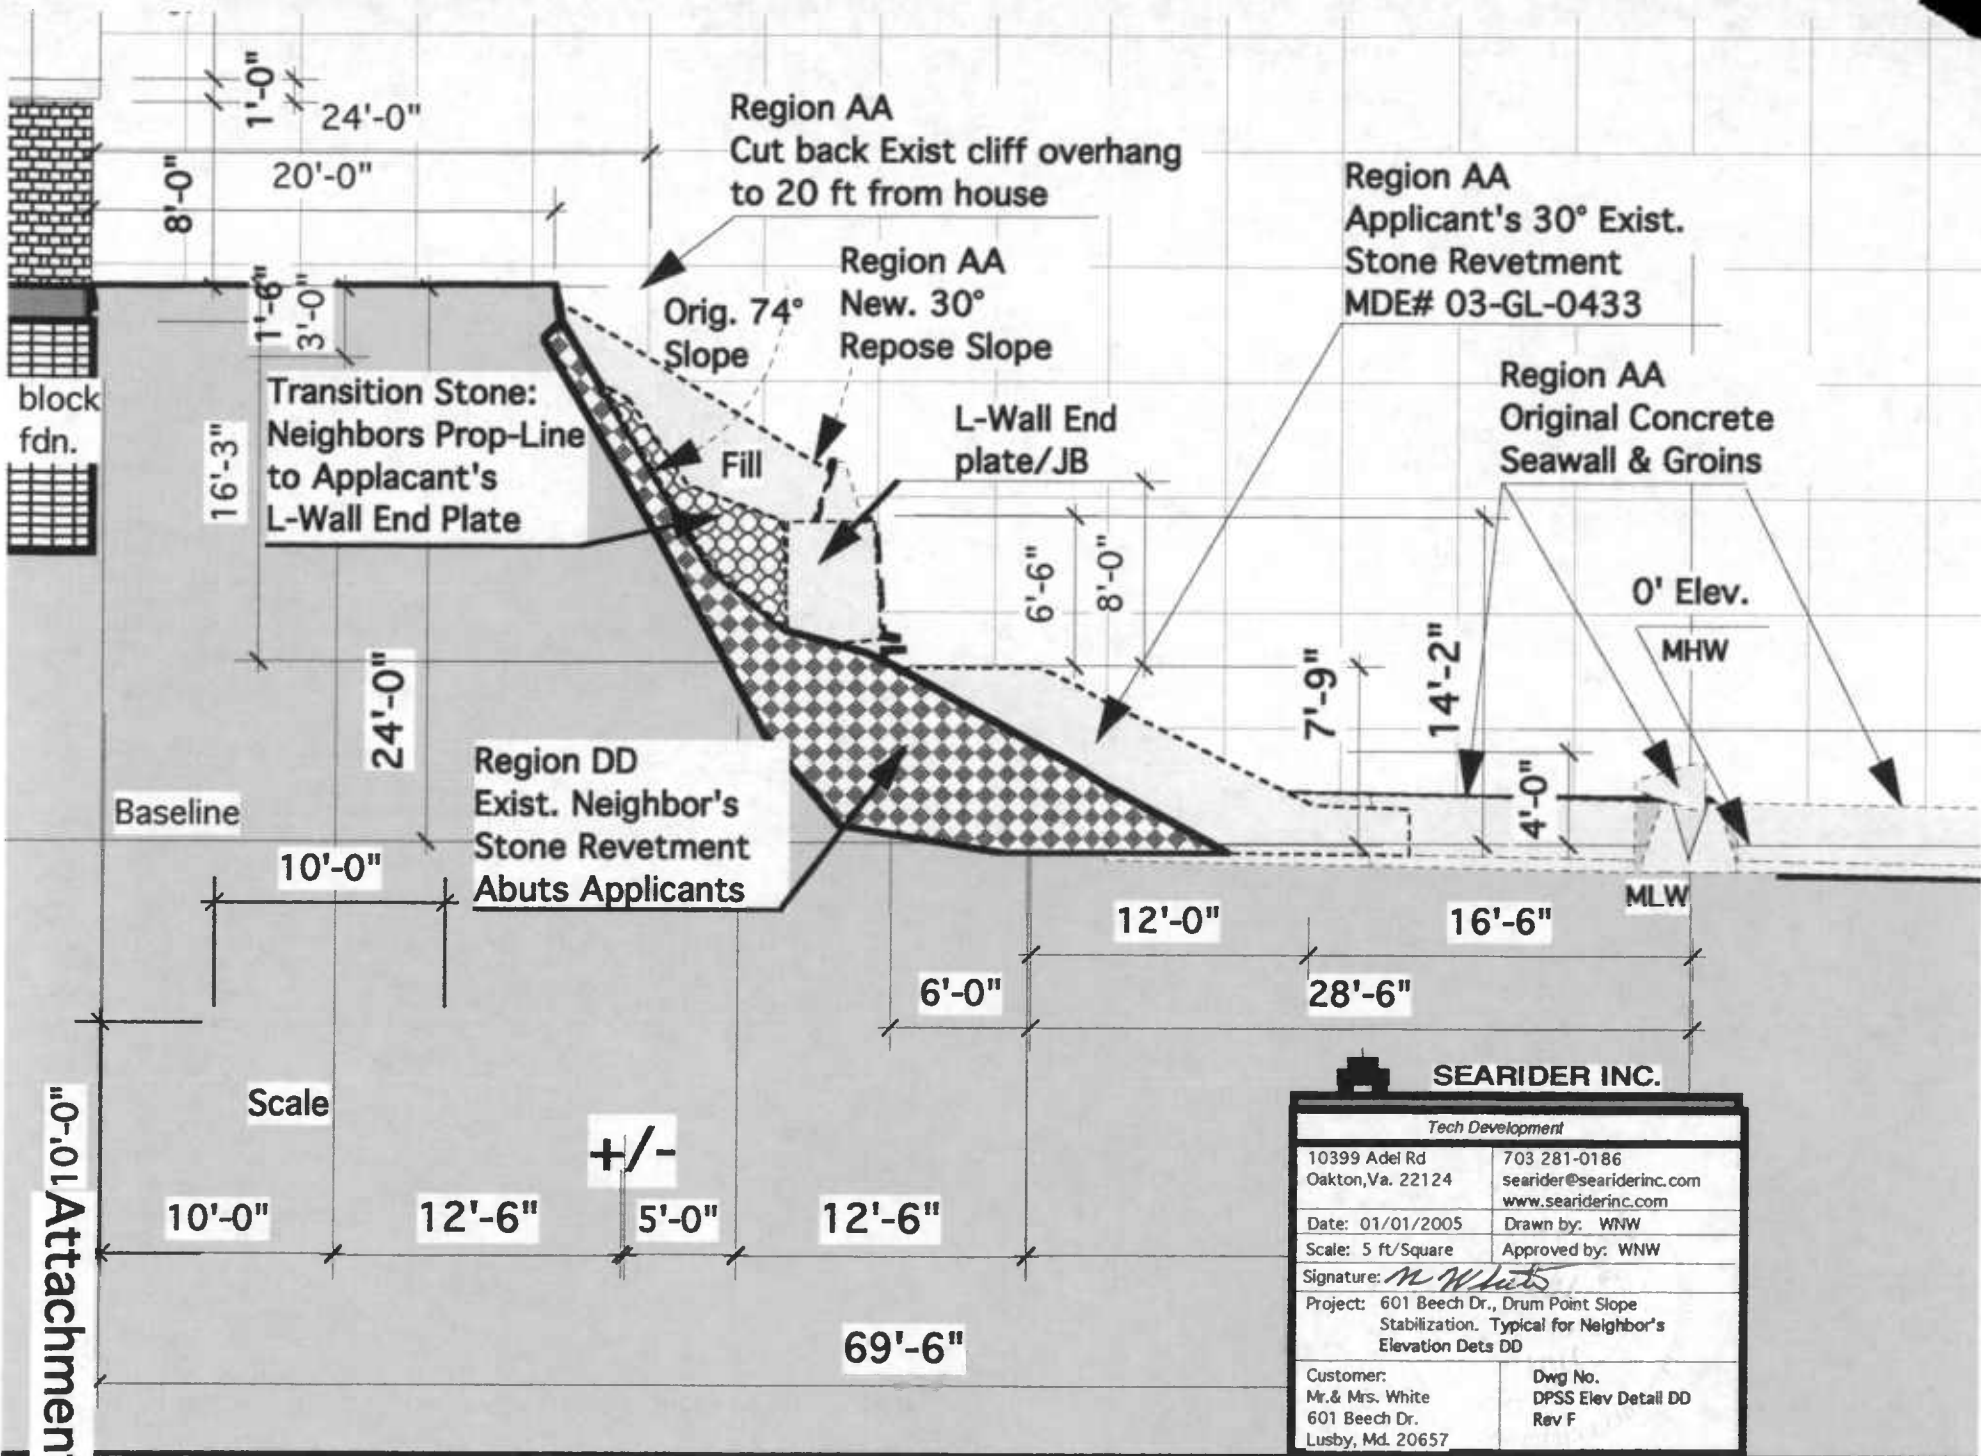
Attachment i.

**Region AA**  
Cut back Exist cliff overhang  
to 20 ft from house

**Region AA**  
New. 30°  
Repose Slope

**Region AA**  
Applicant's 30° Exist.  
Stone Revetment  
MDE# 03-GL-0433

**Region AA**  
Original Concrete  
Seawall & Groins

**Transition Stone:**  
Neighbors Prop-Line  
to Applicant's  
L-Wall End Plate

**Region DD**  
Exist. Neighbor's  
Stone Revetment  
Abuts Applicants

The Detail AA Elevation of Attachment g, shows the L-wall/JB installation with Filter Cloth and backfill of the south-most section. This will prevent continued cliff face slumping into the Bay as has been occurring with each severe storm this past fall of 2004. Detail DD of Attachment i, shows the neighbor's property and his existing Stone Revetment that abuts the applicant's Stone Revetment. It shows that approximately five feet of additional light (6-10in) stone fill will be installed at the property line on the applicants side to seamlessly tie the neighbors upper level stone into the new extended retaining wall and it's backfill. The Elevation of Det BB attachment h shows the middle section with the L-wall/JB installation with Filter Cloth and recovered slump and backfill.

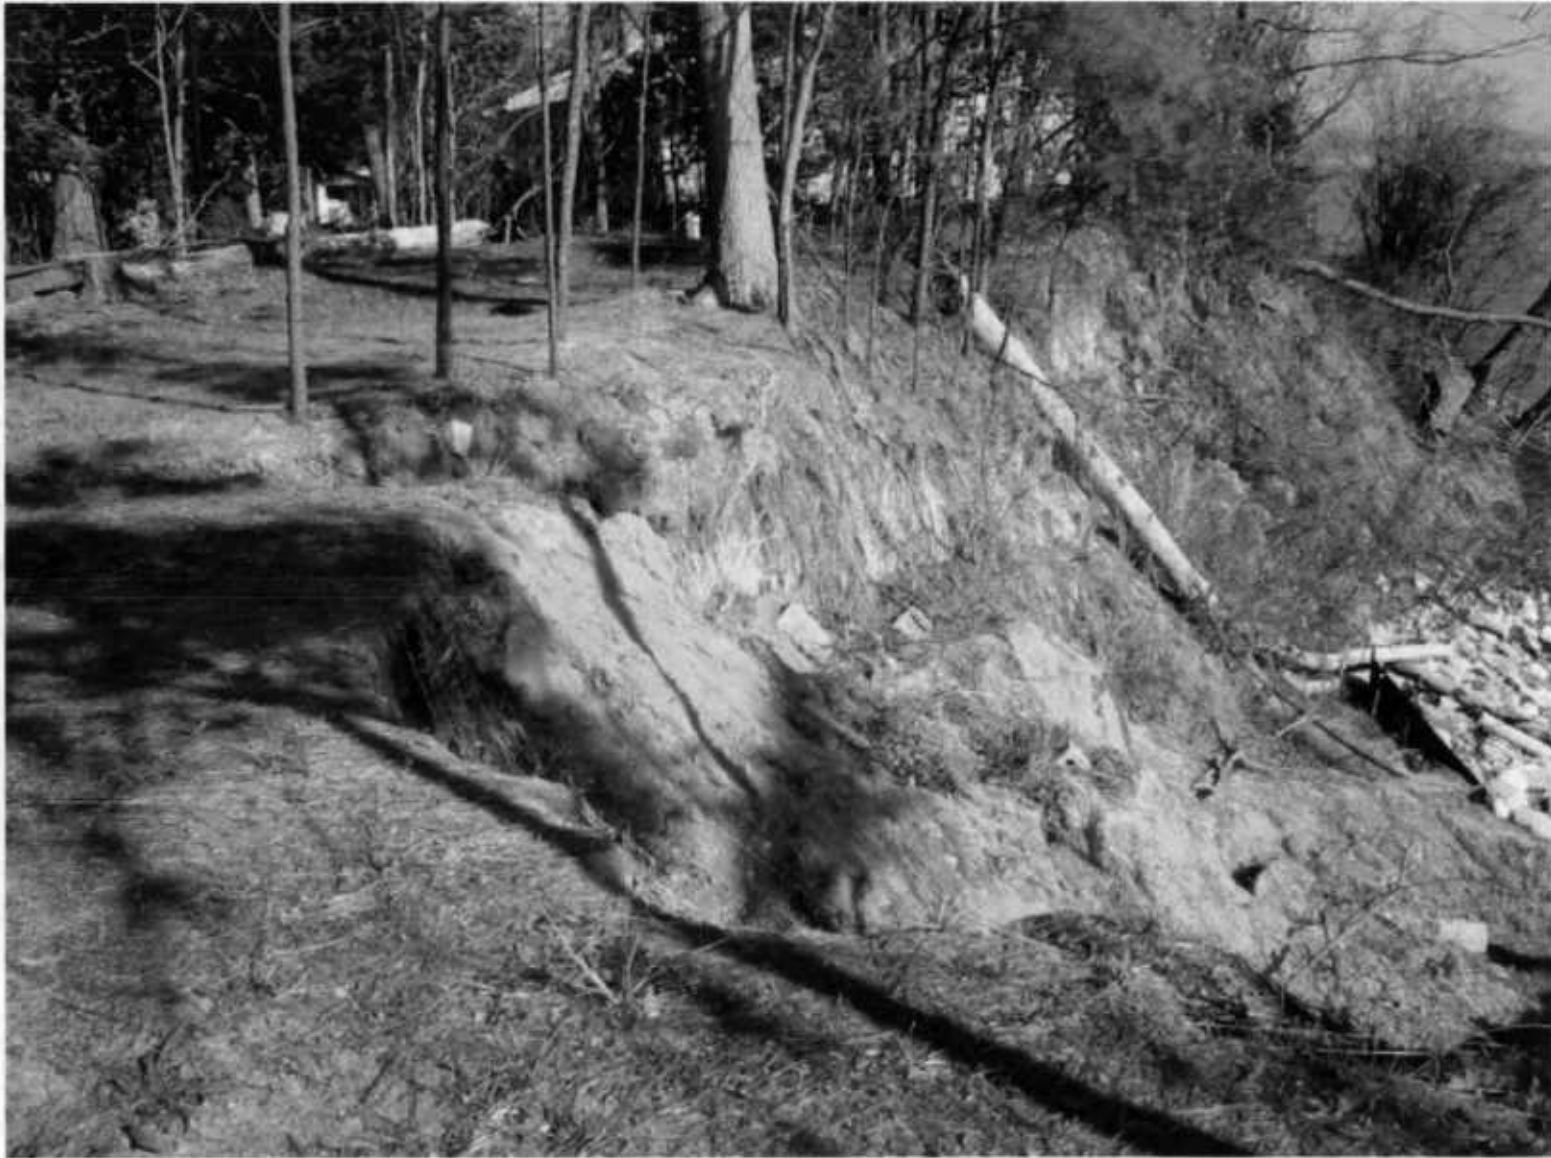
White Property-Cliff Collapse 1/3/05

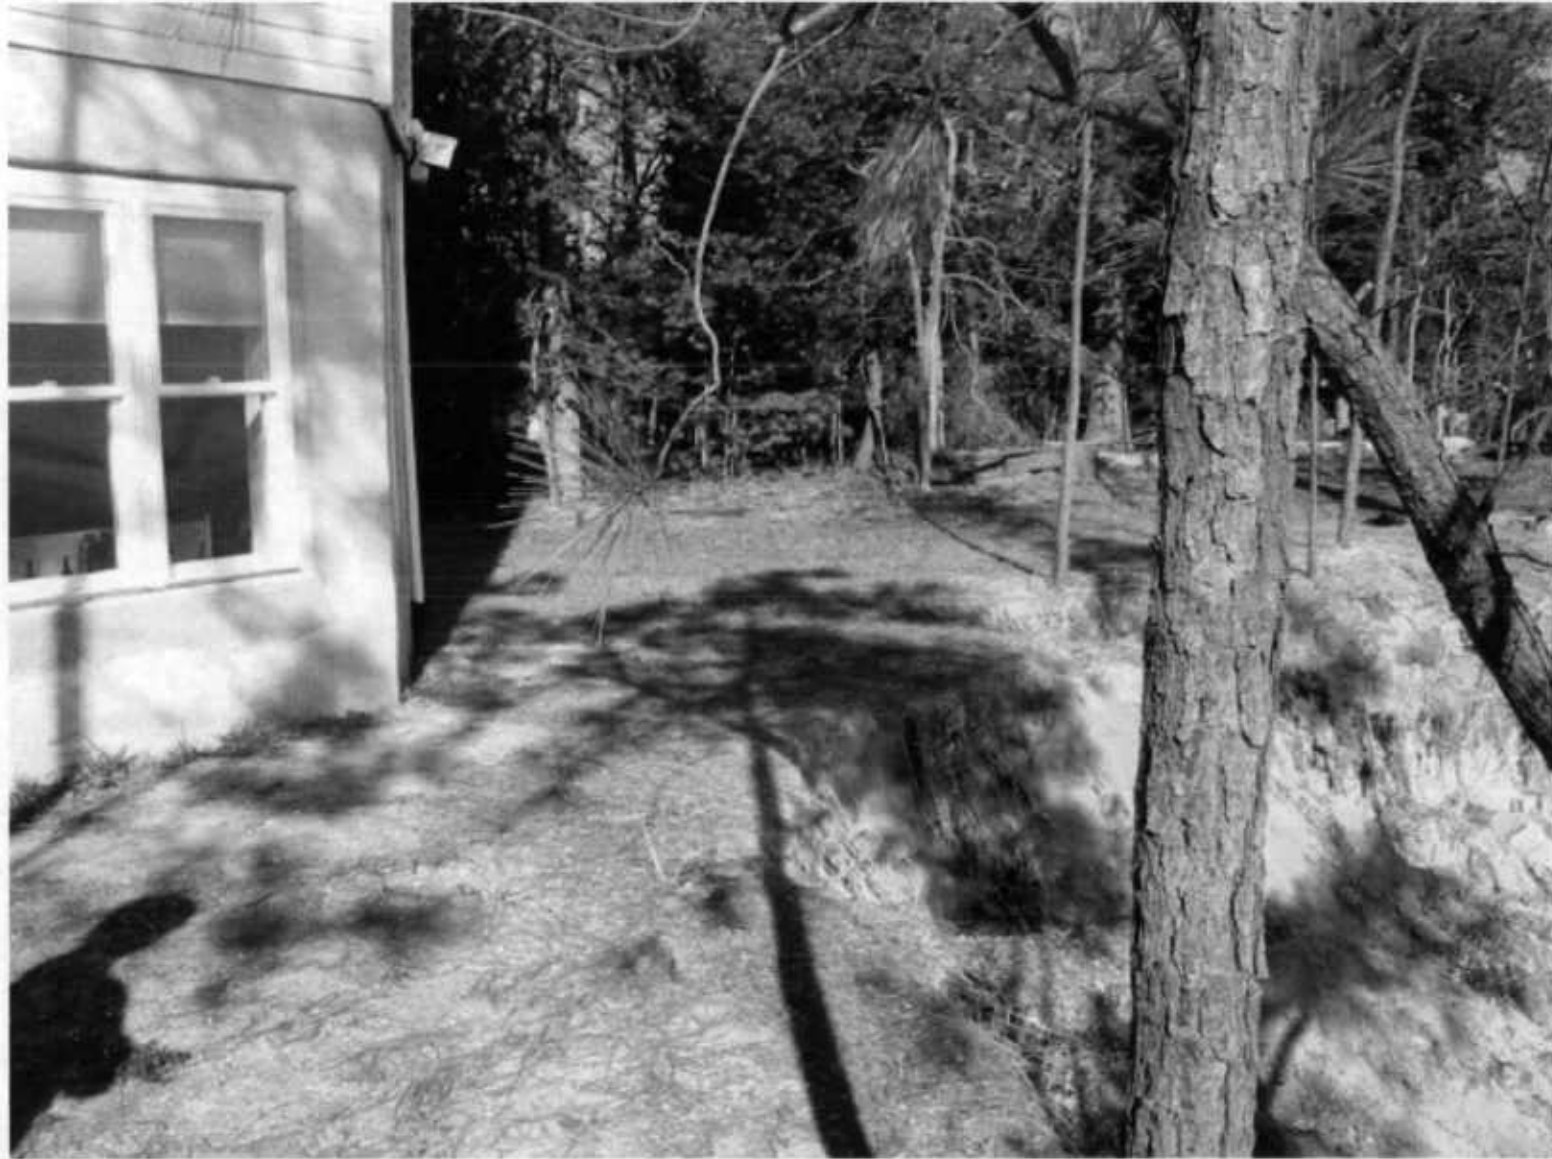
White Property-Cliff Collapse 1/3/05
