Interim Report on Archival and Architectural Evidence
Old Senate Chamber at the Maryland State House

09/17/2008

Report by the John Greenwalt Lee Company

Lead Investigator: Charles A. Phillips, AIA, AIC
with John Lee, Ellen Hagsten, and Lisa Wilkerson (CAD)

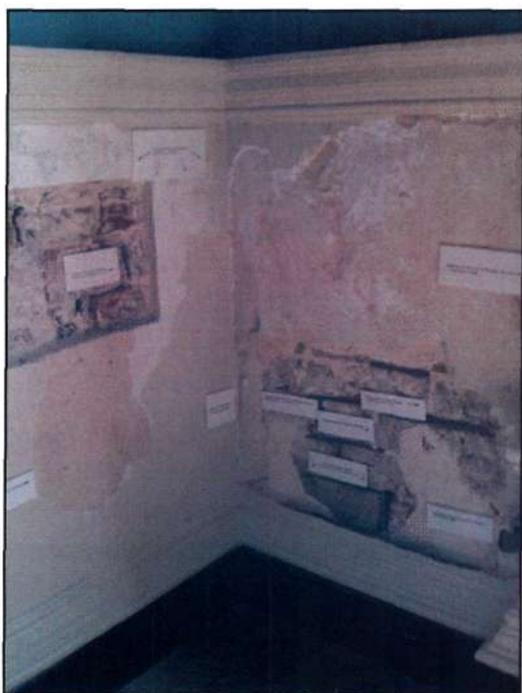
← The initial reveal in the NE corner behind the president's desk with labels.

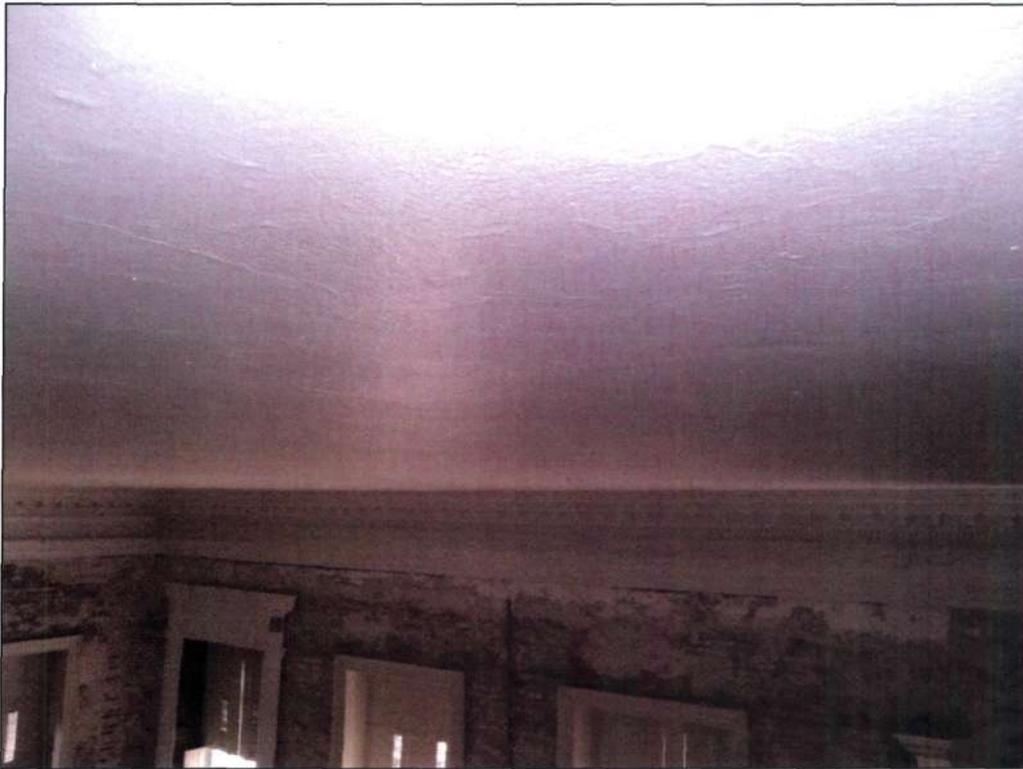
1905 ceiling plaster looks fine from the floor, however it is experiencing the same failure symptoms as the wall plaster – just not yet as pronounced. Recommend replacement as with the wall plaster as it will need to be replaced within the next decade with considerable mess and damage to lower work. Removal may assist current re-piping project

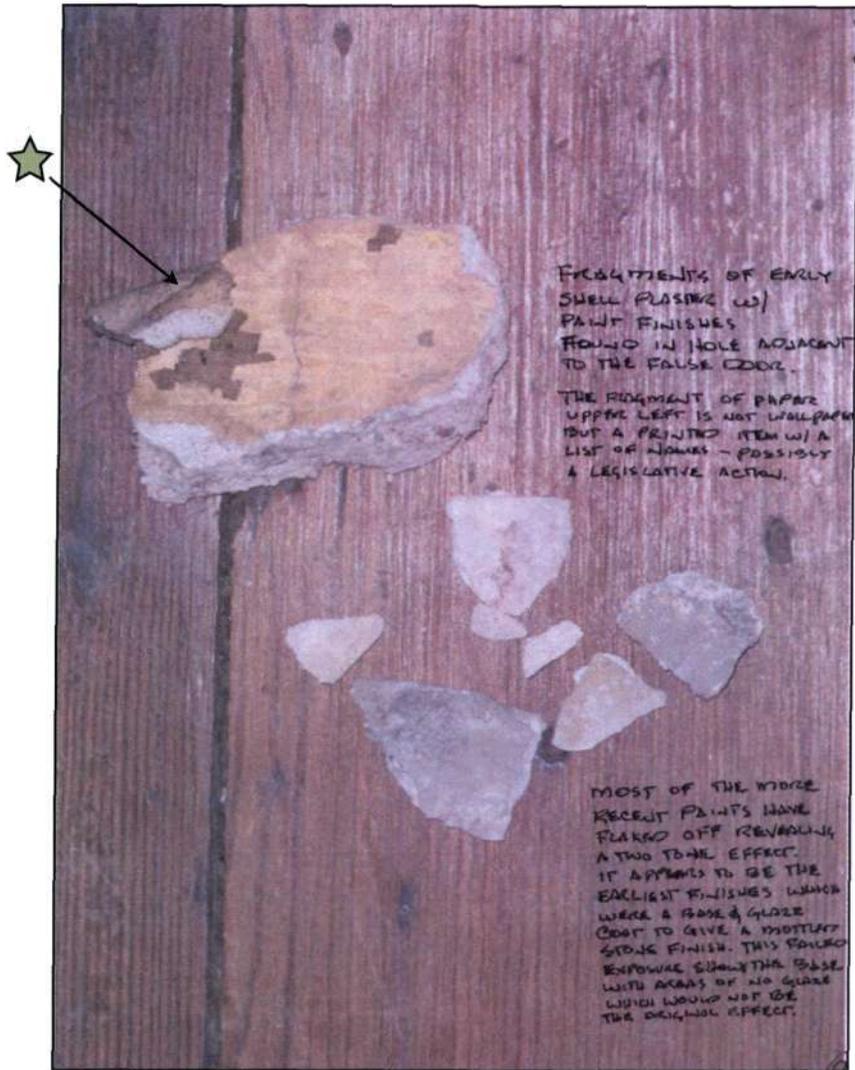
Fragments of early shell plaster with finishes were found in a hole at floor height to the right of the false door.

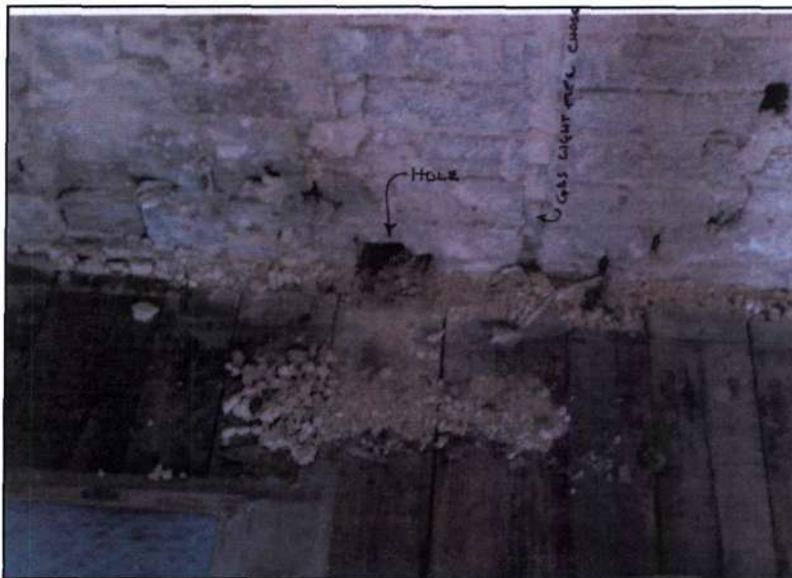
Detail of the location where 2" piece of early wall plaster was found. (Note floor vent in foreground).

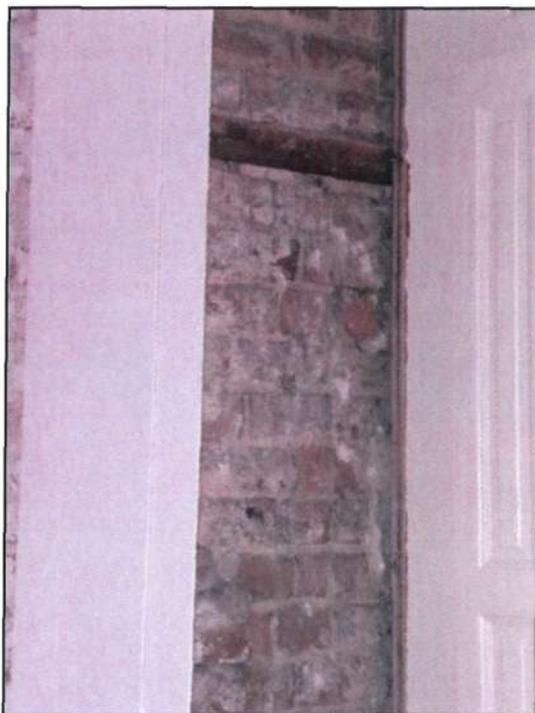
Fragments of early shell plaster remain in the lower half of the shutter pockets, but the brick above has never been plastered. No plastering would be required for wood paneled sides to the window. However the back of shutter pockets are often thinly plastered directly on the brick with the rest of the void receiving the folds of a closed shutter. One possible implication of this physical evidence is that the lower sash were covered by shutters that pocketed into the plastered recess while the upper sash were unshuttered. This may be related to the 1792 Shaw work order.

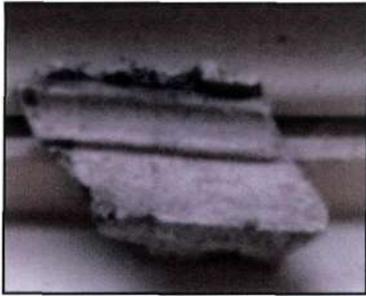
This fragment of plaster found in the space beneath the window recess closed up in 1905 where the gallery wainscot intersects the fourth window. It appears to be mortar that was dropped during plastering of the room onto a window muntin where it cured before being swept away.

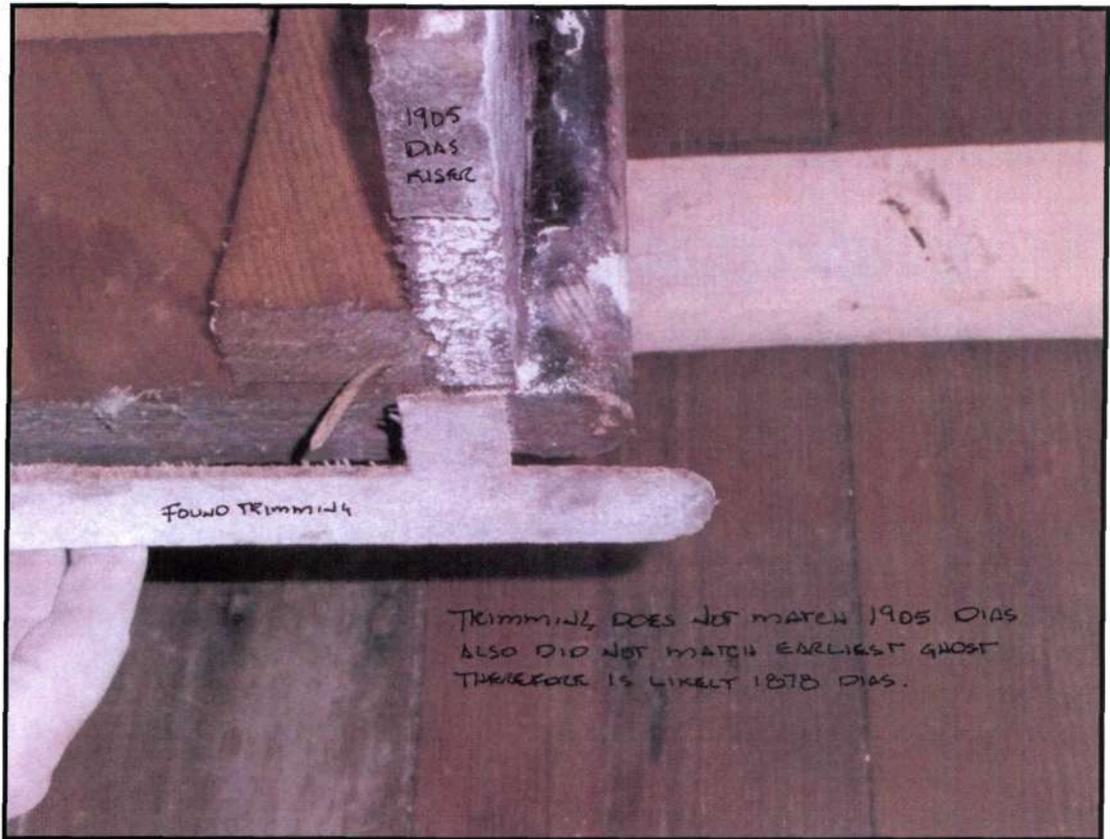
Trimming from the end of a dais tread and partial riser that was found under the existing 1905 dais when pulled out from the wall. Showing a longer nosing than the existing dais treads, it is probably from 1878.

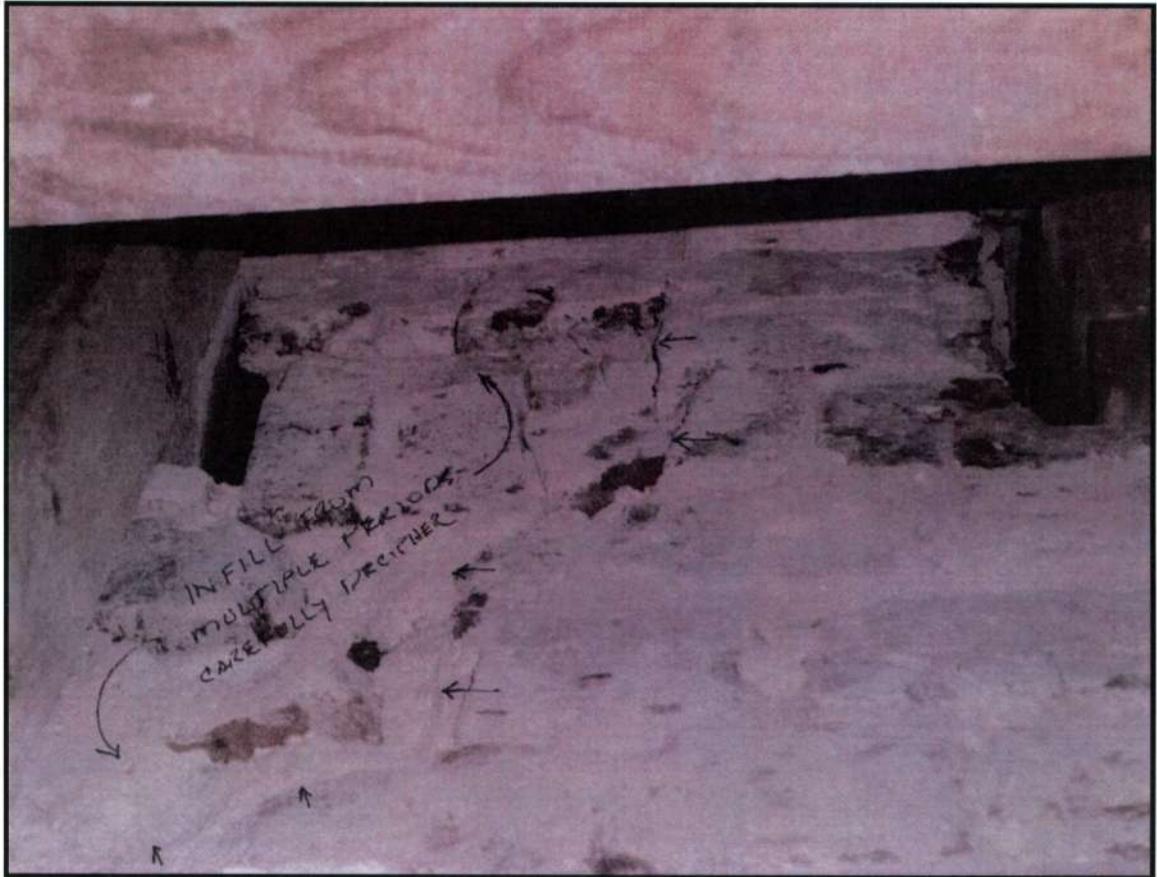
There is a patch of early masonry infill that may be related to the original door to the hall on the back wall approximately aligned with the right-hand column flanking the vestibule.

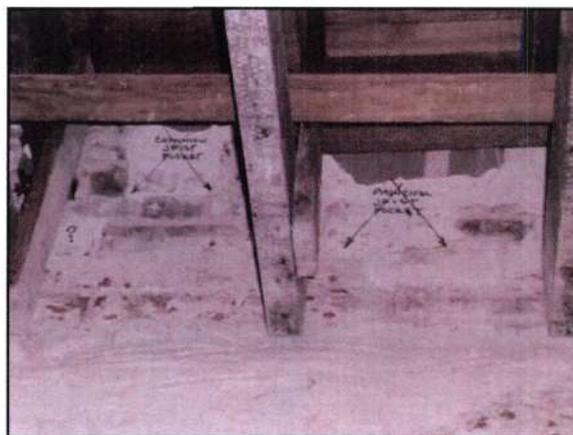
Yet unidentified alterations/patches at the far left end under the gallery at the wall intersection.
