Historical Consultant Report on Structural Floor Penetrations

Prepared by Keast & Hood Company

State of Maryland Department of General Services HVAC and Interior Piping Renovations Maryland State House

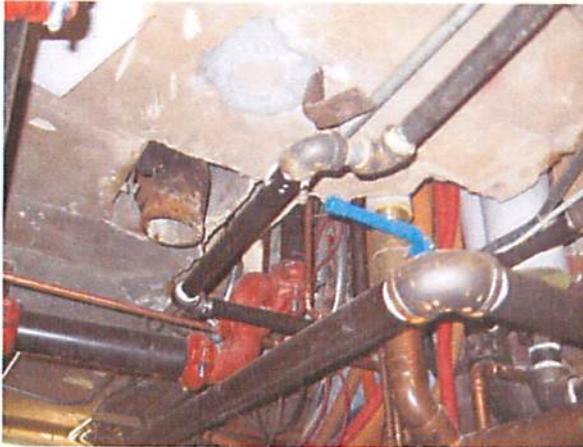
Below men's first floor restroom, 1902 basement floor assembly.

5.01 Abundant Ceiling Penetrations:

Many holes have been cut over the years without consideration of the structural consequences. Although most of the holes that we viewed date from prior renovations, some existing holes may have been enlarged or exacerbated during the current work. Such penetrations destroy the compression continuity of the flat tile arch system, as well as jeopardize the intended fireproofing functionality. Areas below the restrooms on each floor have been especially subjected to an accumulation of penetrations, causing significant damage.

Recommendation: All existing floor penetrations larger than 12"x12" should be reinforced with shotcrete.

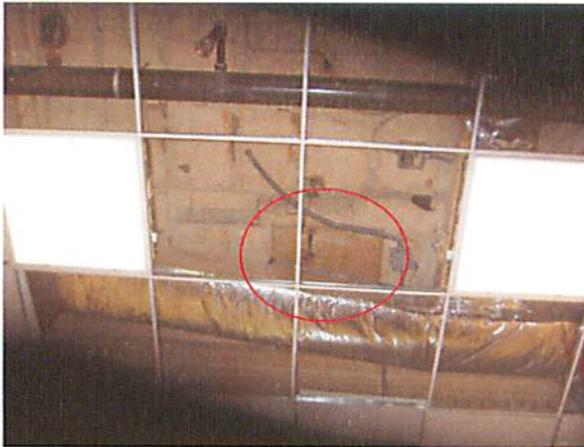
Located below attic floor assembly, 1902 building

5.02 Plywood Patchwork to Ceilings:

We observed several plywood patches under the attic floor in the Annex. It is not clear whether these represent new holes cut in the Attic floor, or new repairs to old holes, or old repairs to old holes. Such penetrations compromise the structural integrity of the entire framework, as well as fireproofing functionality. This particular patch is especially significant because it is part of the attic floor system. The attic floor is constructed in a completely different manner than the lower floors. The attic floor system more closely resembles a one-way slab of reinforced concrete,

with terra cotta tiles providing the compression area and the reinforcing rods resisting the tension stress. The floor deck of the attic spans from beam to beam (or between bearing walls) and is comprised of 4" deep three (3)-cell terra cotta tiles. The relatively shallow nature of the 4" attic floor system renders it extremely fragile in comparison to the other floors. Therefore, any additional penetrations to the existing terra cotta attic floor assemblies can seriously diminish or destroy their structural stability.

Recommendation: As the attic floor is extremely fragile with basically a zero live load capacity, new penetrations through this floor should be consistently avoided. Additionally, we also recommend that a thorough survey of all attic penetrations be conducted. Full documentation of these areas is necessary, and all penetrations should be promptly addressed on this level. Developing an outline of contractor guidelines specifically for the attic space is also recommended.

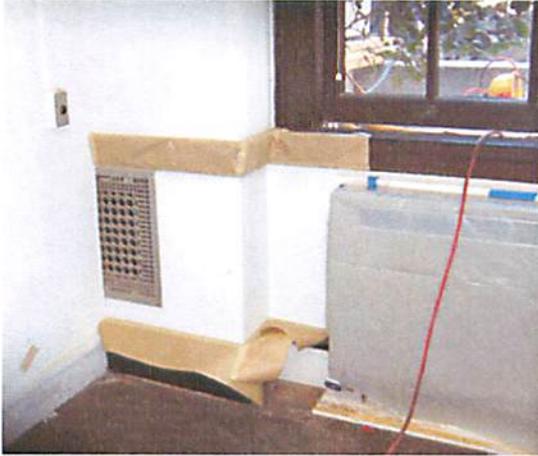
Fan coil unit adjacent to historic vertical shaft in pilaster.

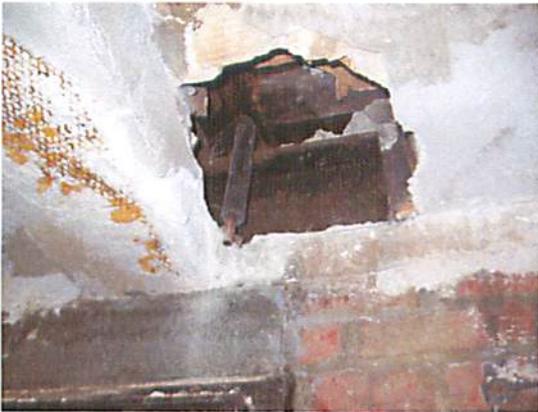
Damage to tile deck typical below fan coil units

Another typical location of structural damage to the tile decks is the holes that were historically cut to feed the fan coil units installed around the perimeter of the first and ground floors. These holes have been reused, although perhaps enlarged and/or altered, during the current renovations. It is unfortunate that alternative locations for vertical distribution of utilities could not be found during the design phase. Fortunately, it is not too late to repair the damage caused by the mechanical penetrations. Subsequent to our 2000 report, in which we recommended removing the tile entirely from beam to beam at large penetrations, we have had success retrofitting damaged tile decks with shotcrete. This is, however, a very messy operation.

Recommendation: Repair tile decks below fan coil units.

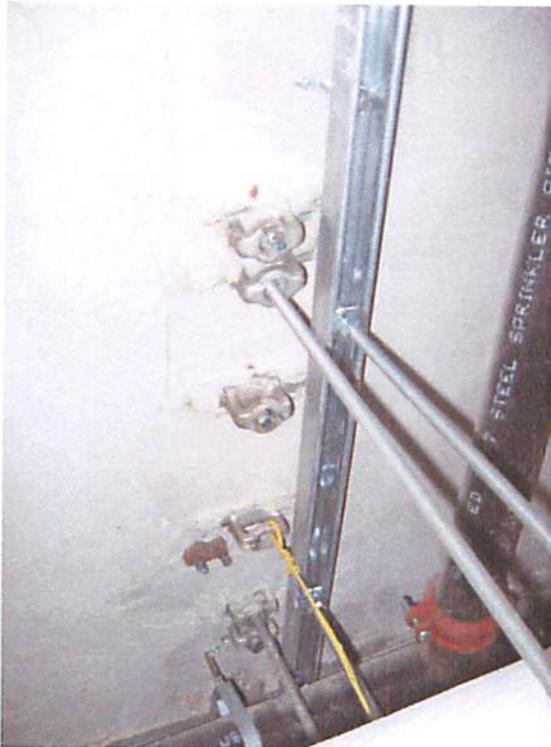
Found near southeast corner of 1902 basement floor assembly

5.04 Hanging HVAC and Plumbing Hardware Directly from Ceiling Tiles:

While this photograph actually depicts an appropriate historic ceiling hanger (left row of hangers) attached directly to a beam flange above, there are many locations in the basement ceiling where mechanical equipment is not supported from a beam, hanging directly from the ceiling tiles instead (right row of fasteners). Historic structural systems, such as the terra cotta tile arch system, are brittle and weakened by installing fasteners directly into the tile.

Recommendation: All attachments should have been directly hung from the bottom flanges of steel beams. K&H Co. recommends that the steel anchor manufacturers be required to perform pull-out tests to qualify the existing installations.

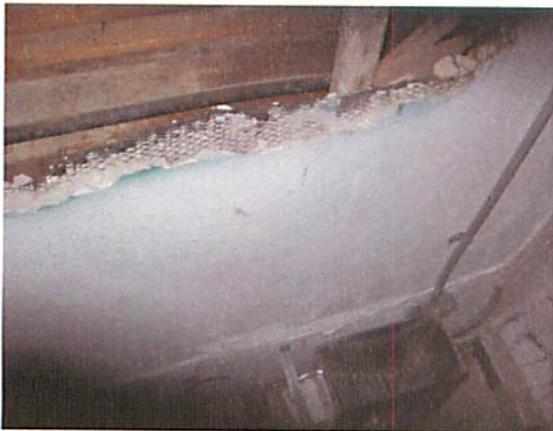
Looking up, northwest corner of 1772 basement

5.05 Loss of Plaster Ceiling:

Plaster was frequently an integral component of the fireproofing system. Large plaster losses such as shown could reduce fire separation protection between floors. Moreover, any additional loss of plaster may affect the building's overall fire rating.

Recommendation: The Architect and state Fire Marshal should advise on existing rated fire assemblies.

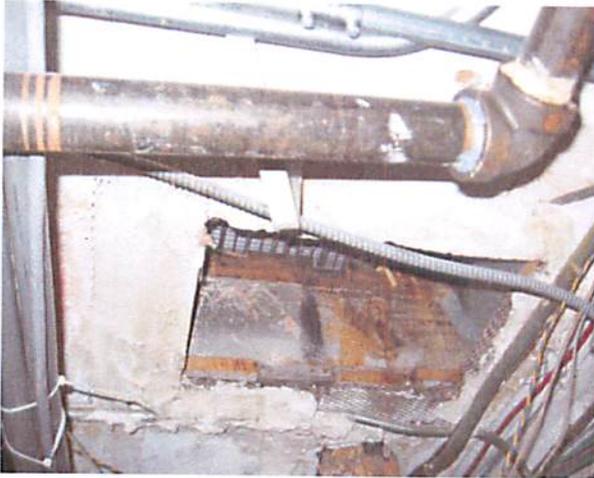
Located below the former visitor's center, in 1772 basement

5.06 Diffuser Grill Notched into Floor Joist:

Here, ductwork cuts into the original wooden floor joists. Such intrusive additions weaken joist live load capacities.

Recommendation: Mechanical system work should avoid joist penetrations, unless the penetrations are compensated for with remedial structural details.

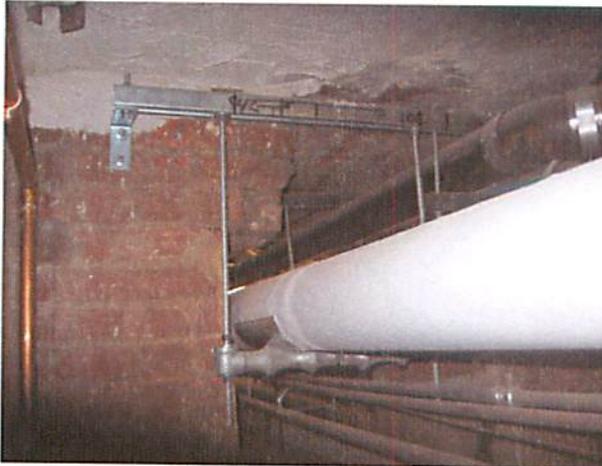
Located near southeast corner of 1902 sub basement

5.07 Masonry Wall Penetrations:

In addition to the floor/ceiling assemblies on all levels being subjected to adverse penetrations, large holes have been cut through foundation walls. Here, there are no lintels or sleeves in place to support this hole and provide structural and fire-separation continuity.

Recommendation: Coring is acceptable under certain conditions. Otherwise, install lintels or sleeve details to sufficiently support all existing masonry wall penetrations, and maintain fire separations where appropriate.

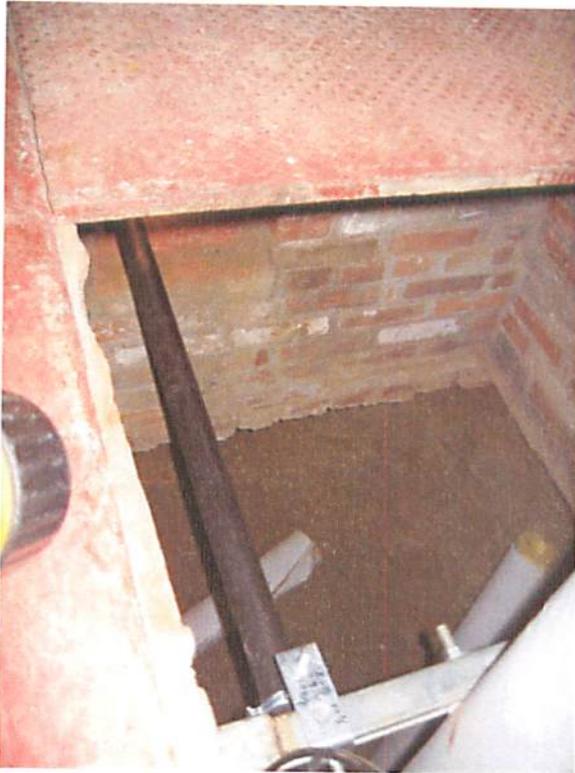
Found in the 1772 basement, immediately to the right of the doorway to the 1902 sub basement

5.08a Deep Shafts not Underpinned:

These photographs depict raw earth exposed below foundation walls in two separate areas.

Recommendation: These areas need to be properly underpinned immediately.

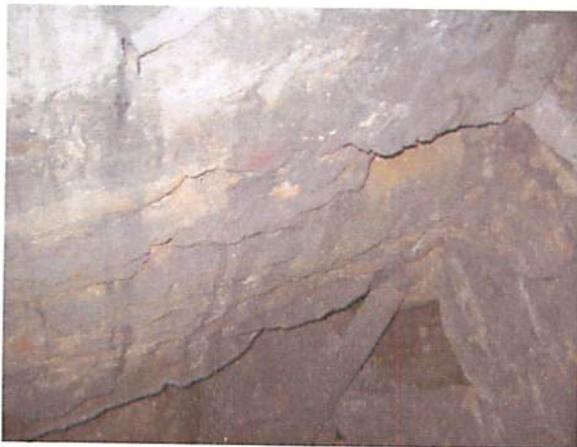
Found along the northeast wall, 1772 basement.

5.08b

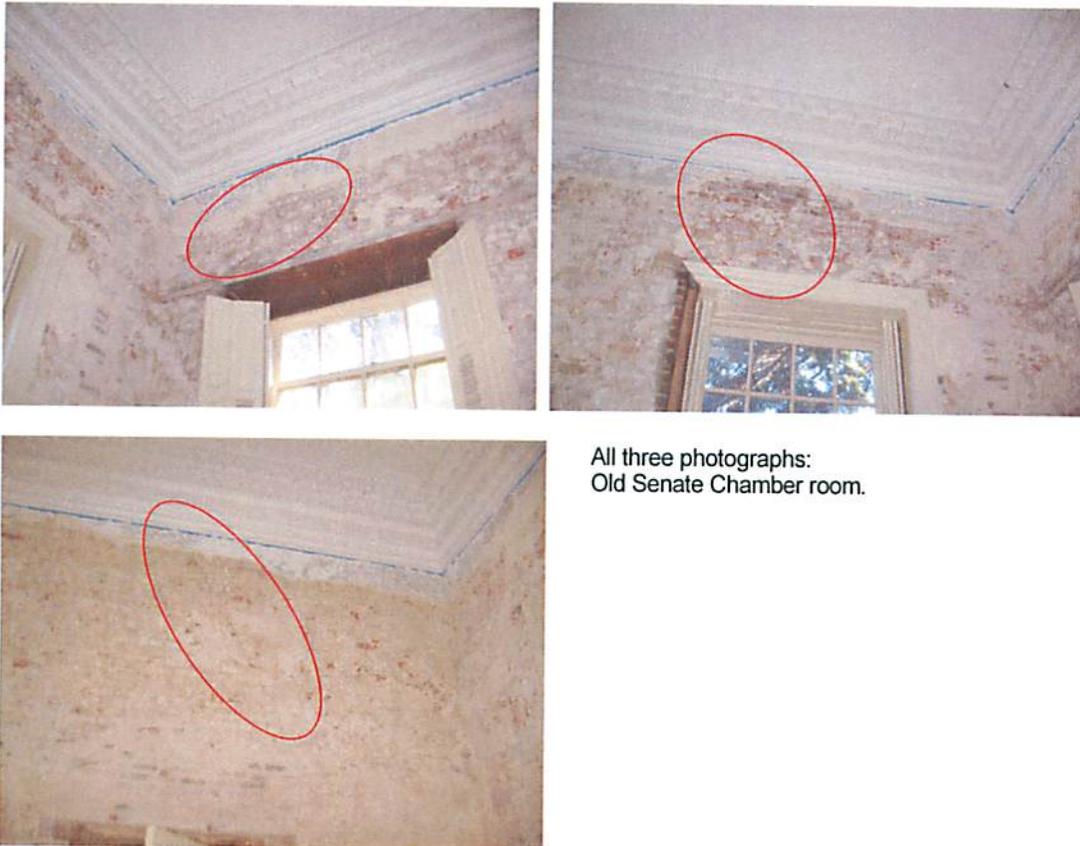
All three photographs:
Old Senate Chamber room.

5.09 Cracked Walls:

As a direct result of the lack of foundation shaft underpinning, additional building settlement and separation has occurred. Significant cracks were observed in both the interior and exterior walls of the Old Senate Chamber on the second floor, as well as the second floor wall bordering on the brick-vaulted room. The cracked wall areas correspond with the locations of the undermined foundations shown in 5.08b and 5.10.

By previous reports, the wall plaster had been subject to moisture damage. We found evidence of a decayed wood nailer embedded in the brickwork. The fungal decay of the wood demonstrates that the brick wall has been subject to sustained high moisture content, a condition which does not exist in the tile decks. The presence of structural settlement cracks in the walls, likely due to the foundation undermining noted previously, is an obvious source of moisture penetration which must be addressed.

Recommendation: Fill cracks in these walls and address moisture intrusion issues before replastering in Old Senate Chamber occurs; concurrently, address underpinning needs of foundation walls.

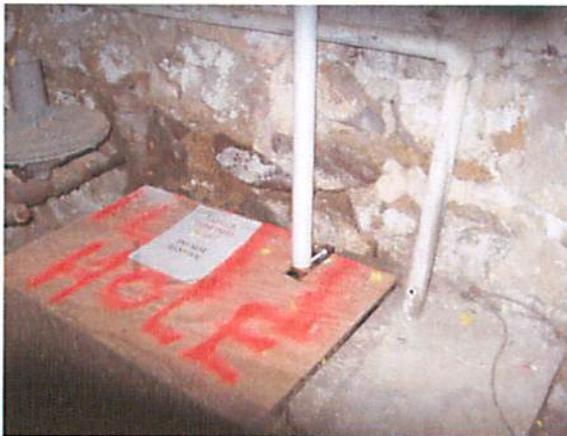
Found along the northeast wall, 1772 basement.

5.10 Potential Loss of Stone Above Foundation Tunnel Opening:

This plywood covering prevented us from fully investigating the condition of the undercut foundation wall.

Recommendation: This temporary plywood covering should be removed for further investigation of this location. All undercut stonework needs to be adequately supported.
