Maryland Historical Trust

Maryland Inventory of Historic Properties number: AL-V-A-307

Name: COLUMBIA STREET OVER JENNINGS RUN

**Description:**

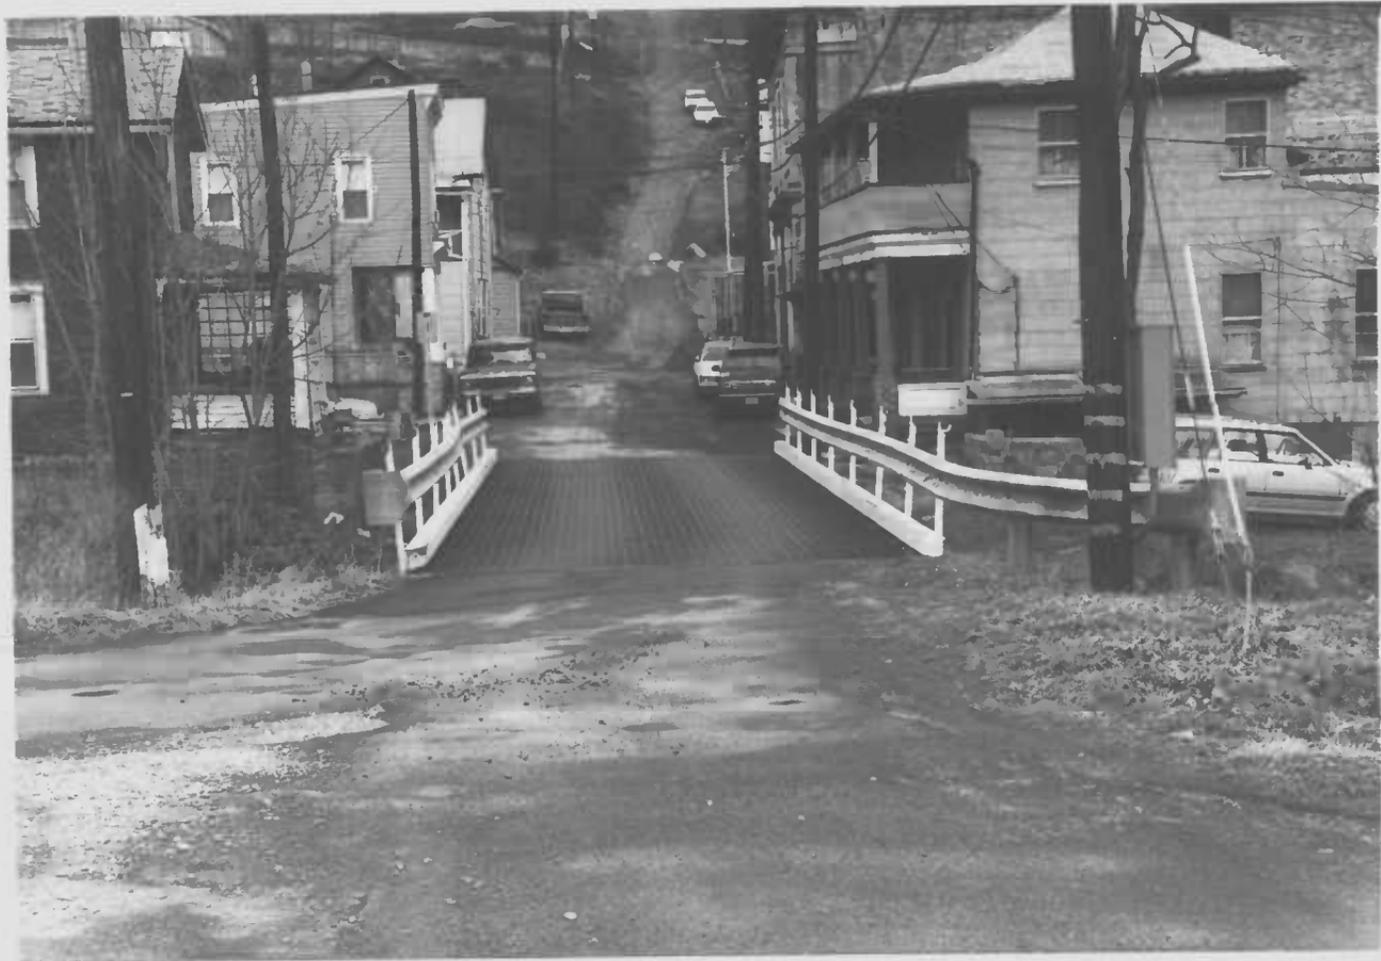
1 OF 4

SOUTH APPROACH

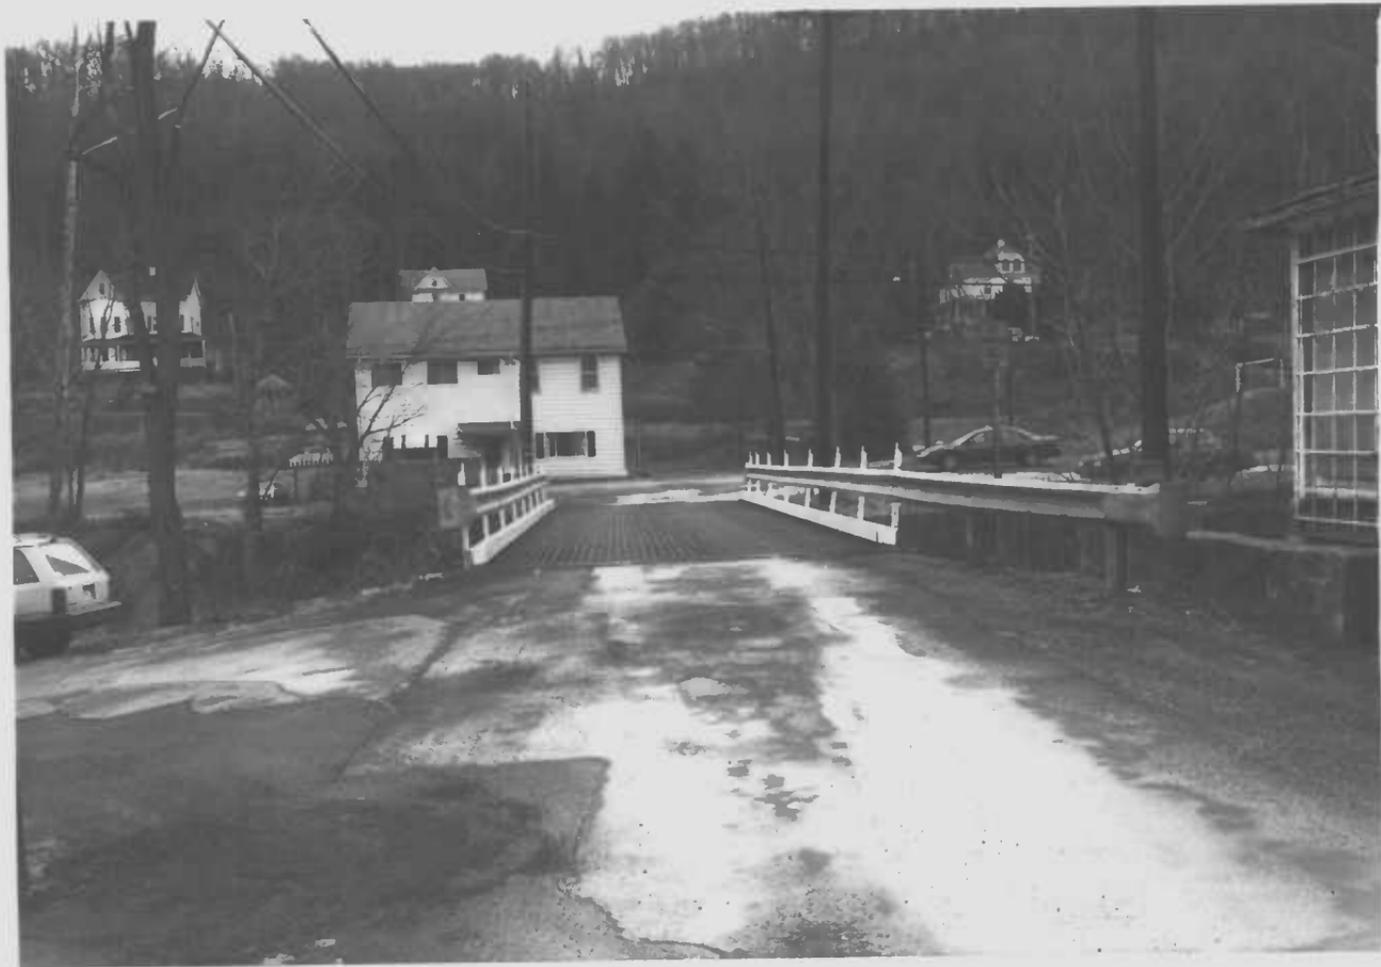
2 OF 4

NORTH APPROACH

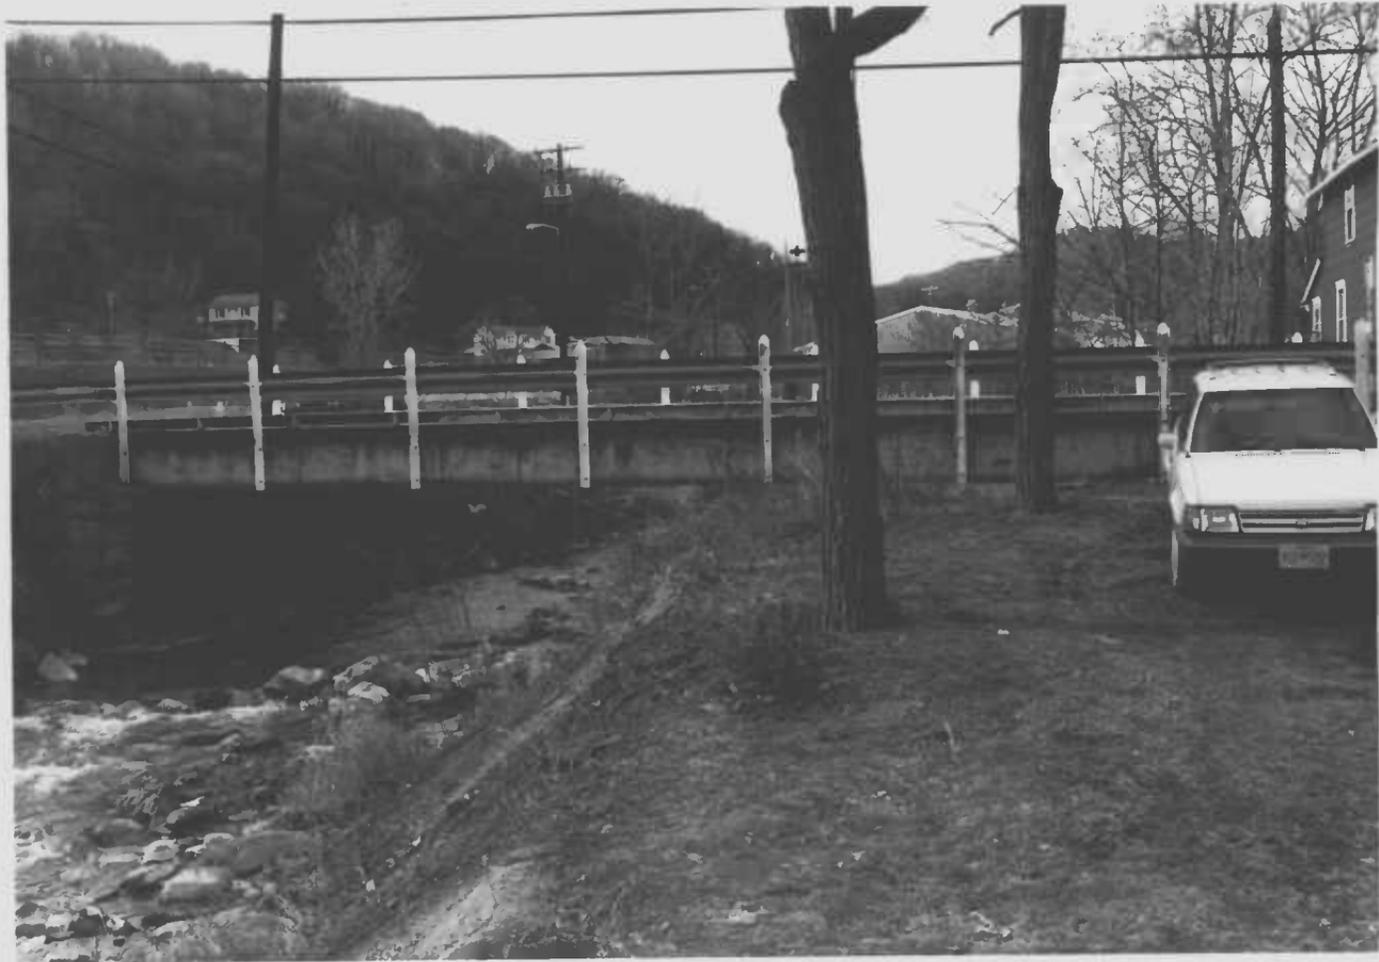
3 OF 4

EAST ELEVATION (DOWNSTREAM)

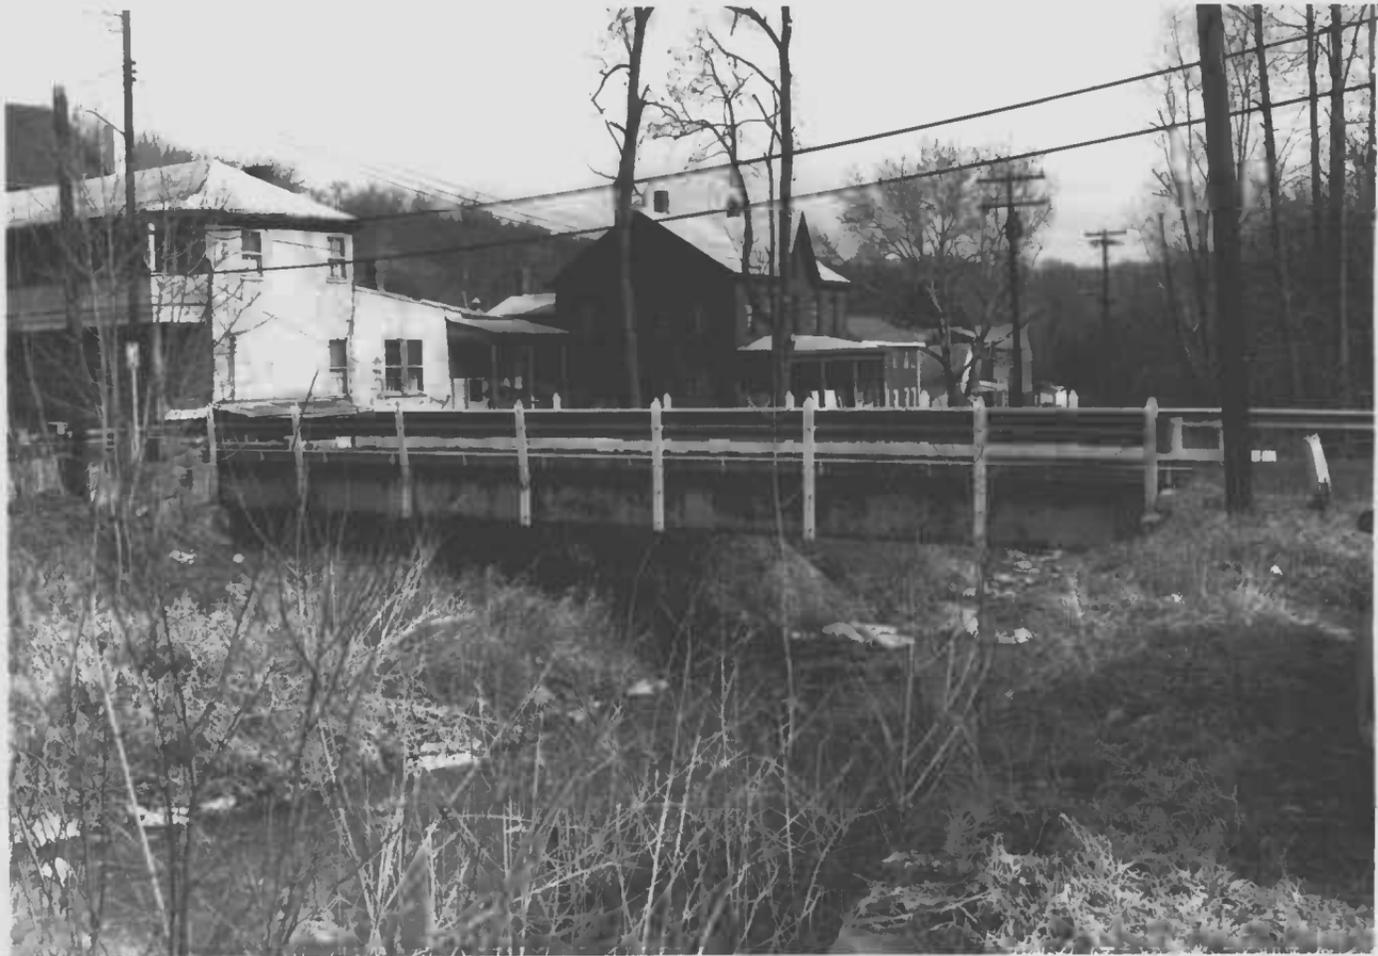
4 OF 4

WEST ELEVATION (UPSTREAM)
