# Maryland Historical Trust State Historic Sites Inventory Form

and/or common TENANT HOUSE ON ST. GEORGE BARBER PROPERTY

Survey No. AA-845

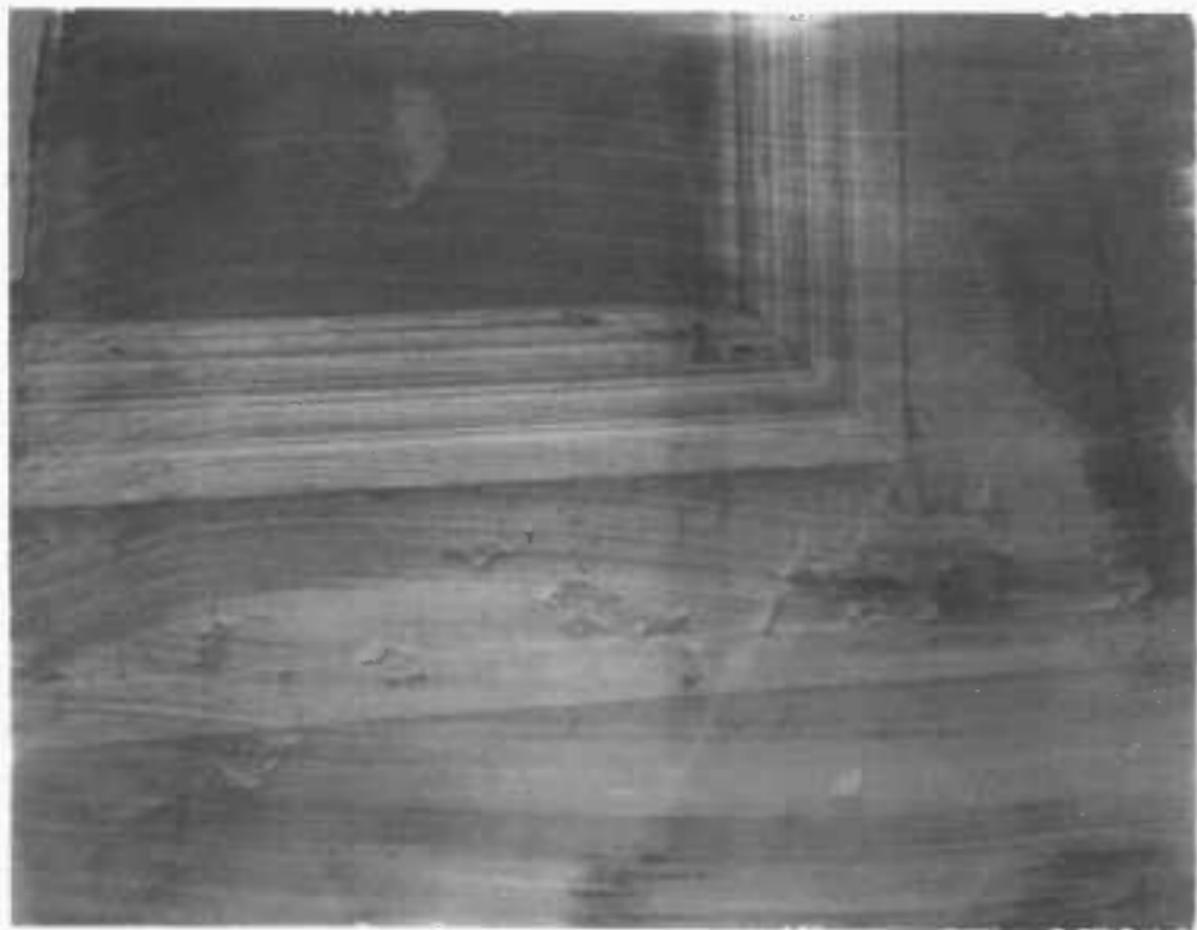
Interior trim detail
