1. STATE Maryland
 COUNTY Baltimore
 TOWN Lutherville VICINITY
 STREET NO. Kurtz and Melanchthon Avenues

HISTORIC AMERICAN BUILDINGS SURVEY INVENTORY

2. NAME St. Paul's Evangelical Lutheran Church

DATE OR PERIOD 1898-1899
 STYLE Shingle Style
 ARCHITECT
 BUILDER Emanuel Herman

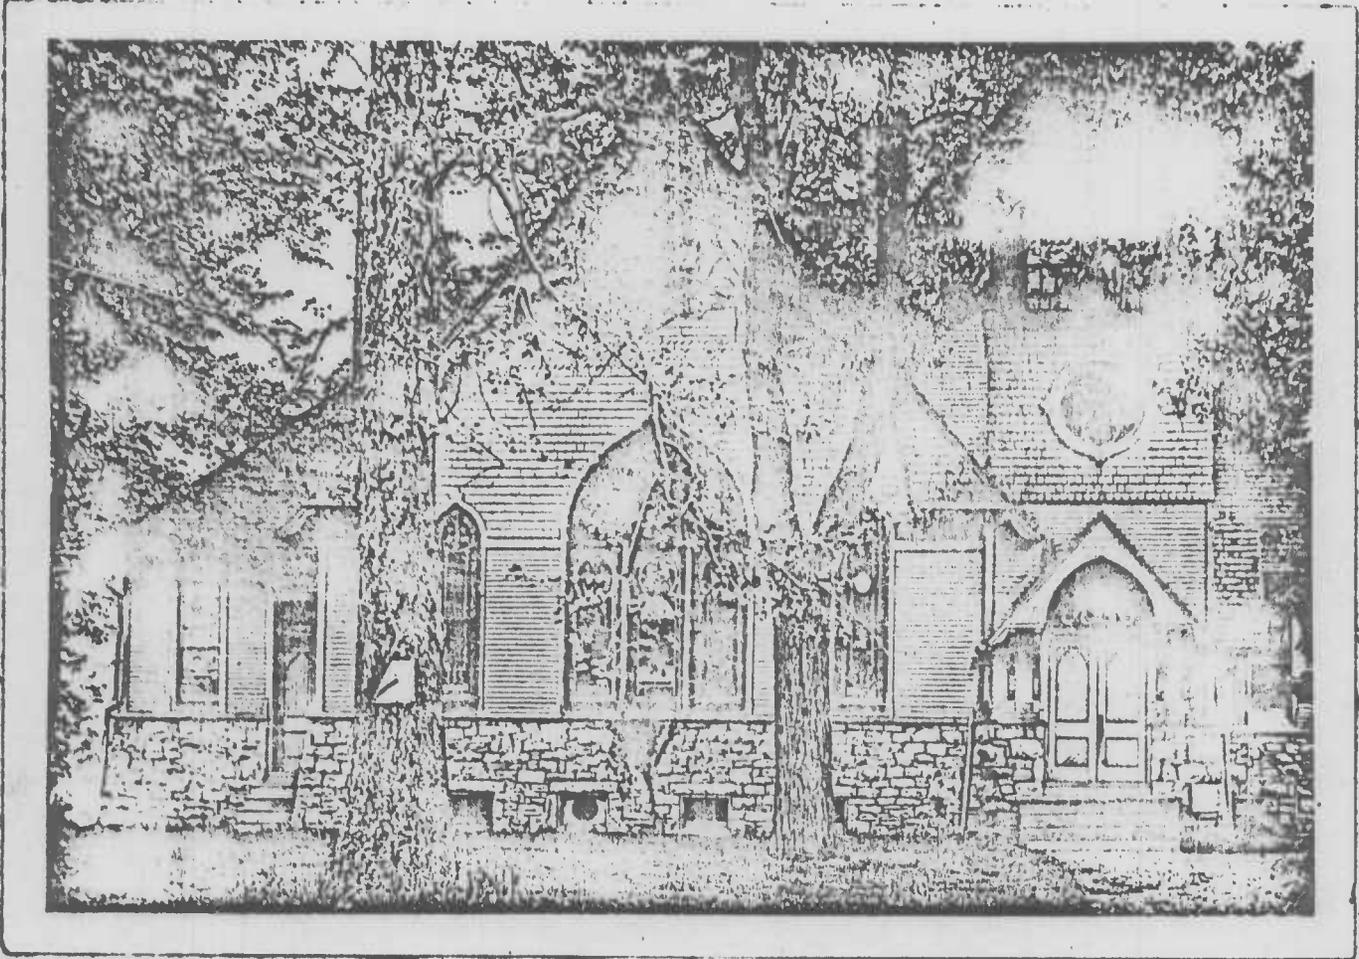
St. Paul's Evangelical Lutheran Church, Kurtz and Melanohthon
Avenues, Sheet 3

An old view of St. Paul's, circa 1915.
