090 13153 04

POSTMAN HOUSE
CH-131

"BURDETTE'S REST"

CH-131
 FIELD SKETCHES 24 JUNE 1970
 BURDETTE'S REST
 CHARLES COUNTY, MD.

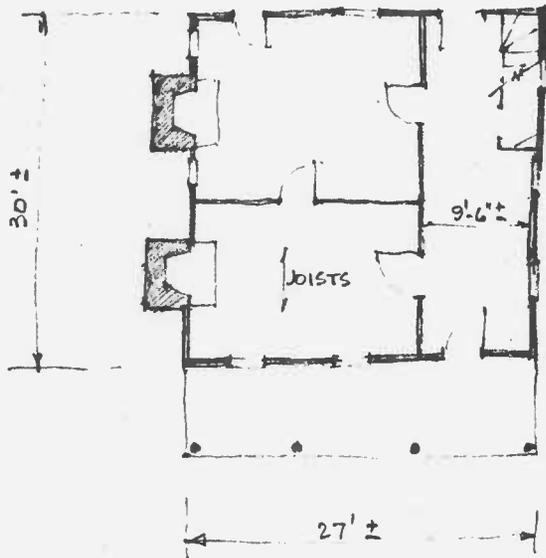
FIRST FLOOR

VERT. BOARD PARTITION REMOVED. 6P DOOR IN HALL, STILL

JOISTS NOT CONTINUOUS N TO S. LAPPED 2' ± OVER PARTITION. NO EVIDENCE OF DIFFERENT AGE

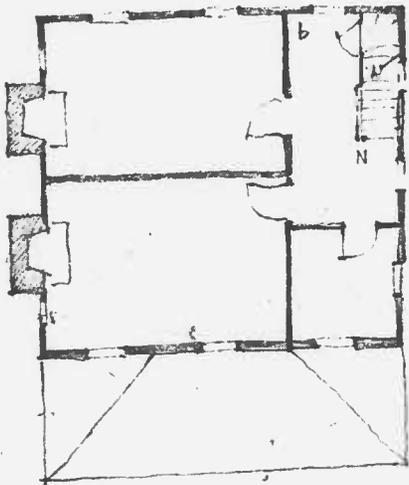
SECOND FLOOR

b BEADED HORIZONTAL WAINSCOT

N PAIR SQUARE NEWELS

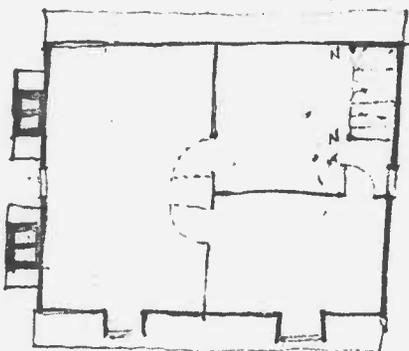
THIRD FLOOR

N ARCHED NEWEL
