**CARR- 217 St. Paul's Lutheran Church**

FIELD SHEET--HISTORIC RESOURCES SURVEY

SURVEY NUMBER: CARR-217

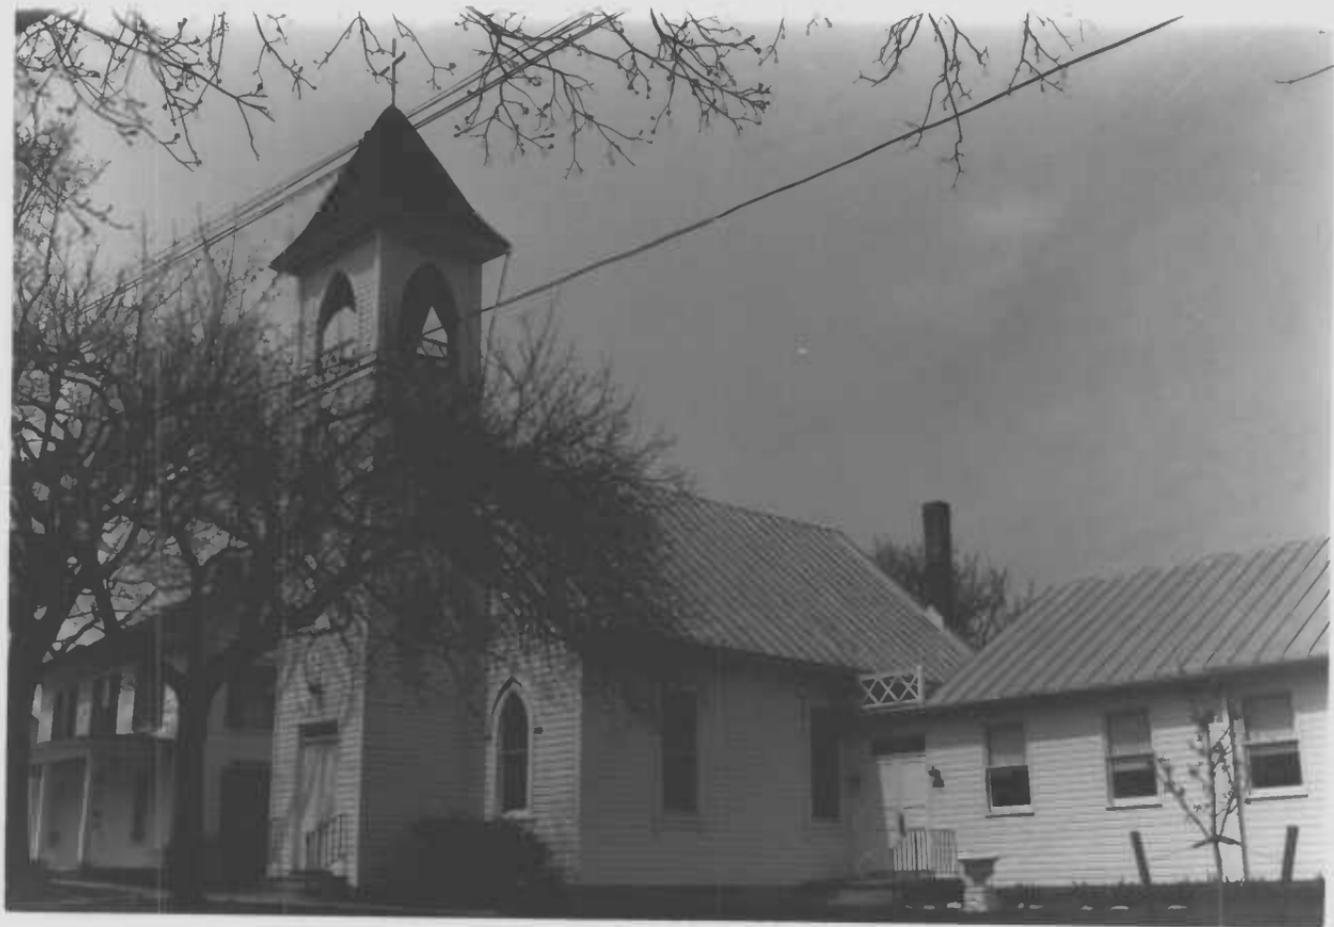
1. CARR-217 St. Paul's Lutheran Church
2. Carroll County, Maryland
3. Joe Getty
4. November, 1984
5. Maryland Historical Trust, Annapolis, Md.
6. South & east elevations (camera facing  
northwest)
7. 1/1
