CARR - 407

FENBY FARM

Fenby Farm Road  
Westminster vicinity

FIELD SHEET--HISTORIC RESOURCES SURVEY

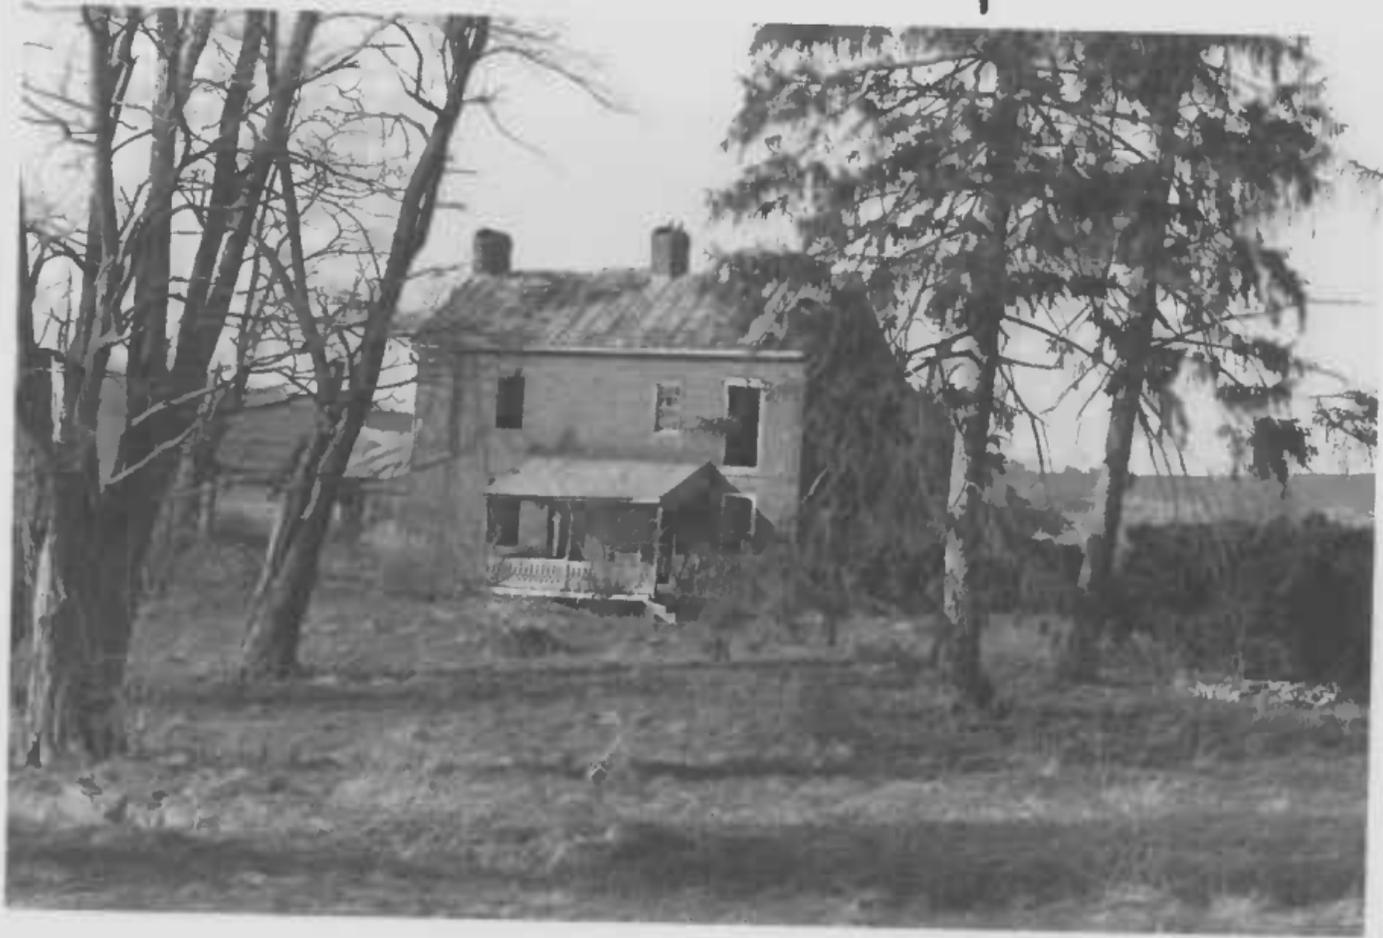
CARR-407

south elevation
