CARR - 681

839 MEDFORD ROAD

FIELD SHEET--HISTORIC RESOURCES SURVEY

SURVEY NUMBER: CARR-681

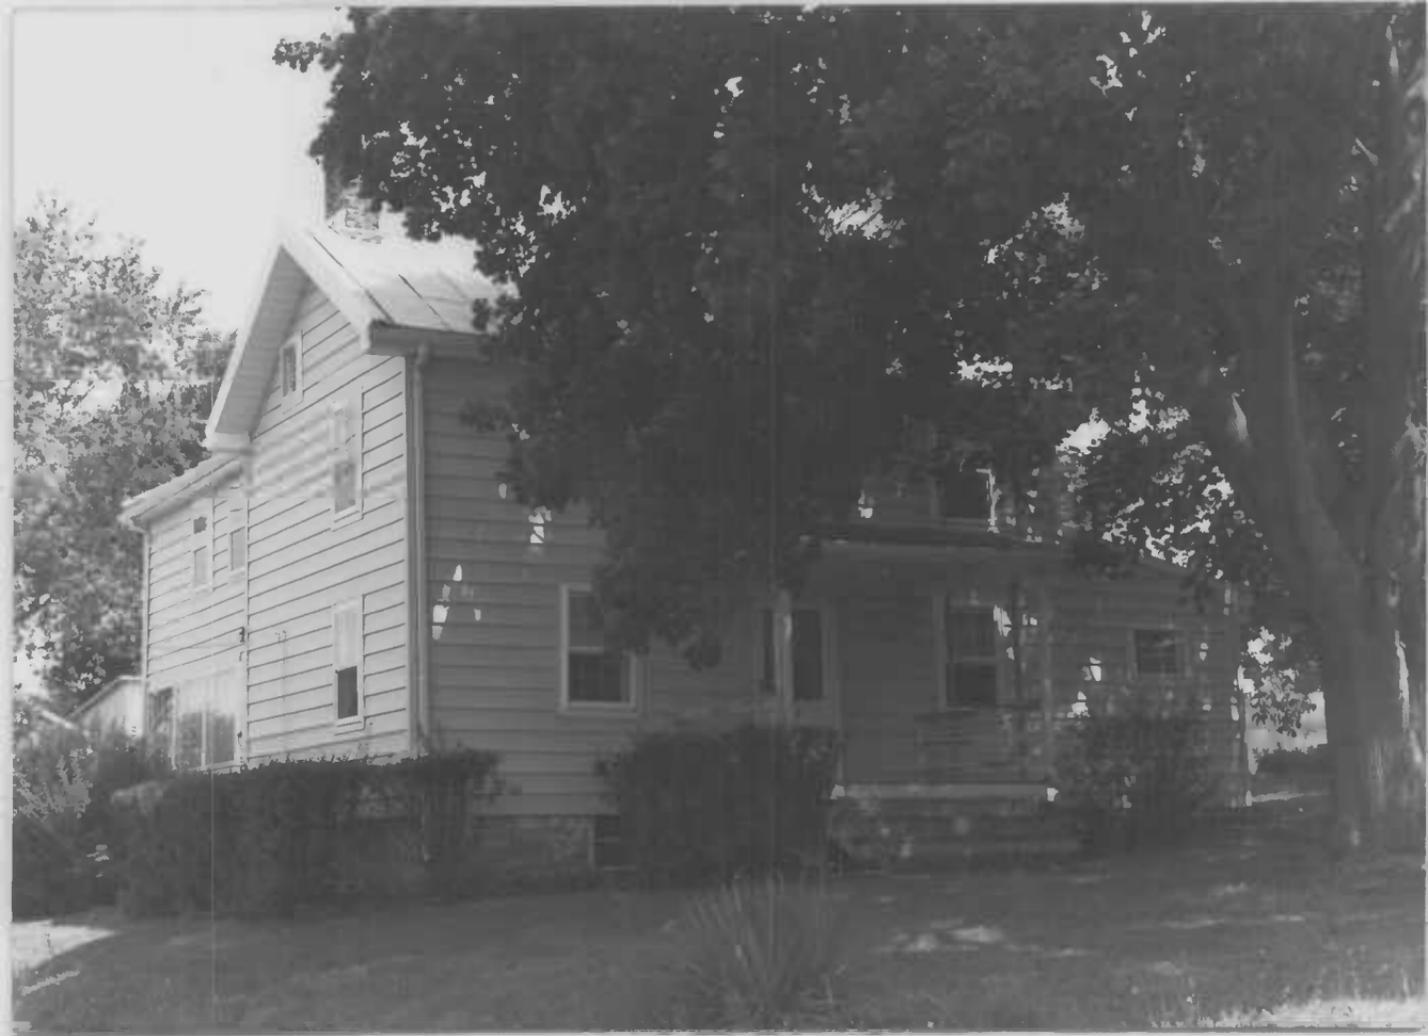
1. CARR-681 839 MEDFORD ROAD
2. Carroll County, Maryland
3. Joe Getty
4. August 1983
5. Md. Historical Trust, Annapolis, Md.
6. South and west elevations (camera facing northeast)
7. 1/1
