CARR-1324

Fair-Miller Farm  
5133 Schalk Road One

# Maryland Historical Trust State Historic Sites Inventory Form

Survey No. Carr-1324

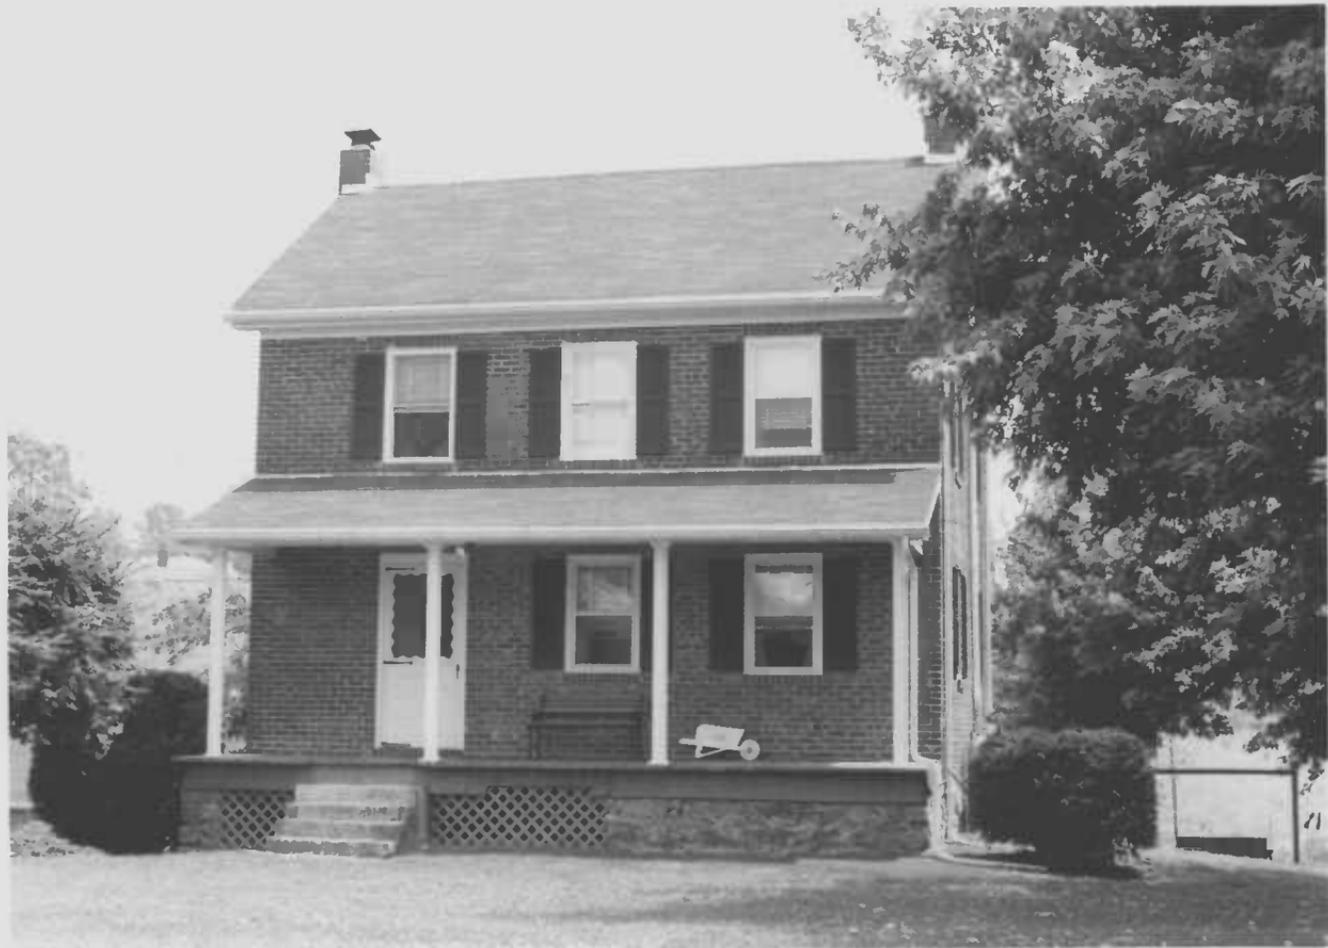
15

house - northwest elevation

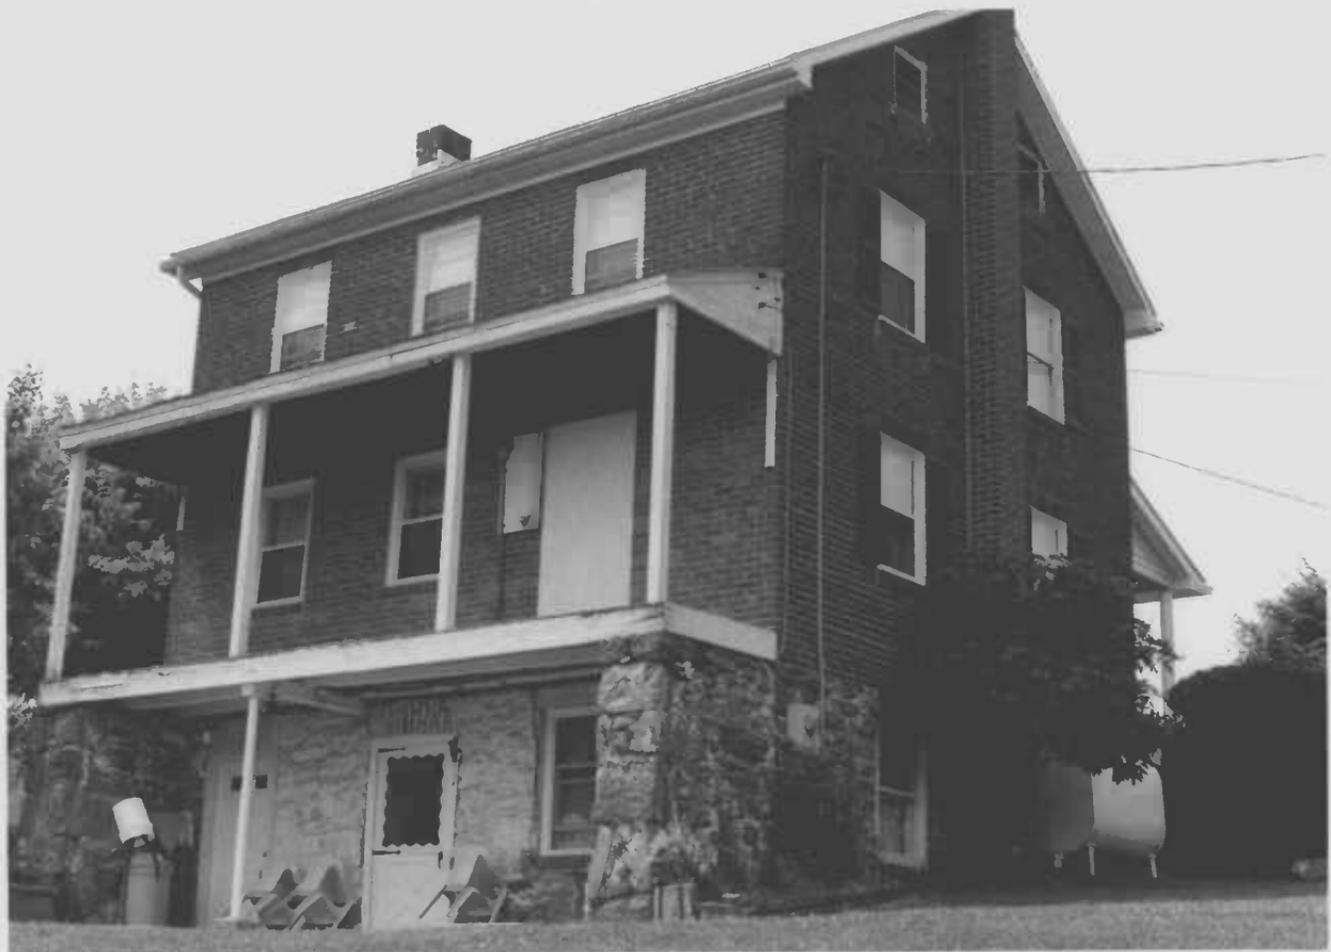
3/0

house - Southeast = northeast elevation is

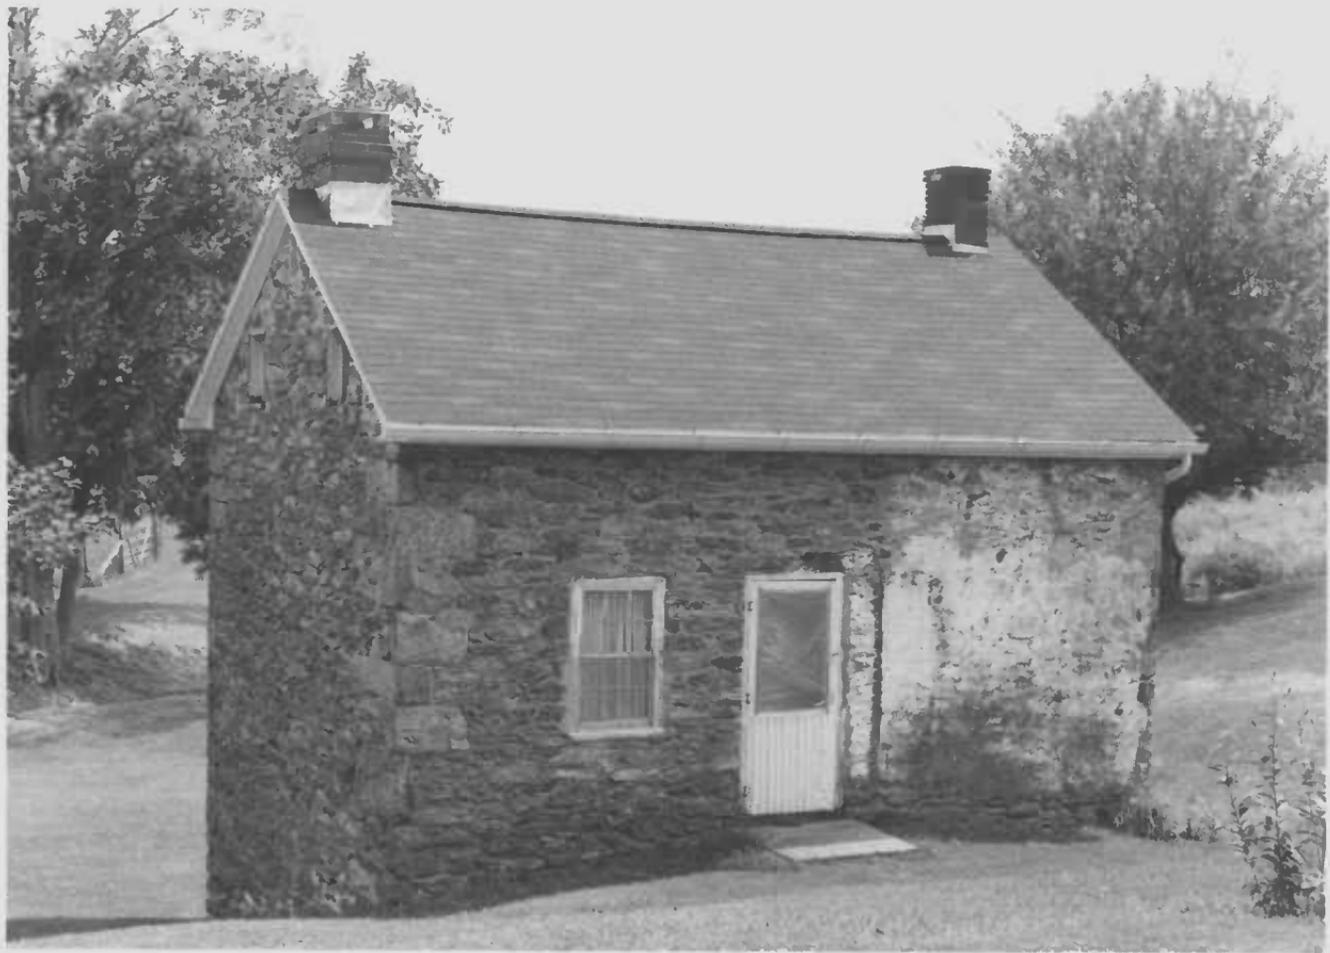
Stone house - northeast - northwest elevations

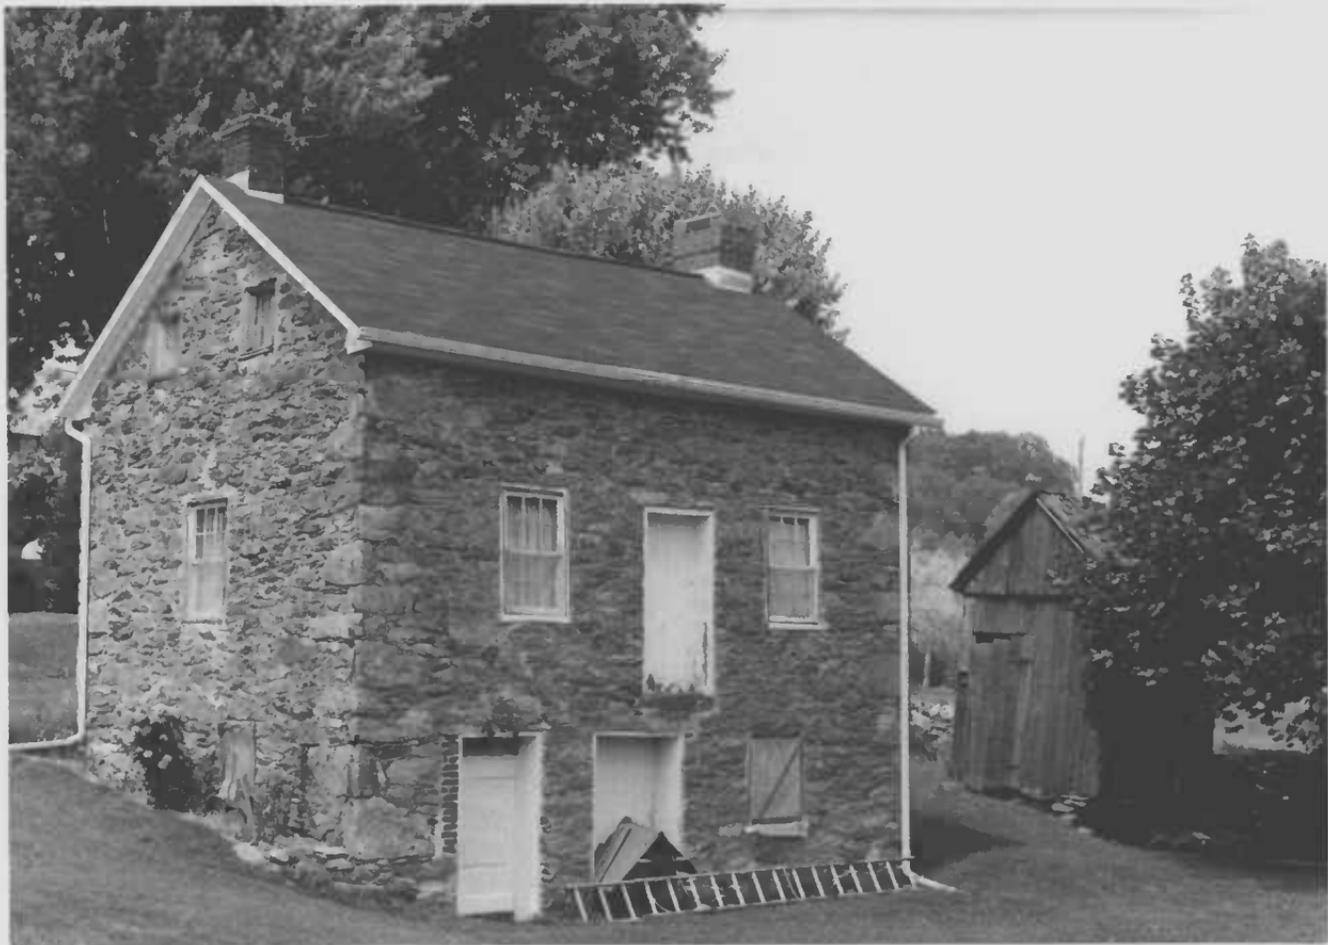
4/6

<sup>Stone</sup> House - Southeast - Southwest elevations

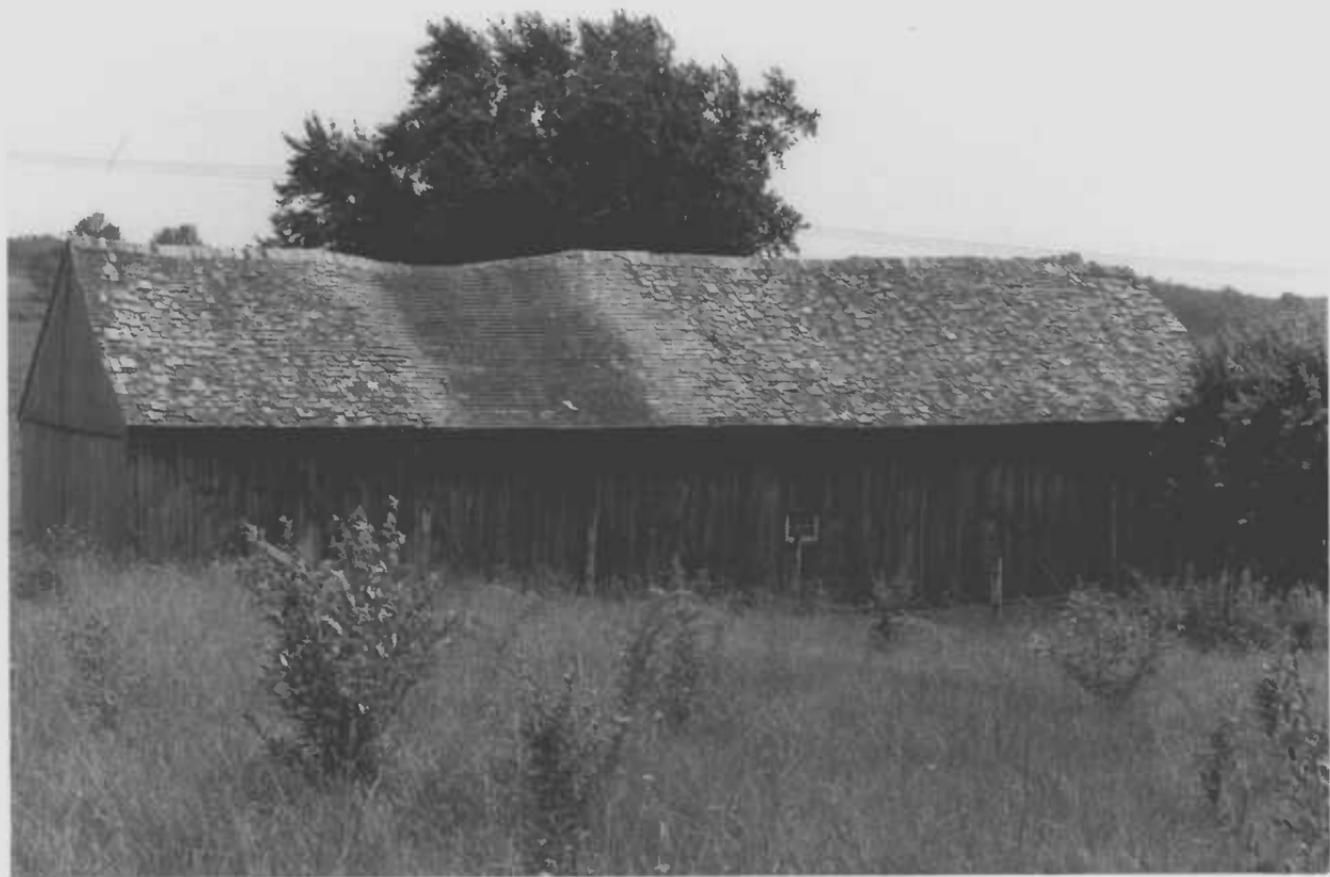
5/6

Dam - northeast & northwest elevations

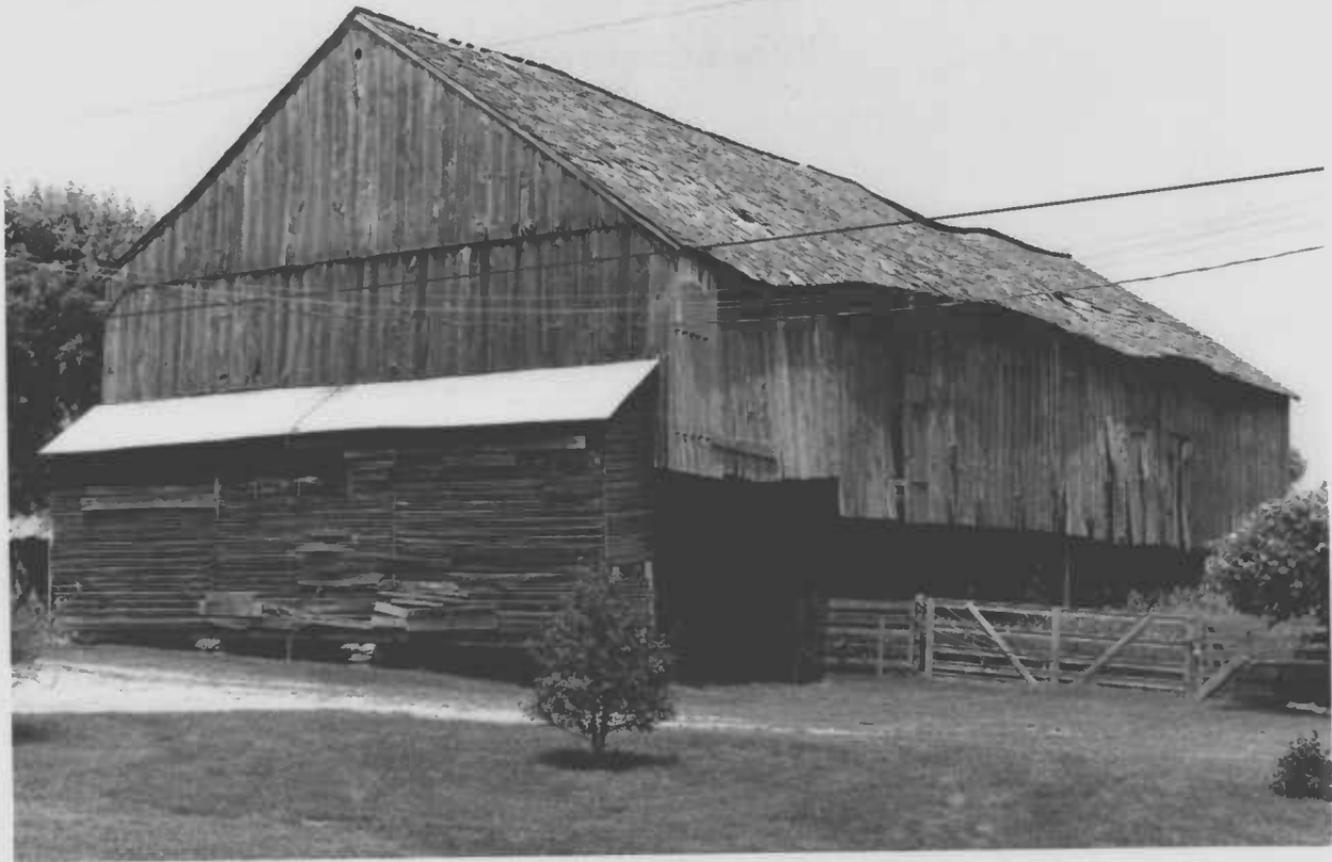
1/1

barn - southwest & southeast elevations
