HA - 1752

Deaton Farm

Bel Air, Maryland

# Maryland Historical Trust State Historic Sites Inventory Form

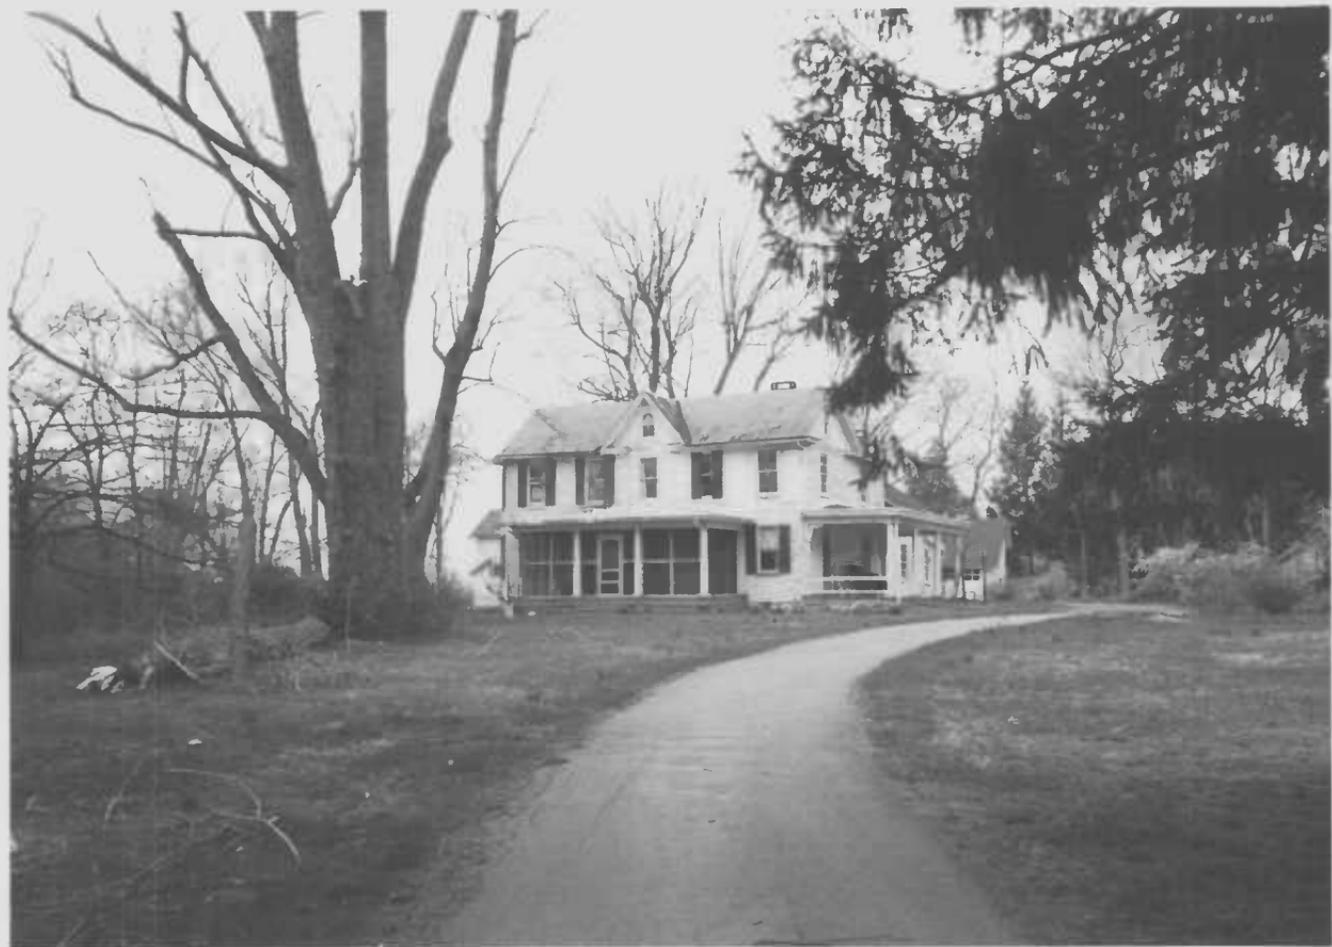
1/13

General view from entrance drive of southeast elev.

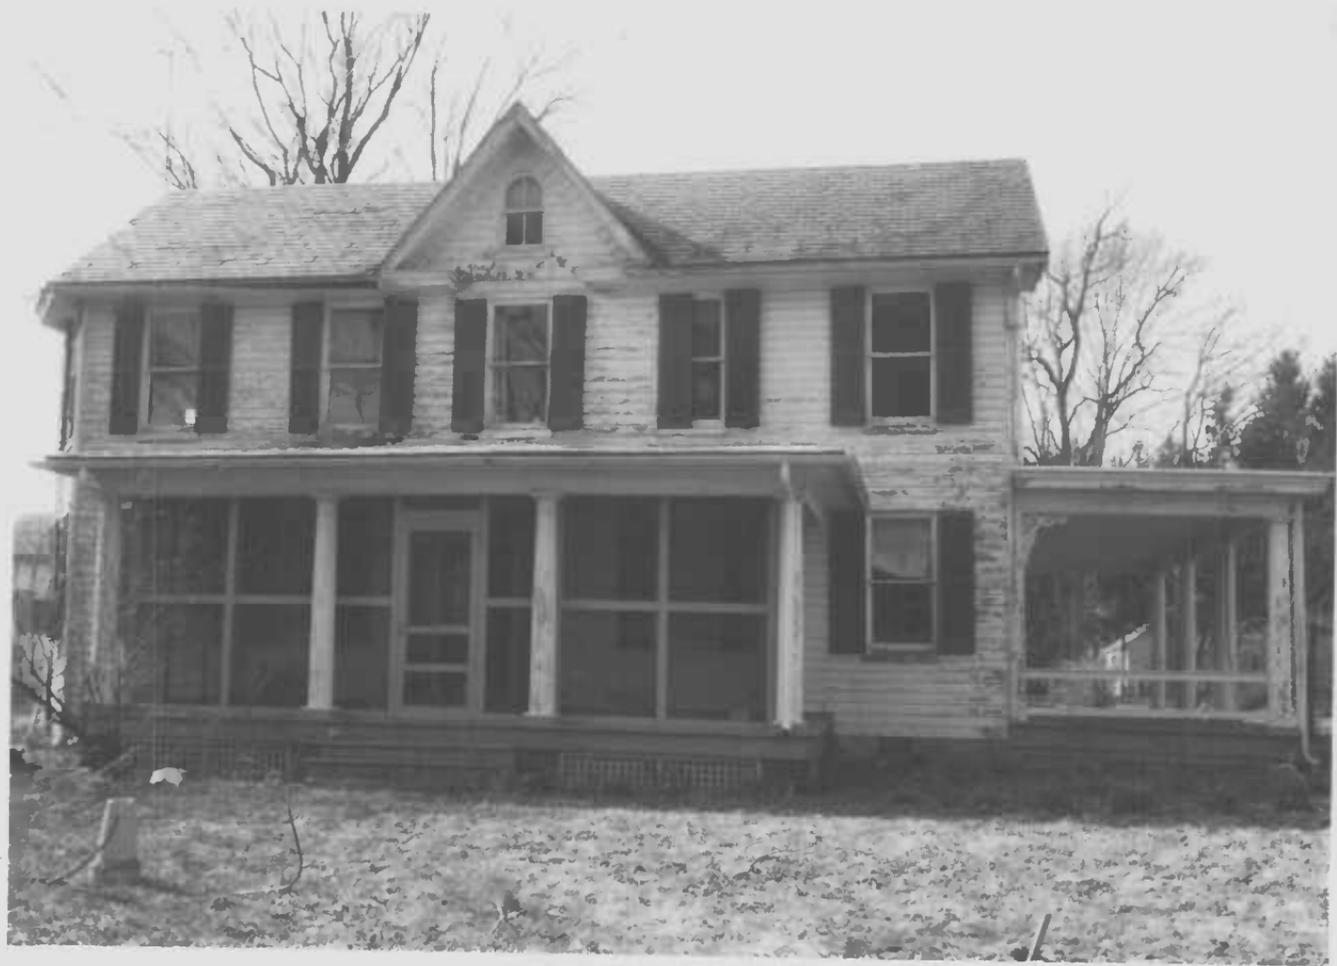
2/13

Southeast elevation

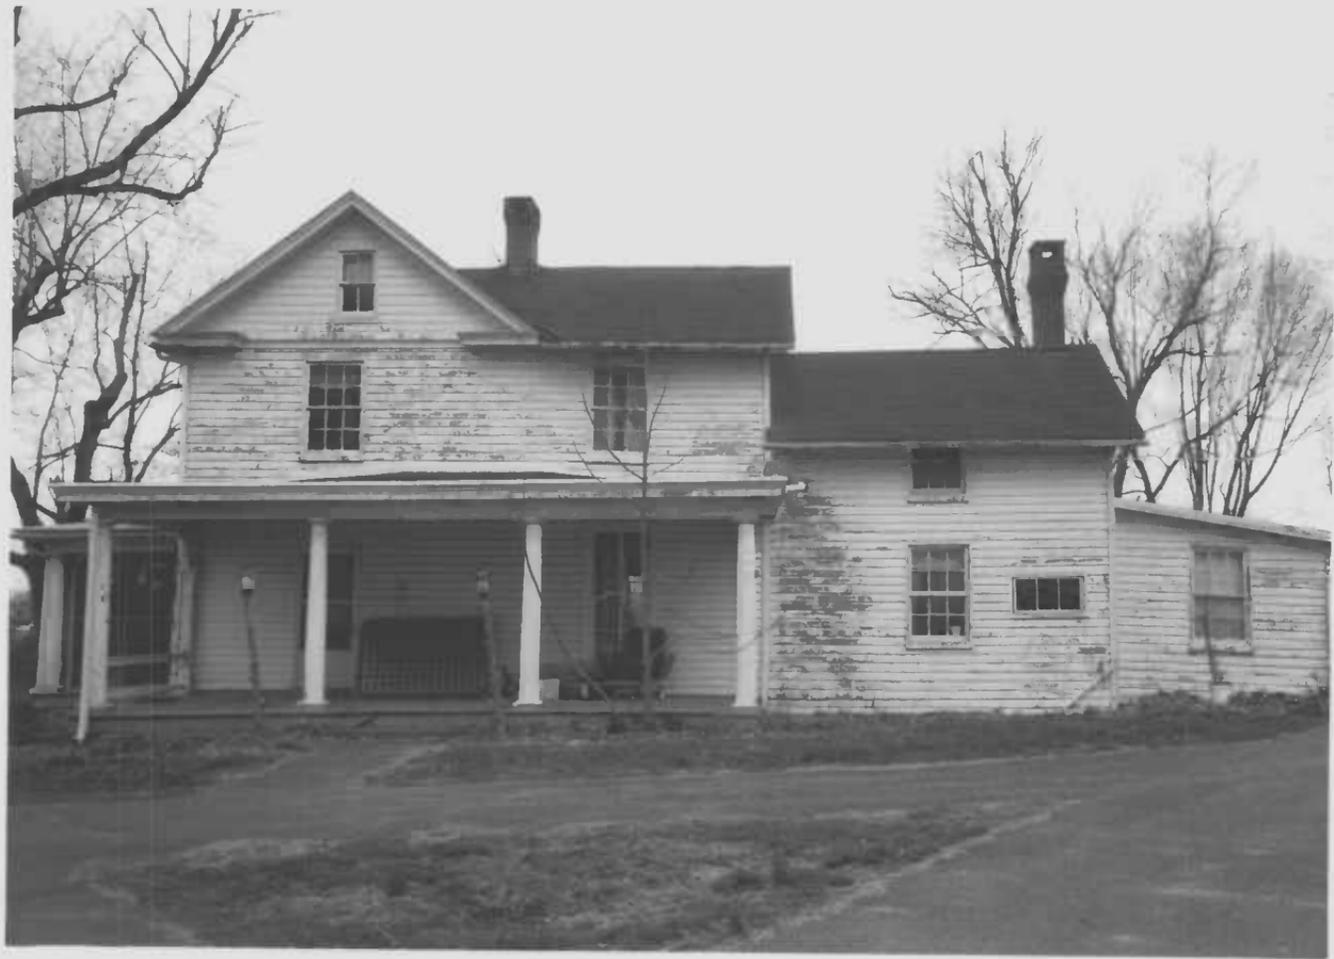
3/13

Northeast elevation

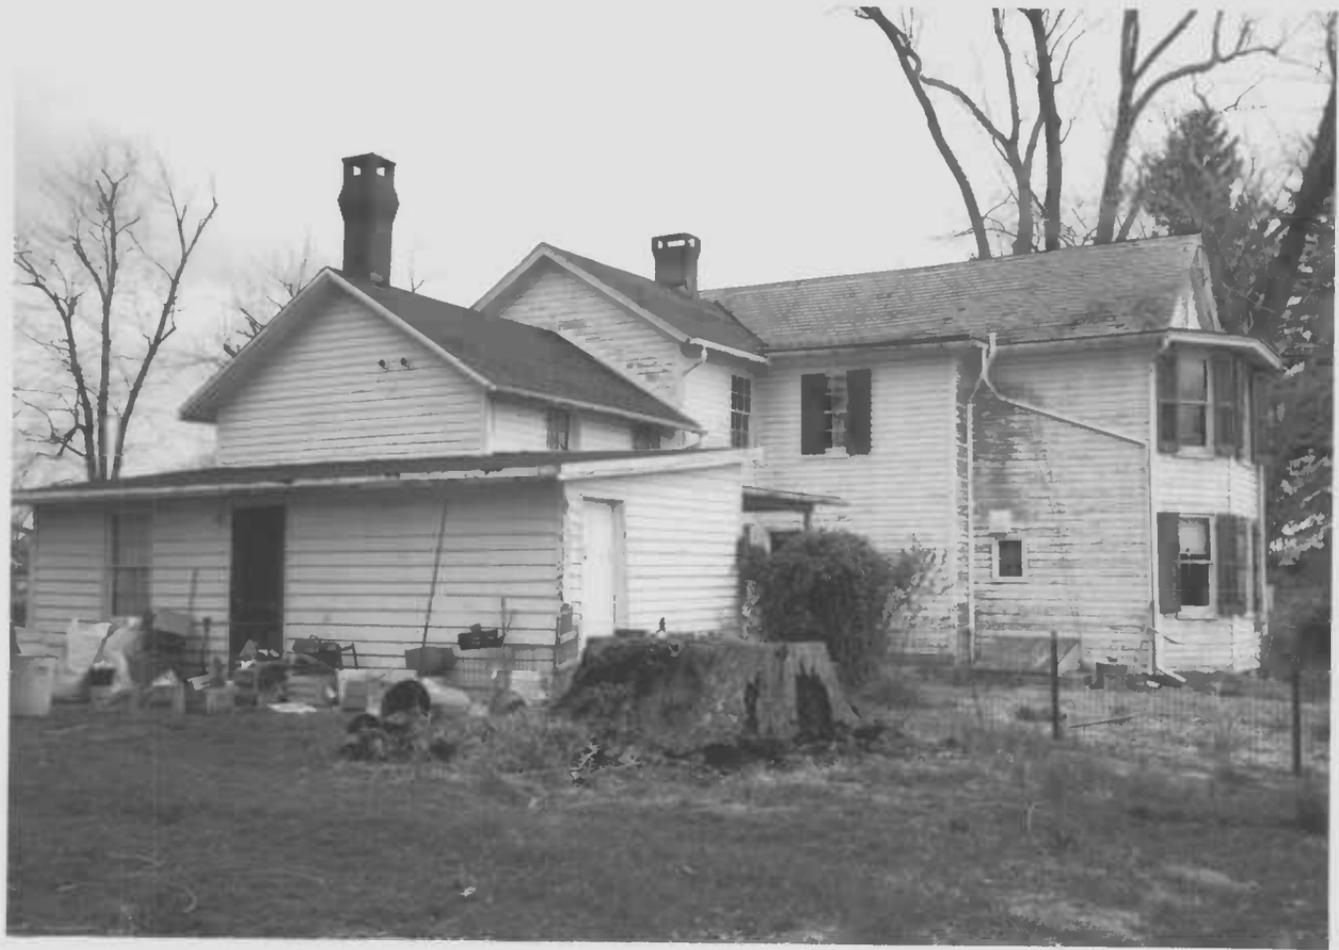
5/13

Northwest elevation

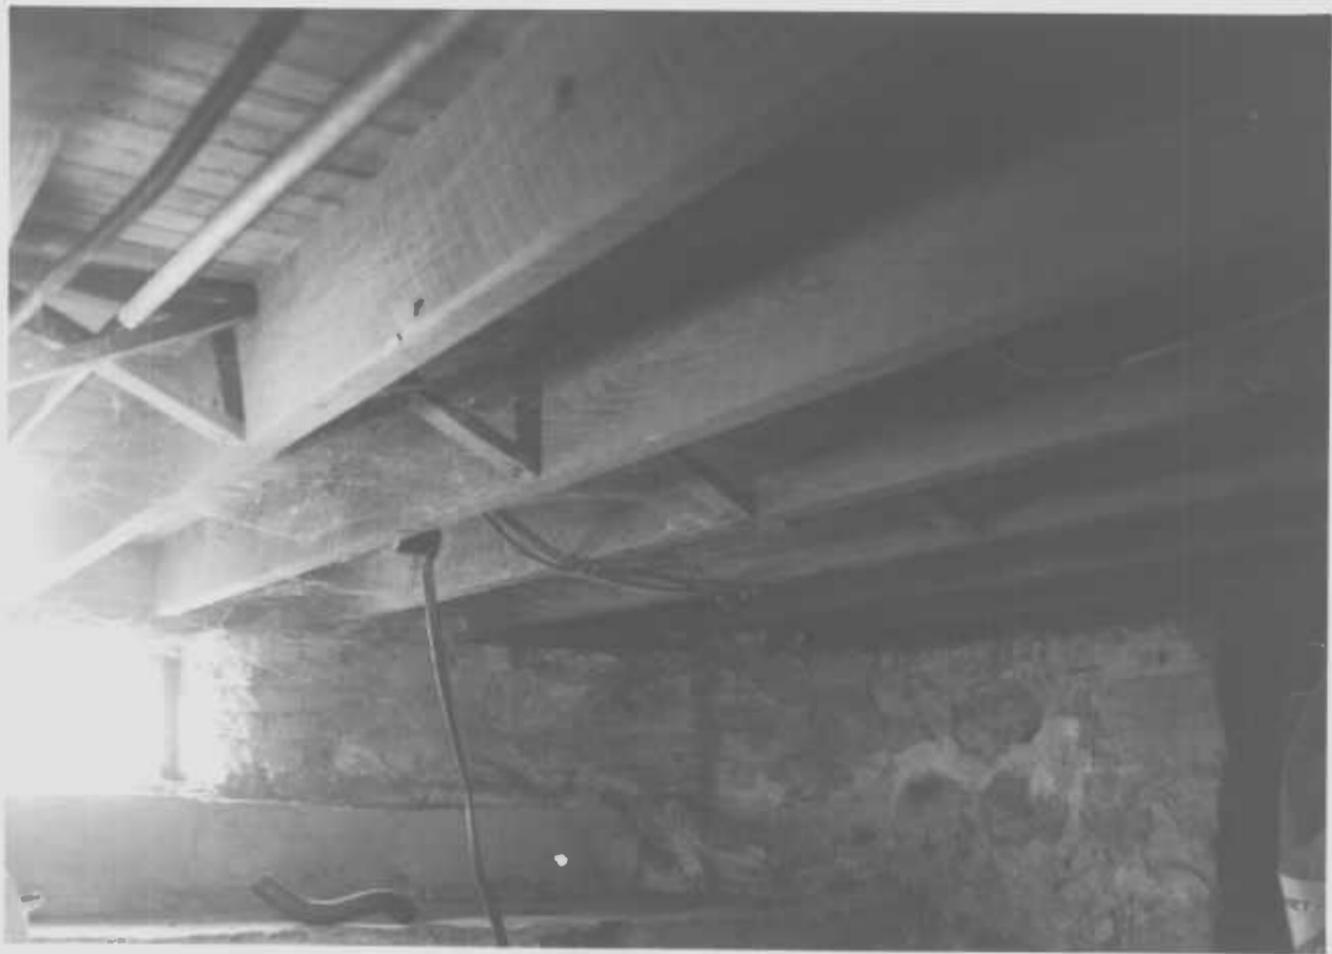
6/13

View of floor joists and foundation in cellar

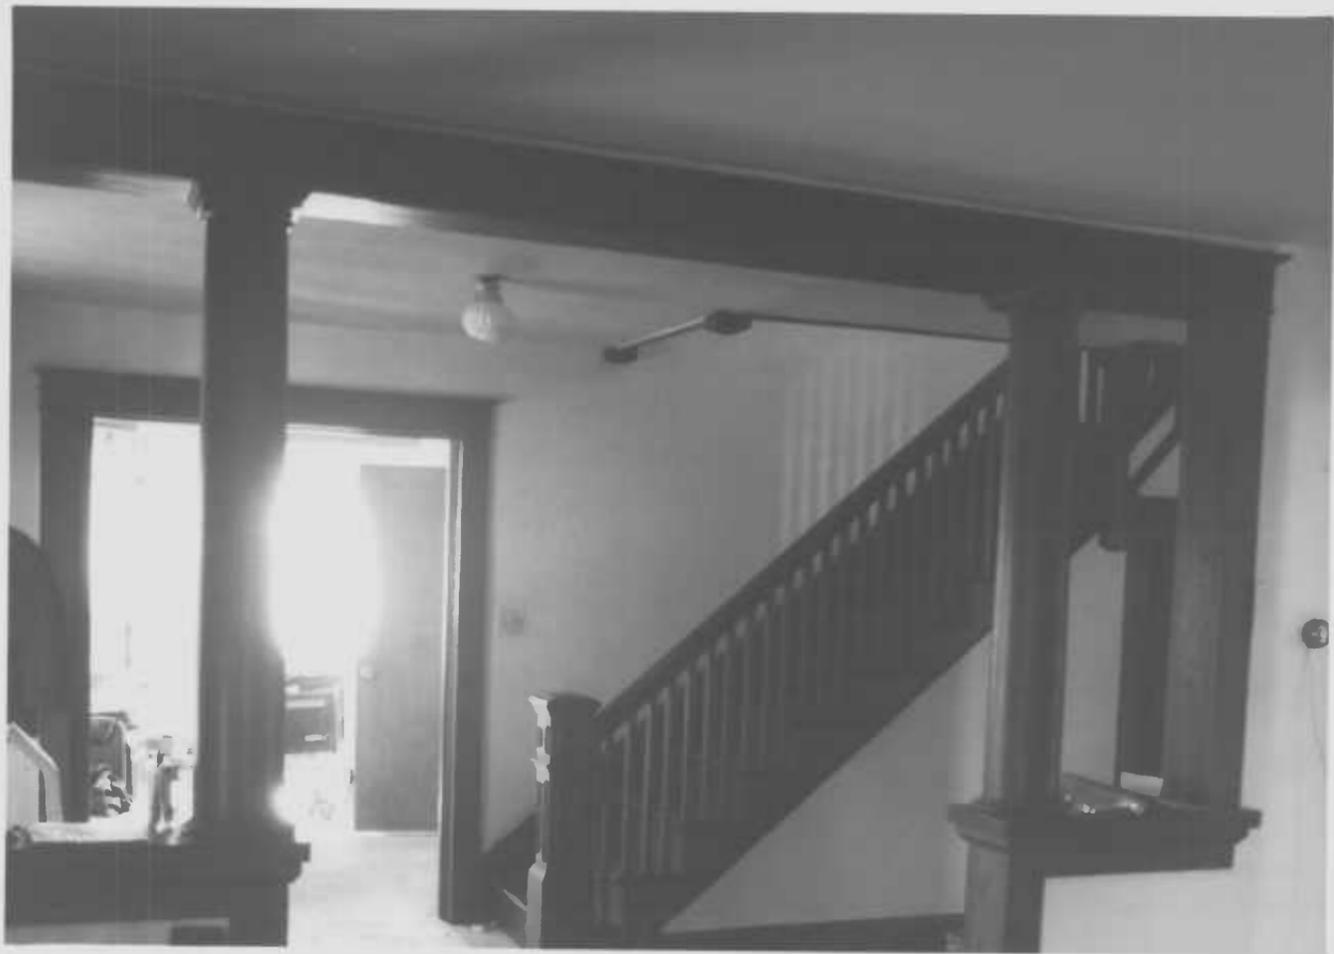
7/13

The interior plan is basically a single pile, center hall type, (See Floor Plan.) The hall is separated from the northeast room by a columned archway. The southwest room with the polygonal bay is entered via a doorway with pocket doors. The staircase has a square newel with molding panels. The railing has plain square balusters. All the interior trim in the main section is dark stained oak. The living room on the northeast has an oak mantel with ogee curve brackets supporting the shelf. The fireplace is closed off. The walls are painted plaster over lath. The southwest room was used by Mrs. Deaton as a music room and once contained a grand piano. After her death and when Mr. Deaton's health began to fail, the room was made into a bedroom with a small bath added in the northeast corner. The dining room has a plain painted wood mantel over an arched opening.

General view, main hall and staircase

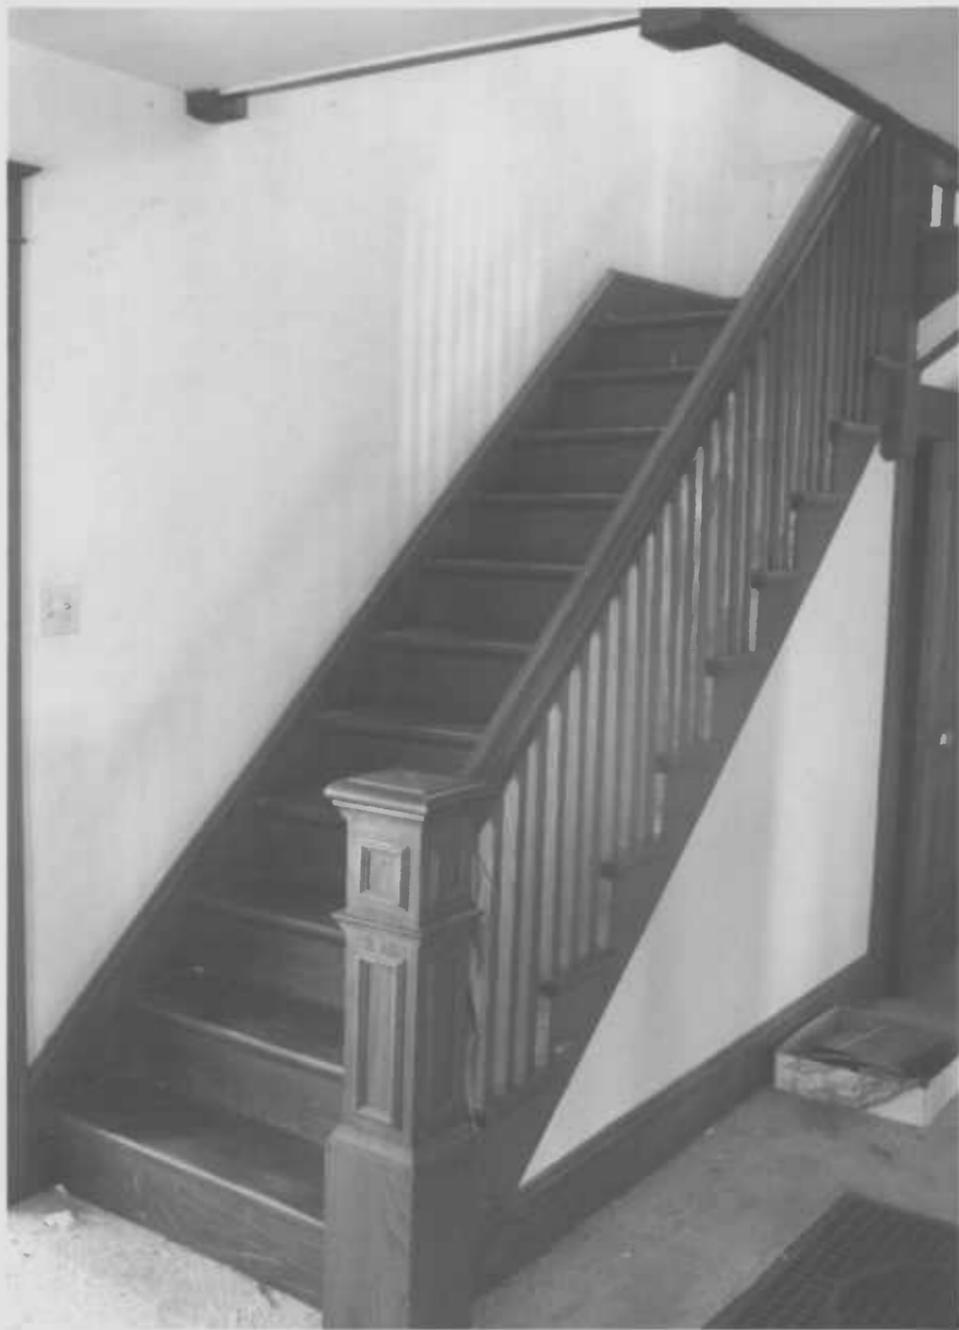
8/13

Main staircase

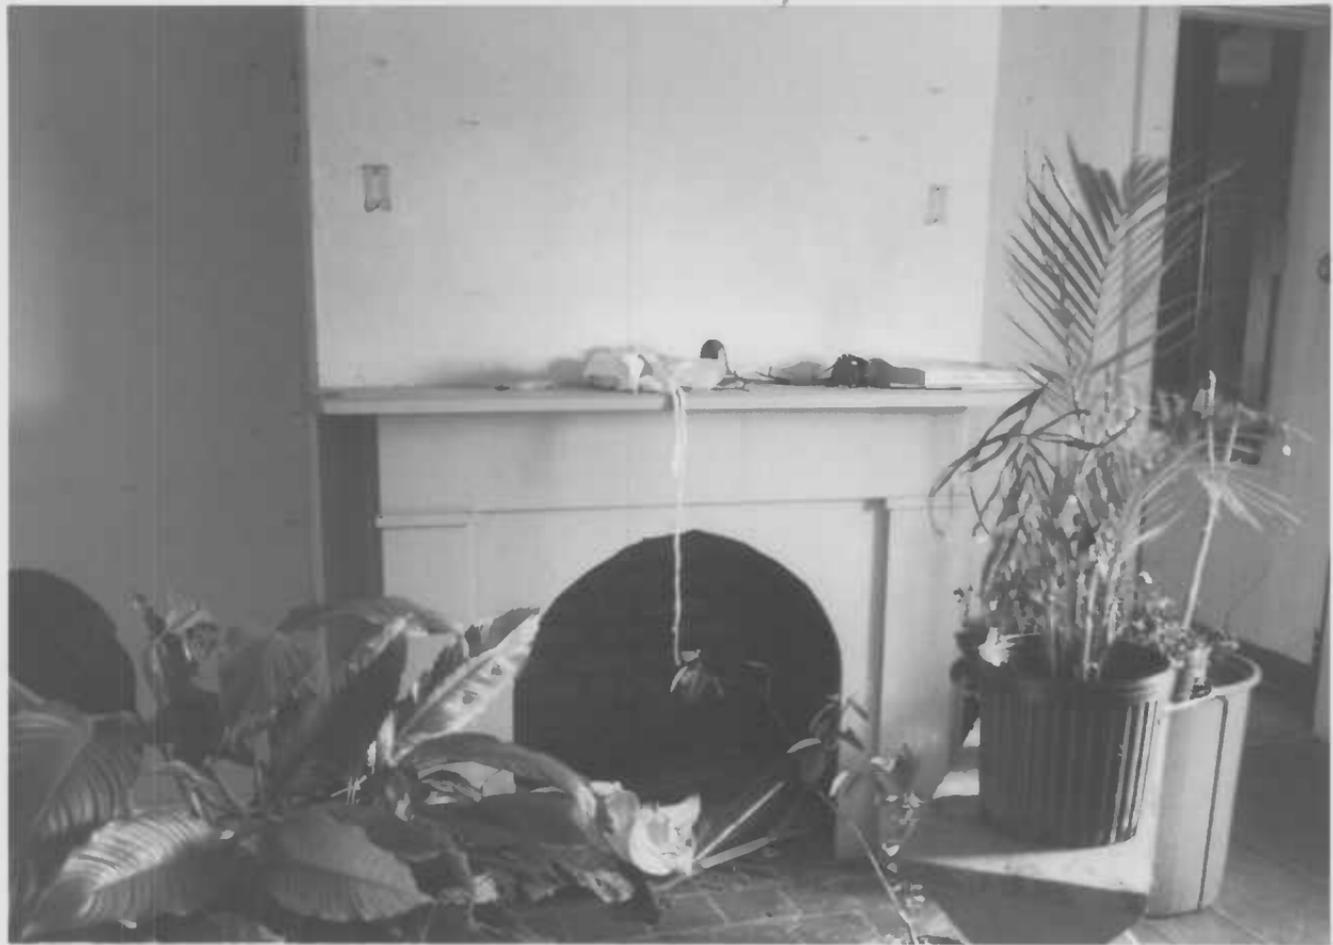
10/13

Mantel piece, dining room

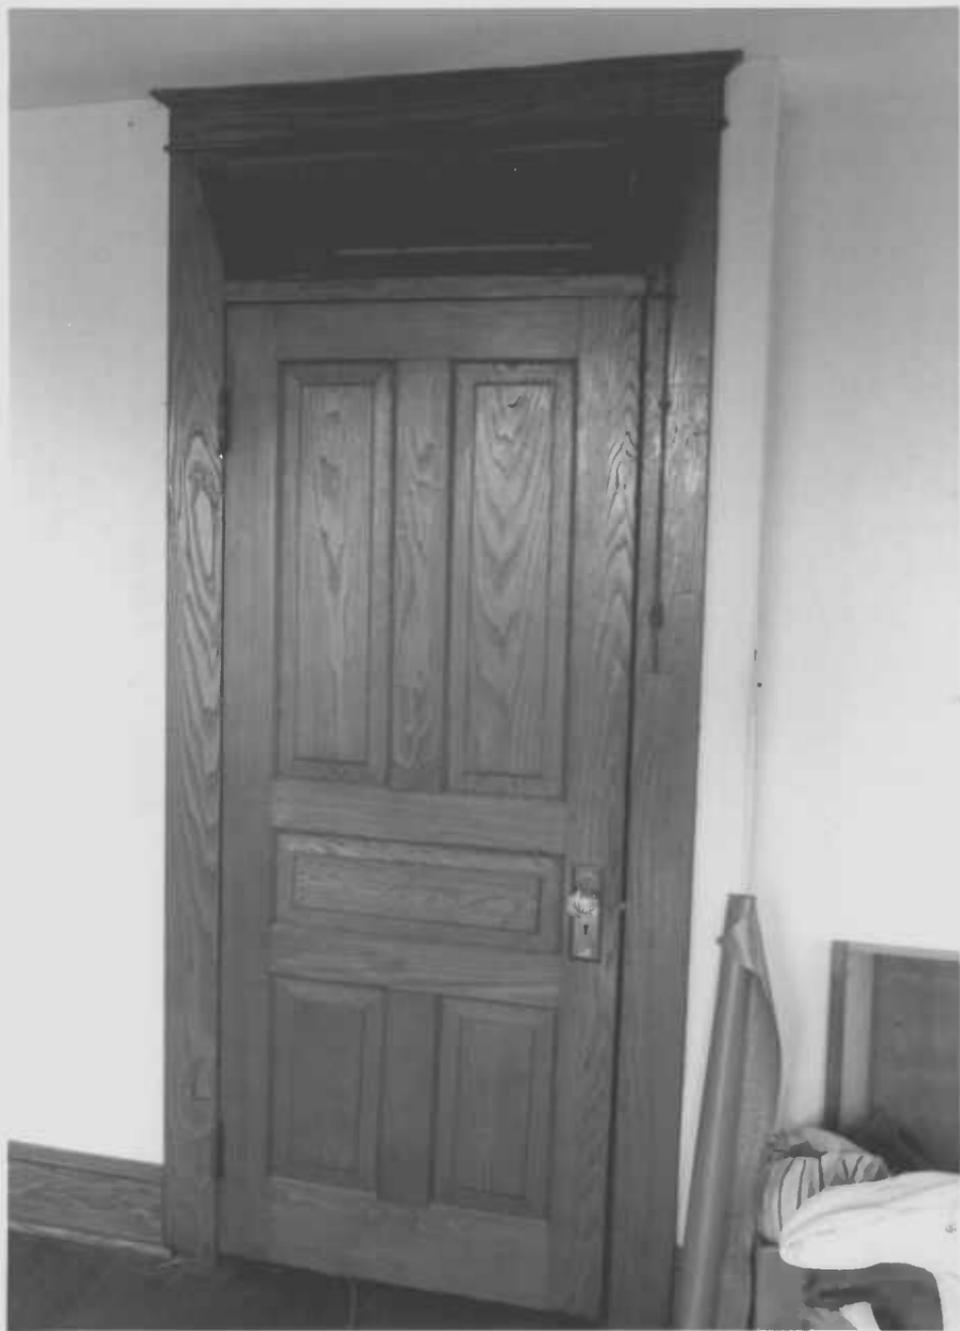
11/13

The only other feature of importance is the floor-to-ceiling window opening on the side porch. The kitchen has been remodeled several times, but still has an entrance to the back stairs leading to the low-ceilinged room above, which suggests it was built as a servant's bedroom. The four upstairs bedrooms are notable primarily for the oak woodwork and raised panel doors. Each door has a working transom.

Typical door, second floor

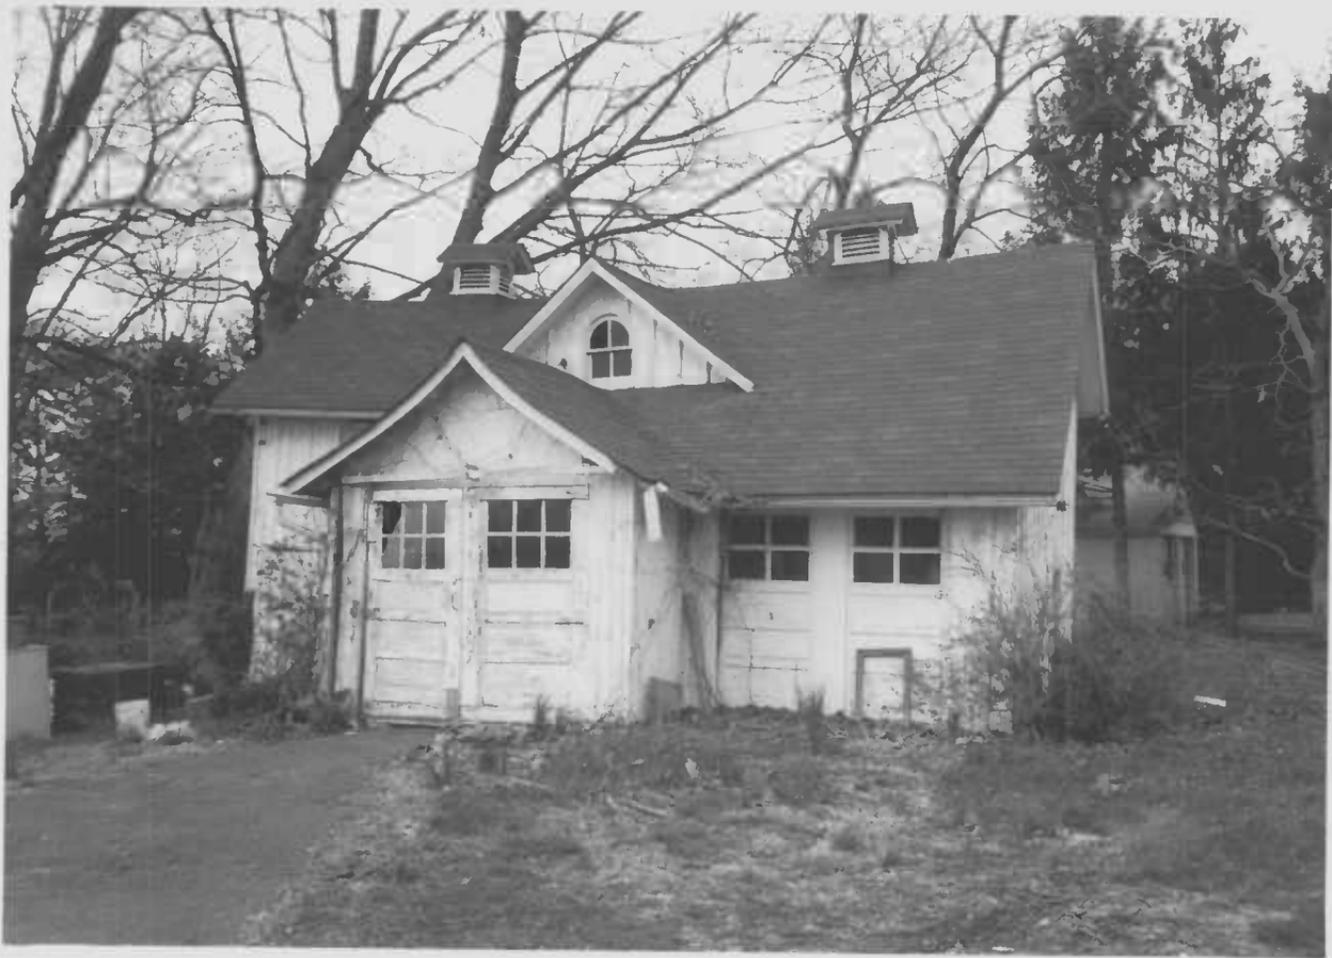
12/13

The outbuildings are clustered west of the house except the stable/garage, which is opposite the end of the rear ell to the north. This building was erected as a board and batten rectangular structure with a central cross gable and an arched window duplicating that of the main house. Twin vents ride the ridge of the main roof. The roof was probably originally slate like the main house, but it is now composition. In the early twentieth century, the facade on the northeast corner and in the center were brought forward and a second projecting gable with a slight bellcast was built. Double doors open into a central space for an automobile. The barn is a tall frame building with vertical flush siding. The three sheds, located south of the barn, show the different roofing and siding materials common to small agricultural buildings whose use has changed over time.

Stable/garage, southeast elevation

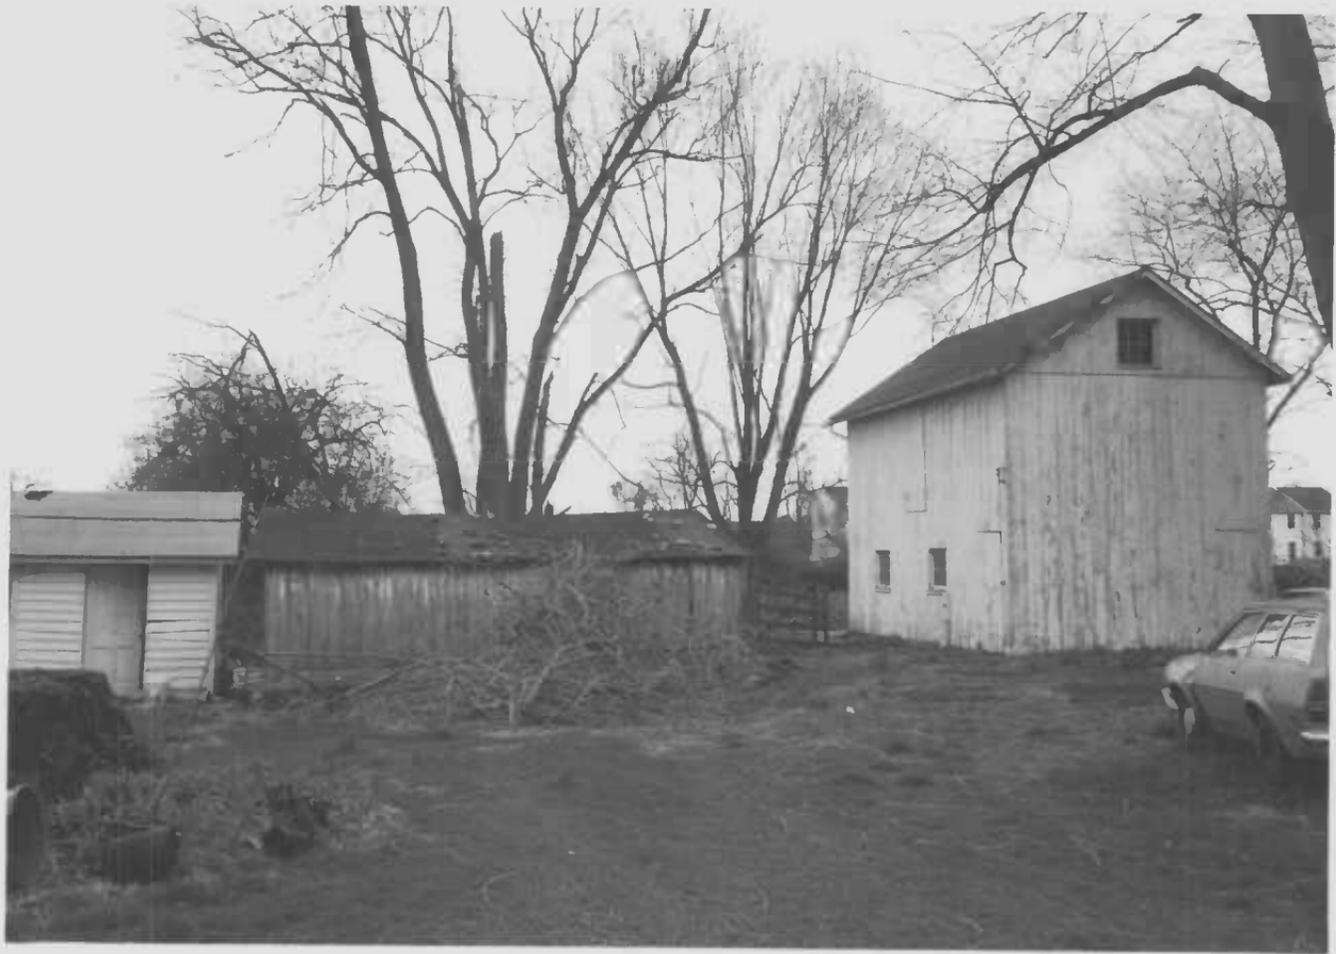
13/13

Barn and sheds, view from east
