Maryland Inventory of Historic Properties number: HO-657

Name: River Rd over Gockelburn Branch

Maryland Historic Highway Bridges  
Bridge Type Metal Girder  
Map D-12 Baltimore SW  
County Howard  
Bridge # and name HO 6/River Road  
over Rockburn Branch HO-657

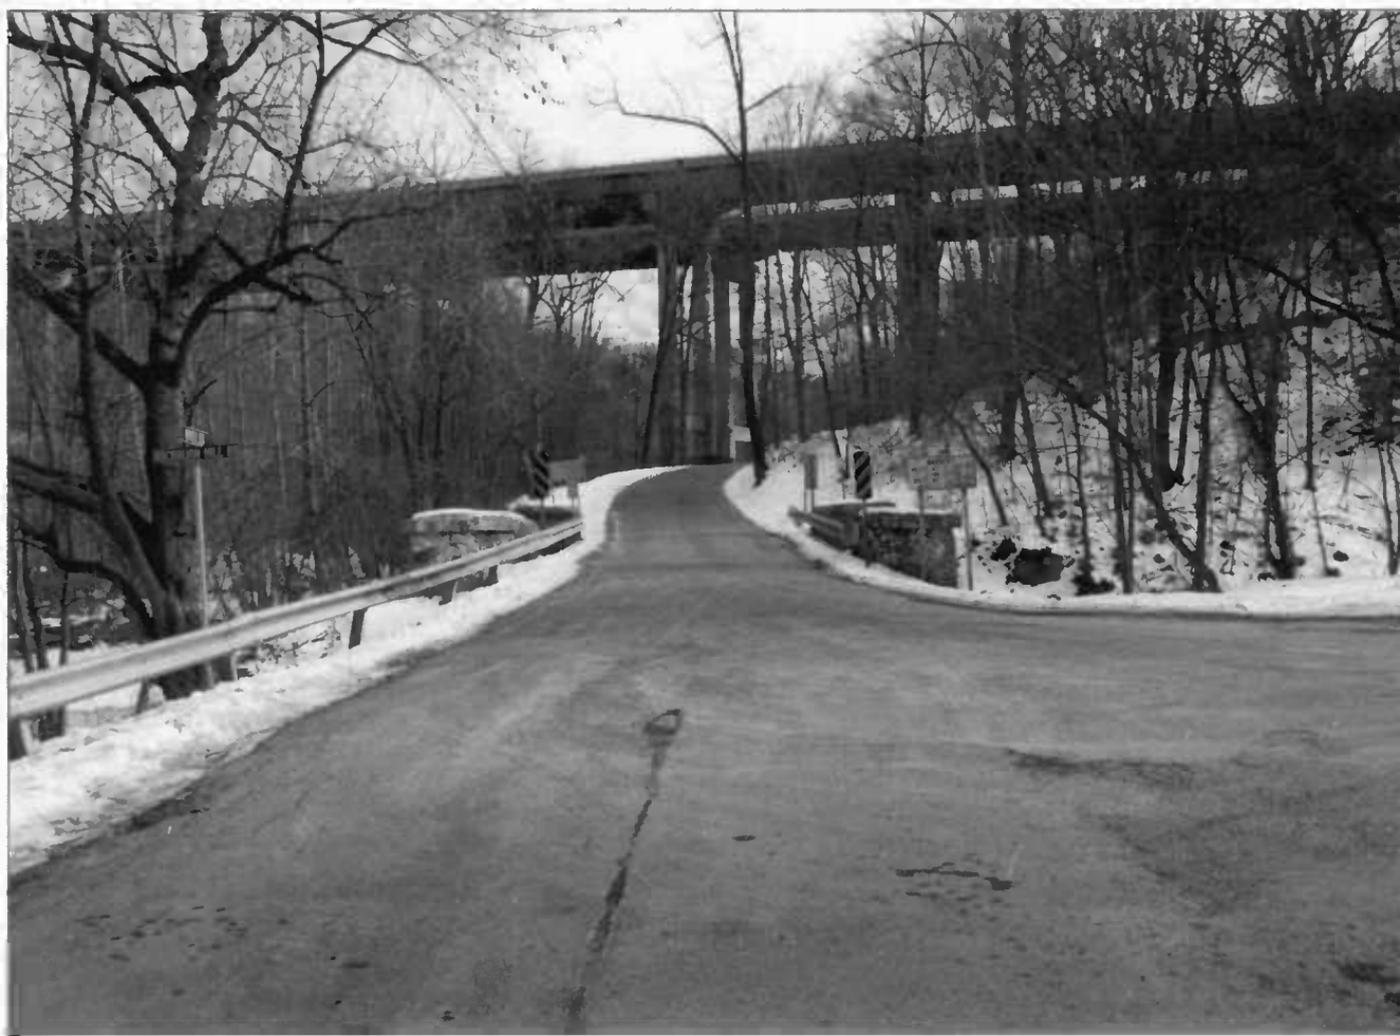
Number <sup>1</sup>33 of <sup>4</sup>36

Description WEST APPROACH

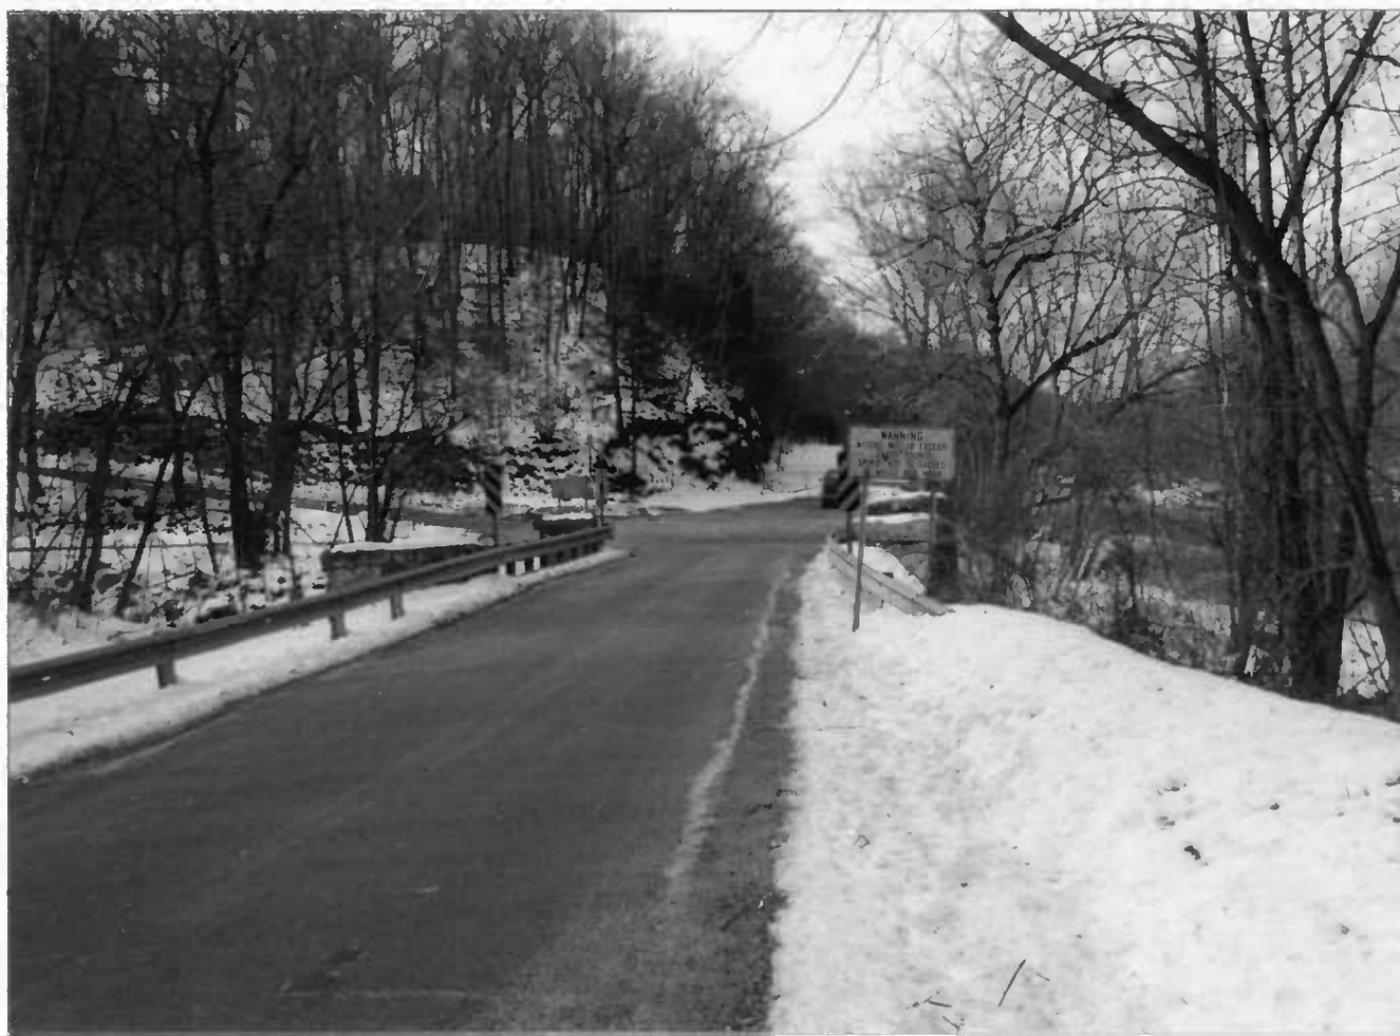
Number 2 of 4  
~~34~~

Description EAST APPROACH

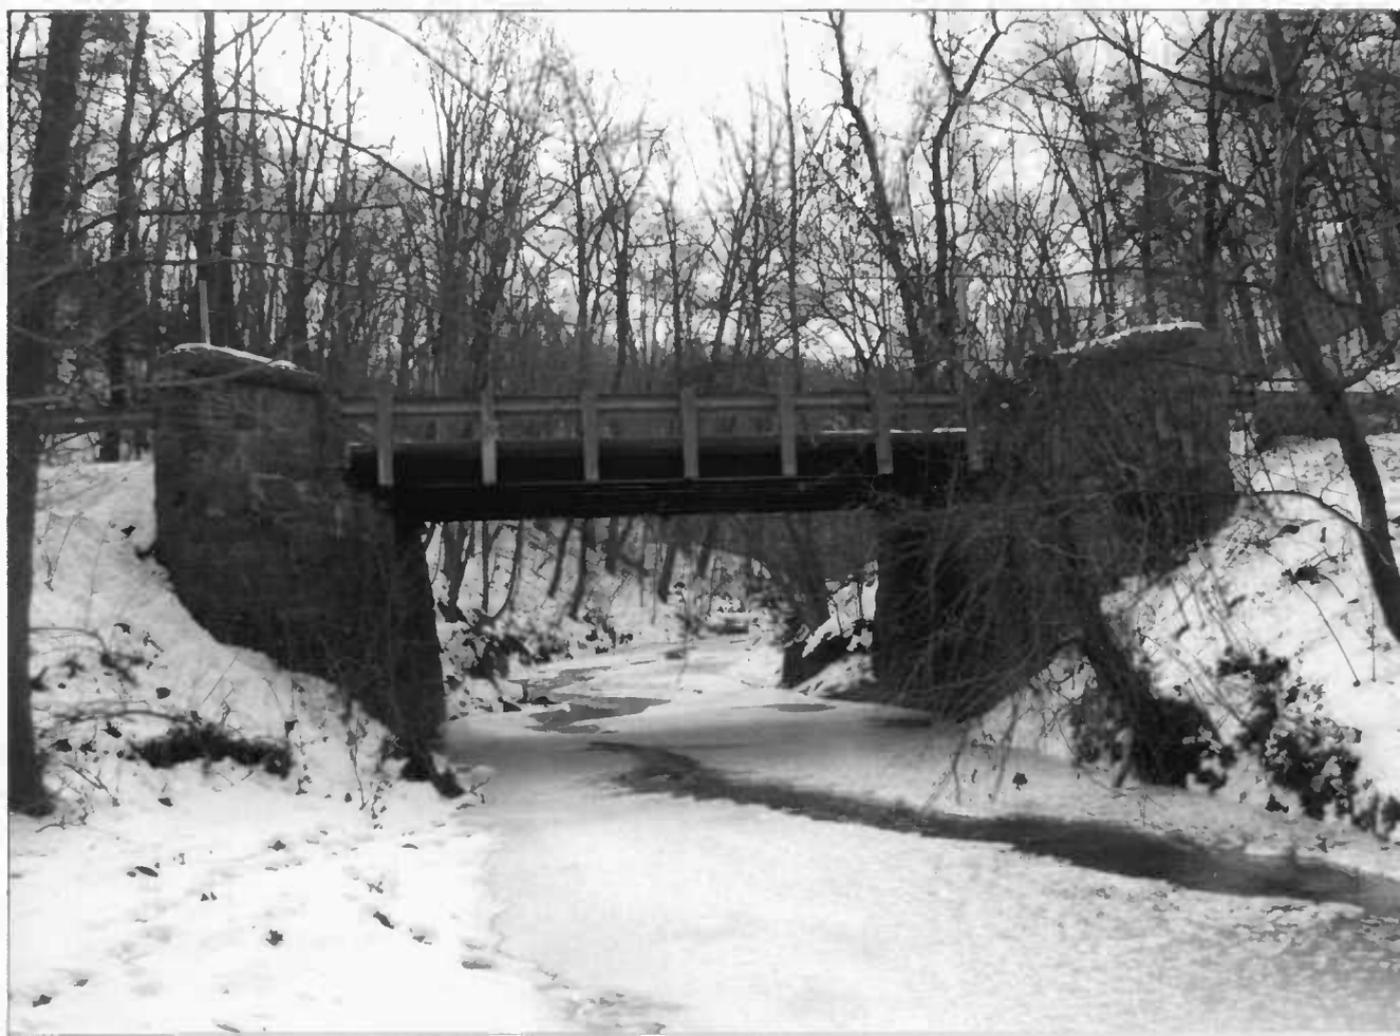
Number 3 of 4  
~~30~~ of ~~30~~

Description NORTH ELEVATION

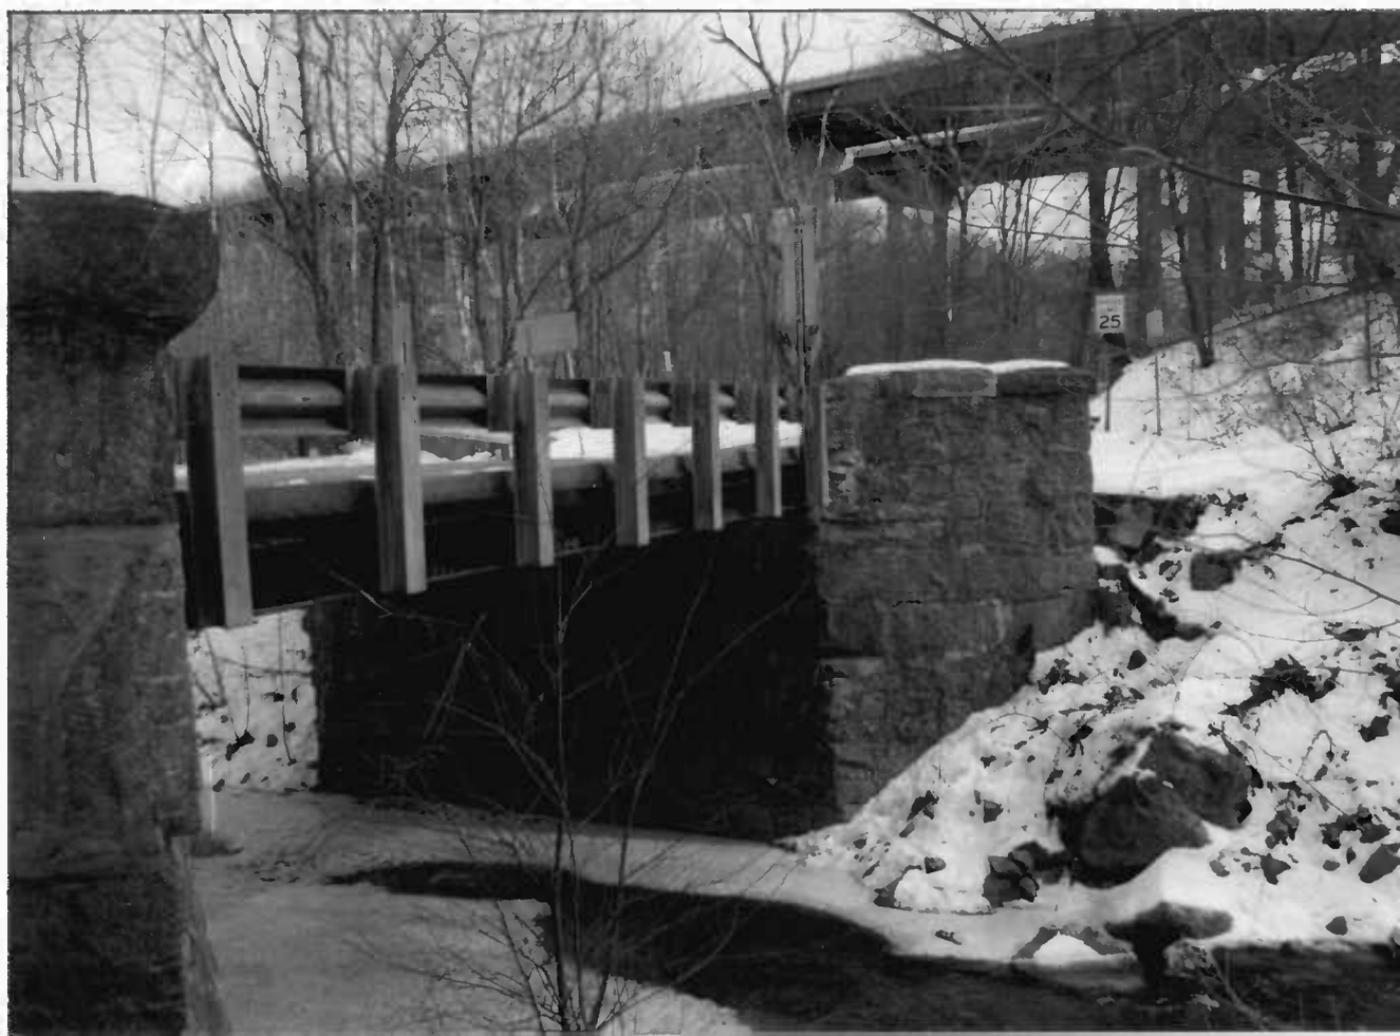
Number 4 of 4  
30 of 30

Description SOUTH ELEVATION
