Maryland Historical Trust

Maryland Inventory of Historic Properties number: HO-658

Name: Stephens Rd over Hammond Rd

Name H013-STEPHENS RD OVER HAMMOND BRANCH

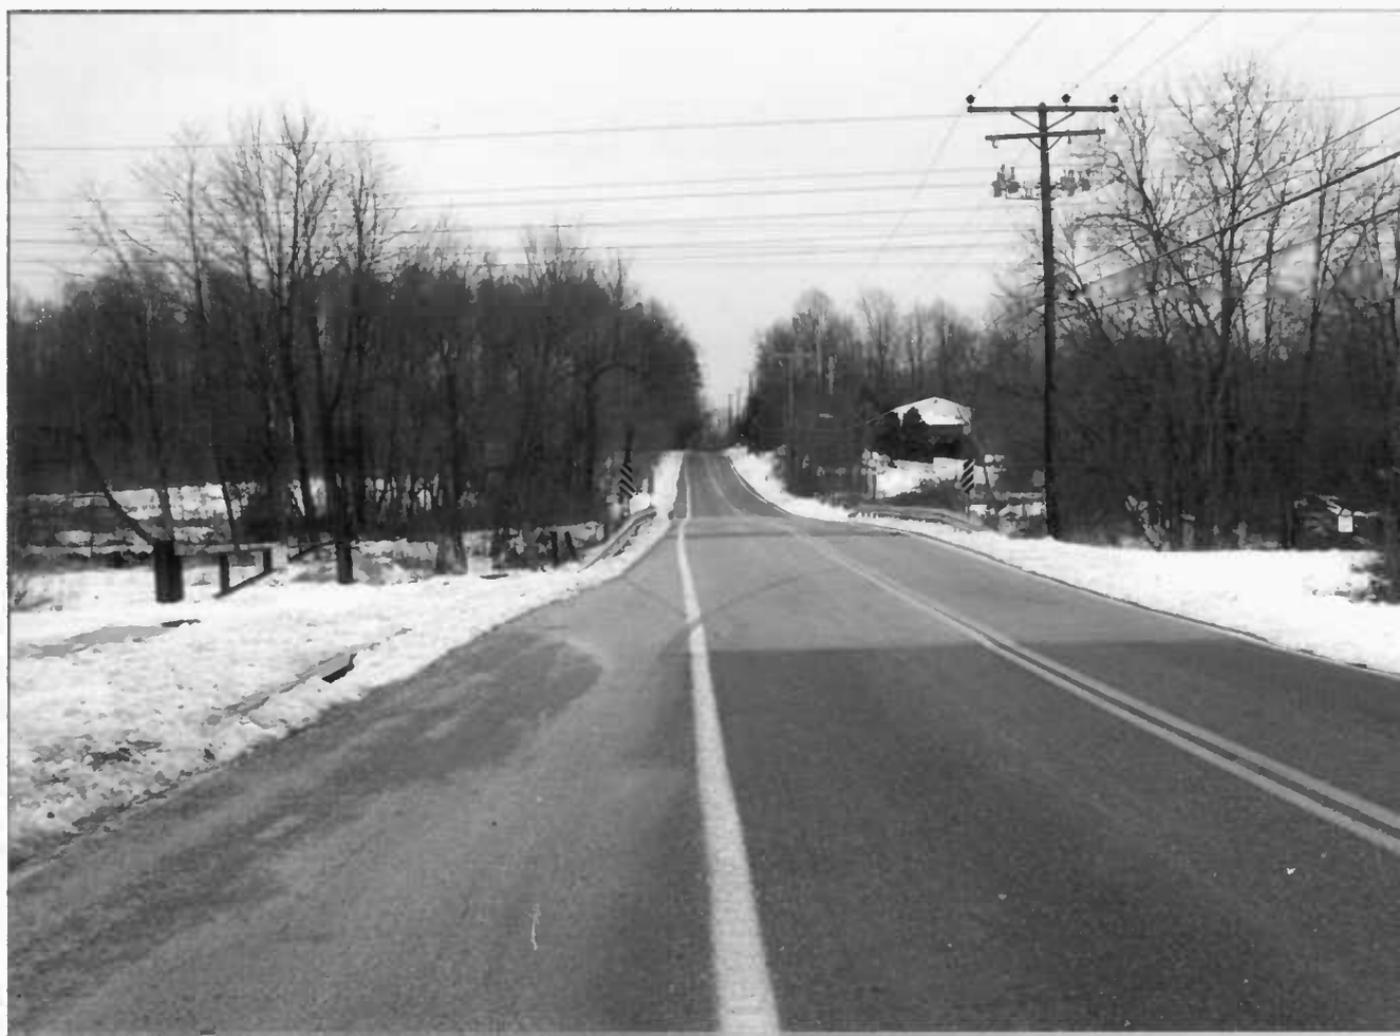
Number 18 of 22

Description NORTH APPROACH LOOKING

SOUTH

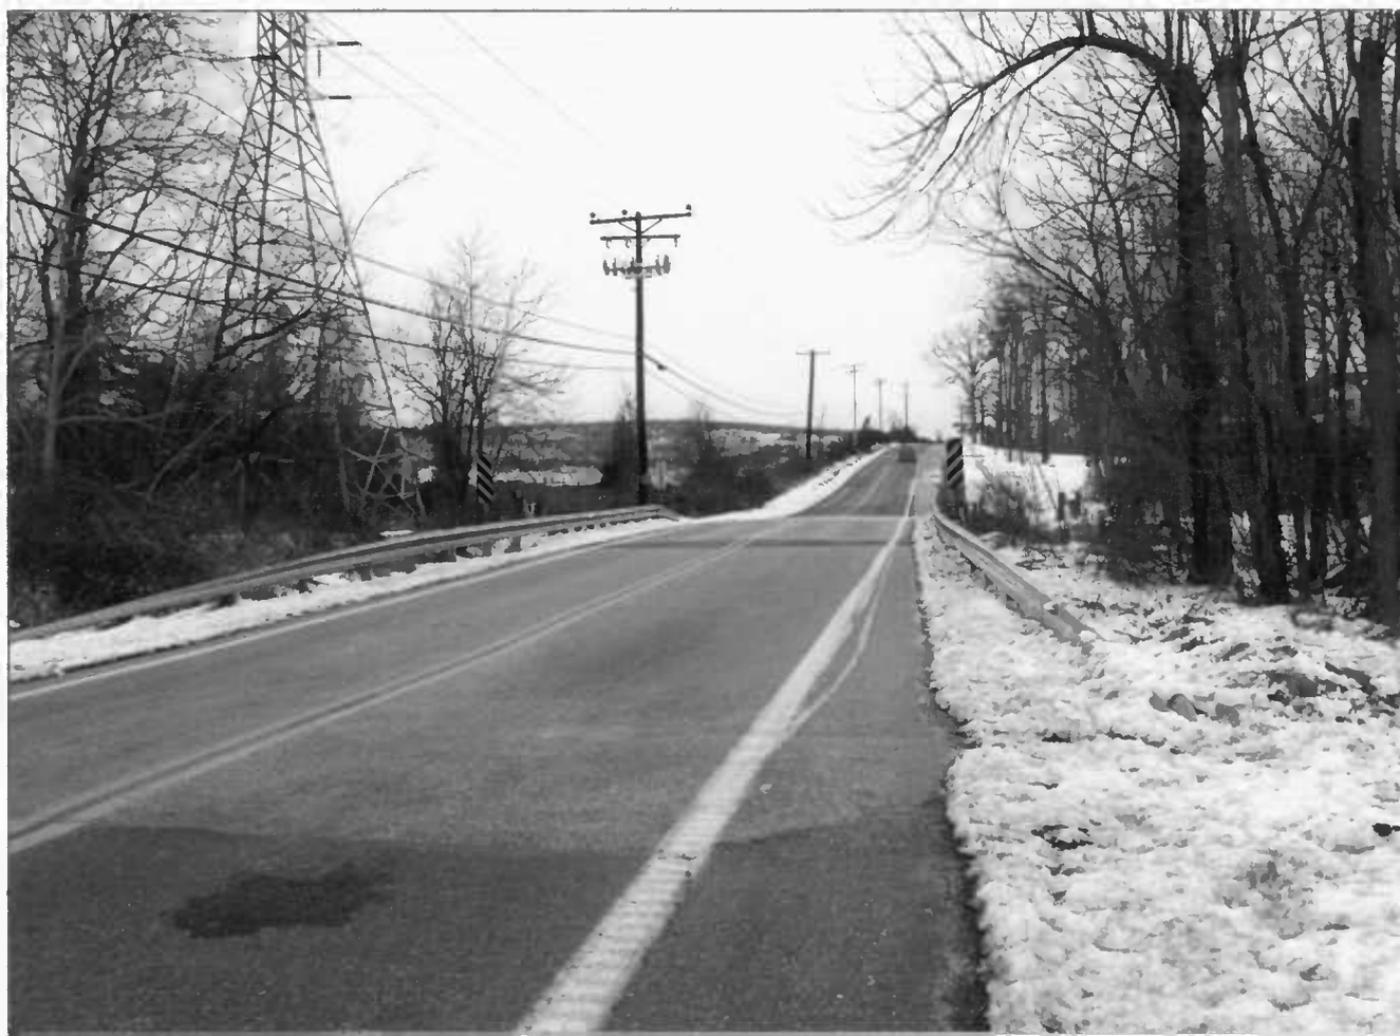
Number 2 of 4
~~19~~ of ~~32~~

Description SOUTH APPROACH LOOKING
NORTH

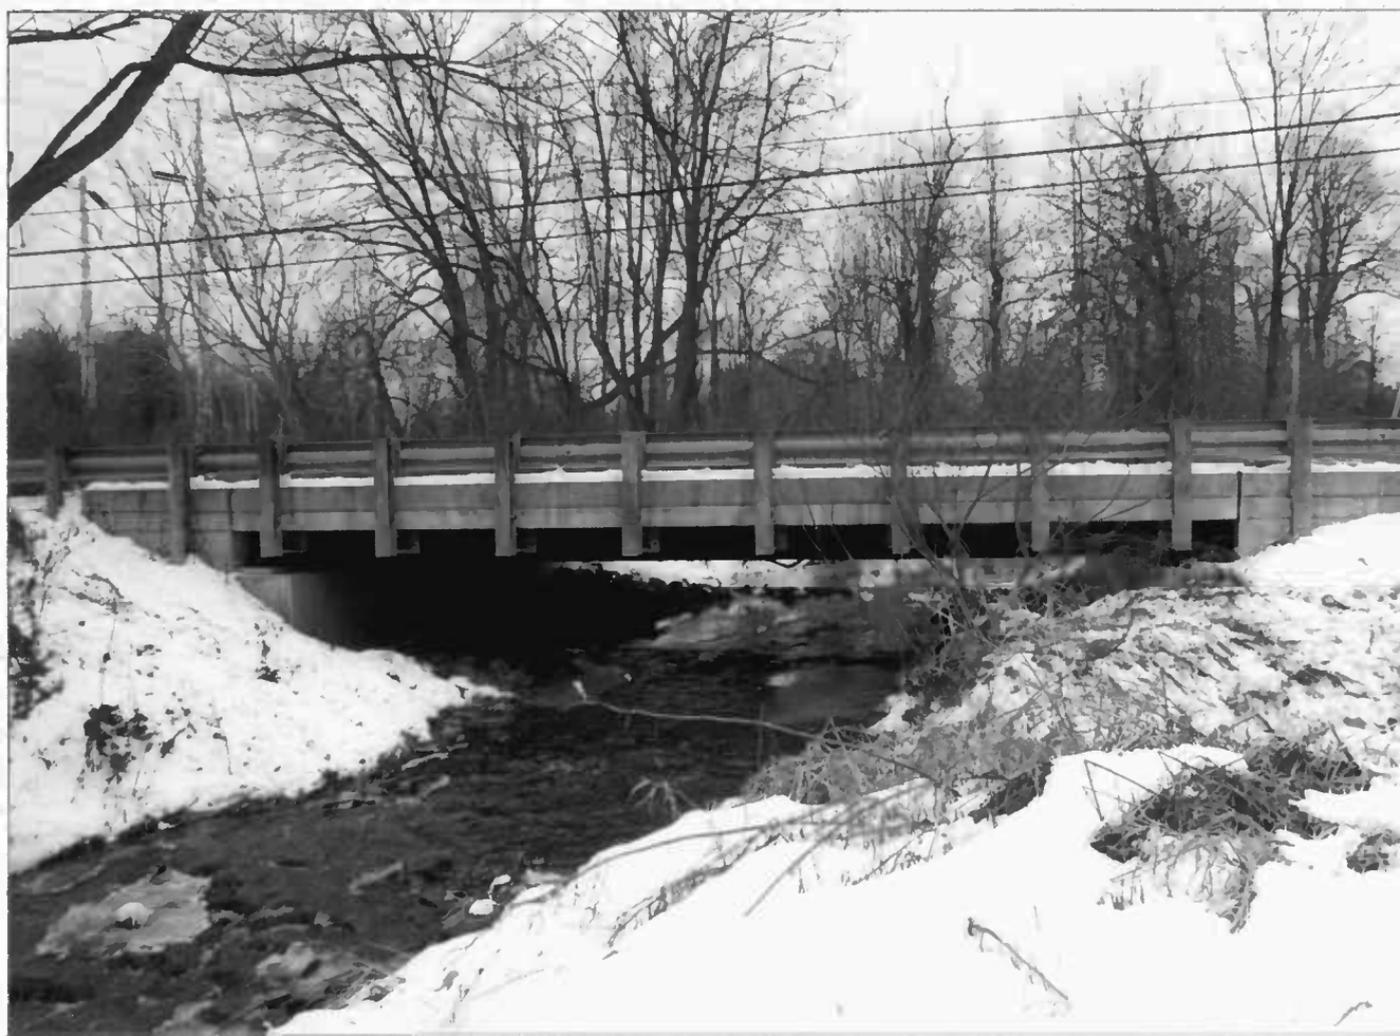
Number 3 of 4
20 of 32

Description EAST ELEVATION LOOKING WEST

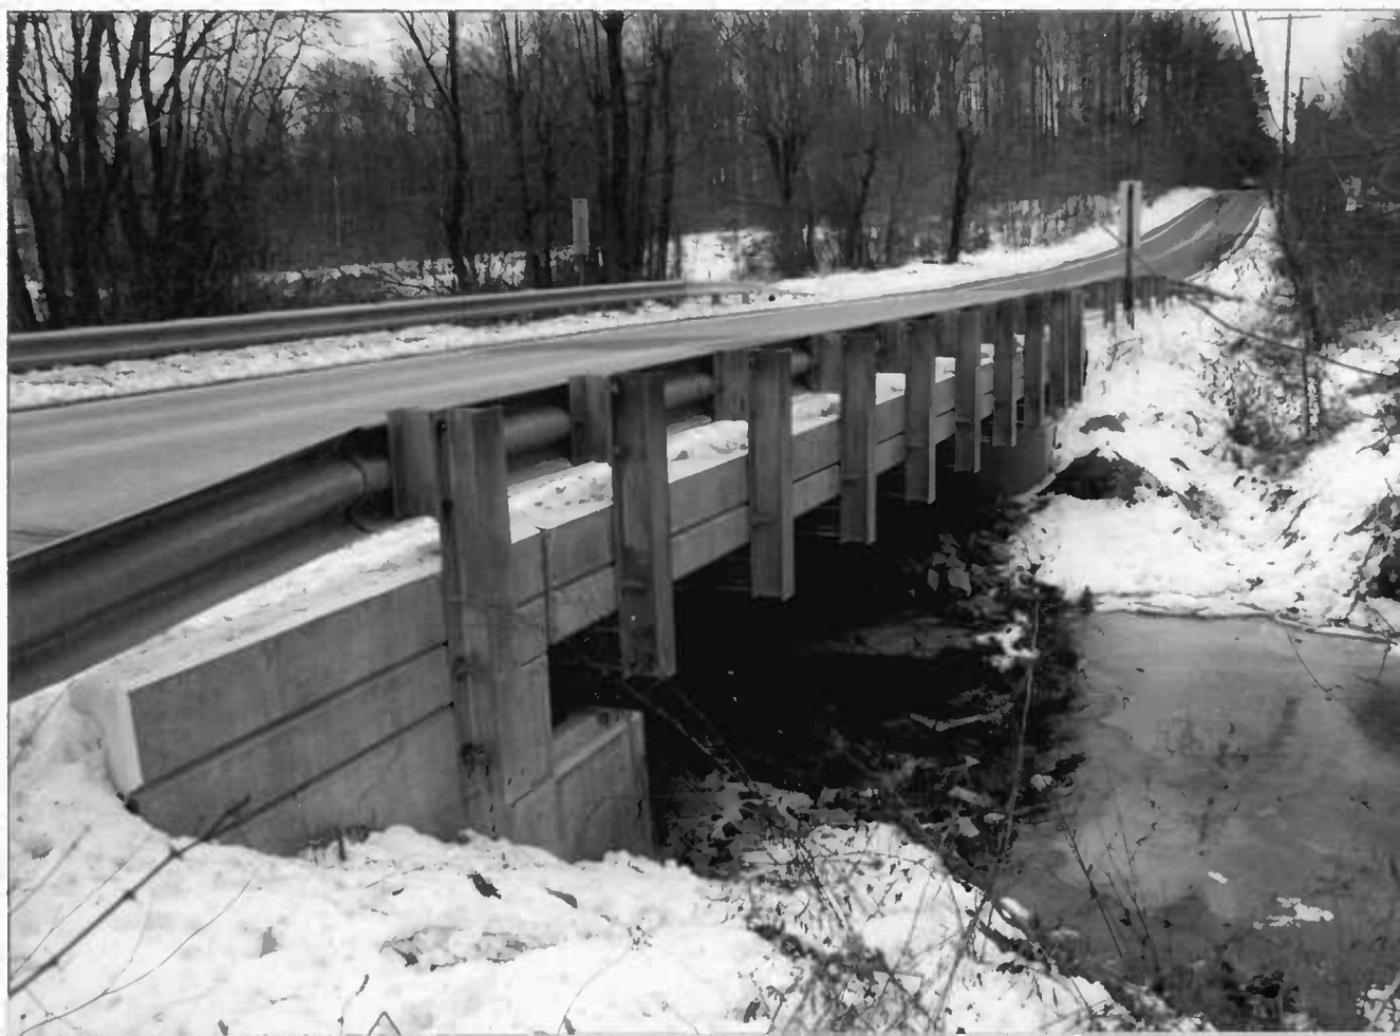
Number 4 of 4
32

Description WEST ELEVATION LOOKING
SOUTHEAST
