Maryland Inventory of Historic Properties number: HO-666

Name: Old Montgomery Rd. over Little Patuxent River

Maryland Historic Highway Bridges
Bridge Type Metal Girder
Map D-12 Baltimore SW HO-666
County Howard
Bridge # and name HO 55/Old Mont-
gomery Rd. over Little Patuxent River
WORTHINGTON

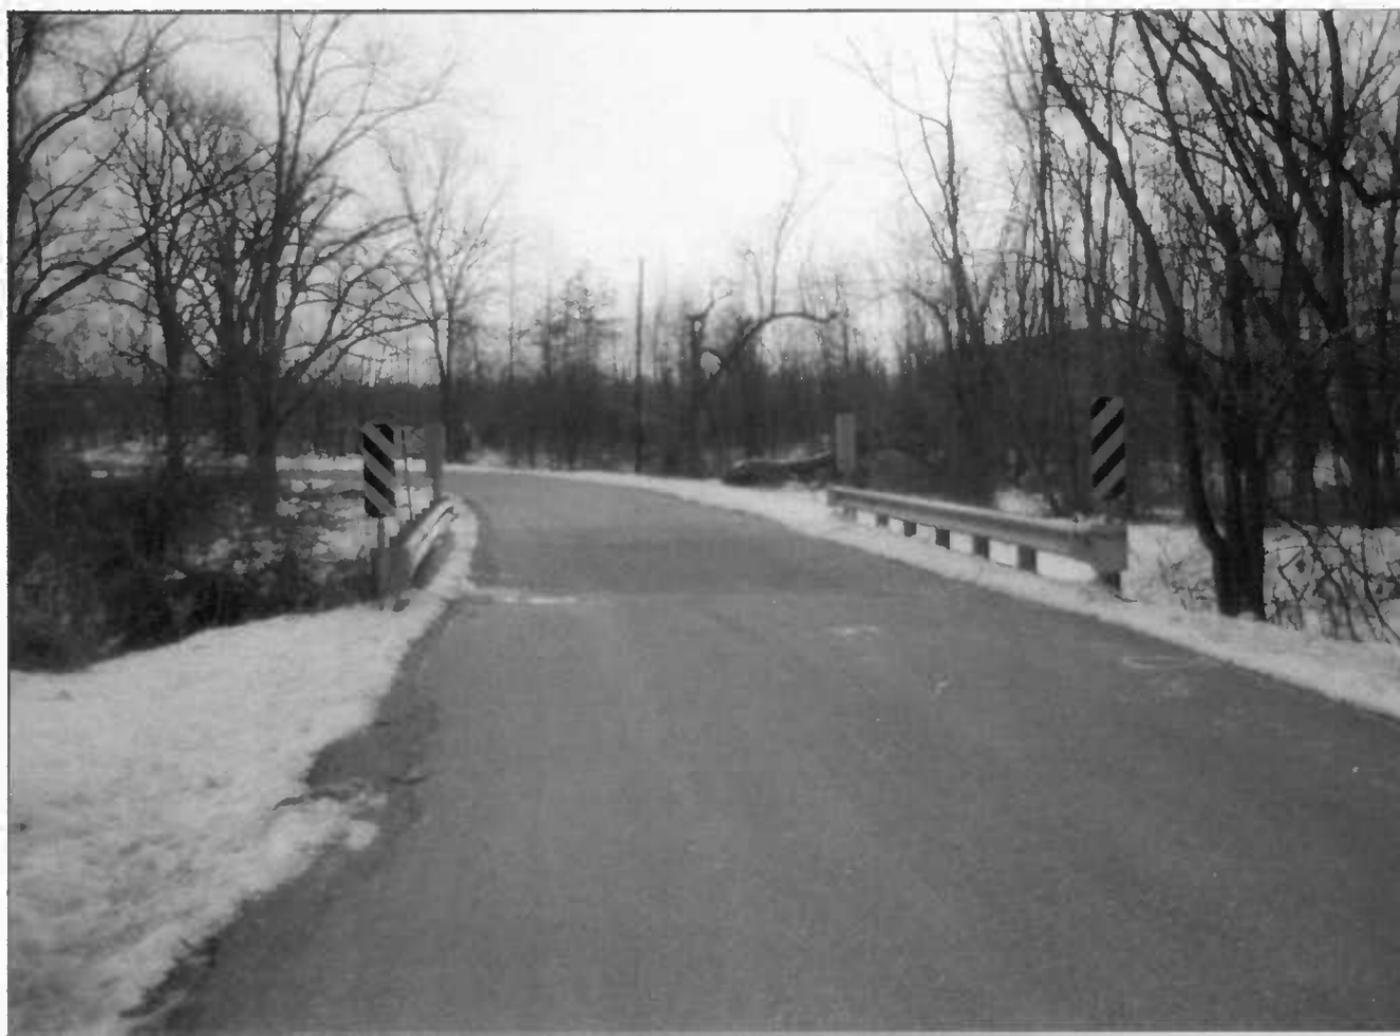
Number 1 of 4
13 of 16

Description WEST APPROACH

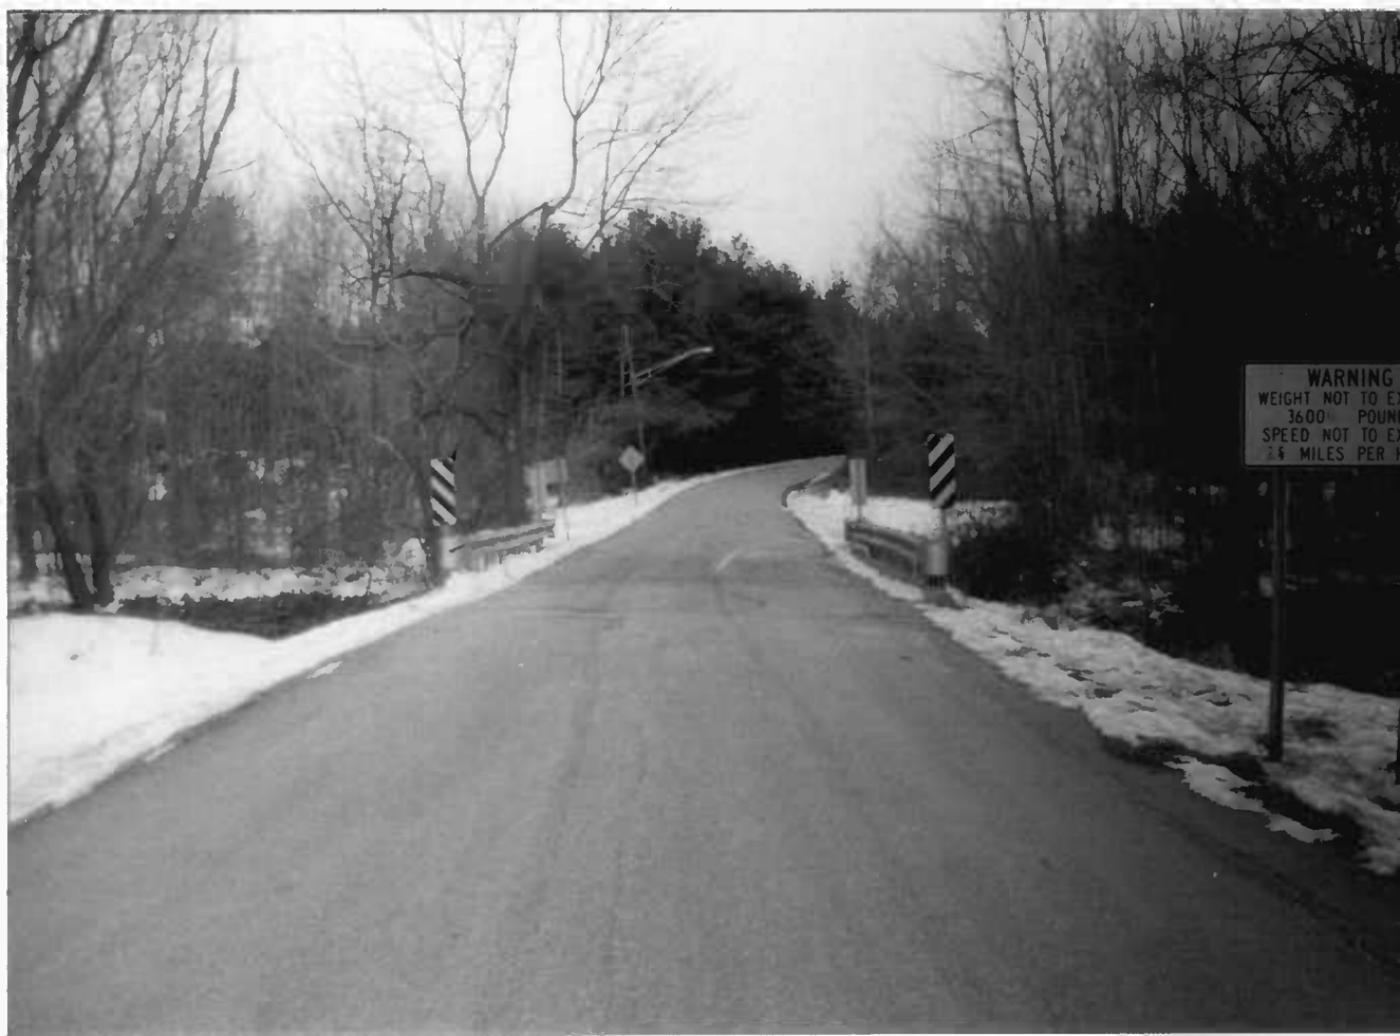
Number 2 of 4

Description EAST APPROACH

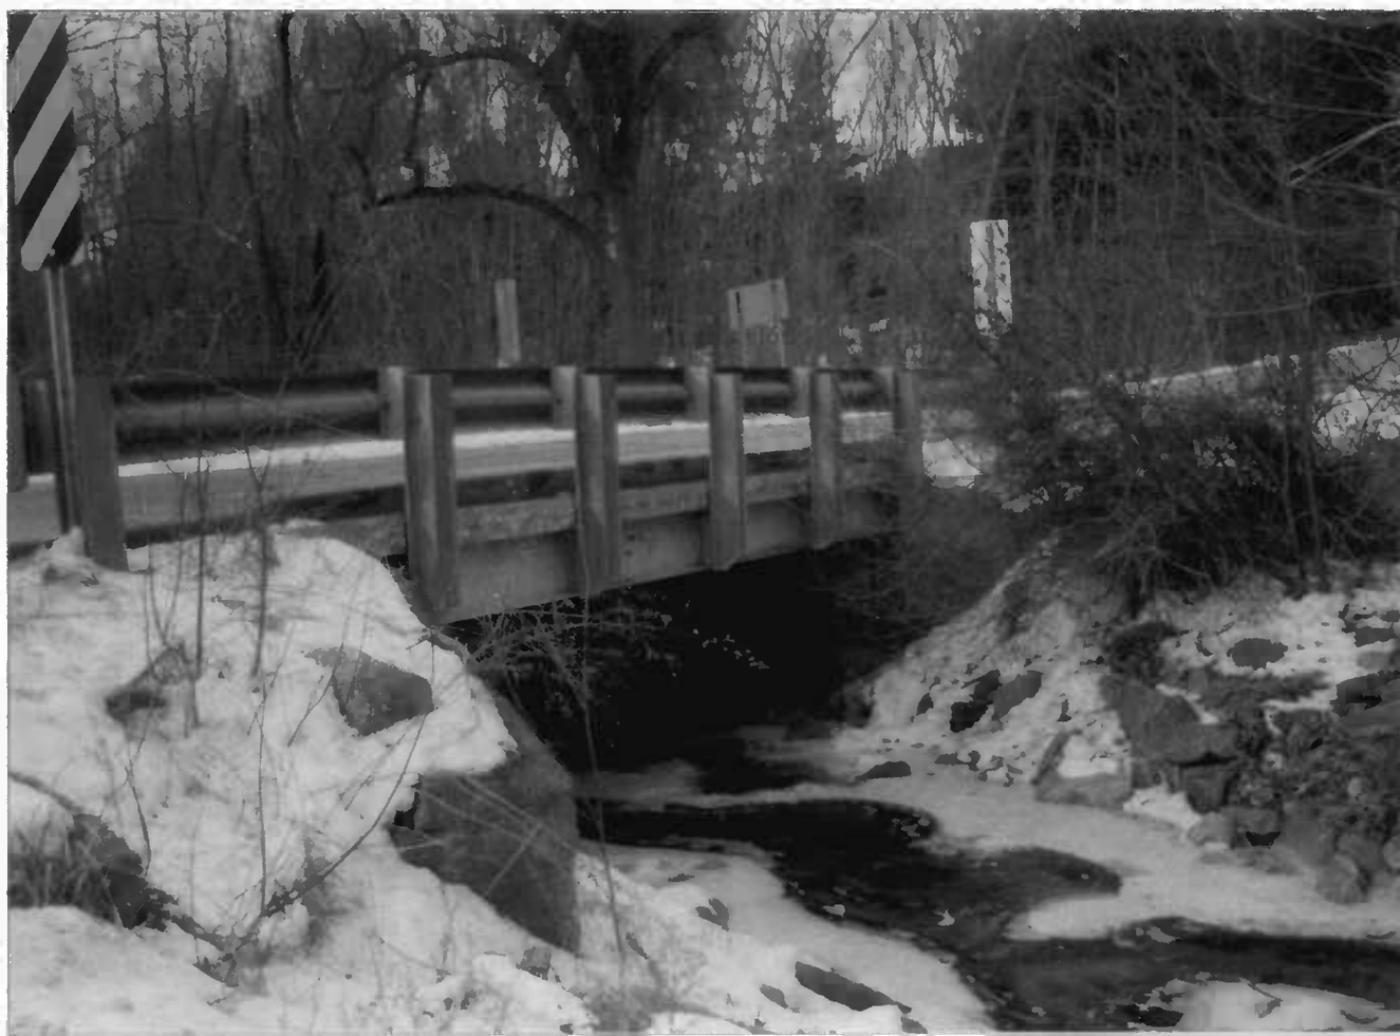
Number 3 of 4

Description NORTH ELEVATION

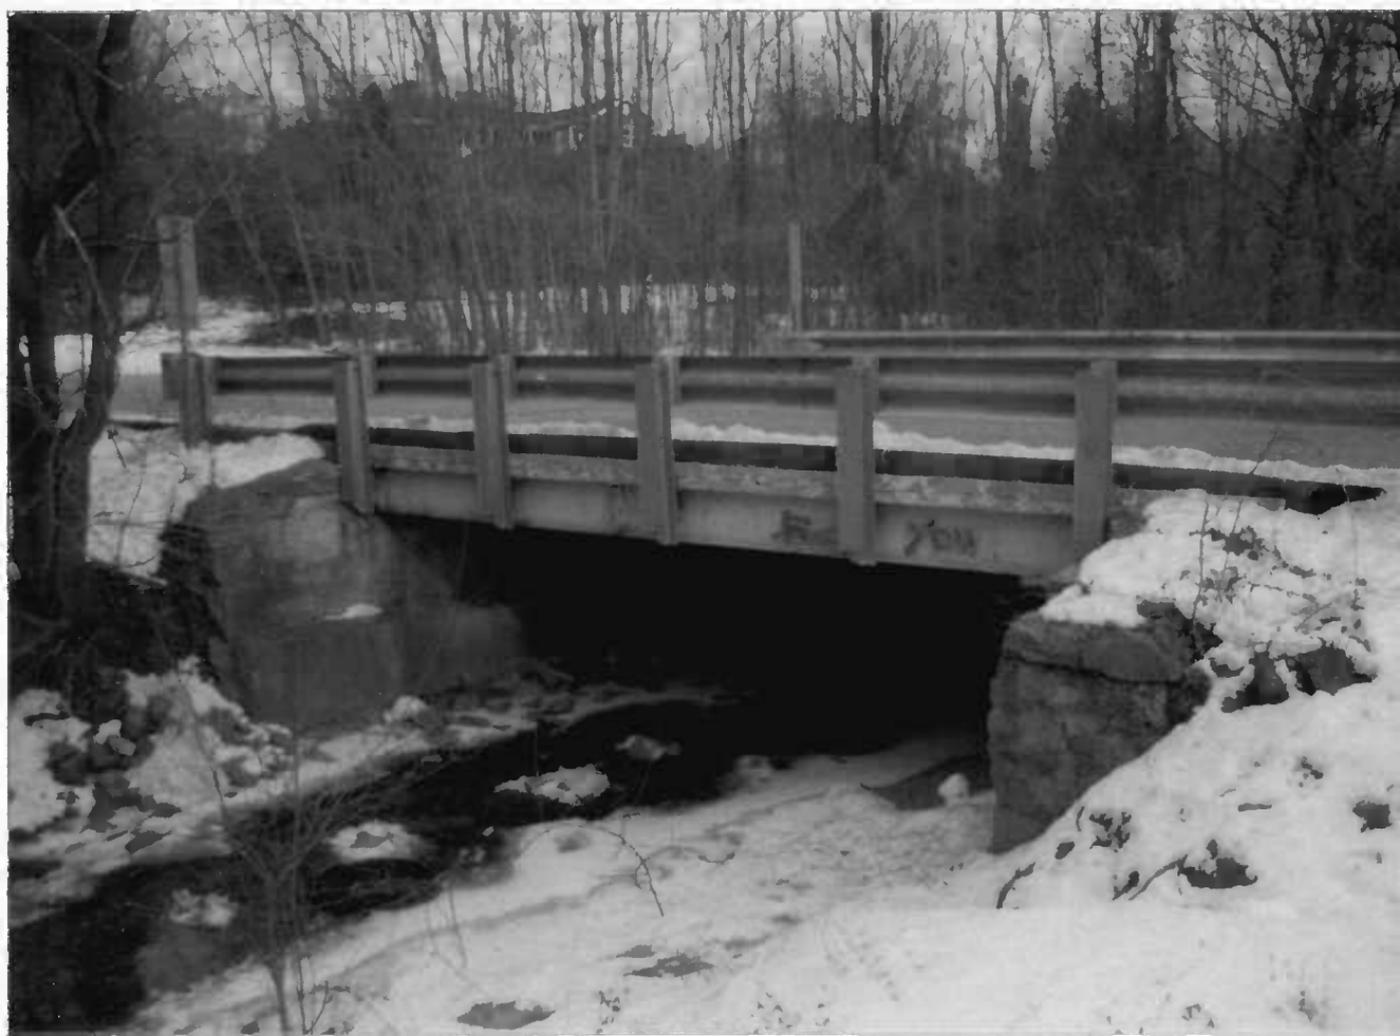
Number 4 of 4

Description SOUTH ELEVATION
