ACHS SUMMARY FORM

1. Name: Stone House Farm (Zeigler Stone House)

INVENTORY FORM FOR STATE HISTORIC SITES SURVEY

Stone House Farm

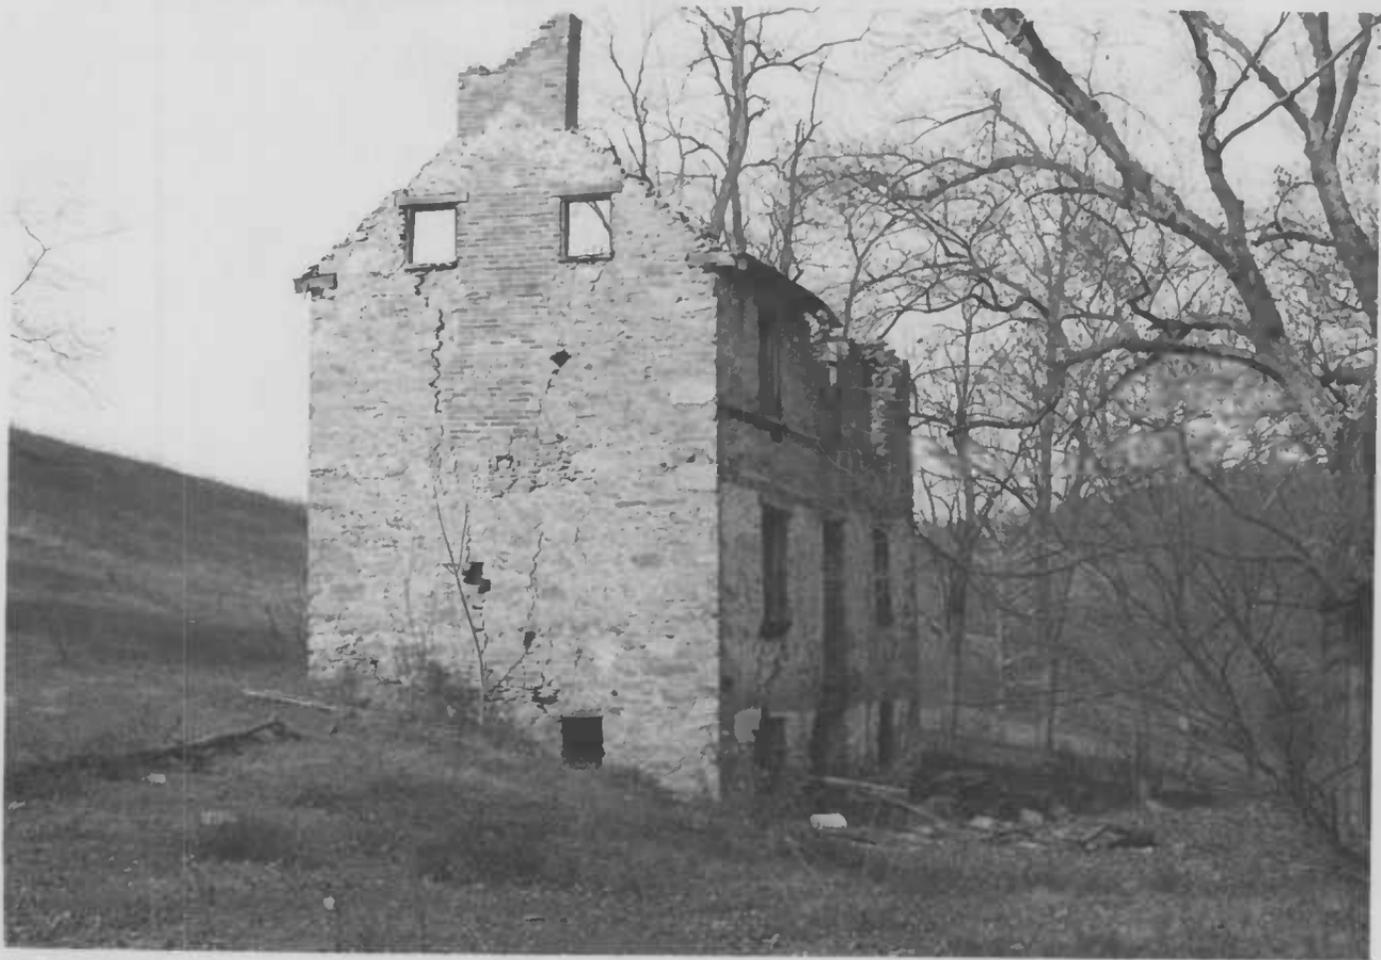
NAME # 10-56 ZEIGER STONE HOUSE (M-NCPPC)

FACADE SW
