Maryland Historical Trust State Historic Sites Inventory Form

and/or common George Butler Farm

street & number 24222 White's Ferry Road not for publicationcity, town Dickerson, vicinity of congressional districtstate Maryland county Montgomery

Survey No. M: 16-28

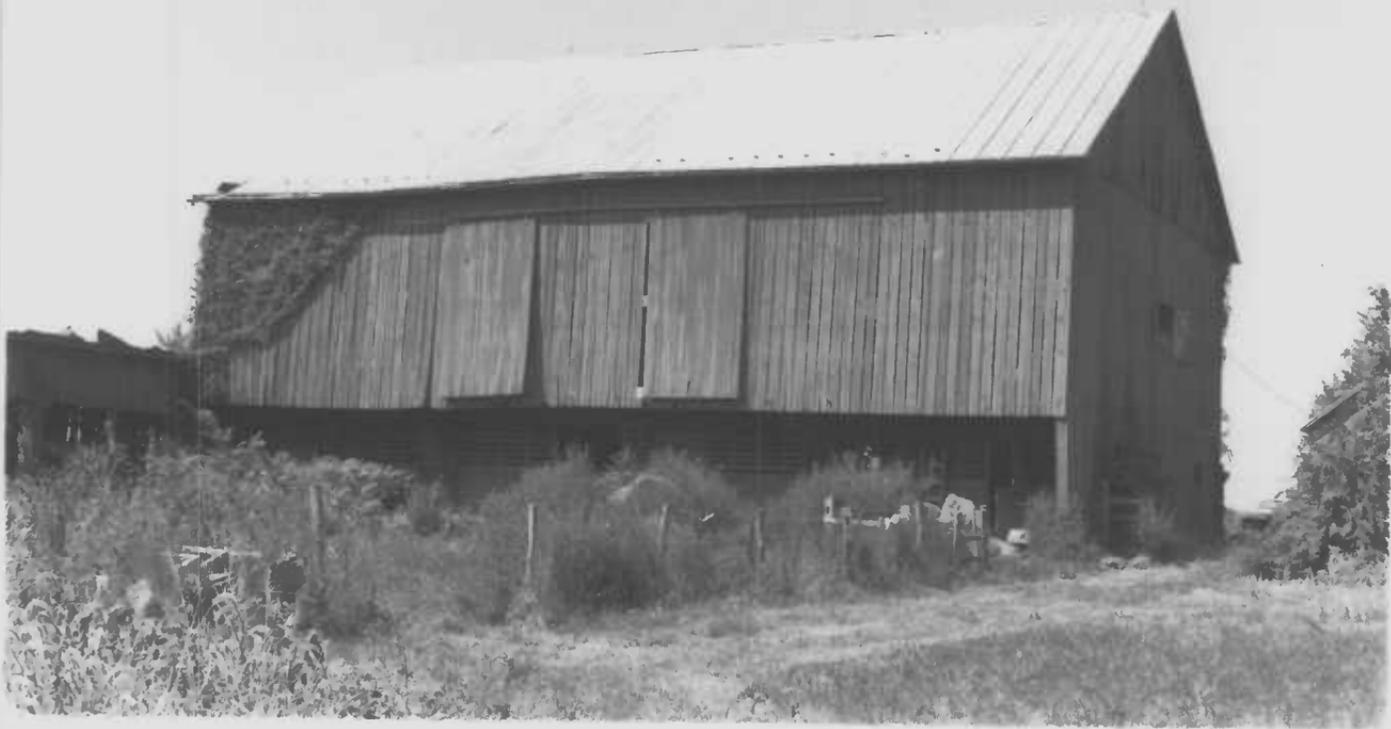
The stabling area on the ground level opens onto the southwest elevation of the barn. This elevation has the overhang typical of general purpose bank barns. The recessed wall of the ground floor has several dutch doors, between which the wall consists of horizontally applied boards on the lower half and widely spaced horizontal boards above. Three small windows in the southeast wall provide additional light to the stabling area, which is divided into two areas for free-ranging cattle, with a manger between. There are several small pens in the northwest end of the stabling area.

The exterior wall above the stabling area is simple vertical boards, with two doors suspended from tracks covering two separate doorways in the middle of the southwest elevation. In the center of the southeast elevation at the hayloft level is a small opening with a hinged door.

Southwest elevation
