Maryland Historical Trust

Maryland Inventory of Historic Properties number: ~~PG 85B-11~~
Name: Cedarville Blower Mattawoman
Crk

Maryland Historic Highway Bridges
 Bridge Type Metal Girder
 Map H-11 Mattawoman
 County Prince George's
 Bridge # and name P 407/Cedarville Rd. over Mattawoman Creek

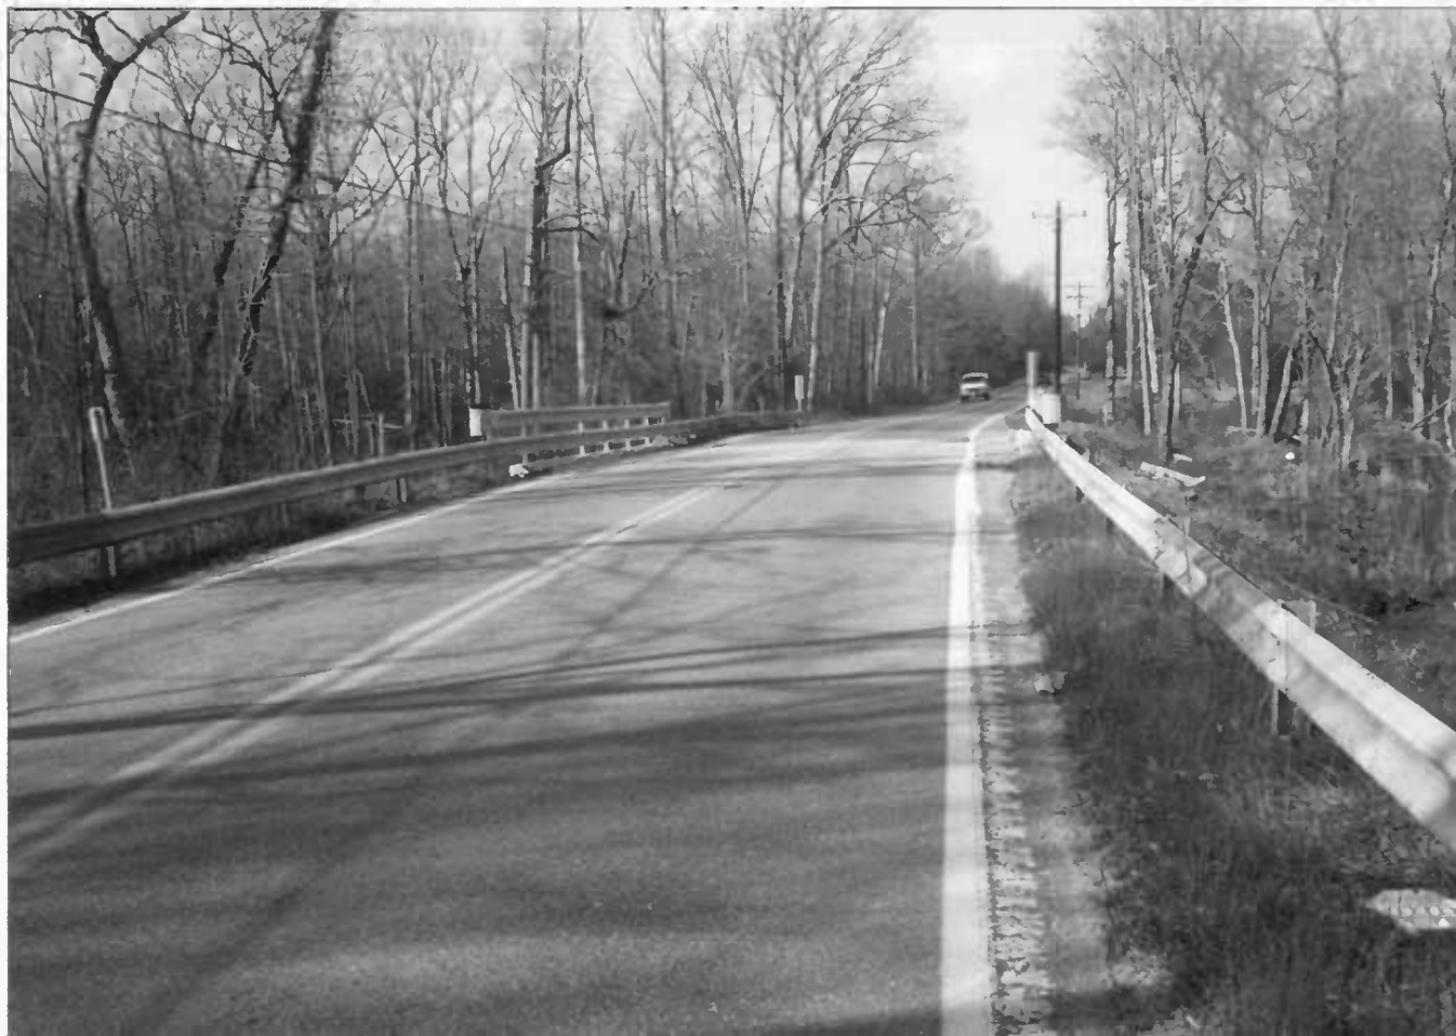
Number 1 ⁴ ~~23~~ of ~~24~~

Description EAST APPROACH LOOKING WEST

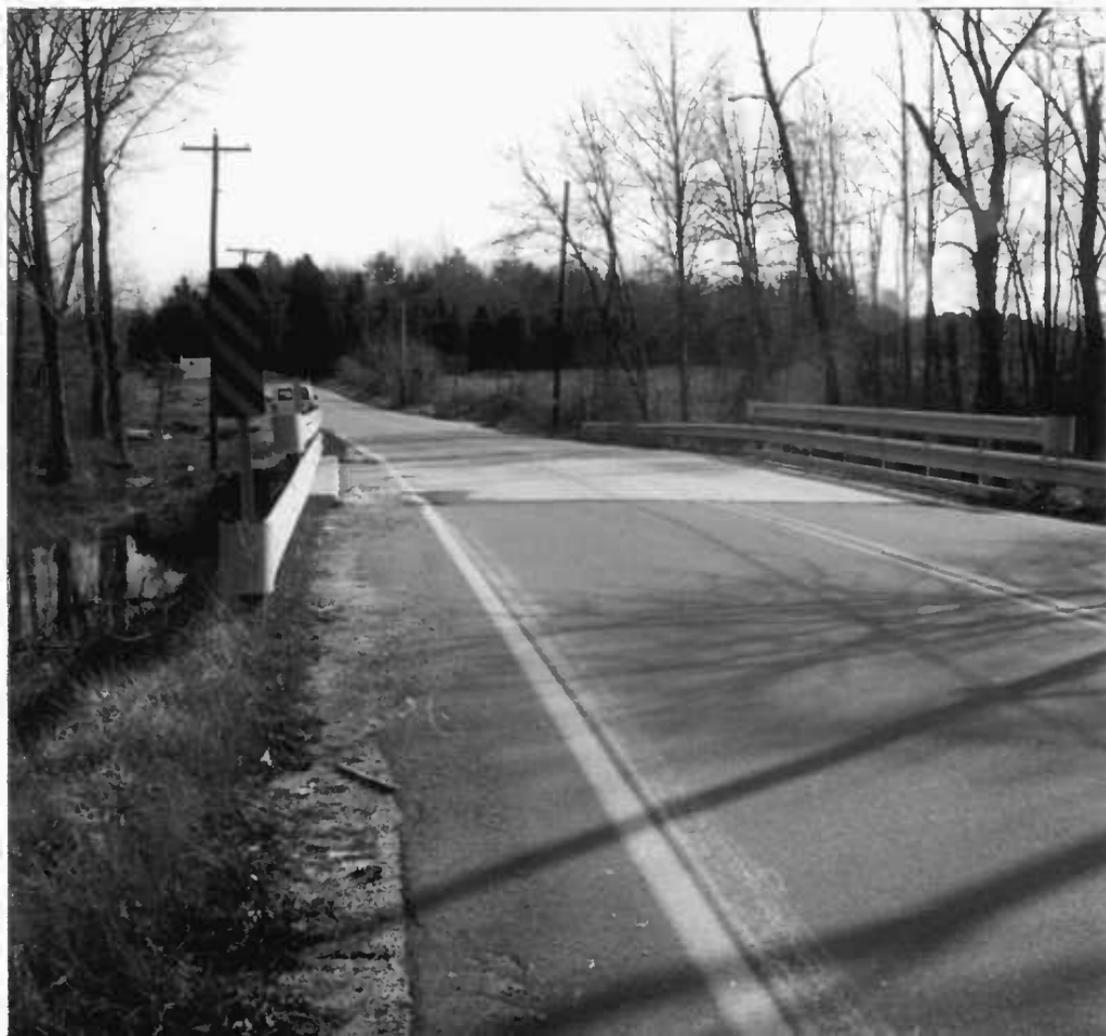
Number 2 of 24

Description WEST APPROACH LOOKING EAST

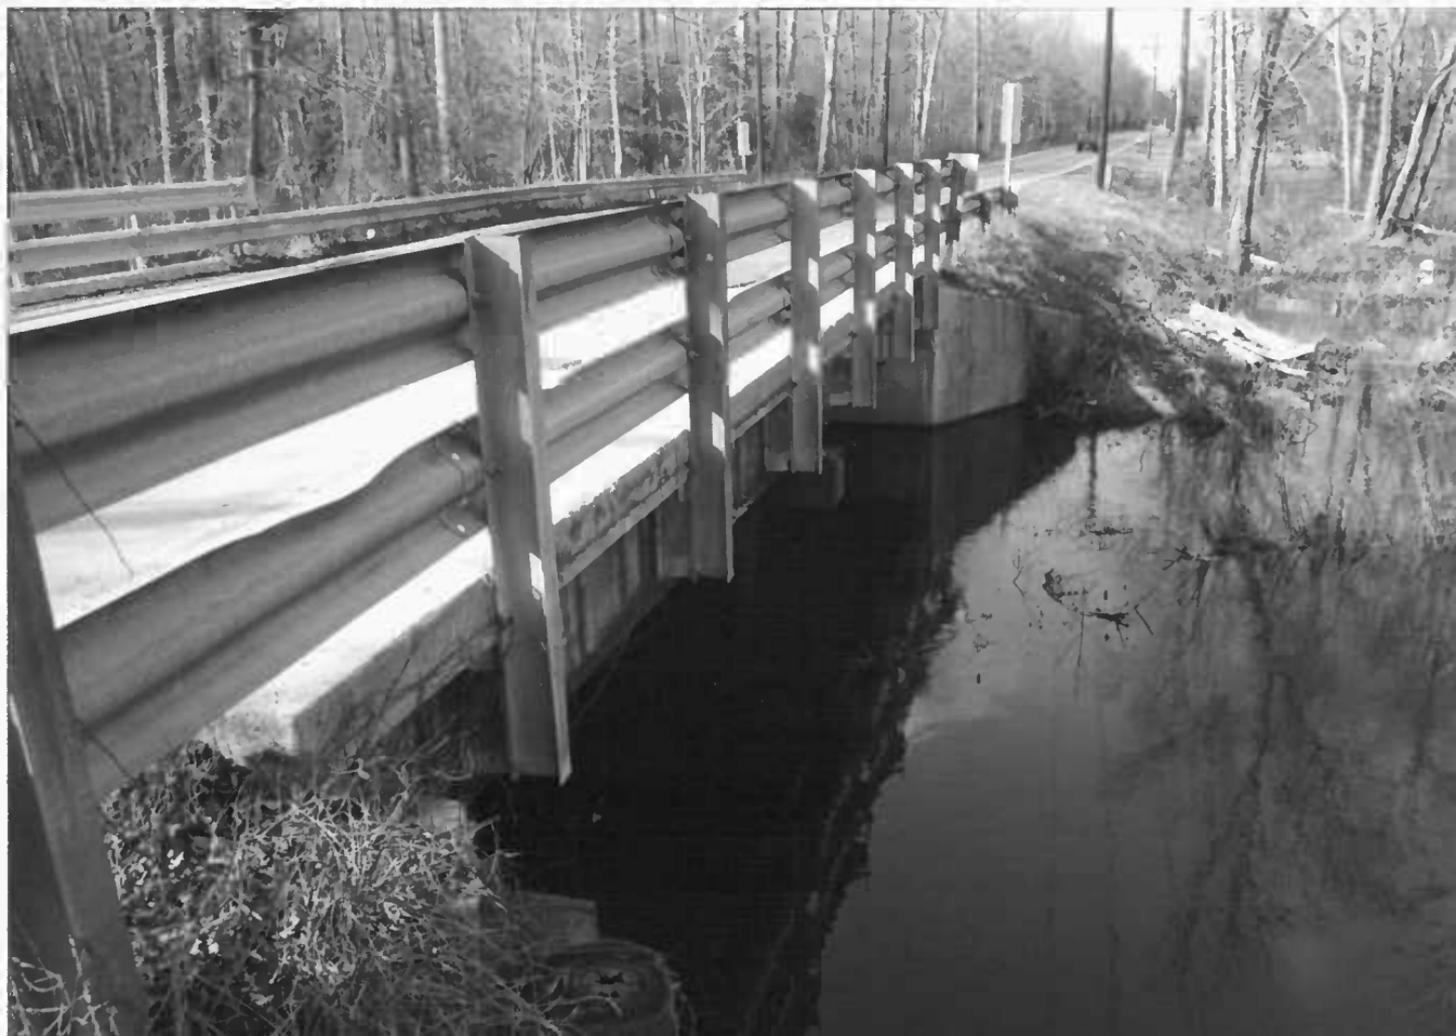
Number 3 of 4

Description NORTH ELEVATION

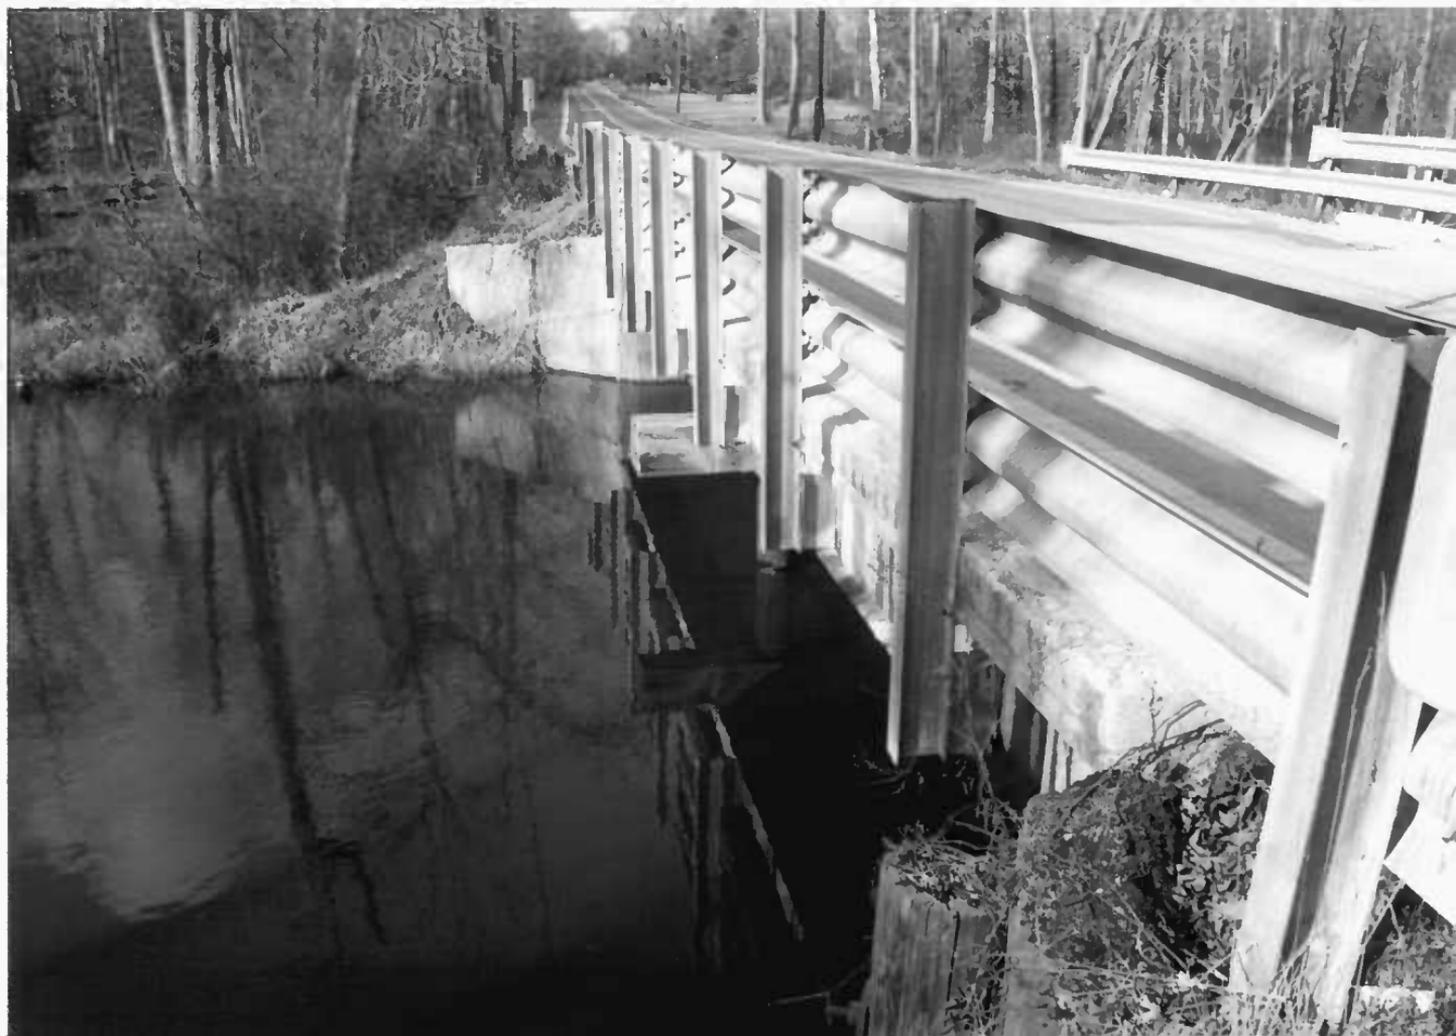
Number 48 of 4

Description SOUTH ELEVATION
