CAPSULE SUMMARY CT-1112 MEADOR BARN

Maryland Historical Trust State Historic Sites Inventory Form

and/or common Meador Barn

Survey No. CT-1112

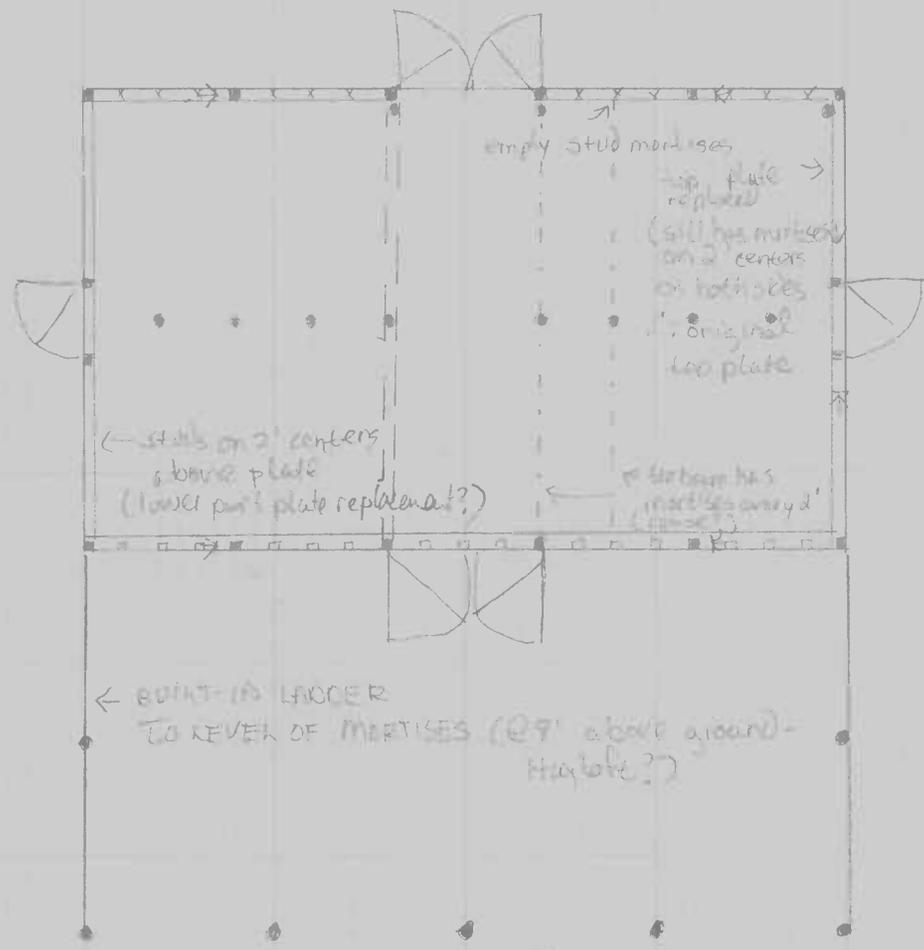
x = empty stud mortise in top plate
□ = stud
- - - - element removed
