# Maryland Historical Trust State Historic Sites Inventory Form

historic Pullen's Neglect

and/or common Orchard's Cove Farm

Survey No. D-645

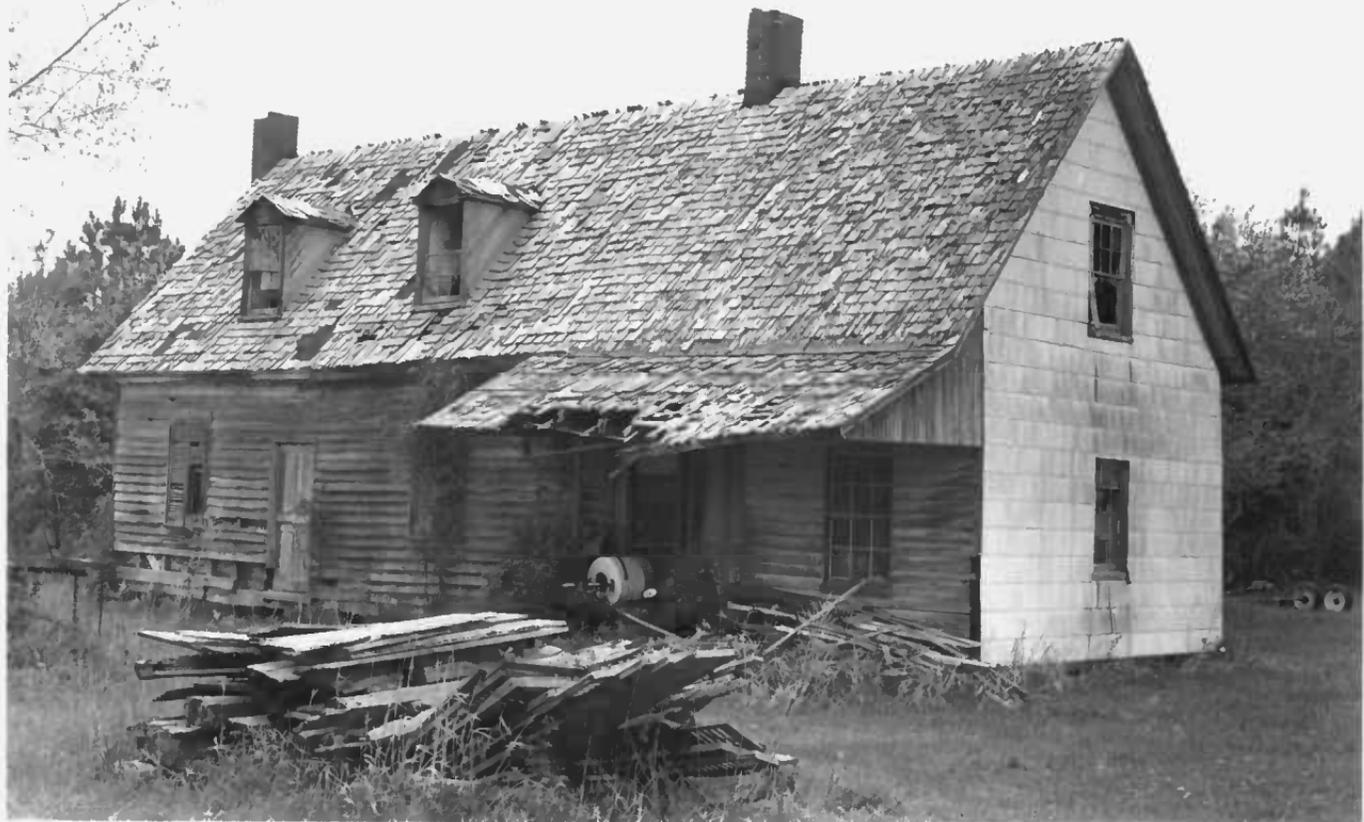
D-645 Pullen's Neglect  
Cambridge vicinity  
Orlando Ridout V Spring 1983  
View from Northeast

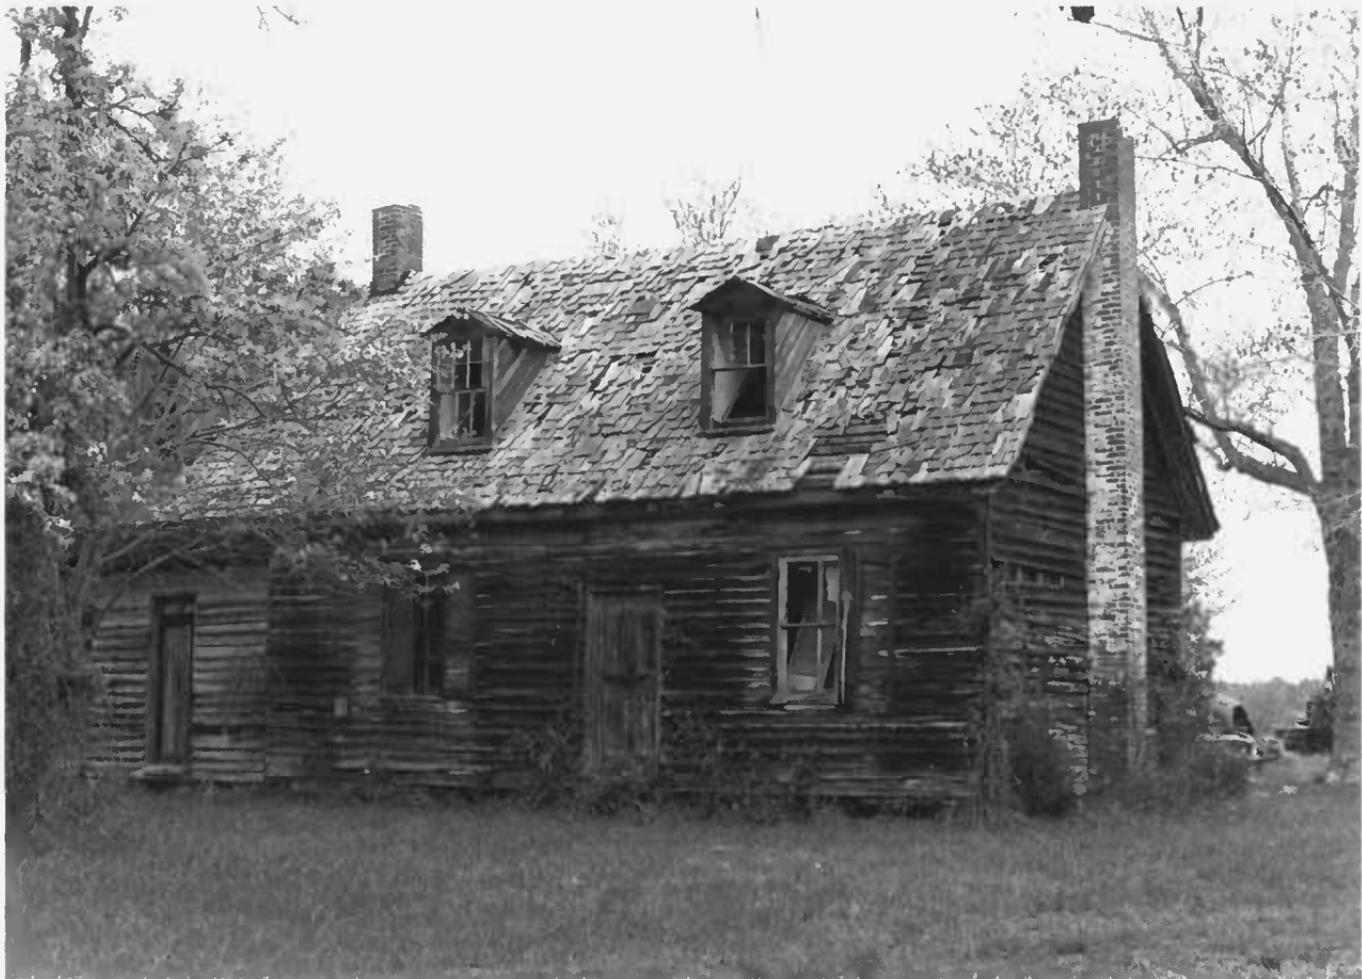
The rear of west facade is virtually identical to the front facade, with the original south window sash replaced with 2/2 sash. The dormer windows, siding, cornice and roof match the front facade.

D-645 Pullen's Neglect  
Cambridge vicinity  
Orlando Ridout V Spring 1983  
West facade
