Maryland Historical Trust State Historic Sites Inventory Form

Survey No. K-104

historic Bungay Hill Farm, Bungay, Bungy

K-104
Bungay Hill Farm
(Bungay, Bungy)
6029 Edesville Road, Rock Hall
Rock Hall Quadrangle

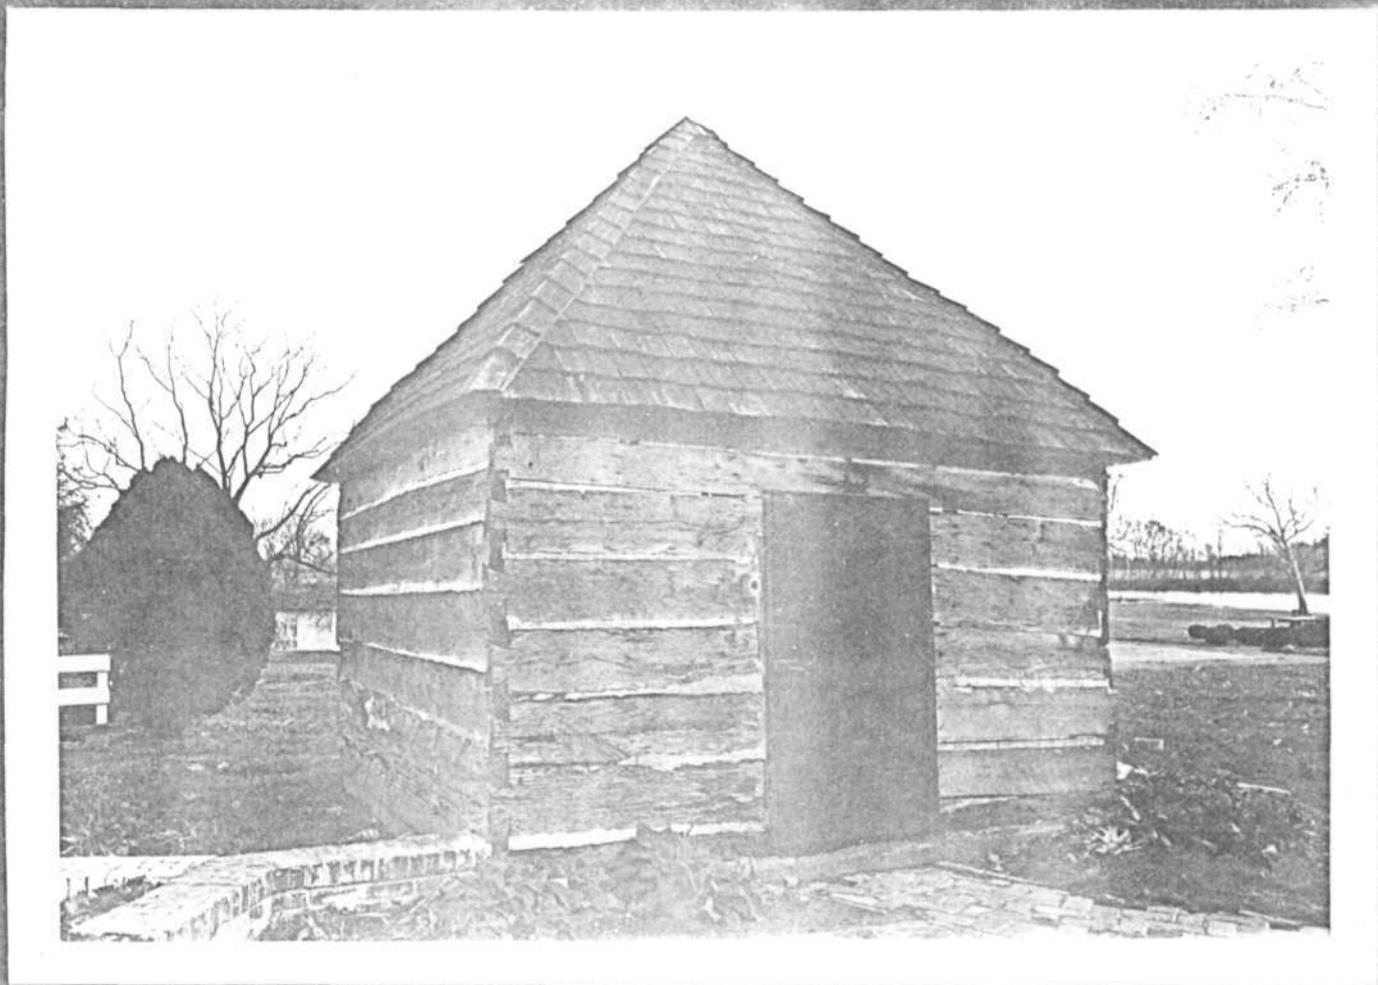
MEATHOUSE, BUNGAY HILL FARM (K-104)

B. A meathouse about 12 ft. square with a wood shingled pyramidal roof and planked-log wall construction stands to the east/northeast of the house. A few of the planked logs have been replaced; some are in poor condition. They are dovetailed at the corners. Floor is concrete; wall cabinets on interior. Has original? summer beam; roof framing not visible. Door and frame are recent. Set on concrete block foundation; hence structure may have been moved, though its original location is likely to have been in the vicinity of its present location, given the proximity of the house kitchen.

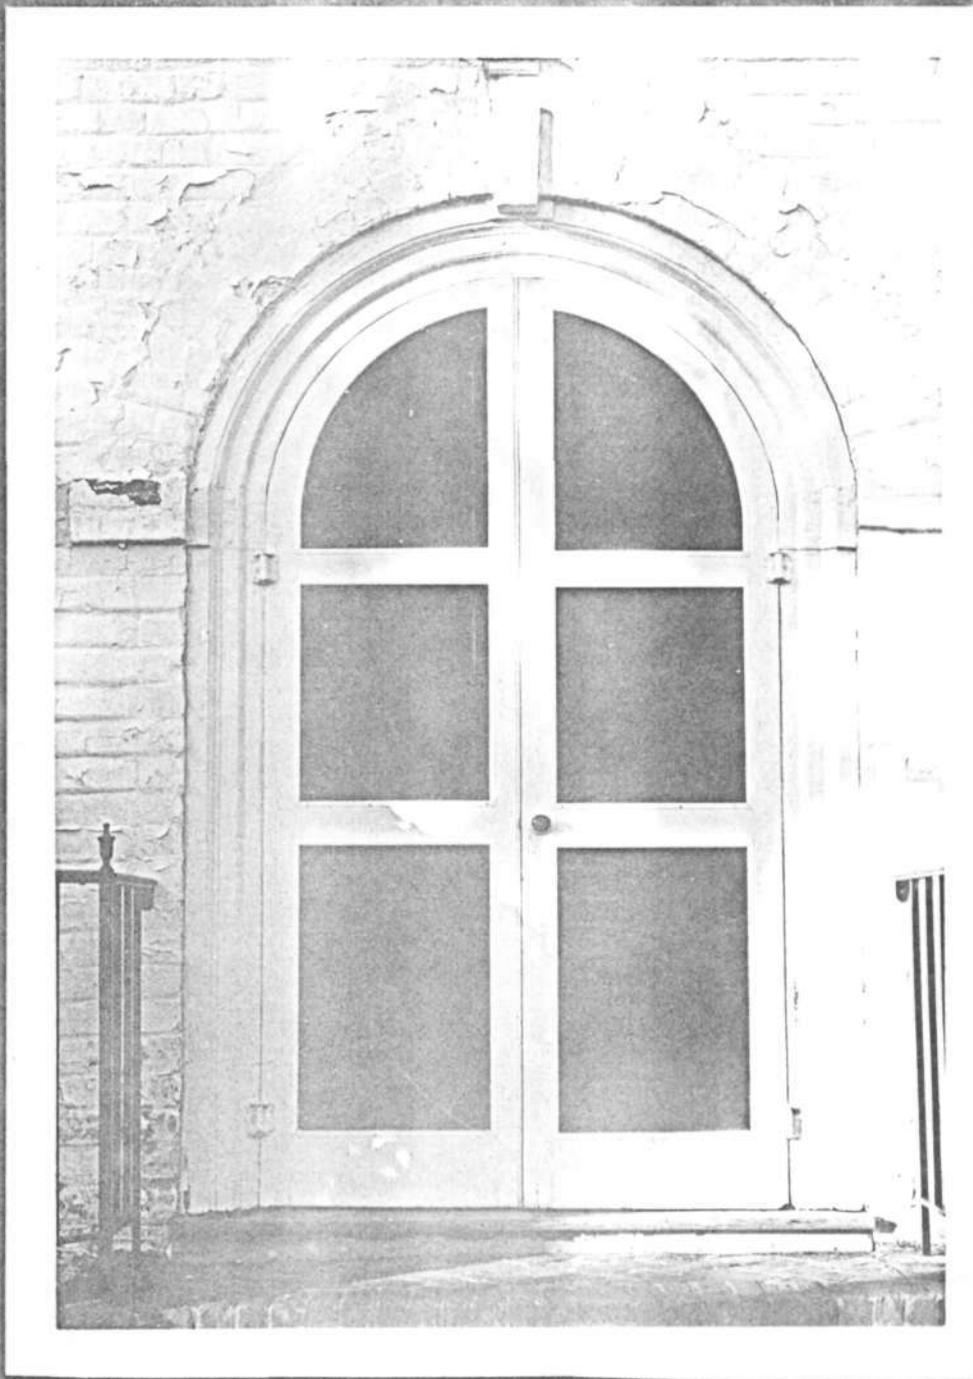
MAIN ENTRY, BUNGAY HILL FARM (K-104)

The main entry is located in the central bay of the south side (but this opening is off-center with reference to other 1st-story openings, and the 2nd story window is not directly over the main entry's double doors, though it may have been were the original door a single one. Doors are double and round-headed as a pair; trim appears old (paint and wear evidence) and has large pegs at base and center of arch. Trim has 3 faces, with ogee between each (2 sizes, the larger between outside and center face); inside face (fillet) has shallow inside bead. Vertical flat large (10 $\frac{1}{2}$ ") brick as keystone. At arch base, serving as imposts, are two stretchers, one atop the other, also 10-10 $\frac{1}{2}$ " long. Arch is round-headed, of alternating stretchers and headers (the voussoirs). Double doors follow the shape of the arch, having three raised and beveled panels each (appear modern).

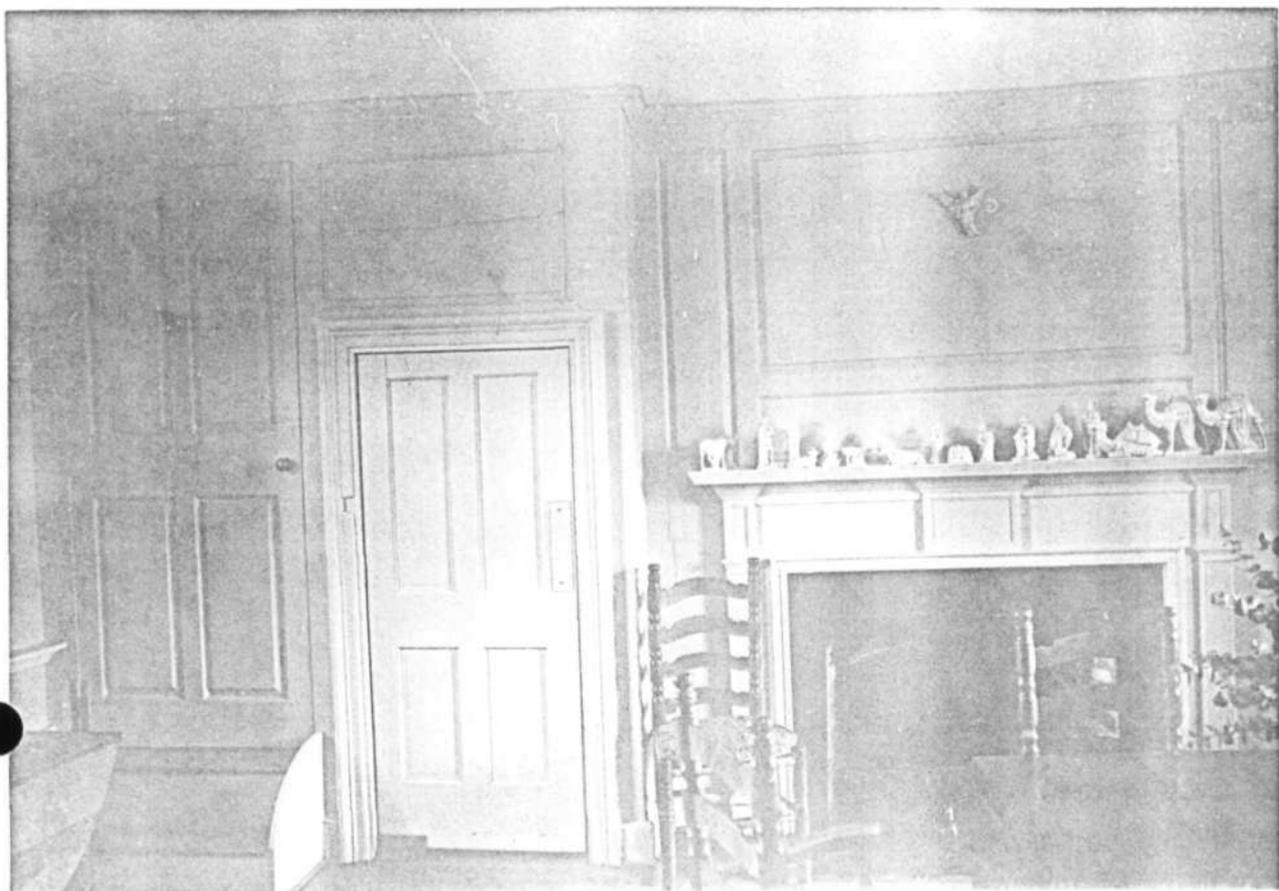
DINING ROOM, MAIN SECTION, BUNGARY HILL FARM
(K-104)

Present dining room (see photo) - Painted raised and beveled paneling, bevel similar in size to that of living room. Overmantle: one large panel above smaller one. Mantle appears later than date on house gable end, toward end of third quarter of 18th century or early 4th quarter. Pilasters have fairly bold reeding. Frieze has center and side raised, then recessed panels with a gouge-work strip between sections. Shelf is straight with composite edge, including a cyma. Alterations around the mantle in addition to the style of the mantle may indicate the mantle is a later addition to the room. Some Federal elements.
