K-650

Old House at Circle Acres

Near Millington'

Maryland Historical Trust State Historic Sites Inventory Form

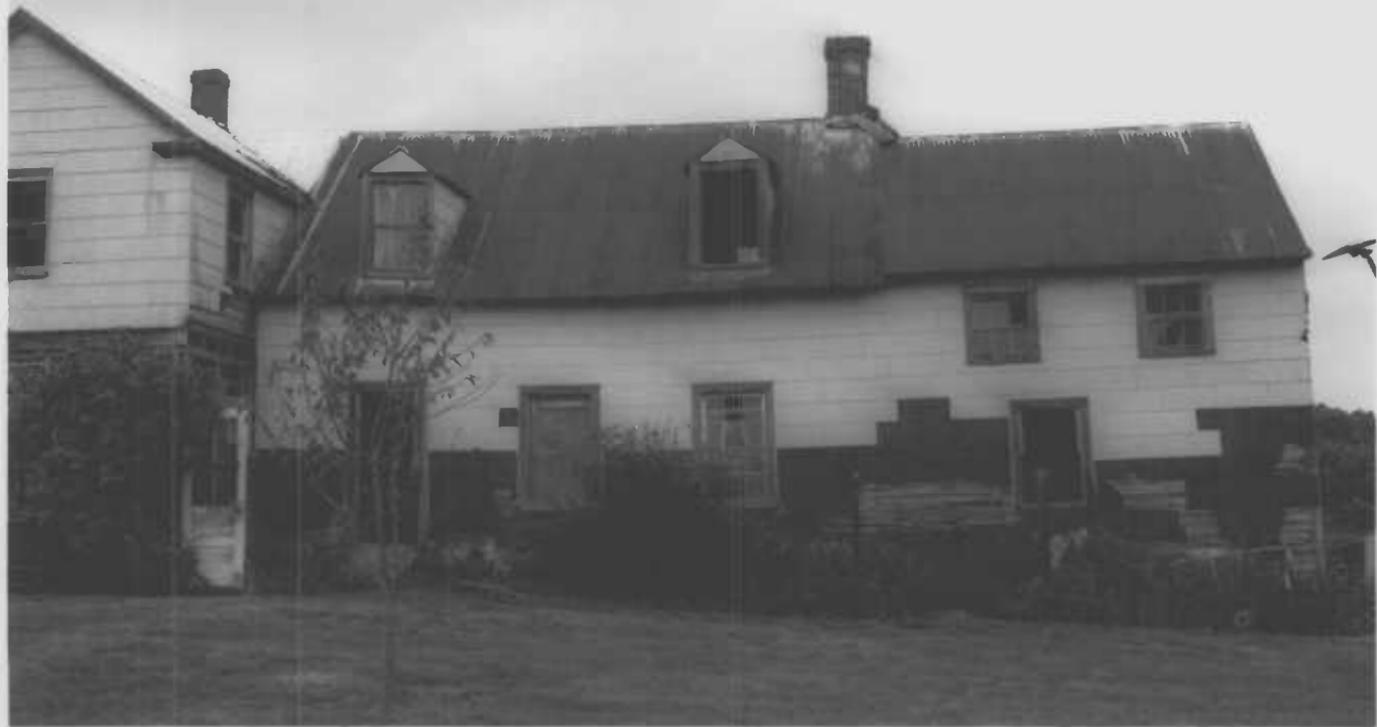
K650-2

View to north

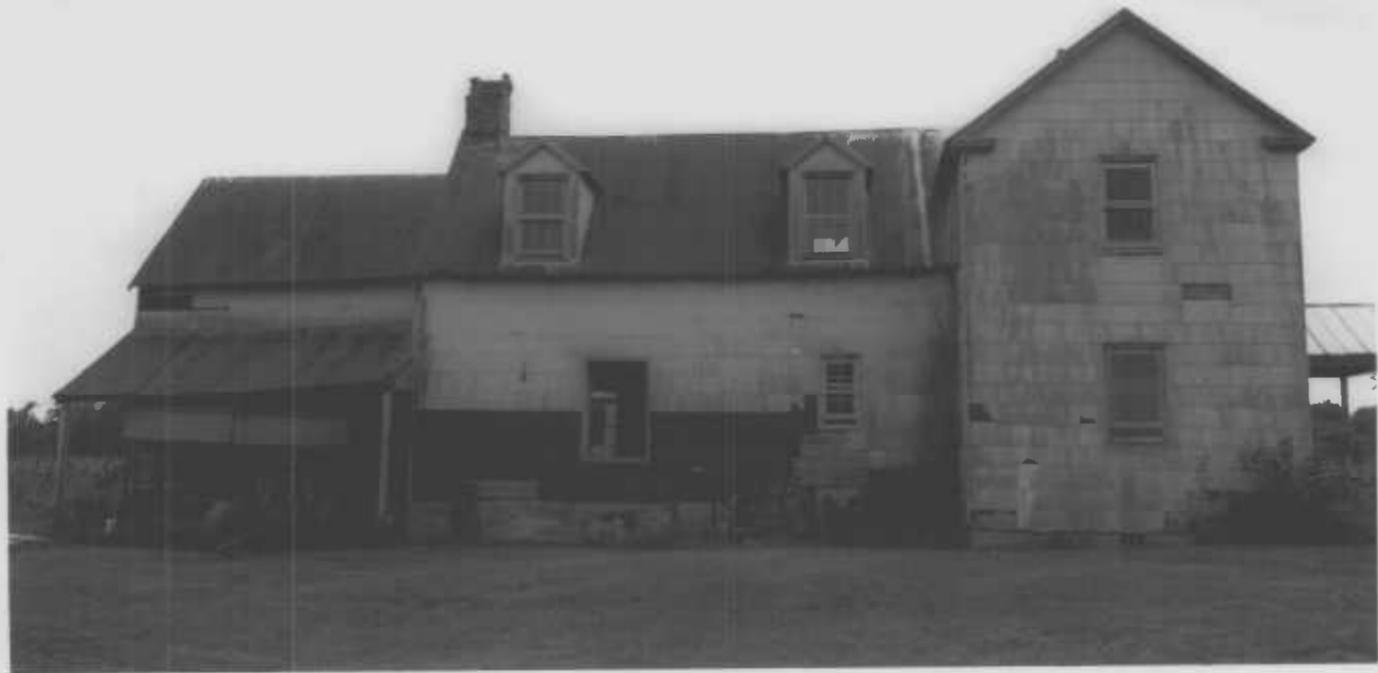
K650 - 34

View to south
