QA-53

William C. Hall Farm
Church Hill vicinity
Private

INVENTORY FORM FOR STATE HISTORIC SITES SURVEY

William C. Hall Farm

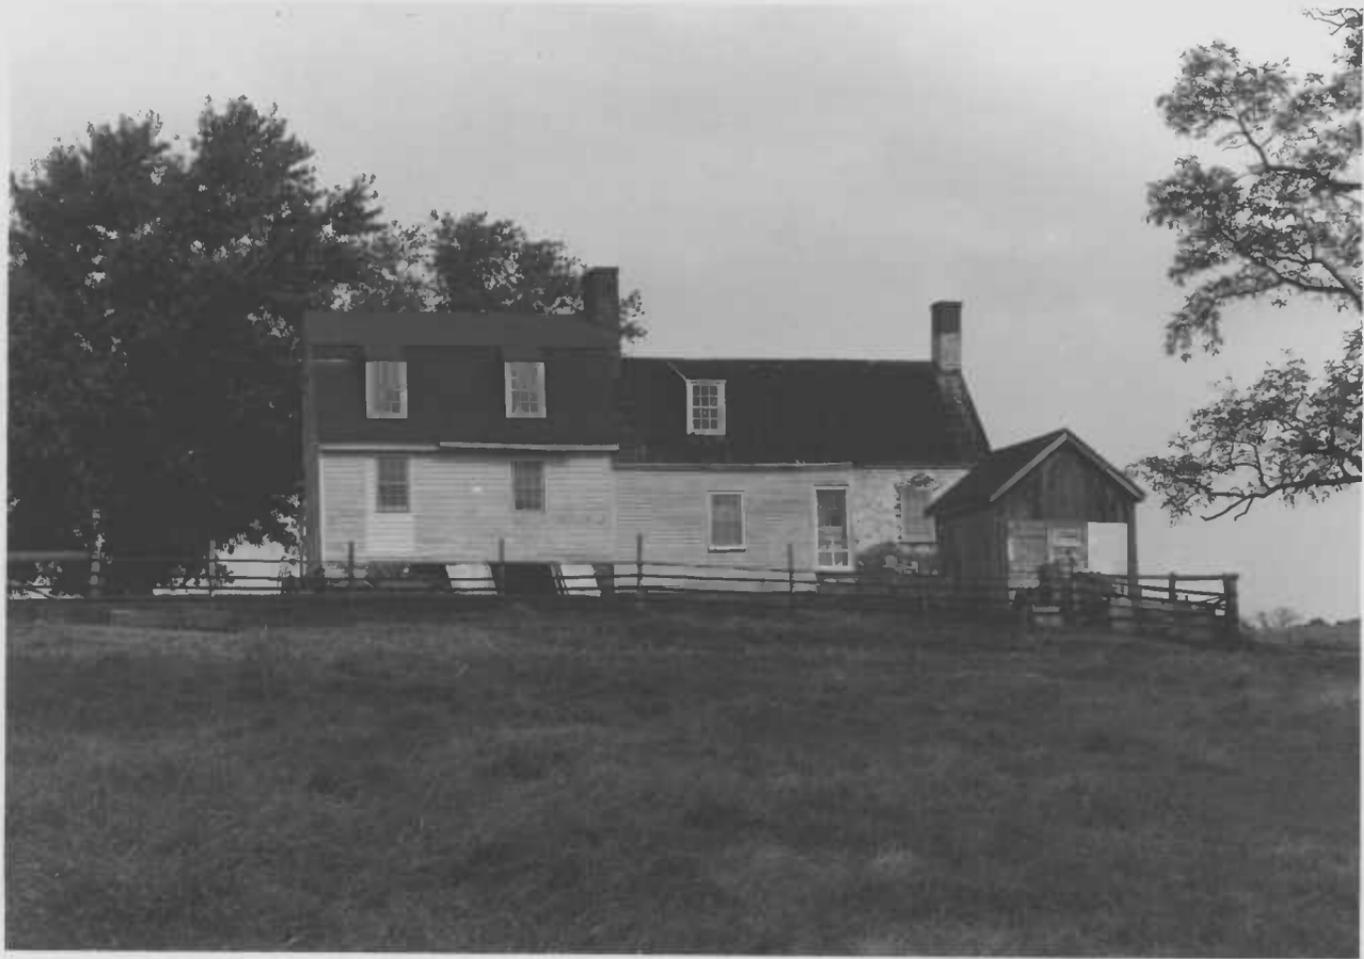
QA-53

William Hall Farm
Church Hill vicinity
Orlando Ridout V 1979
South facade

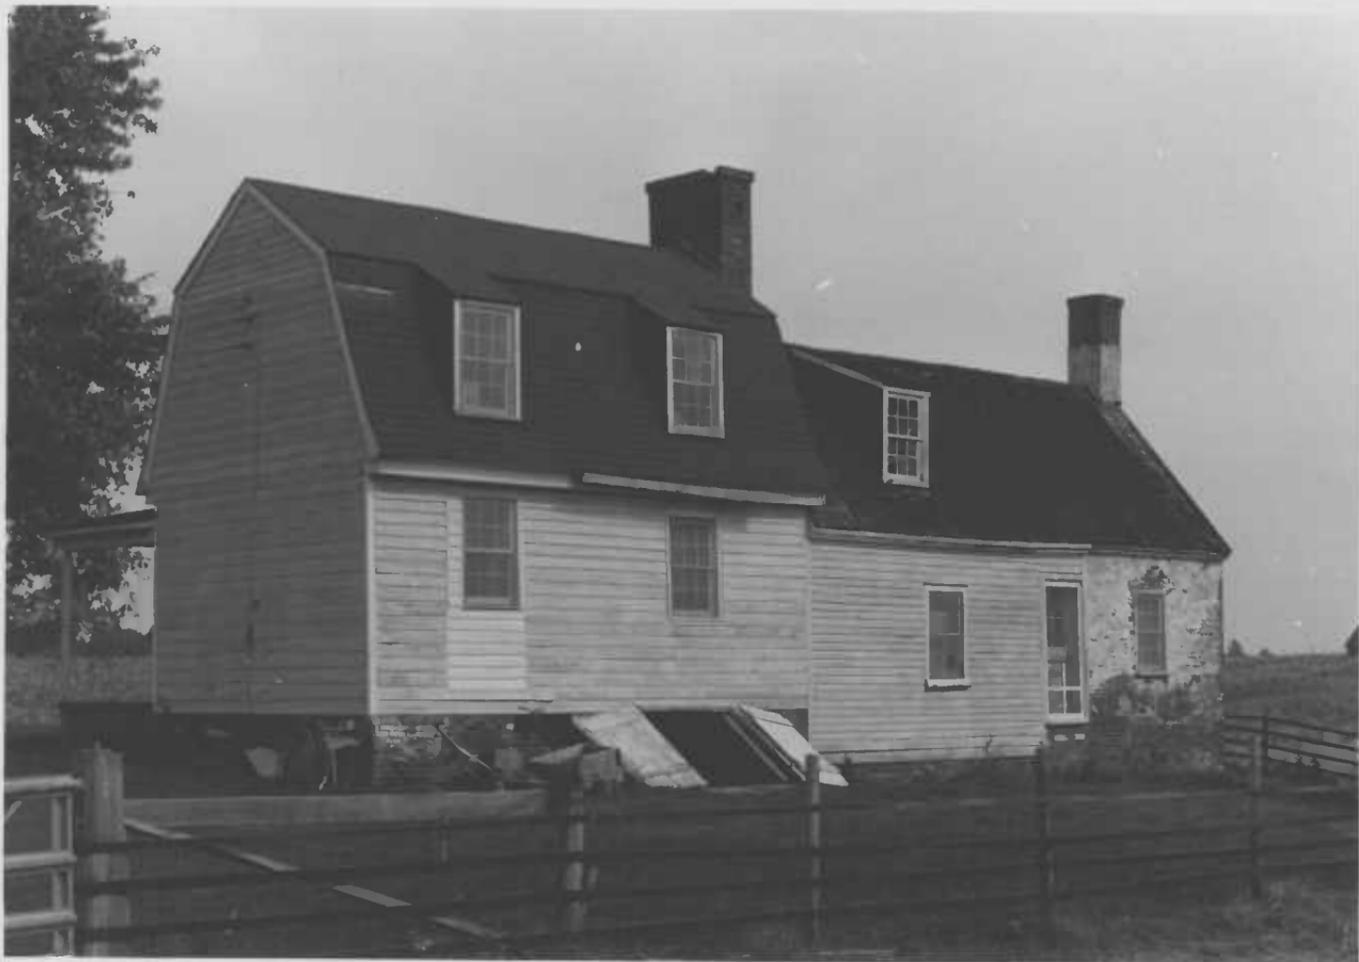
QA-53

William Hall Farm
Church Hill vicinity
Orlando Ridout V 1979
View from Southwest

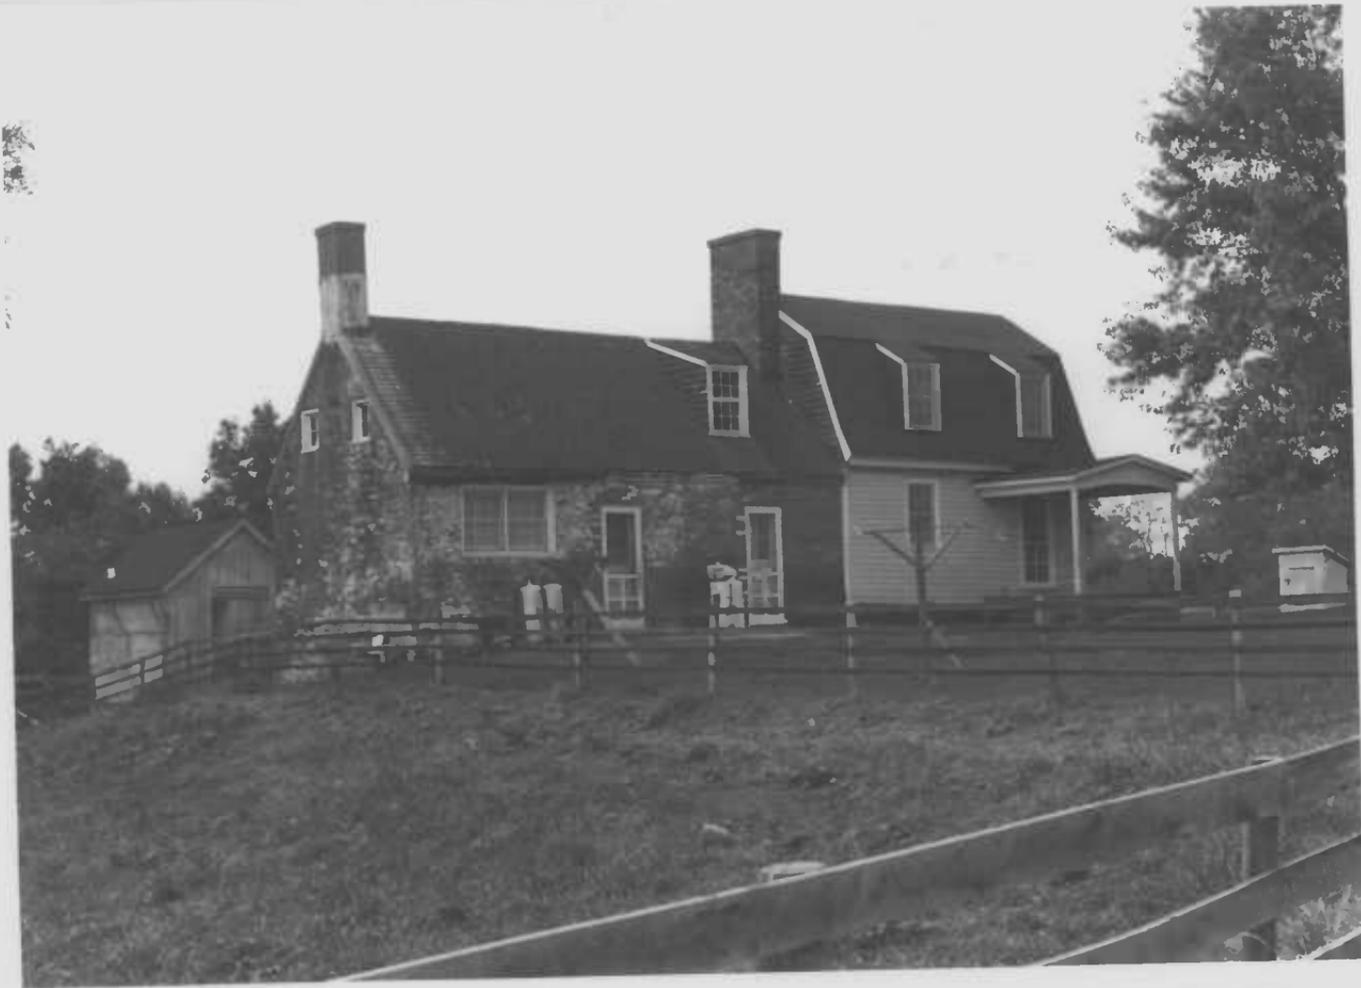
QA-53

William Hall Farm
Church Hill vicinity
Orlando Ridout V 1979
View from Northeast
