QA-62

Caleb Clough House

Price vicinity

INVENTORY FORM FOR STATE HISTORIC SITES SURVEY

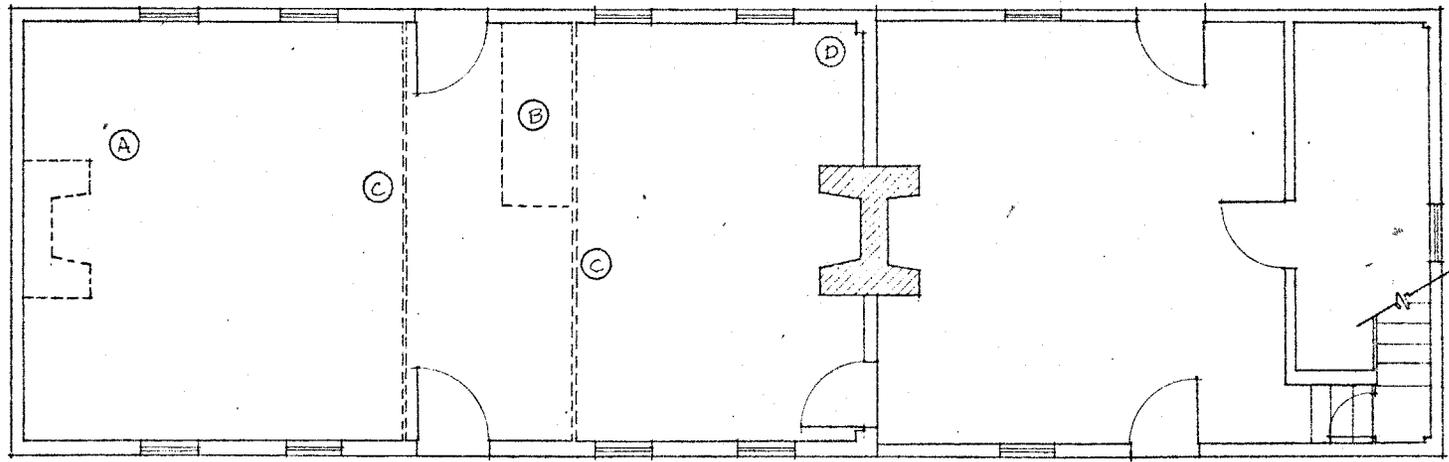
- A APPROXIMATE CONFIGURATION OF FIREPLACE.
- B APPROXIMATE LOCATION OF STAIR.
- C LOCATION OF ORIGINAL BOARDED PARTITIONS.
- D EXPOSED CORNER POSTS.

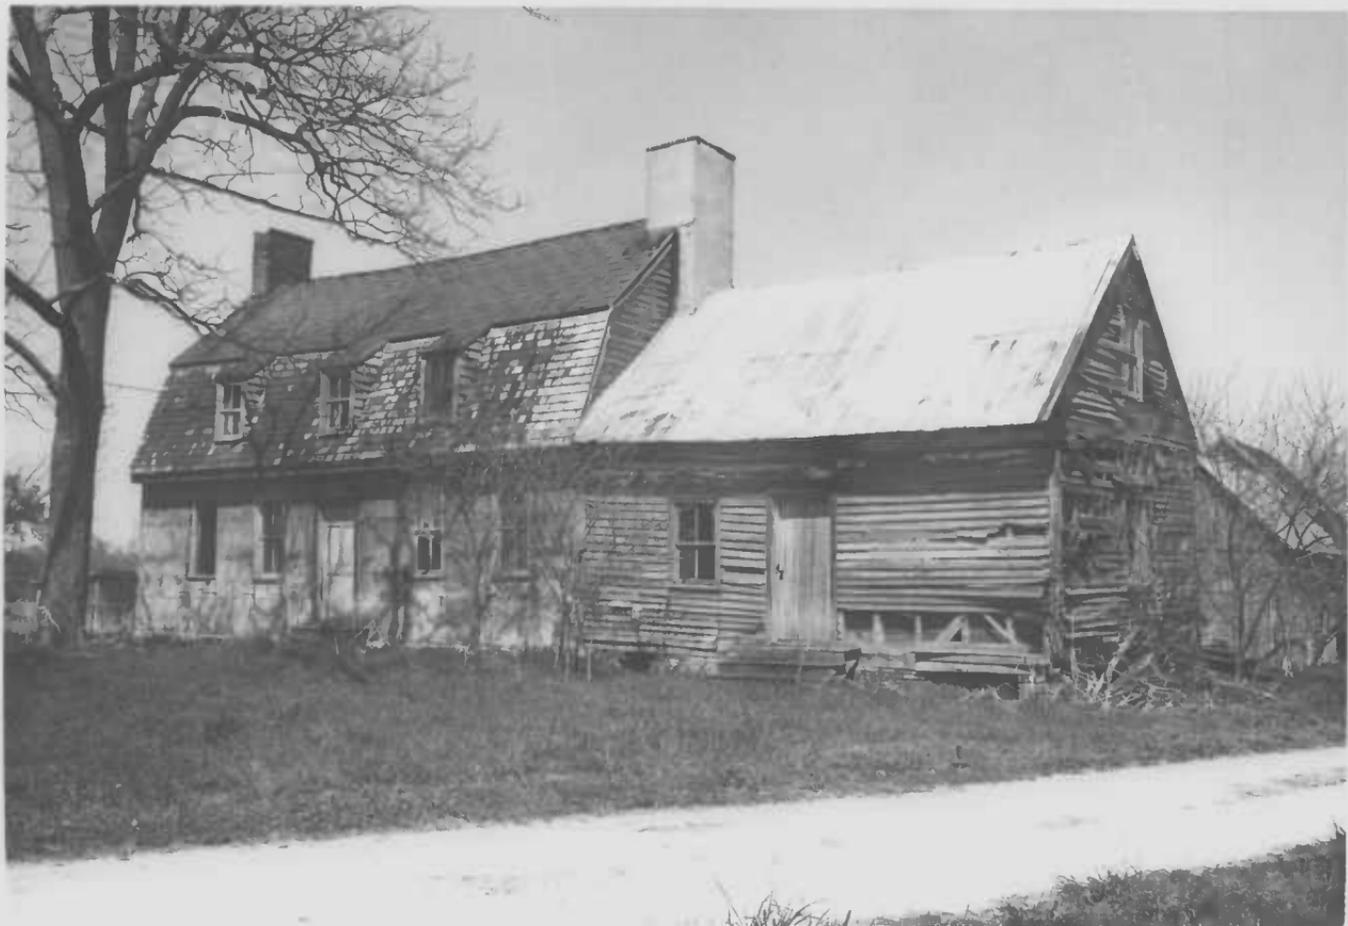
#62

QA-62
Caleb Clough House w/
chimneys still standing
