QA-122

Sally Harris Mill House

Queenstown vicinity

## INVENTORY FORM FOR STATE HISTORIC SITES SURVEY

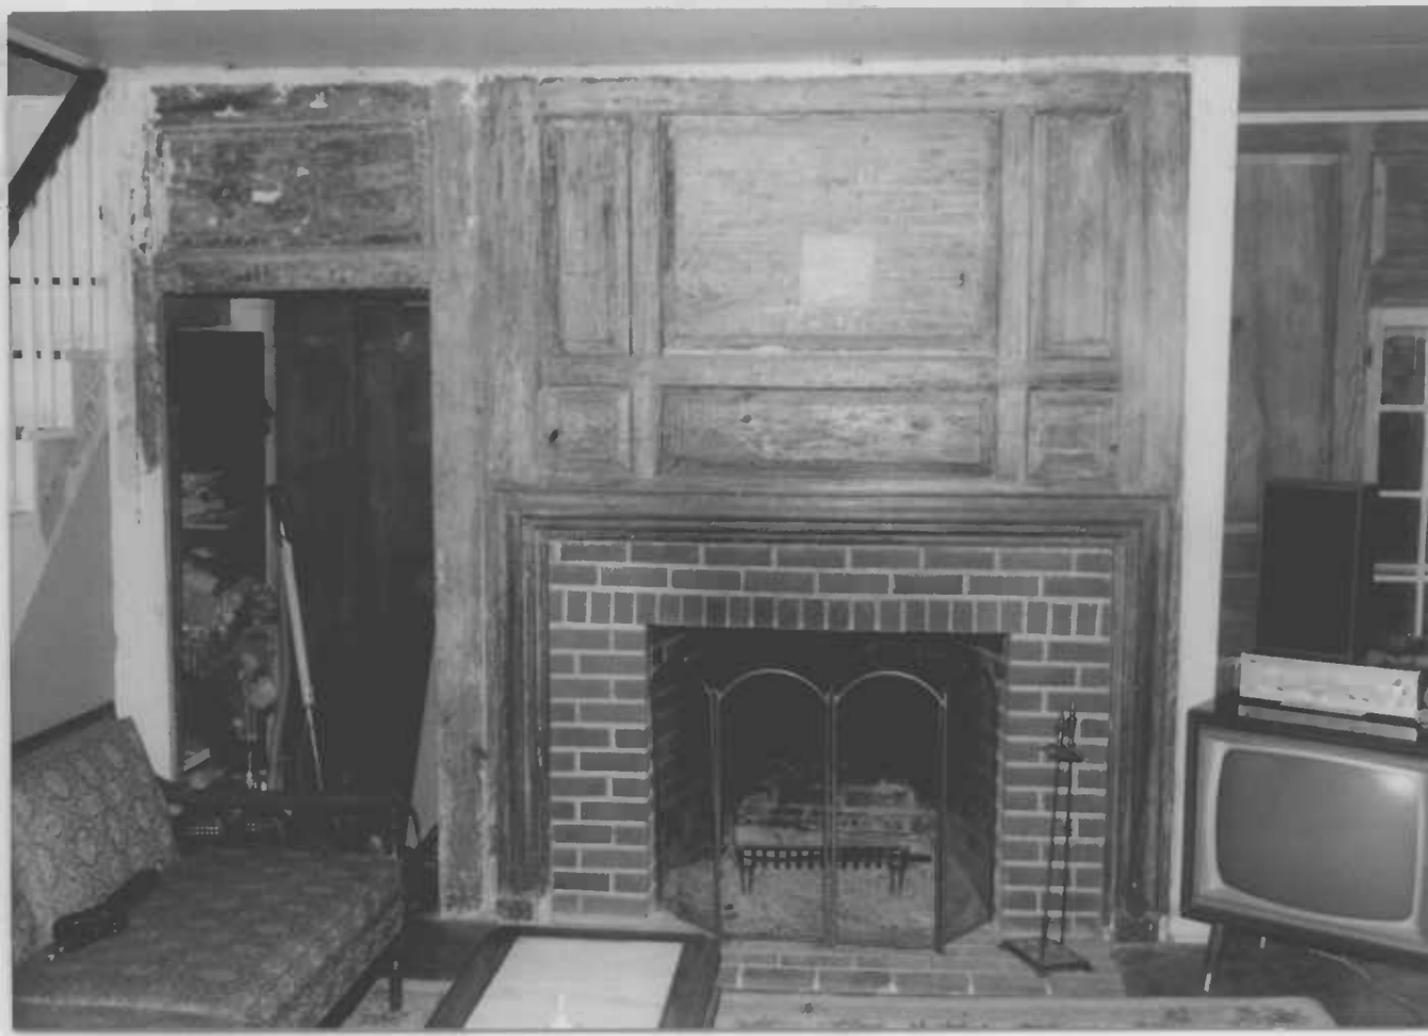
14

The original hall-parlour plan has survived intact on the first floor, but alterations have evidently occurred along the north gable wall. The hall fireplace is centered on this wall, and is strikingly set off with raised pine paneling and a superb bolection mold mantel surround. The paneling is carried across the entire chimney breast and includes a closet to the left of the fireplace, but does not continue around the corner to the right, leaving that side wall of the chimney finished with plaster. More paneling is carried across the alcove to the right, and the

QA-122 Sally Harris Mill House  
Queenstown vicinity, MD  
Orlando Ridout V, 1978 (MHT)  
Interior, North wall of hall
