QA-144

227 North Commerce Street

INVENTORY FORM FOR STATE HISTORIC SITES SURVEY

Orlando Ridout V, Historic Sites Surveyor

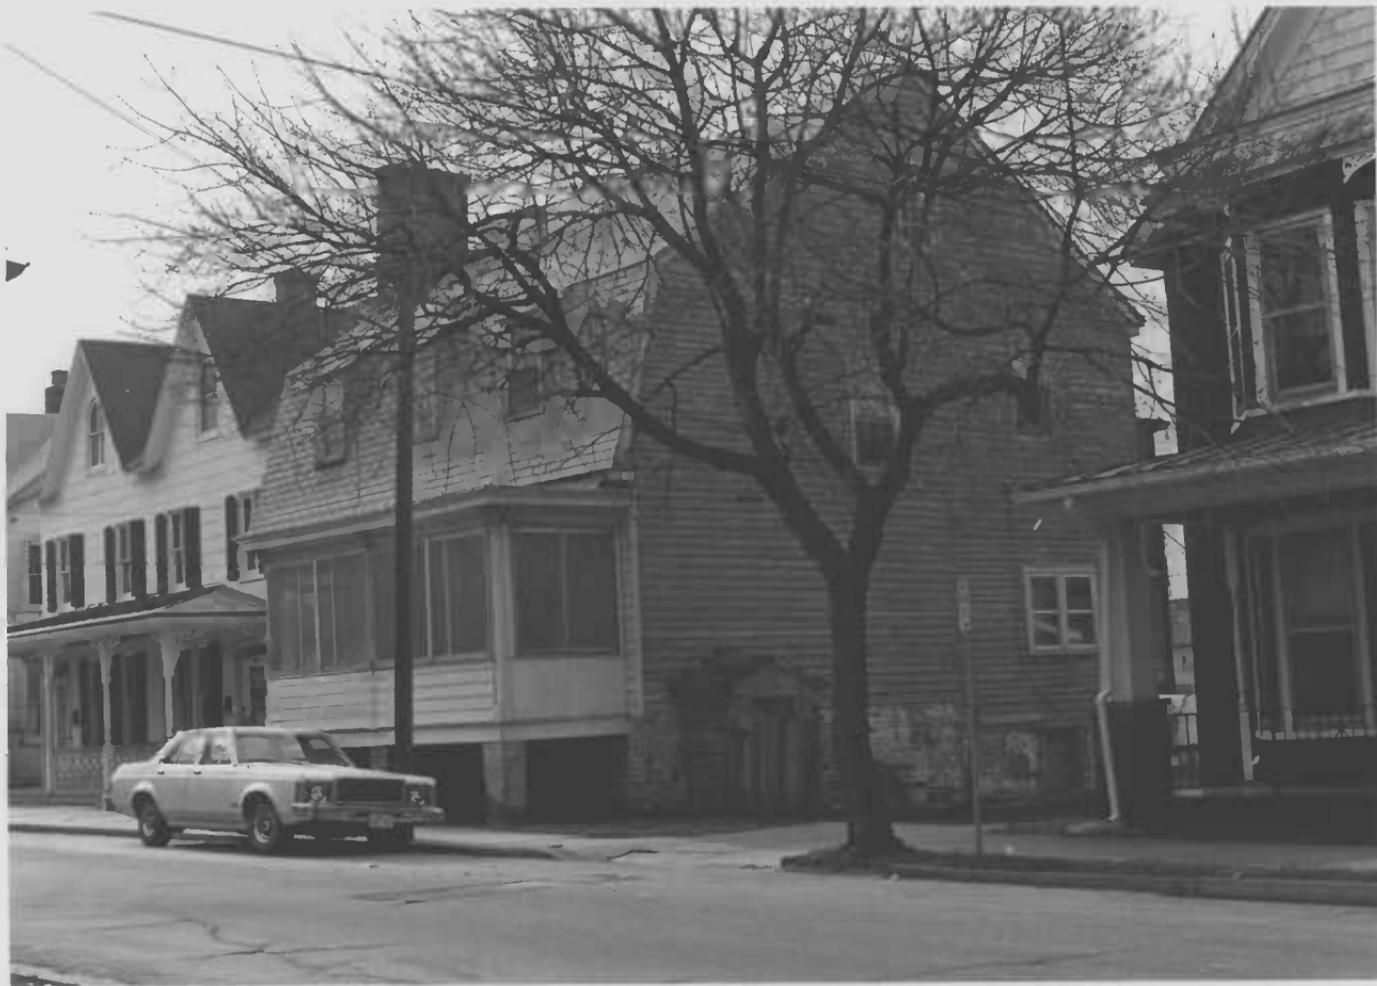
QA-144

227 North Commerce Street
Centreville, Maryland
Orlando Ridout V 1979 (MHT)
Front facade and north gable

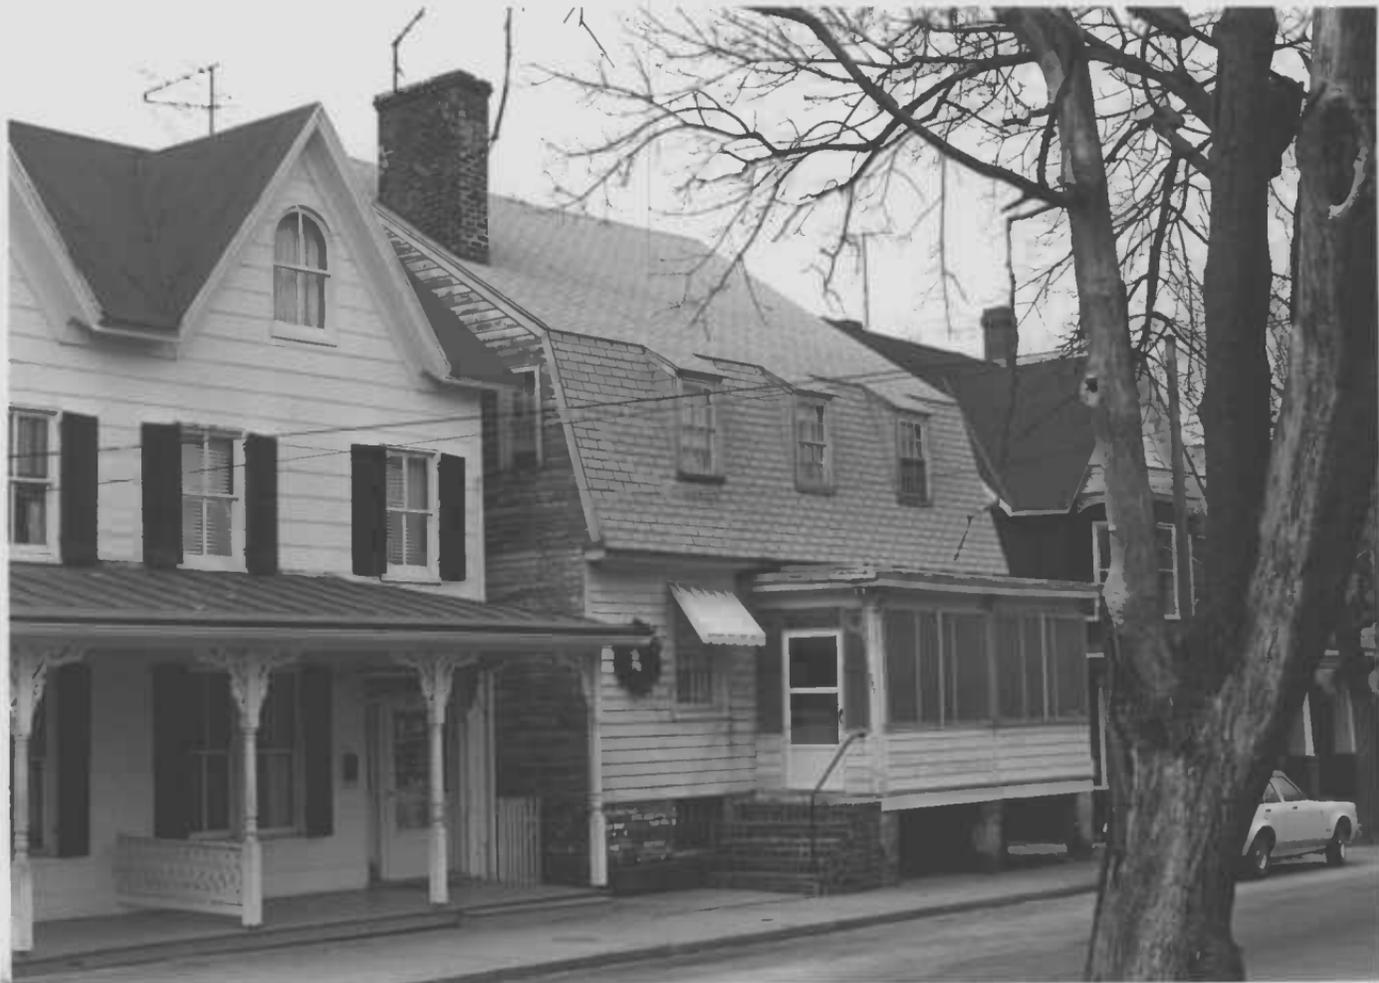
QA-144 227 North Commerce Street
Centreville, Maryland
Orlando Ridout V 1979 (MHT)
View from south

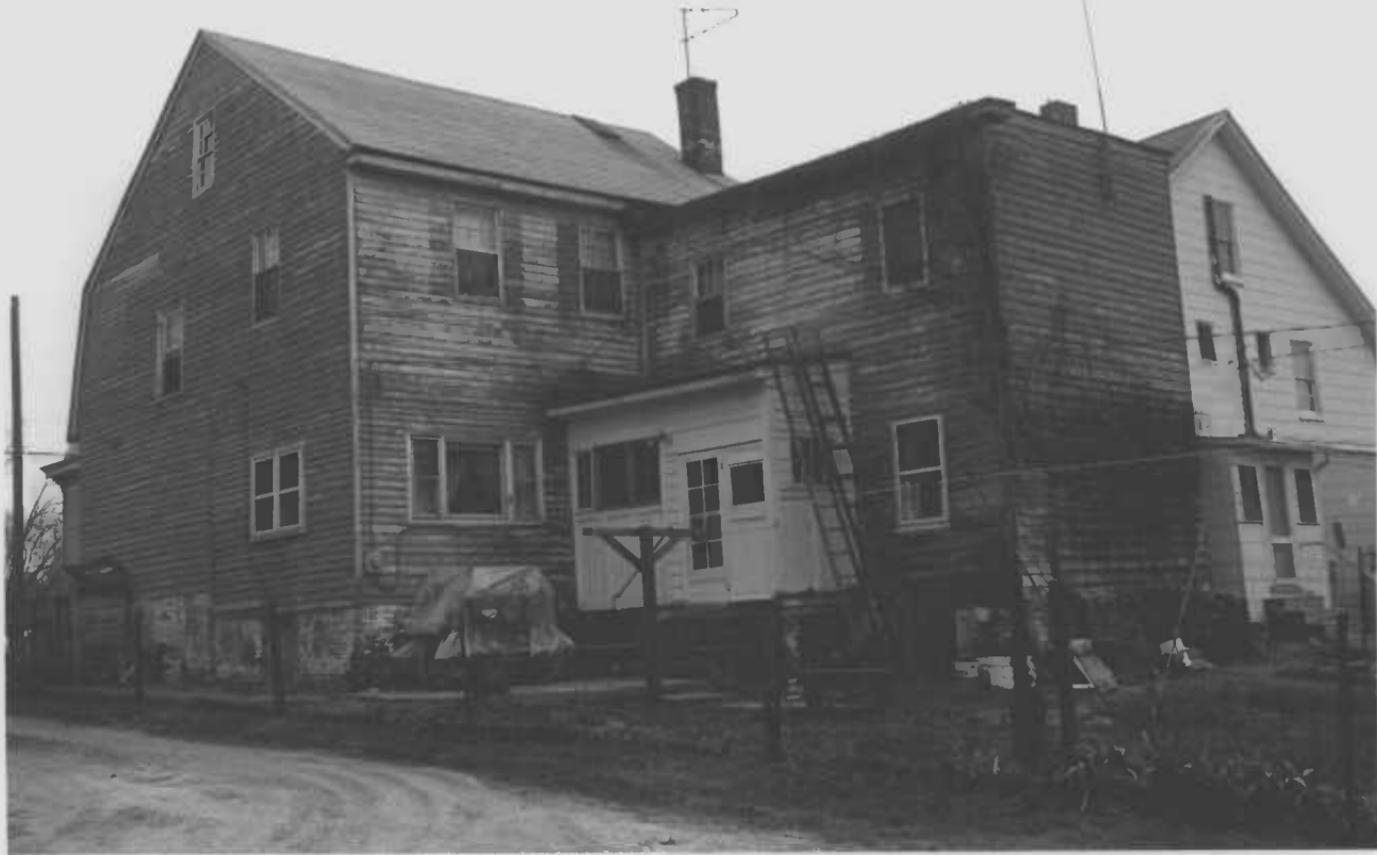
QA-144 227 North Commerce Street
Centreville, Md.
Orlando Ridout V 1979 (MHT)
View from north
