INVENTORY FORM FOR STATE HISTORIC SITES SURVEY

Winterstein Farm

Sudlersville

QA-176

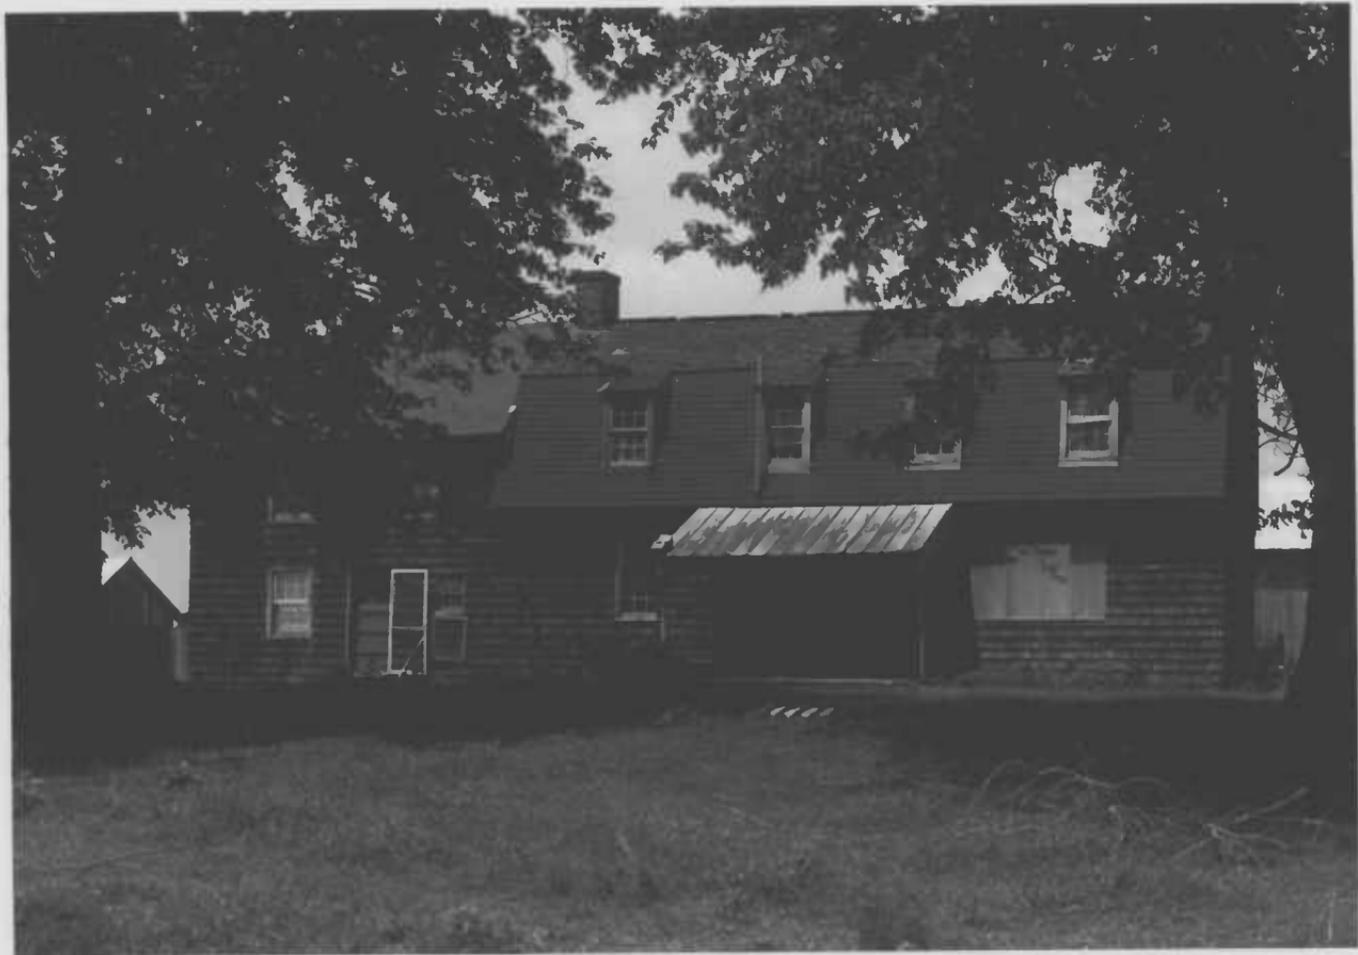
The front facade of the main house faces south. The door is in the center bay, flanked by a single 9/6 window to the west and a modern picture window to the east. Four shed roof 6/6 dormer windows are ranged across the second floor. The house rests on a continuous brick foundation and is covered with wood shingle siding. The eaves are boxed in and trimmed with an early complex crown mold and bed mold. The lower pitch of the gambrel roof is covered with asphalt shingles, the upper pitch with wood shingles. A small 20th century lean-to porch protects the front door.

QA-176 Winterstein Farm
Sudlersville vicinity
Orlando Ridout V 1980
Front facade fromSouth

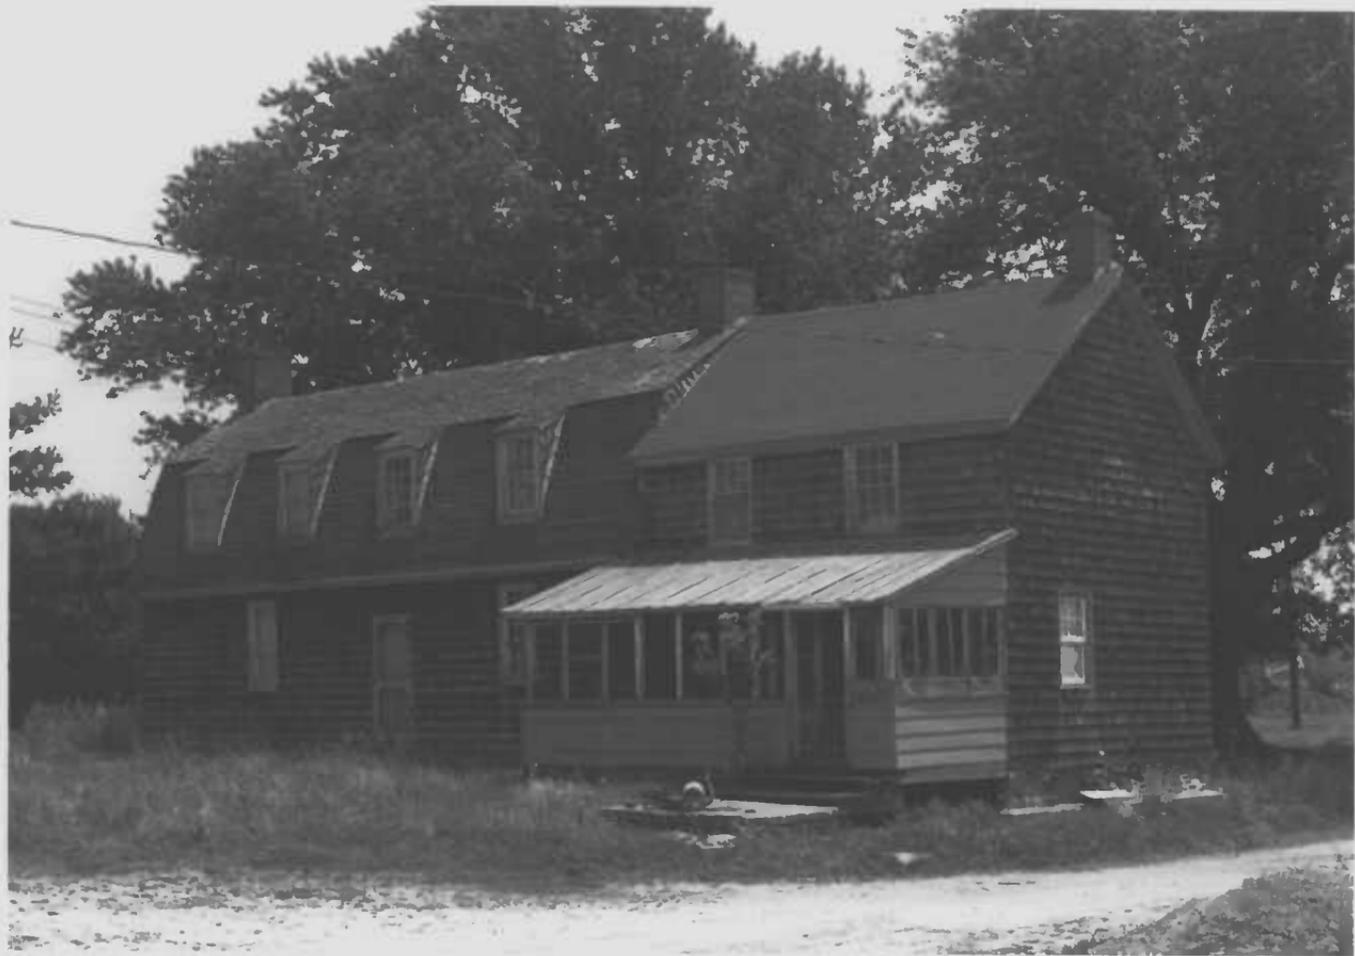
On the rear or north facade, the door is offset to right of center, flanked by single 9/6 windows on each side. Four shed roof 6/6 dormer windows are ranged across the second story. The foundation of this facade is also concrete block. The siding, cornice and roof match the front facade. The rear entrance is fitted with a four-panel door with Italianate moldings.

QA-176 Winterstein Farm
Sudlersville vicinity
Orlando Ridout V 1980
Rear facade from Northwest
