INVENTORY FORM FOR STATE HISTORIC SITES SURVEY

Fort Point Farm

North side Corsica Neck Road

QA-225

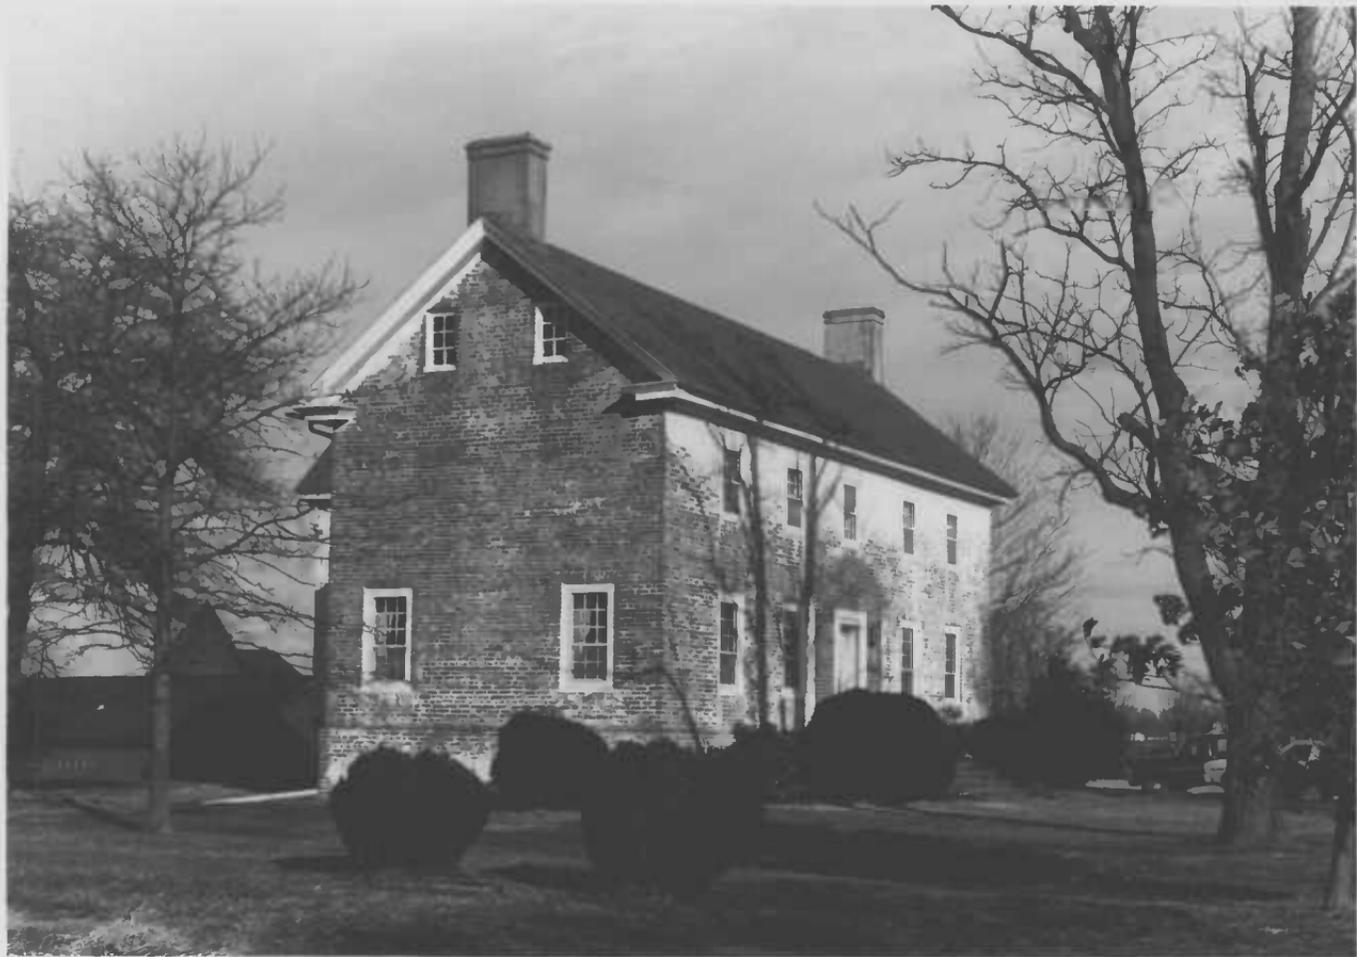
QA-225 Fort Point Farm
Centreville vicinity
Orlando Ridout V 1981
View from Southwest

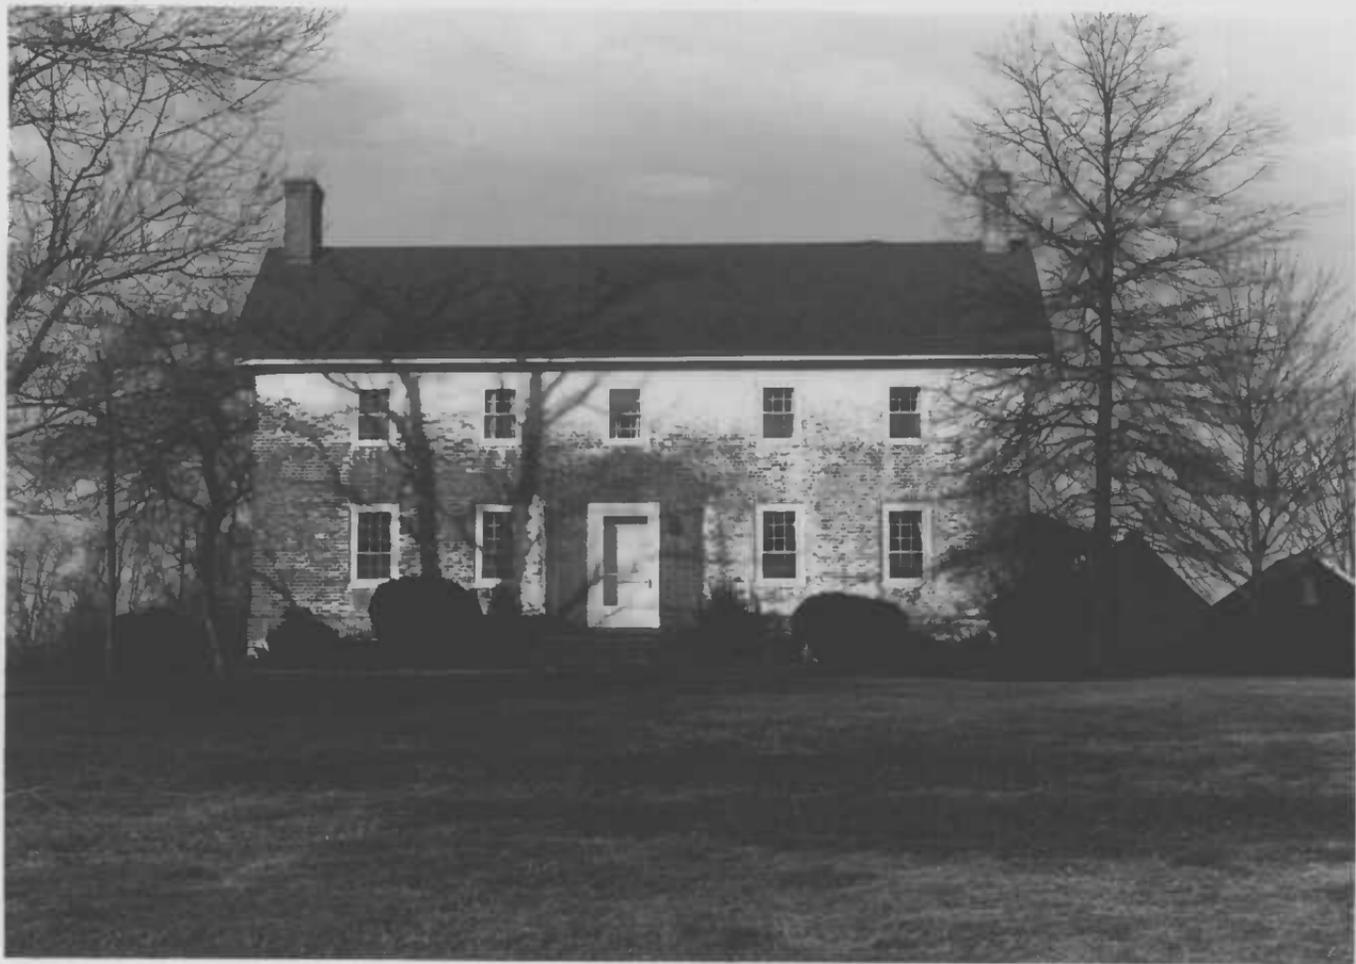
The front facade faces south, toward the road. The door is in the center bay, flanked by two 9/6 windows on each side. There are five 6/6 windows on the second floor and four cellar windows piercing the foundation, one below each first floor window.

The brickwork on the front facade is laid in Flemish bond above a plain water table and a four-course bond foundation. The windows are set in

heavy pegged wood frames with an applied ovolo backband molding and have heavy wood sills and splayed brick jack arch lintels. The door and four-light transom above are framed with plain soffits and jambs and a broken-field architrave with an ogee/astragal backband. The outline of an original entrance porch with delicate columns, an arched ceiling and a pitched gable roof is clearly visible in the whitewashed finish of this facade. Hand-wrought rat-tail shutter dogs also survive on two of the first floor windows. The eaves are boxed in and trimmed with a large, complex bed mold that stops and returns just short of each gable end. A beveled crown piece appears to be 20th century. The boxed soffit was later extended around the corners to return on each gable wall. This was probably done in the post-Civil War period. The wood shingle roof has been covered with a modern asphalt shingle roof.

QA-225 Fort Point Farm
Centreville vicinity
Orlando Ridout V 1981
South (front) facade

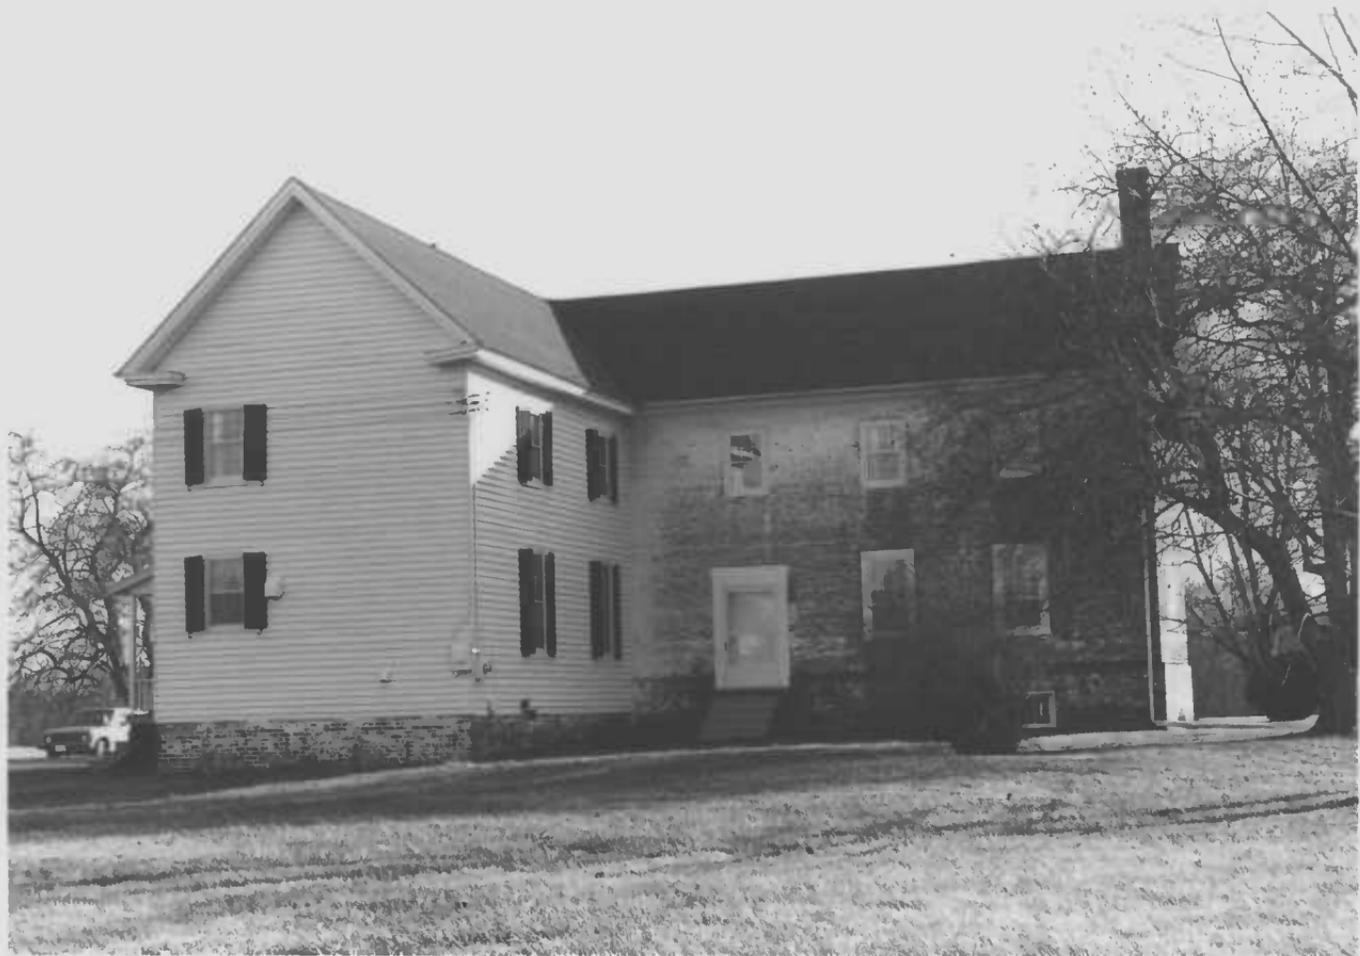
The two story frame wing covers the eastern two bays of the rear or north facade. There is a door in the center bay on the first floor with two 9/6 windows to the right, and three 6/6 windows on the second floor. The brickwork is laid in three-course bond above a plain water table and a three-course foundation. A patch in the foundation to the right of the door identifies the location of an original bulkhead cellar entrance. A single cellar window pierces the foundation in the west bay. The original complex crown mold survives intact on the cornice on this facade, but the backband window trim and the original door architrave are gone.

QA-225 Fort Point Farm
Centreville vicinity
Orlando Ridout V 1981
Rear (north) facade

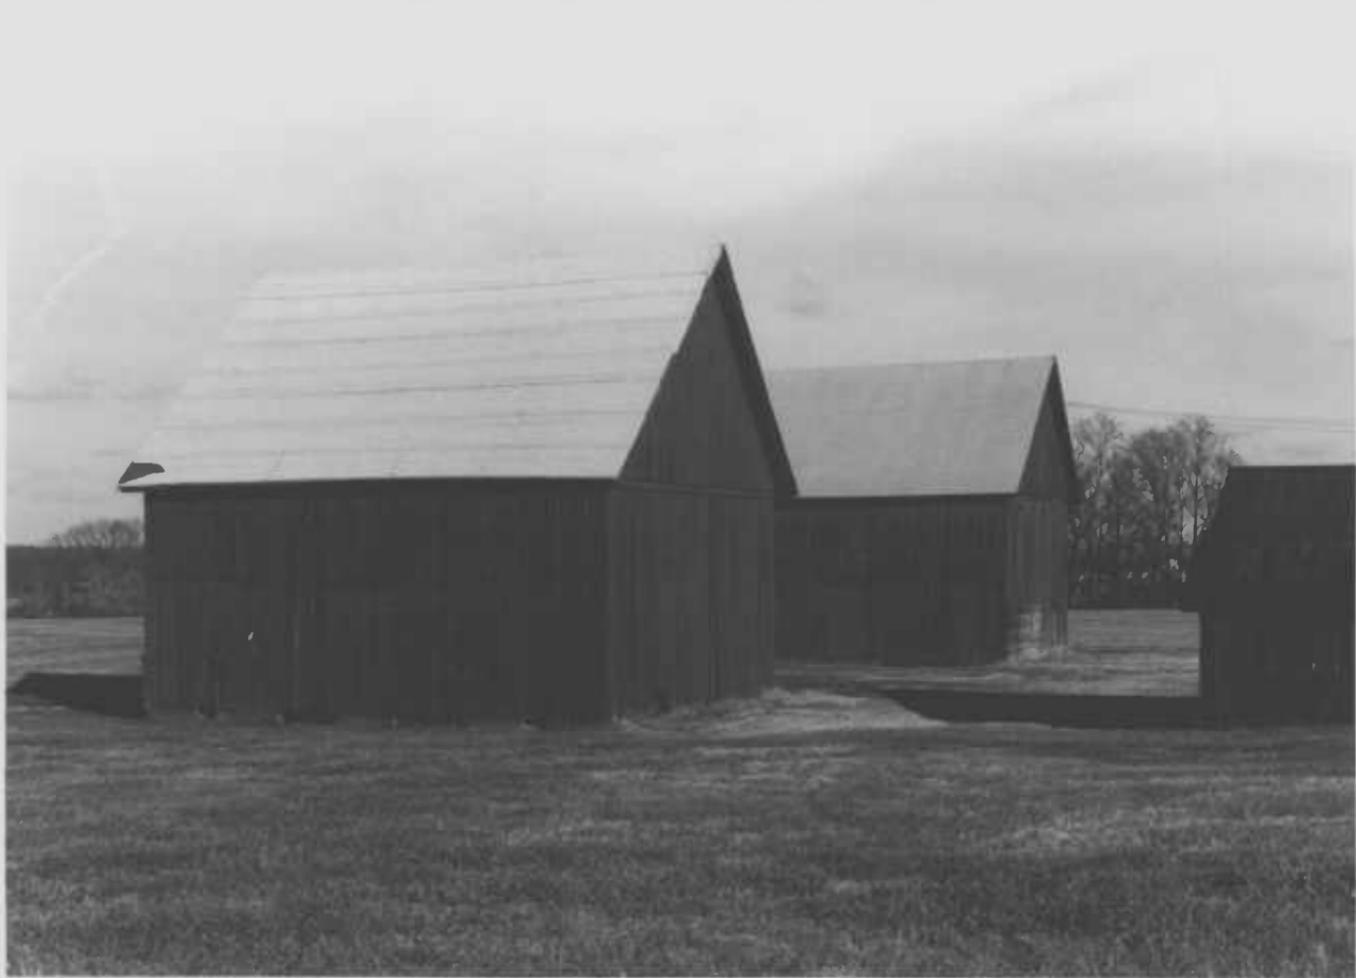
QA-225 Fort Point Farm
Centreville vicinity
Orlando Ridout V 1981
Farm Buildings
