**MARYLAND HISTORICAL TRUST
DETERMINATION OF ELIGIBILITY FORM**

Property Name: Sycamore Farm Inventory Number: BA-3218
 Address: 19946 Old York Road (MD 439) Historic district: yes no
 City: White Hall Zip Code: 21161 County: Baltimore County
 USGS Quadrangle(s): Norrisville
 Property Owner: Richard M. and Mary D. Cornwell Tax Account ID Number: 0703047731
 Tax Map Parcel Number(s): 19 Tax Map Number: 13
 Project: MD 439 at 19946 Old York Road Agency: Maryland State Highway Administration
 Agency Prepared By: Maryland State Highway Administration
 Preparer's Name: Stacey Streett Date Prepared: 10/17/2007

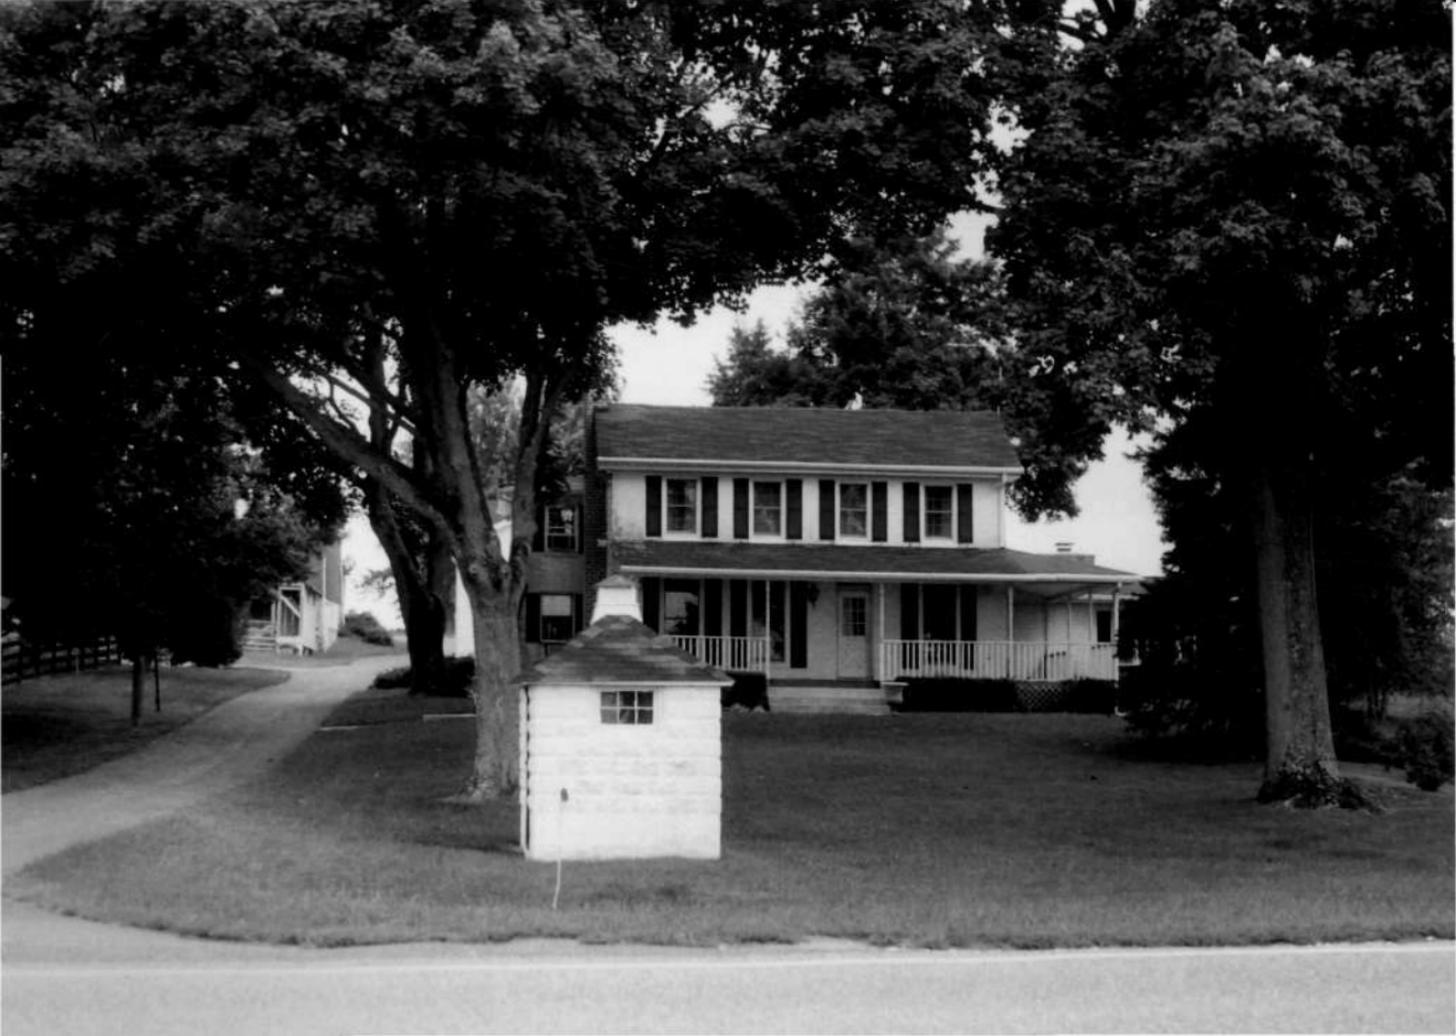
1/29

View of farmstead looking south from Old York
Road 31 08 18 18 09/27/07

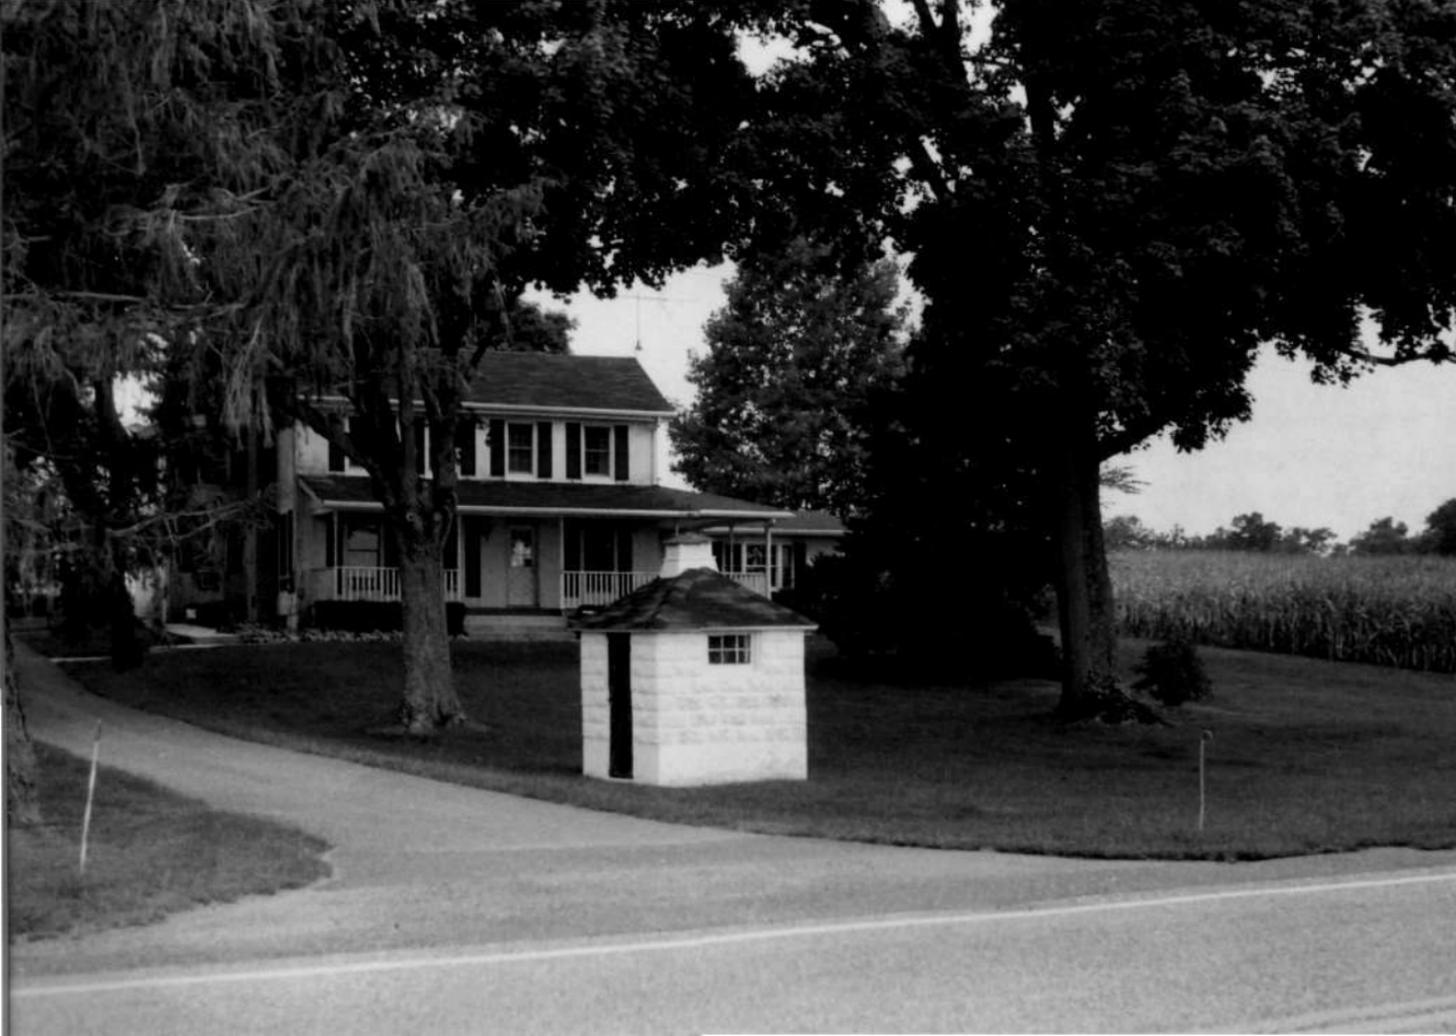
2/29

View of farmstead looking southwest from

Old York Road

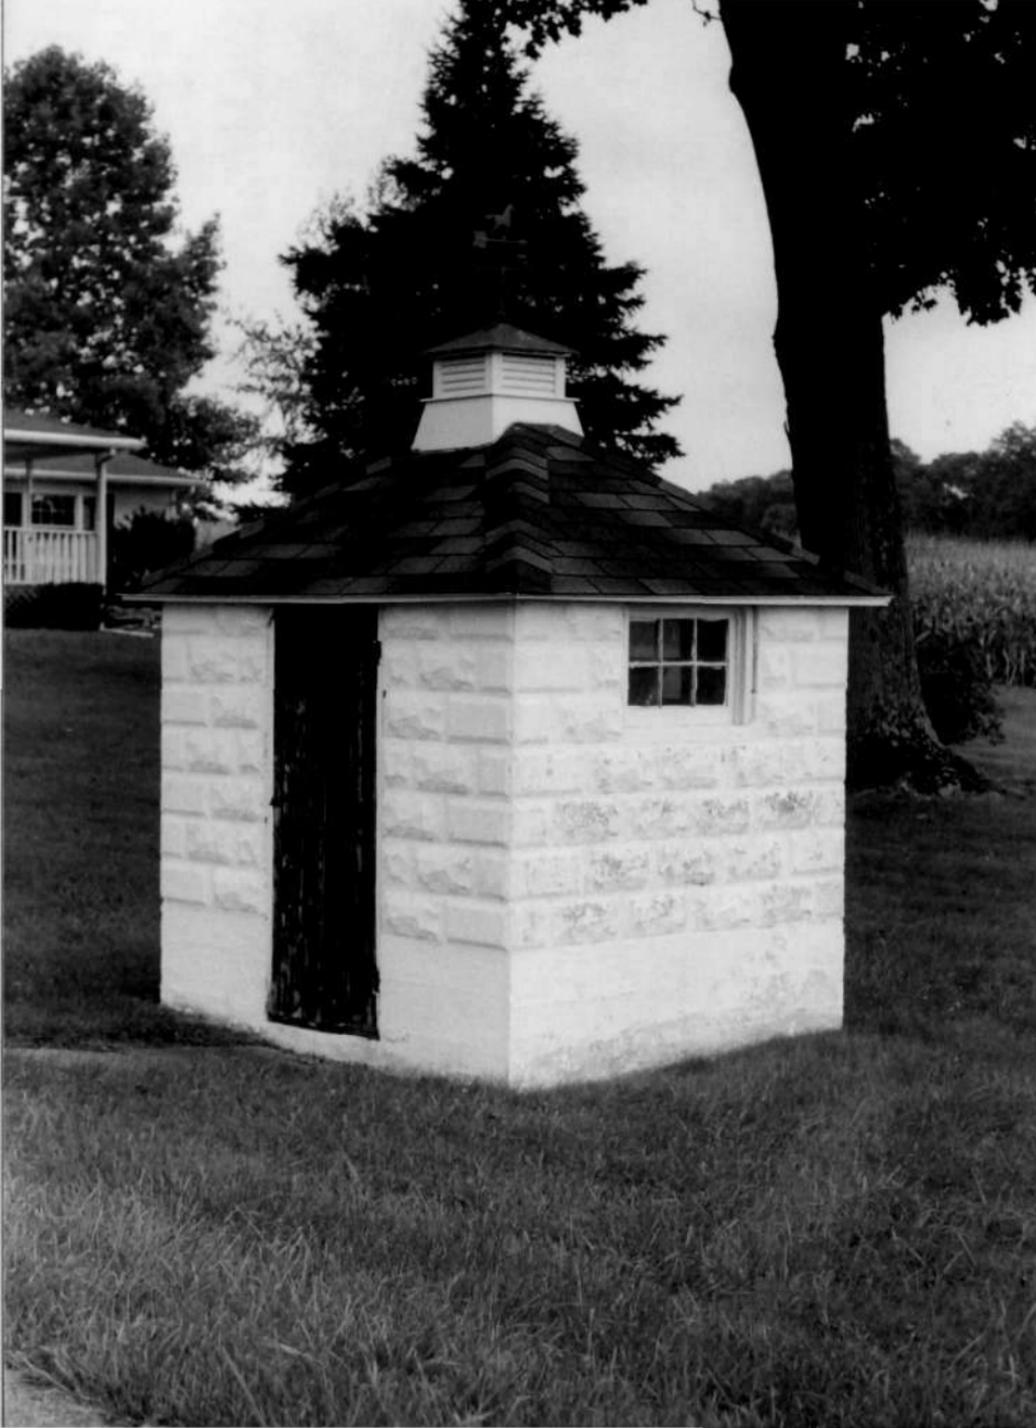
3/29

Well House, NE corner, view SW.

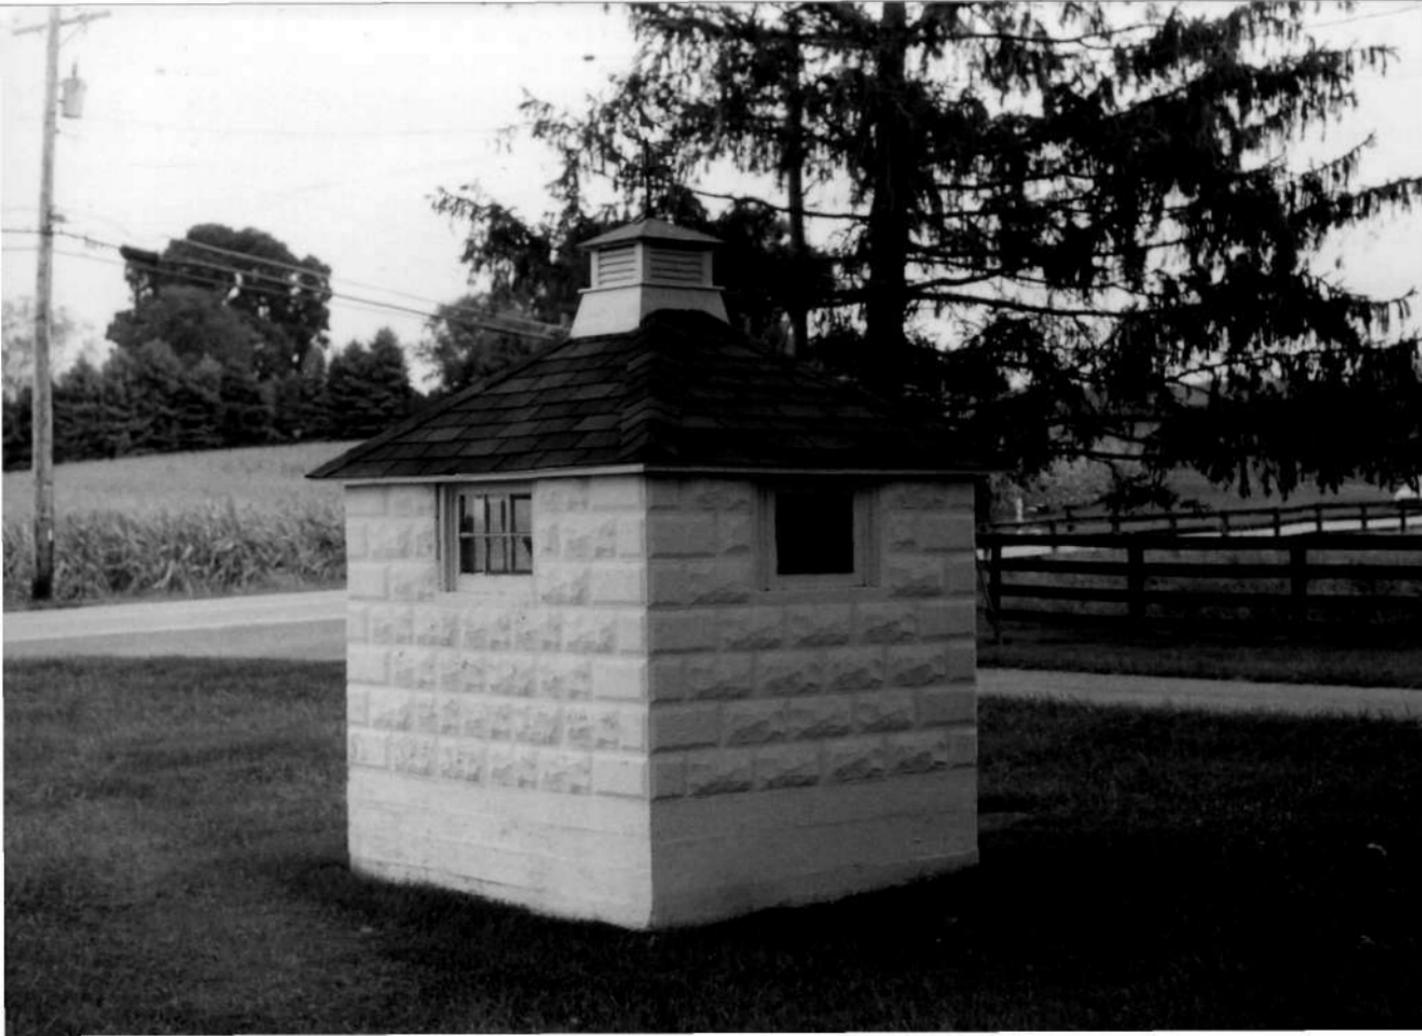
4/29

Well House, SW corner, view NE.

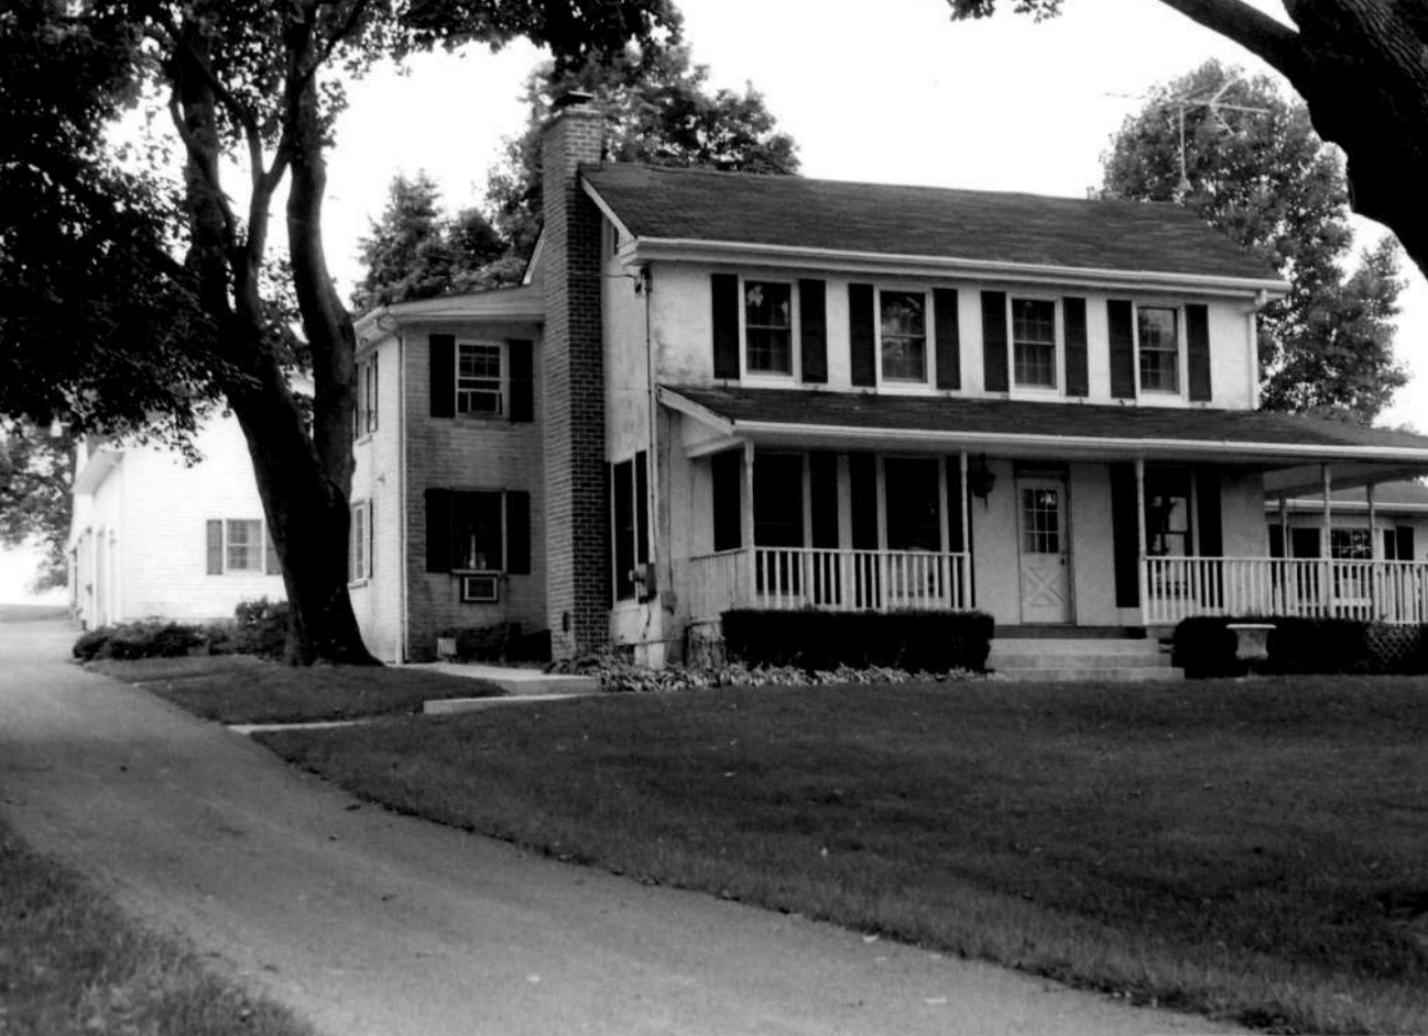
5/29

Farmhouse, Facade (North elevation), view
SW.

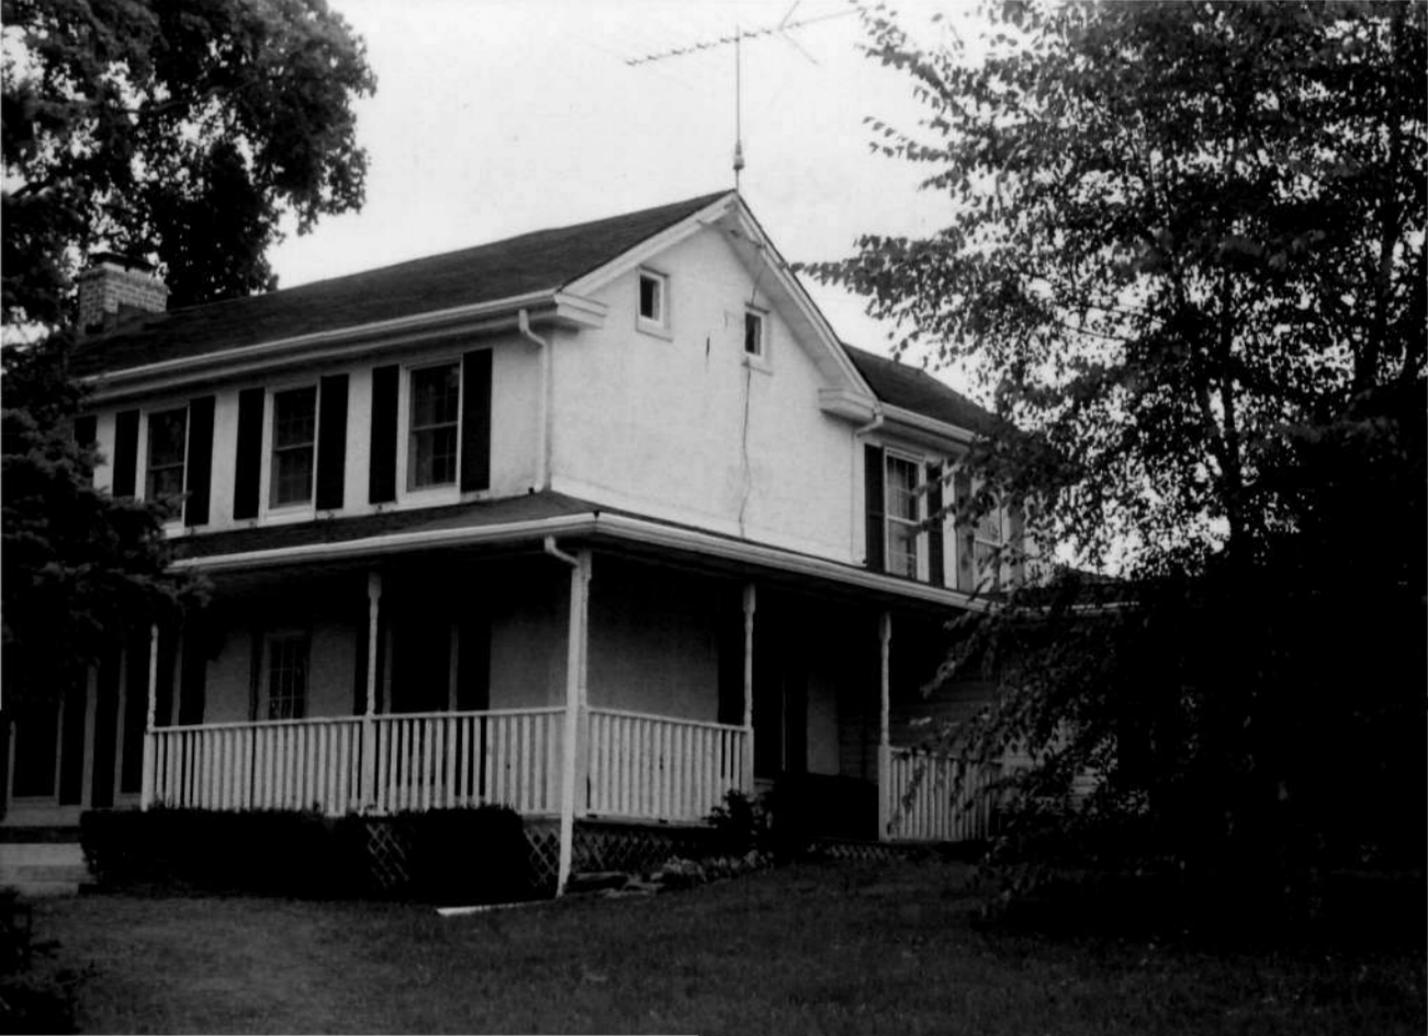
6/29

Farmhouse, NW corner, view SE.

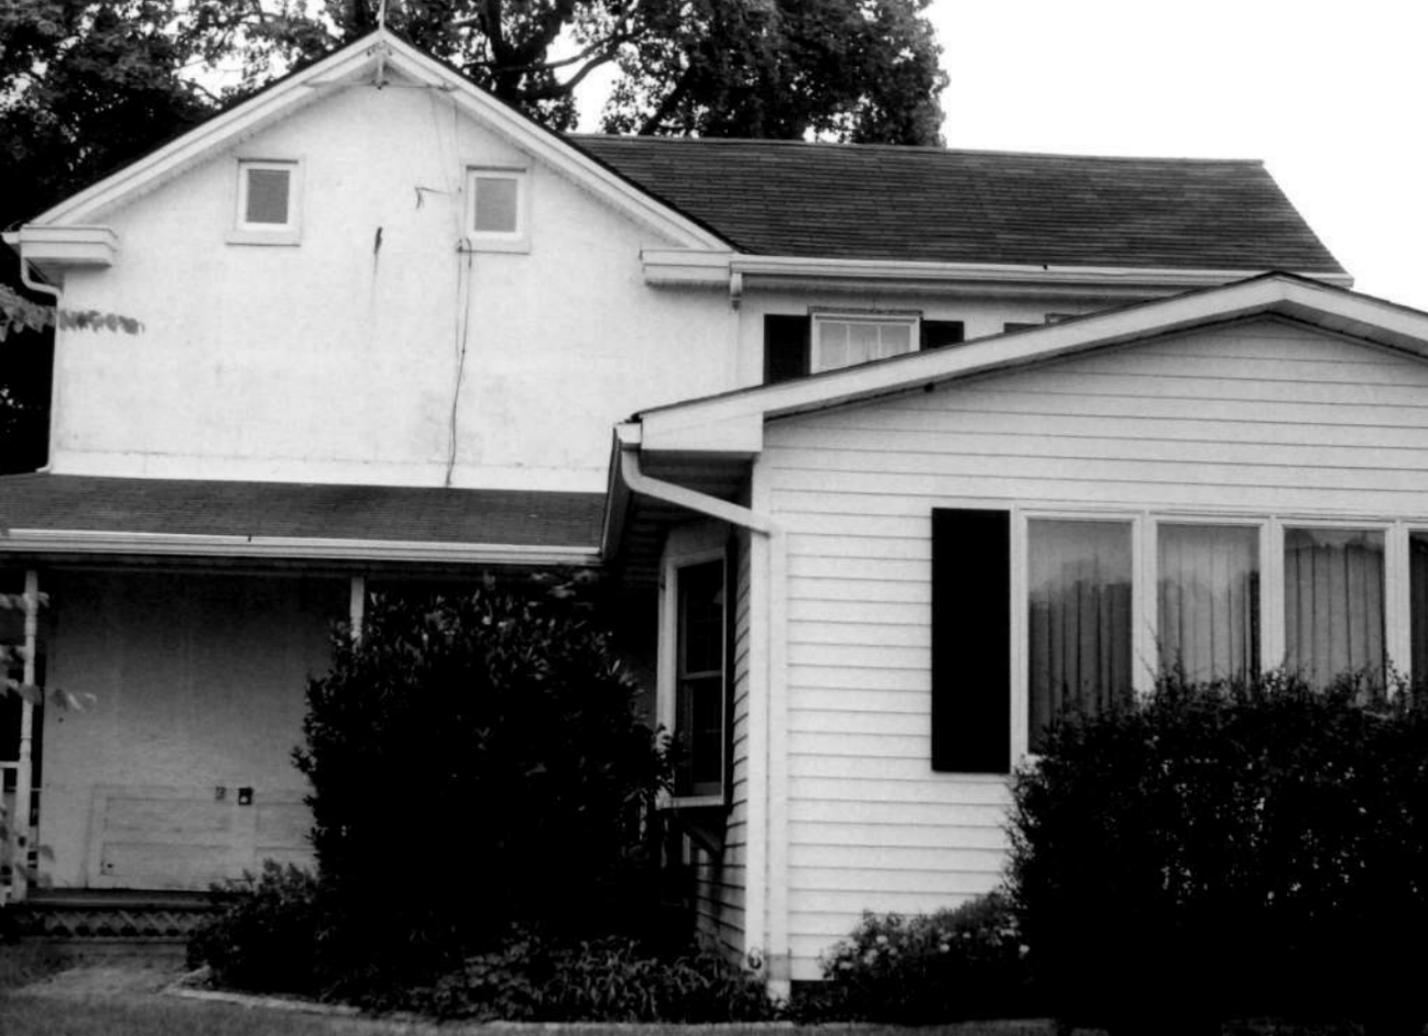
7/29

Farmhouse, west elevation, view east.

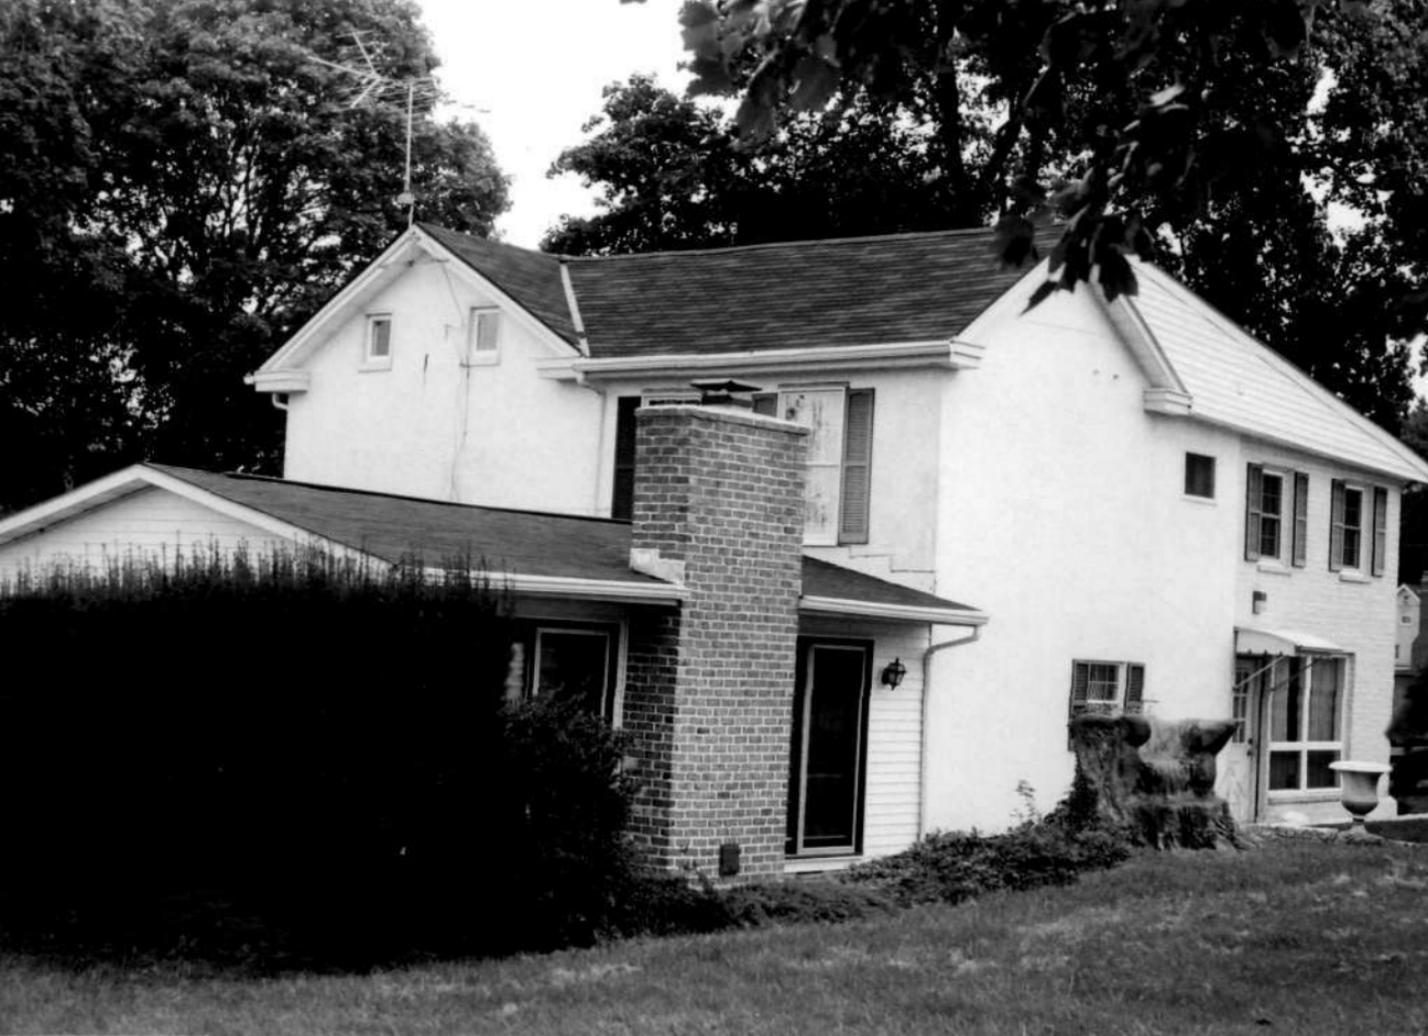
8/29

Farmhouse, SW corner, view NE.

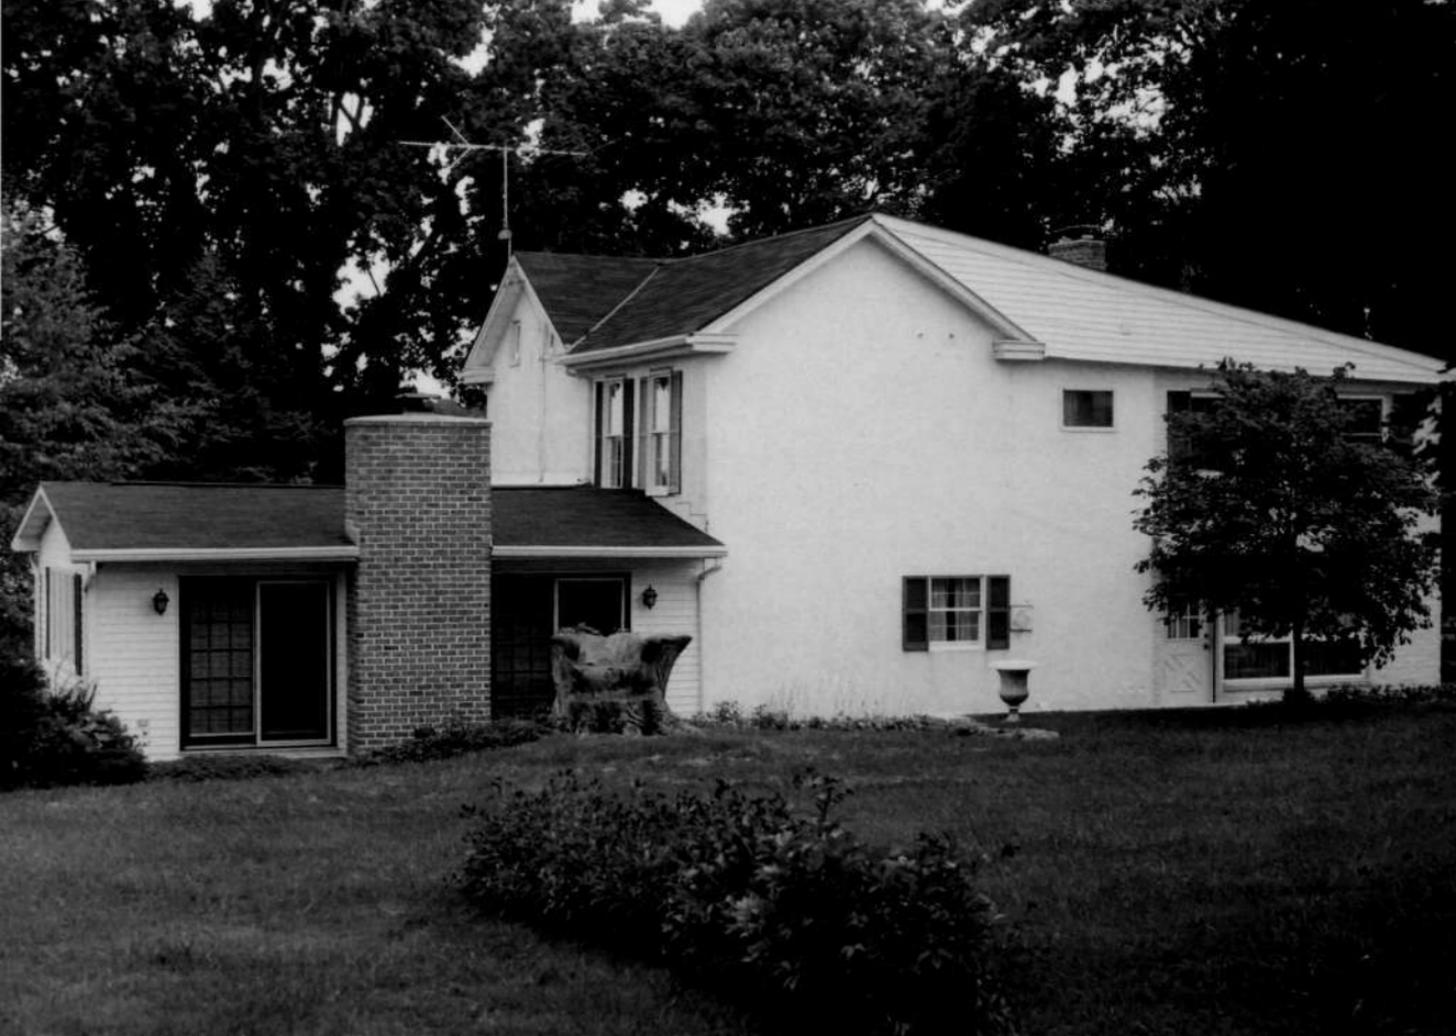
9/29

Farmhouse, south elevation, view NE.

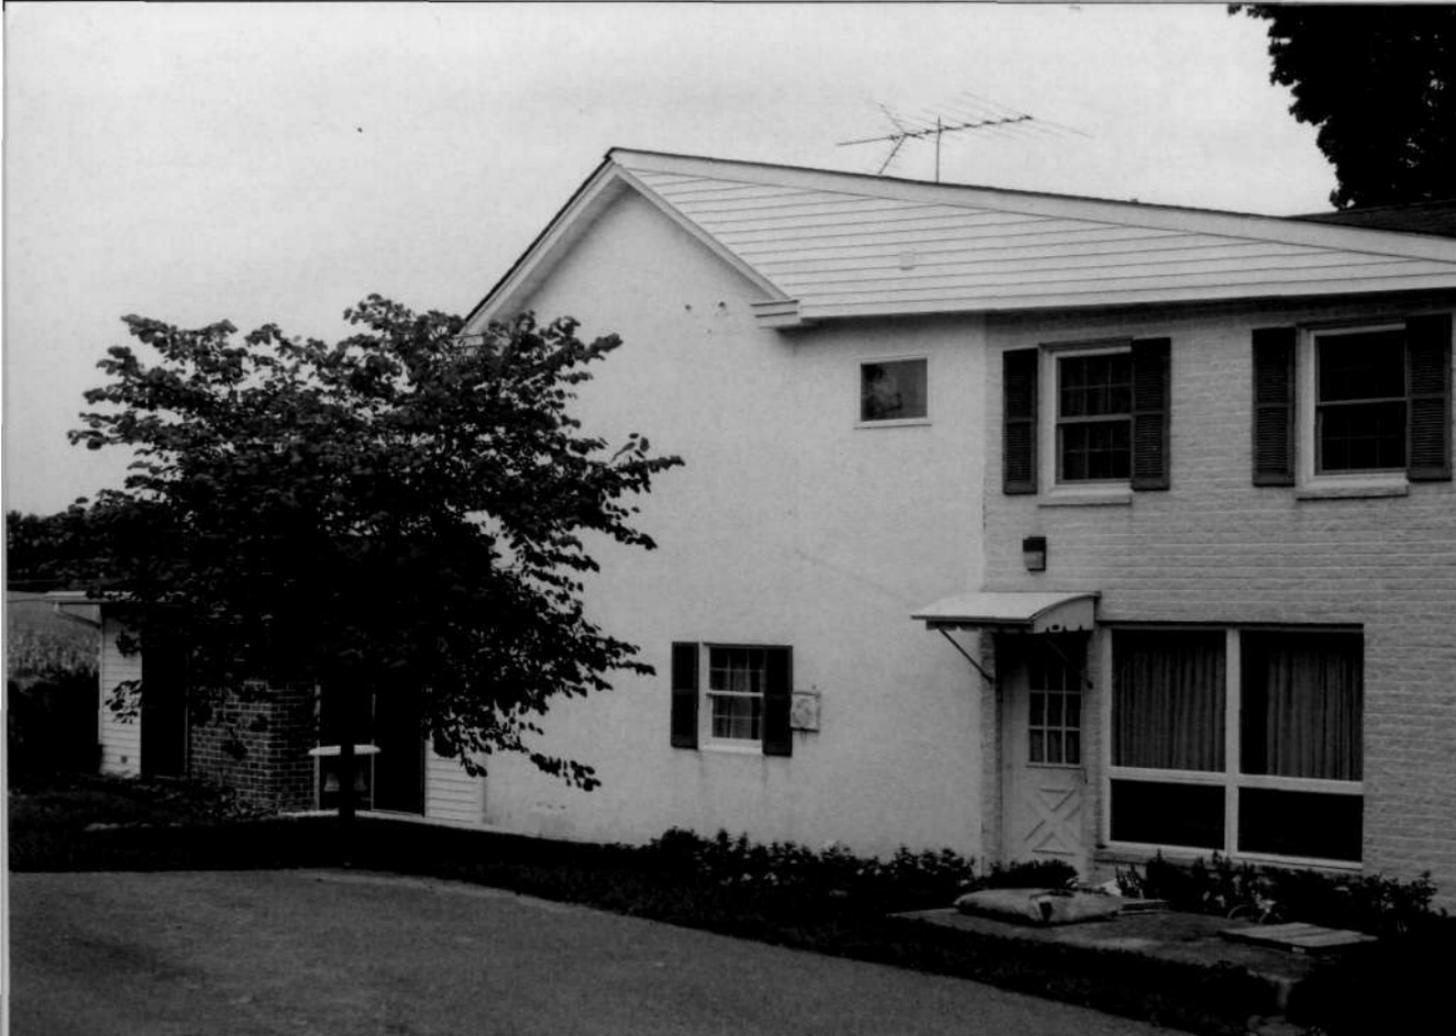
10/29

Farmhouse, south elevation (rear ell and
addition), View NW.

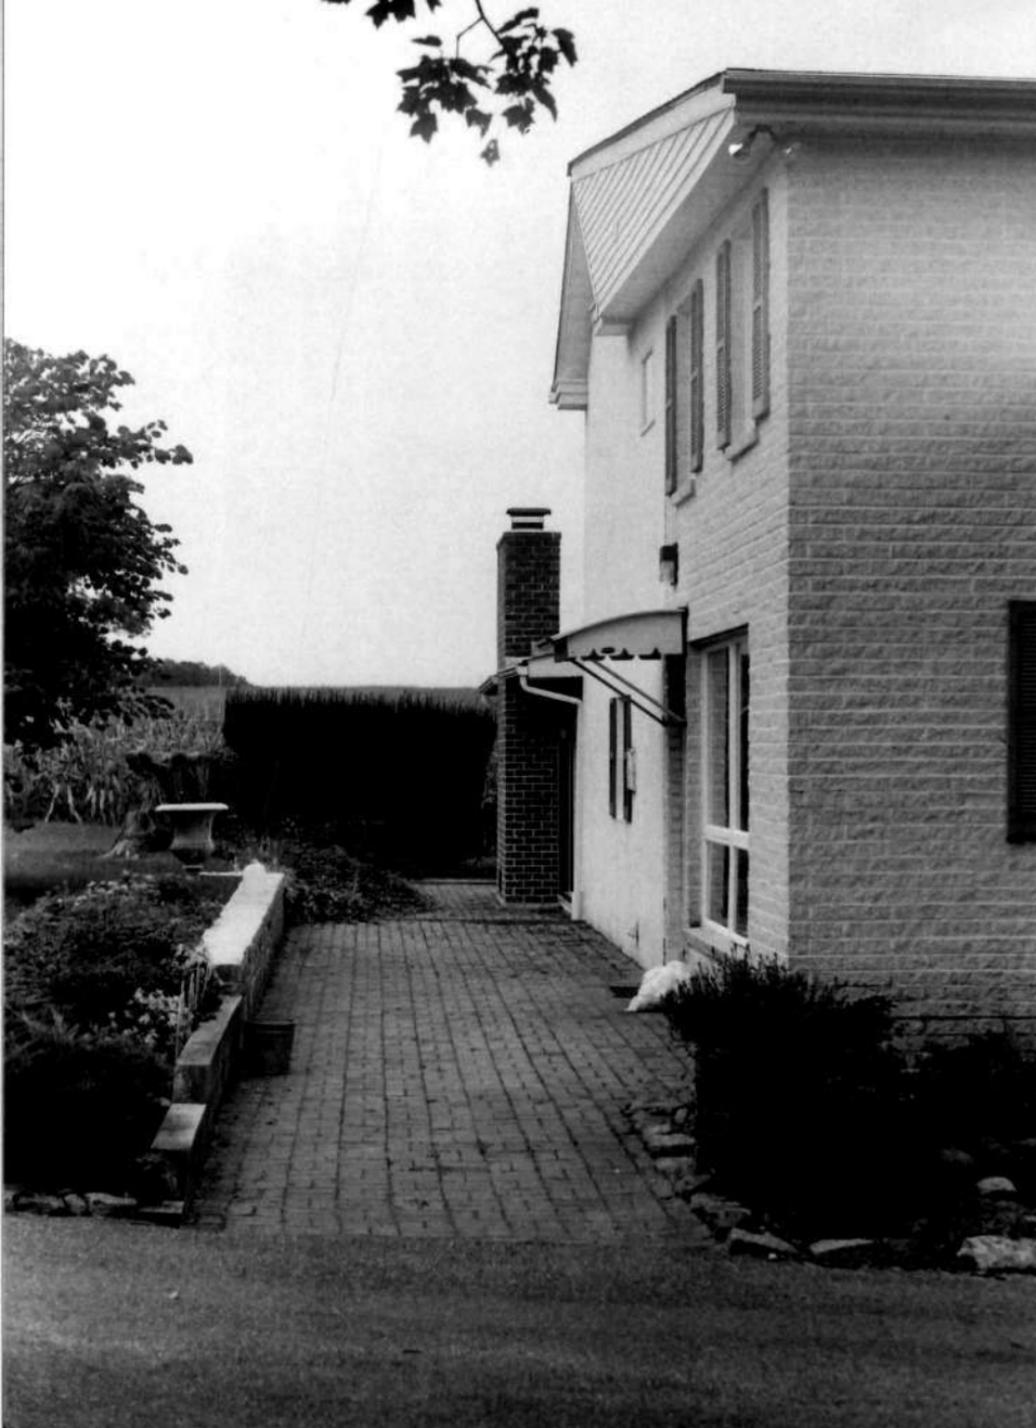
11/29

Farmhouse, SE corner of east wing, view
west.

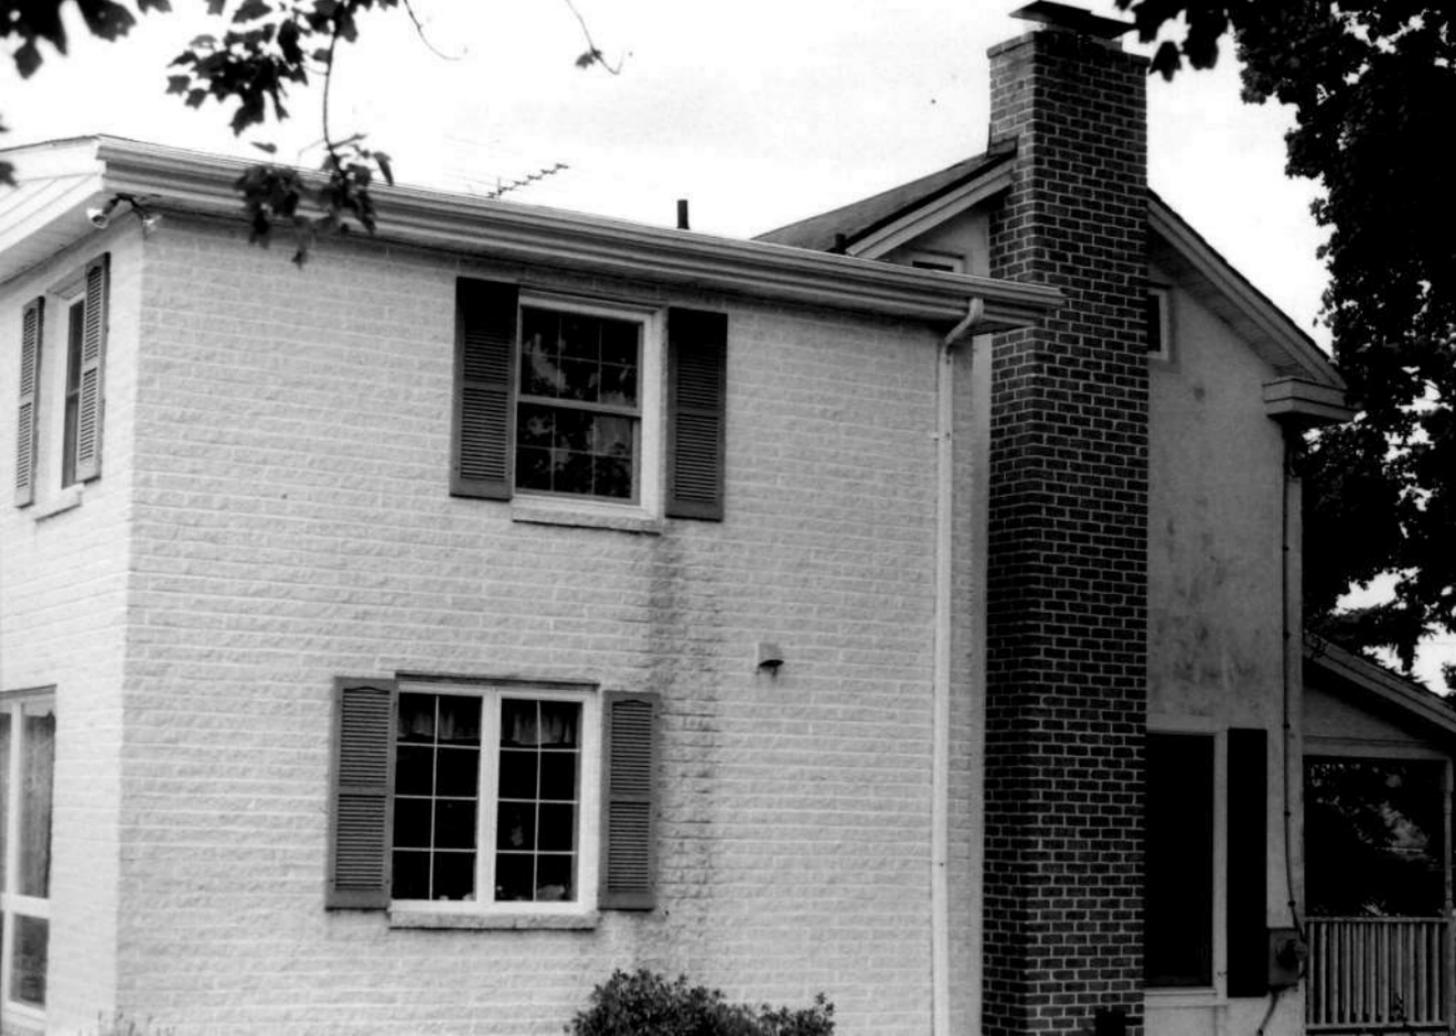
12/29

Farmhouse, east elevation, view NW.

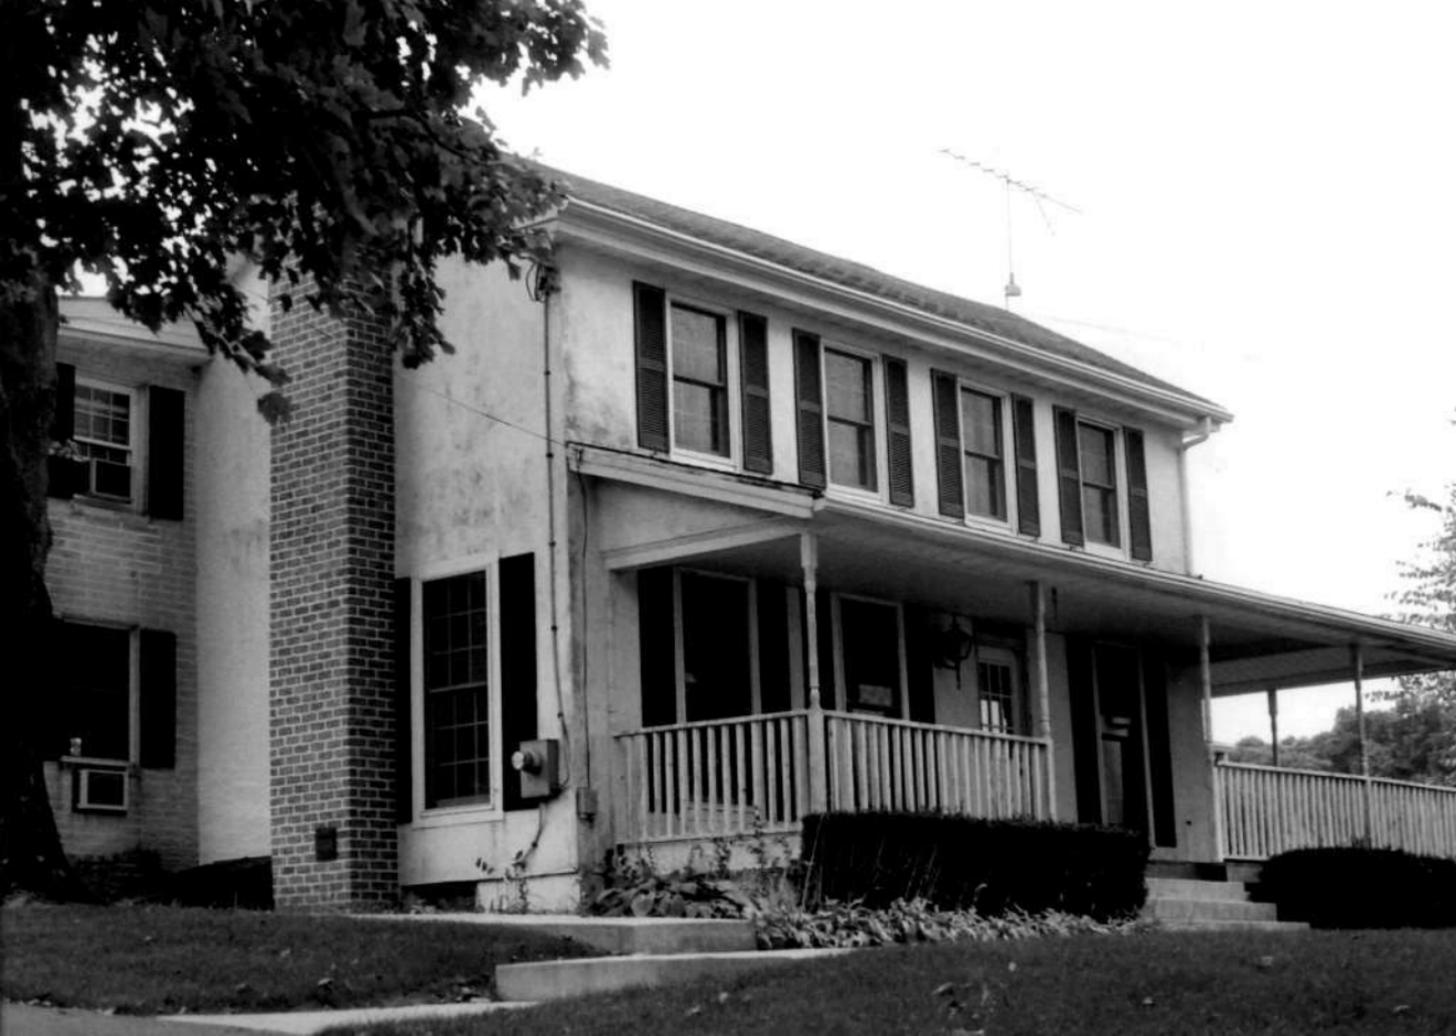
13/29

Farmhouse, NE corner, view SW

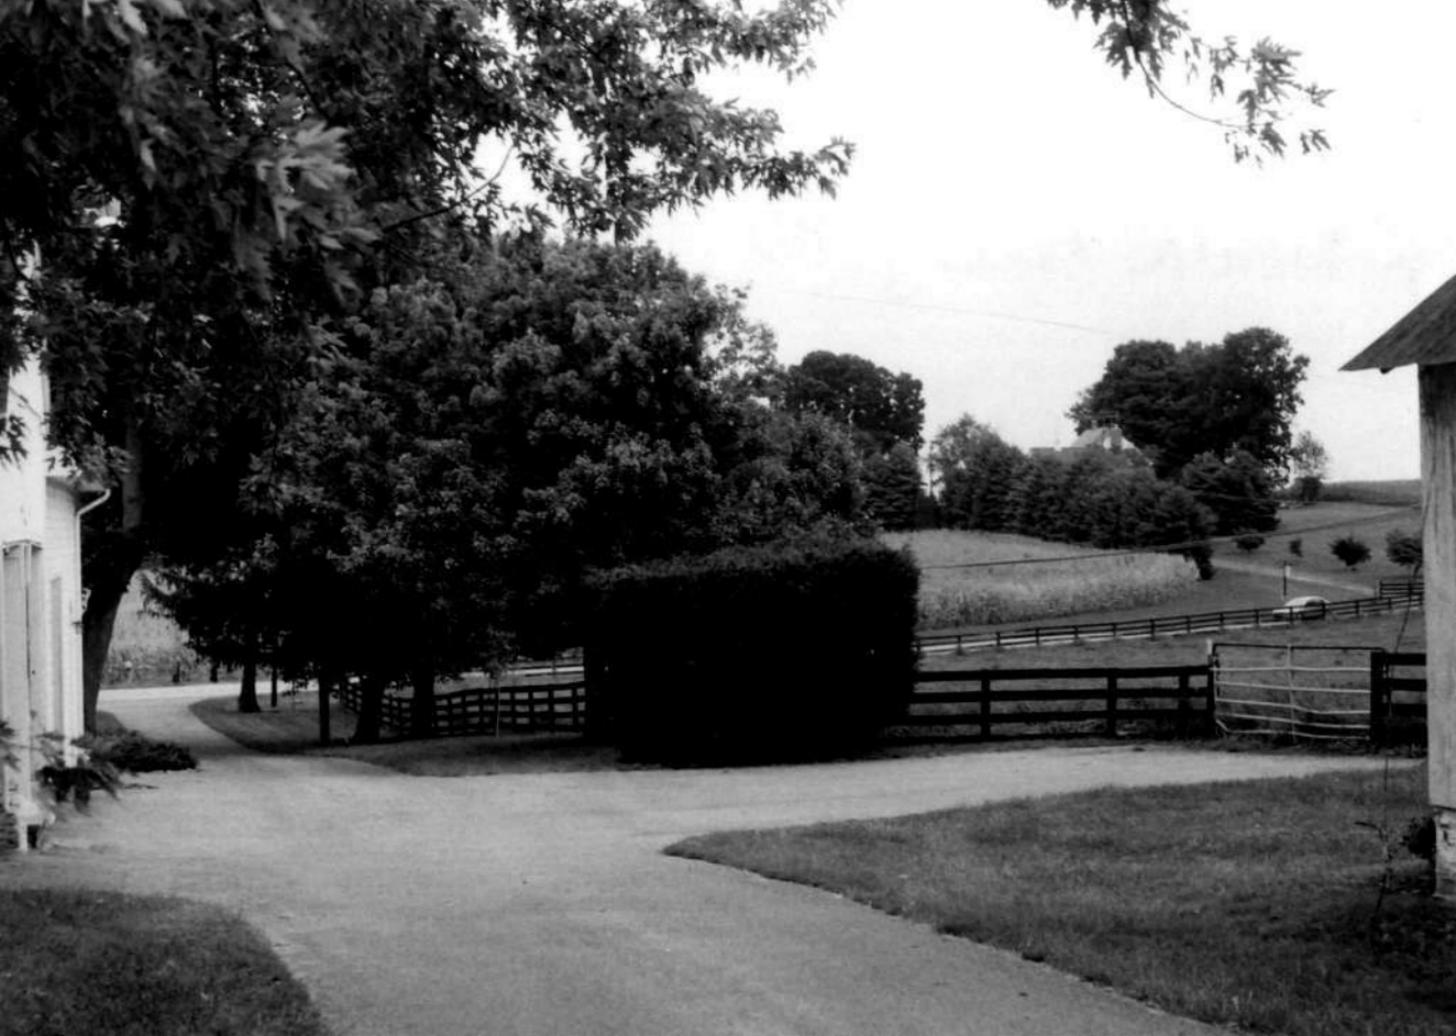
14/29

Farm drive, View North

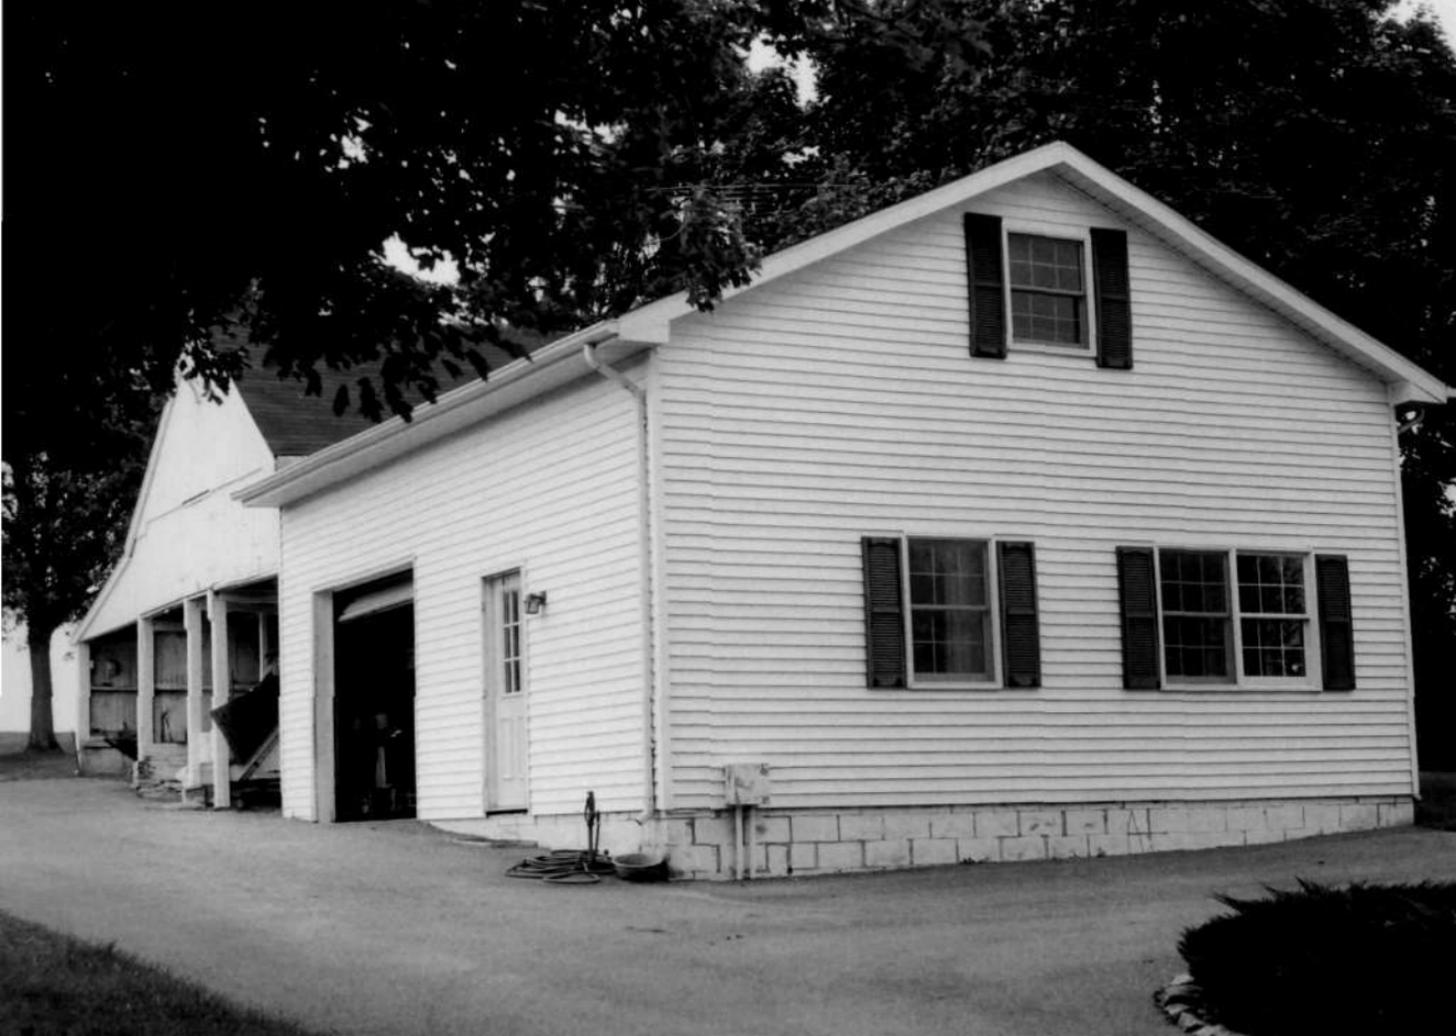
15/29

Frame Garage, NE corner, view SW
