**MARYLAND HISTORICAL TRUST
DETERMINATION OF ELIGIBILITY FORM**

Property Name: Sycamore Farm Inventory Number: BA-3218
 Address: 19946 Old York Road (MD 439) Historic district: yes no
 City: White Hall Zip Code: 21161 County: Baltimore County
 USGS Quadrangle(s): Norrisville
 Property Owner: Richard M. and Mary D. Cornwell Tax Account ID Number: 0703047731
 Tax Map Parcel Number(s): 19 Tax Map Number: 13
 Project: MD 439 at 19946 Old York Road Agency: Maryland State Highway Administration
 Agency Prepared By: Maryland State Highway Administration
 Preparer's Name: Stacey Streett Date Prepared: 10/17/2007

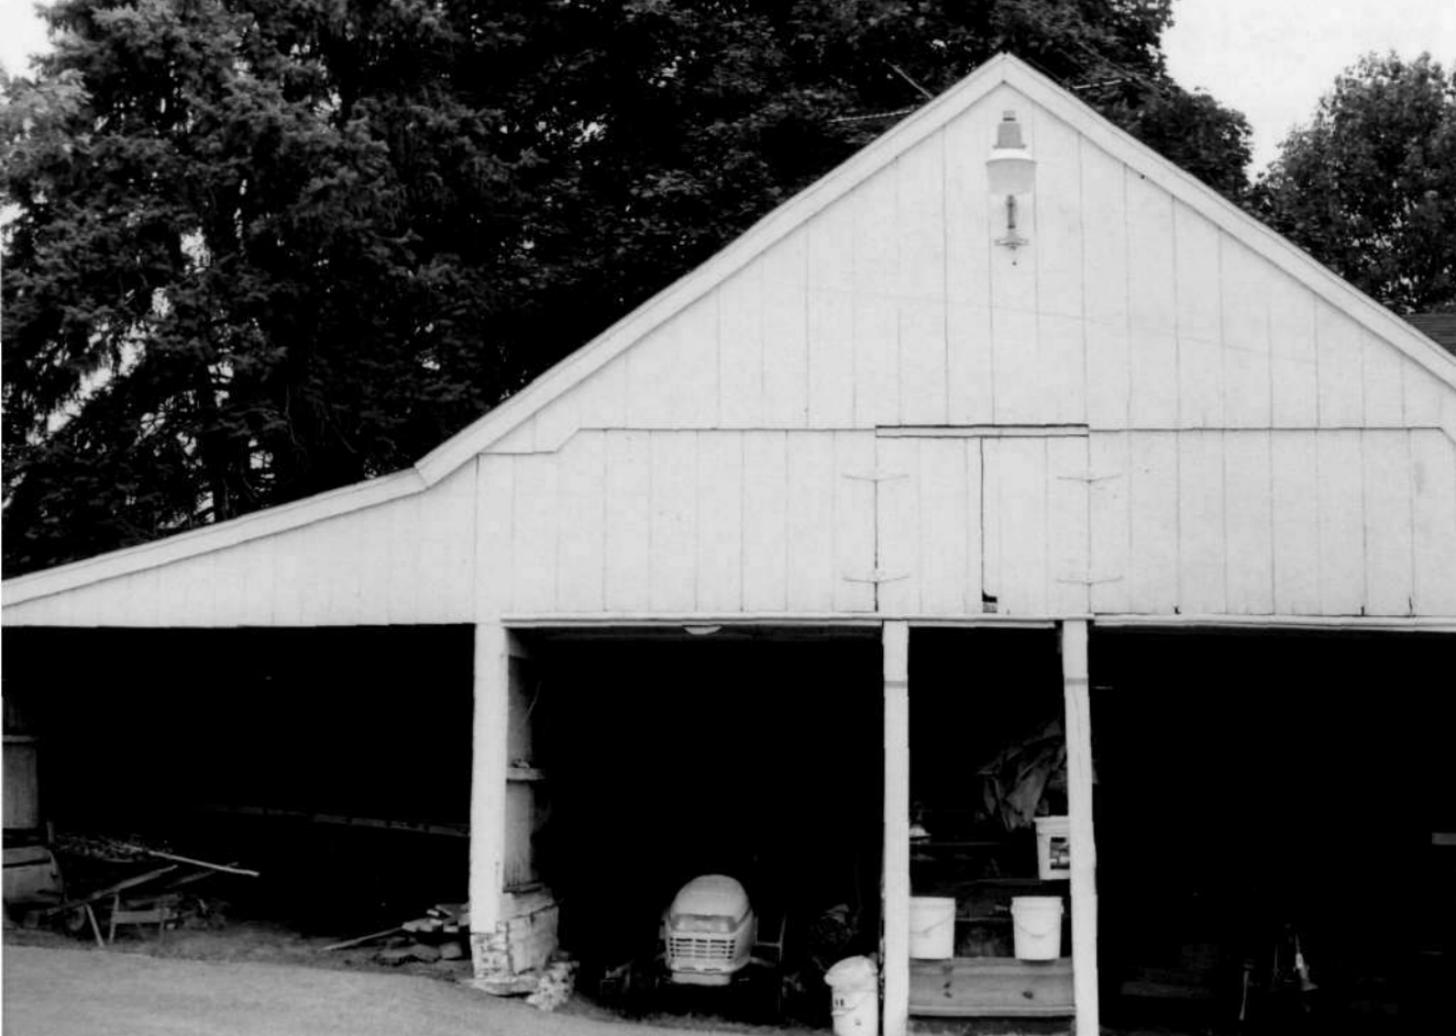
16/29

Frame Garage, east elevation, view west.

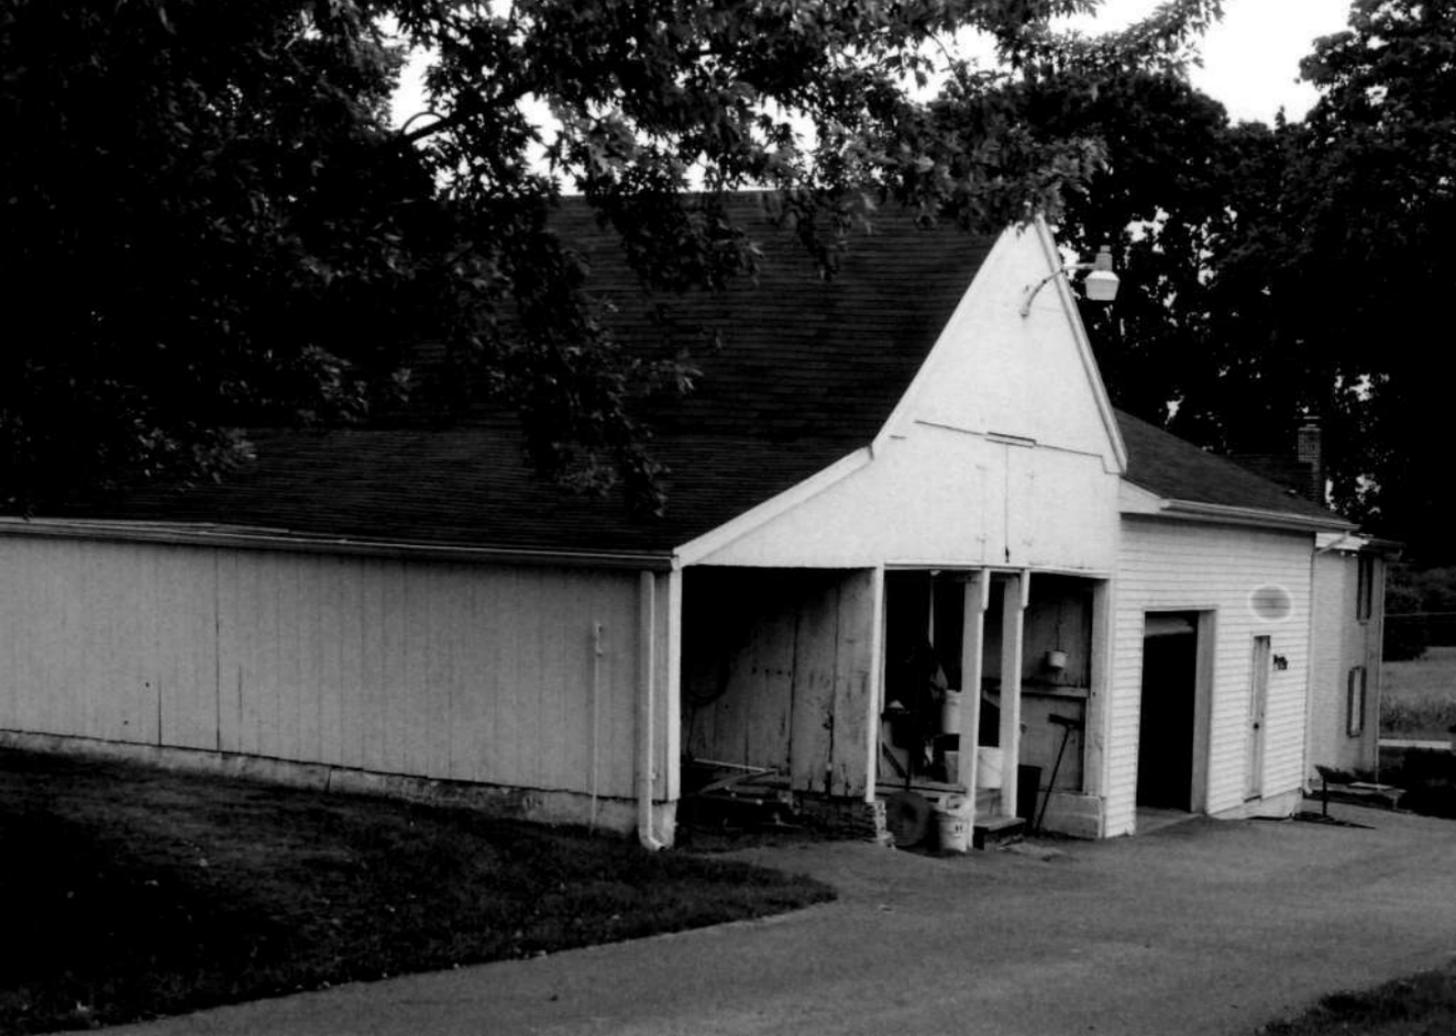
17/29

Frame Garage, SE corner, view NW

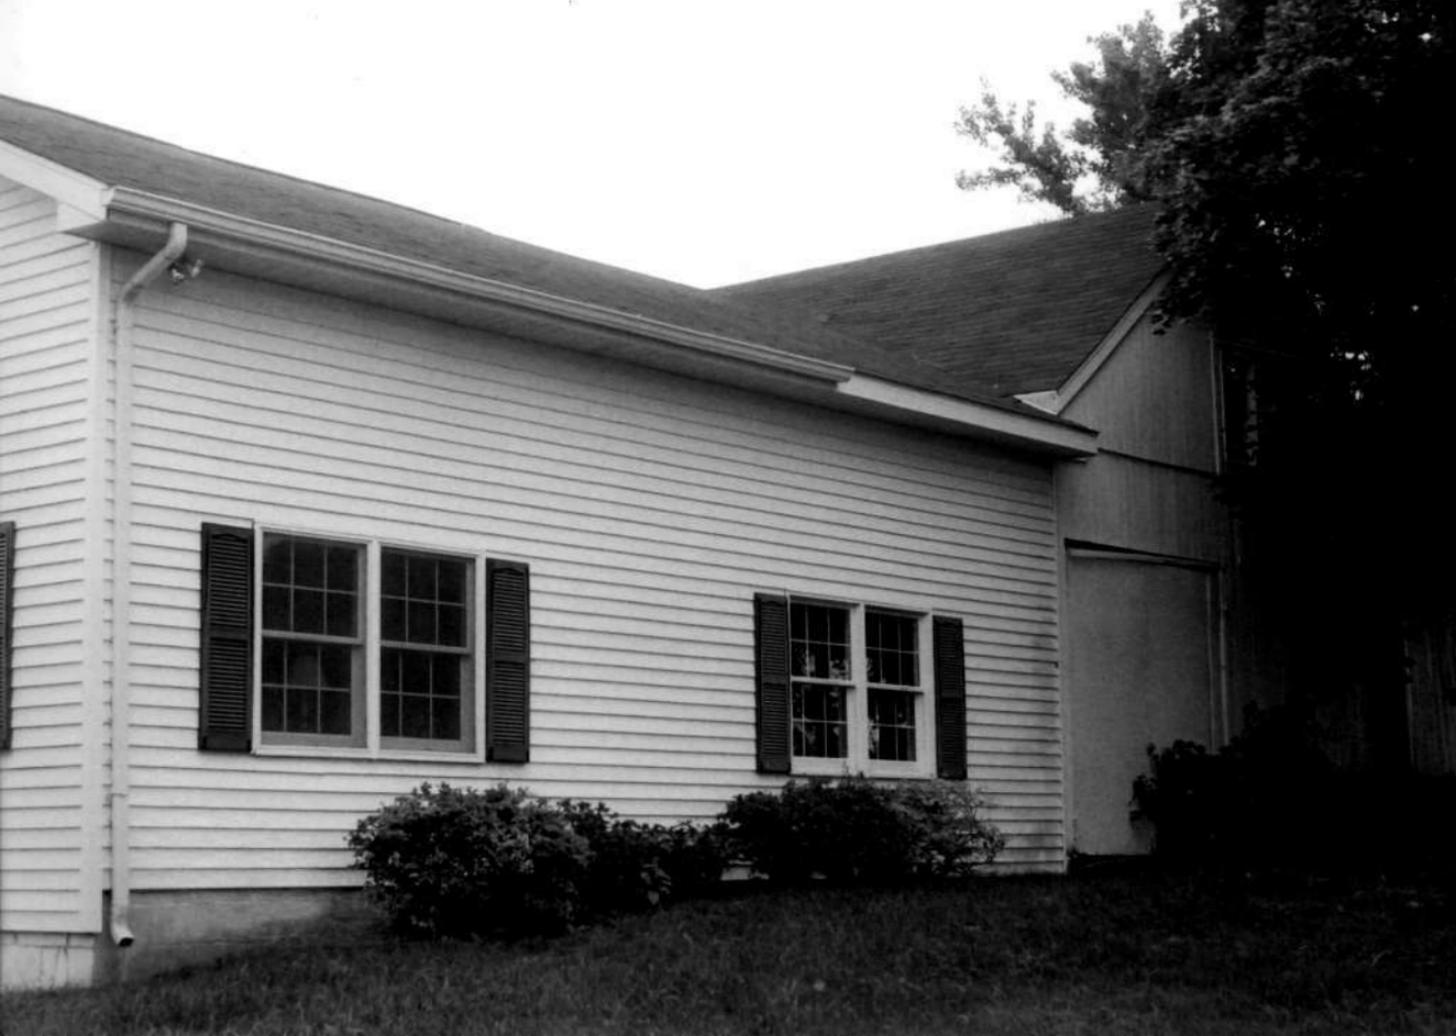
18/29

Frame Garage, west elevation, view SE.

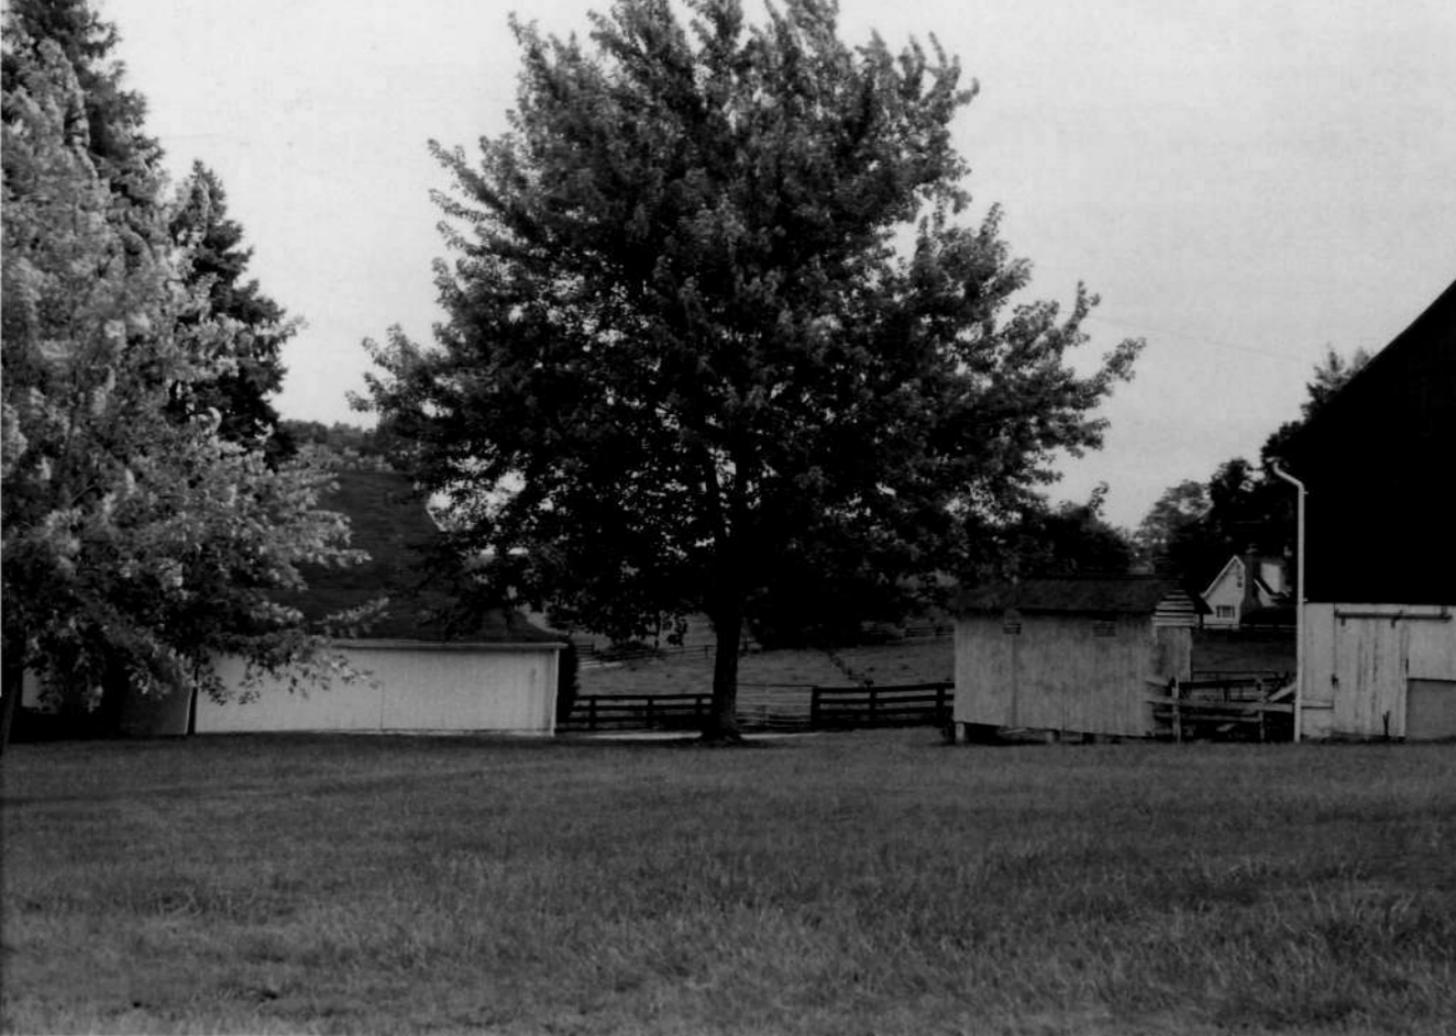
19/29

View to the east of agricultural
buildings.

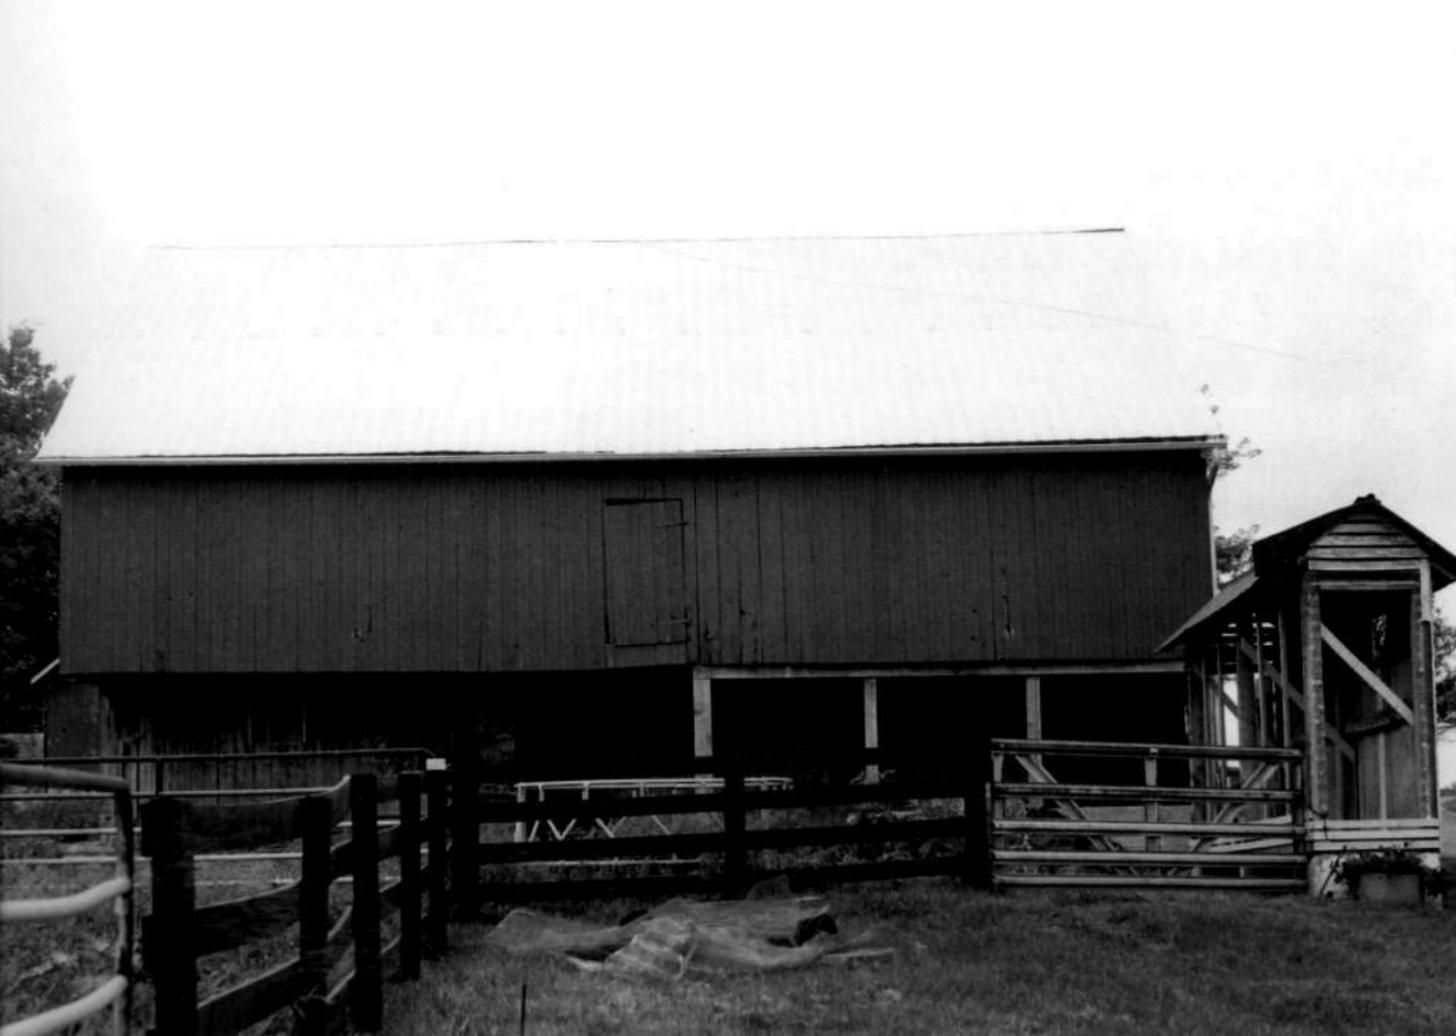
20/29

Bank Barn, North elevation (forebay side)
View south.

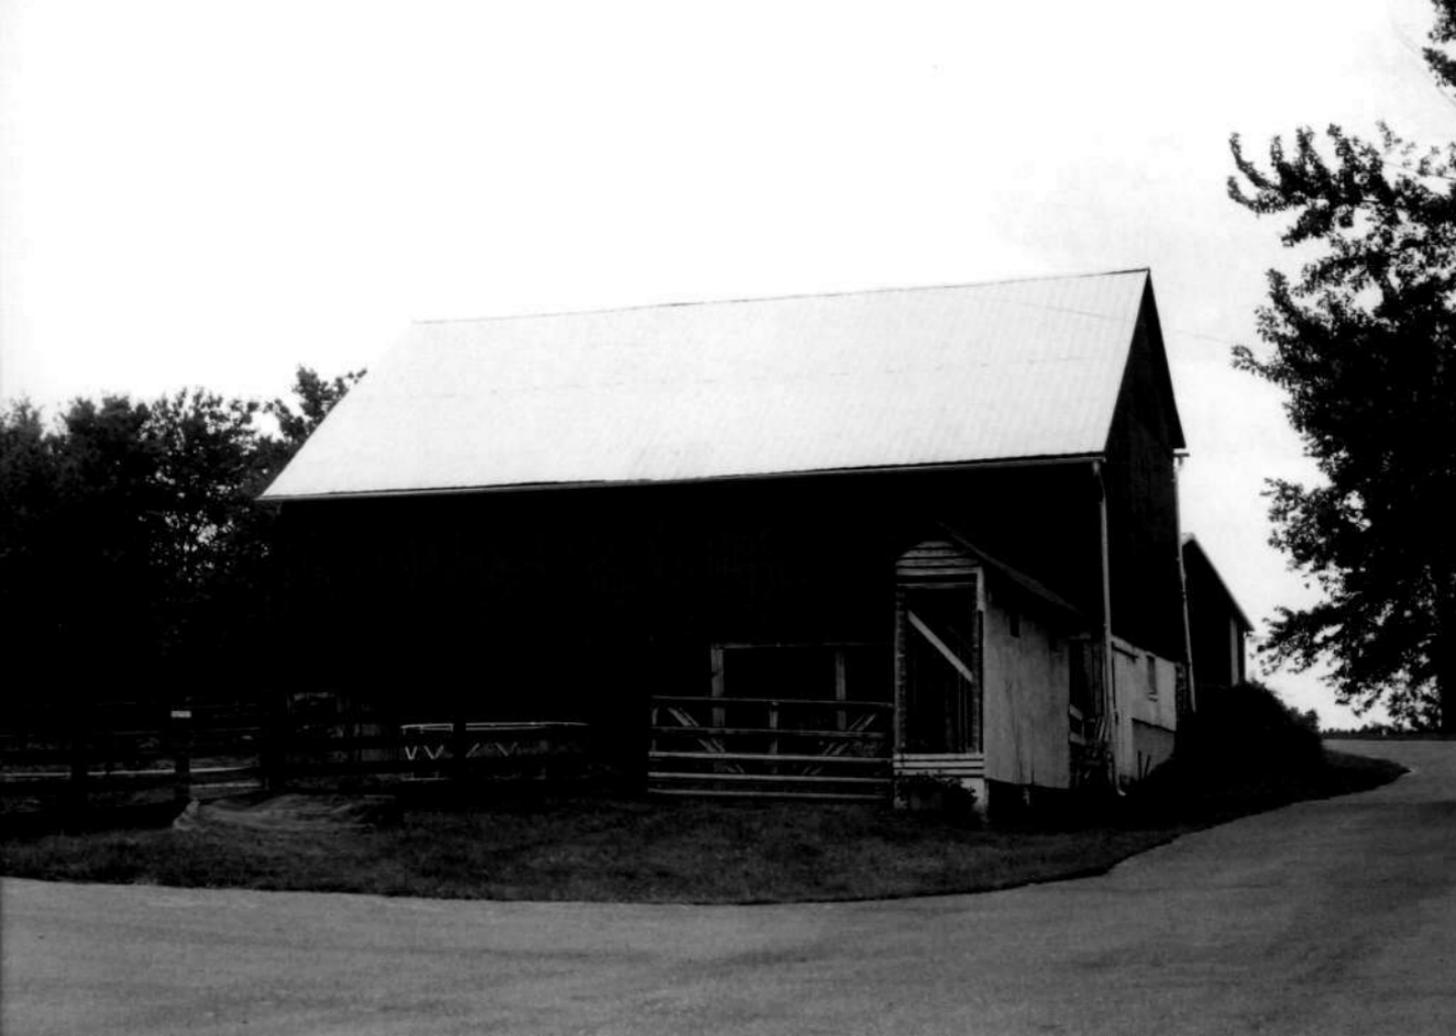
21/29

Bank Barn and corn crib, view SE.

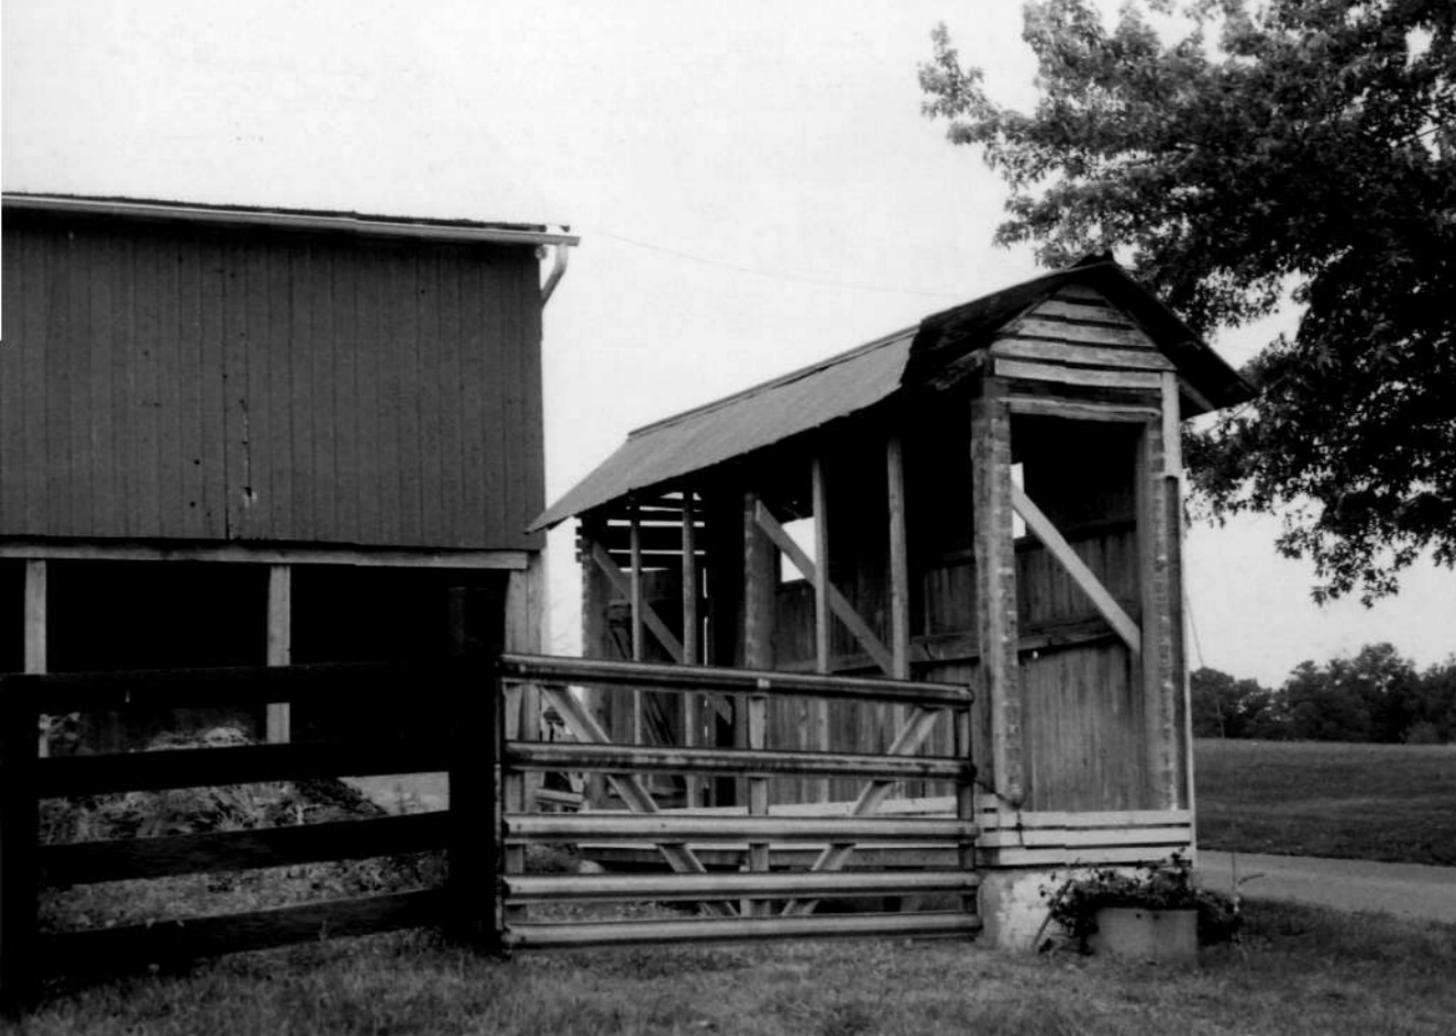
22/29

Corn Crib, view SW

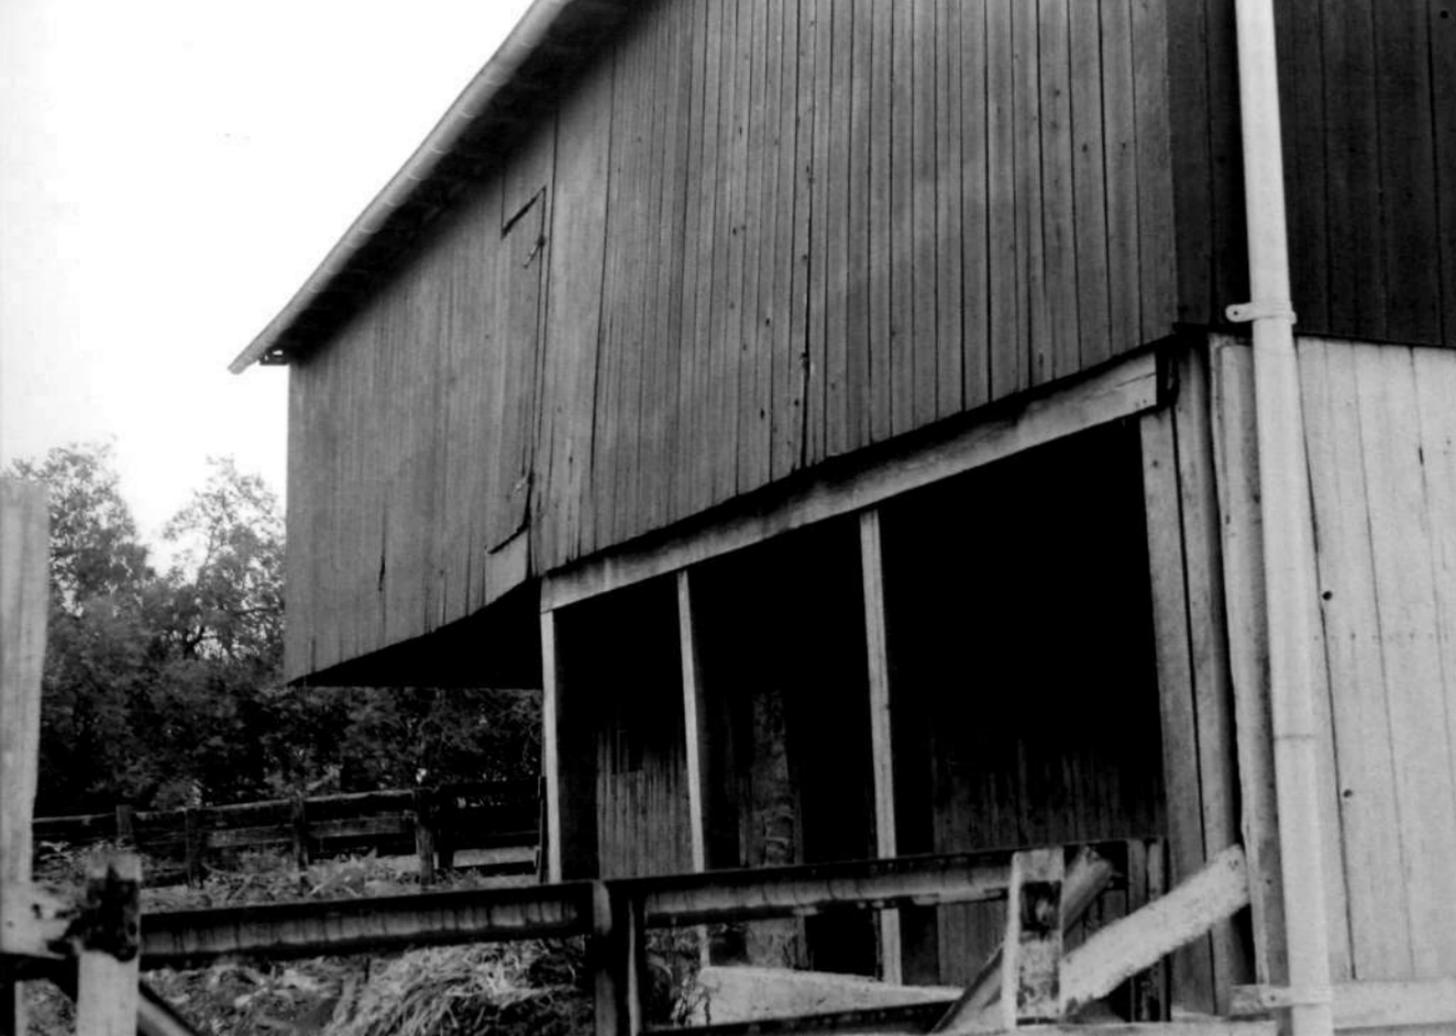
23/29

Forebay of Bank Barn, view east.

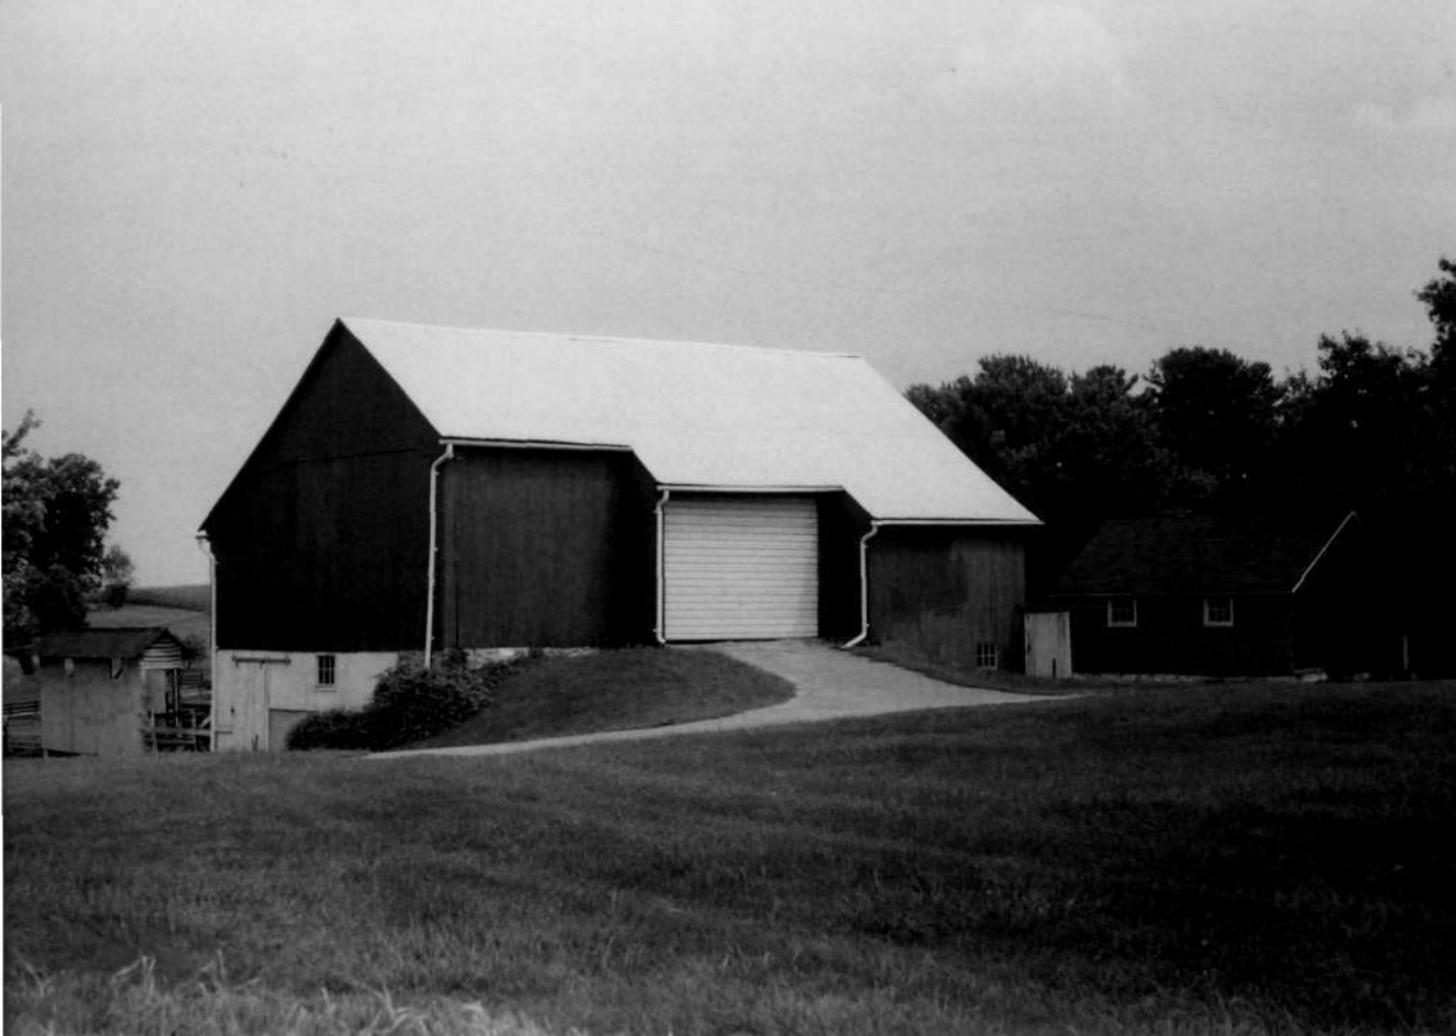
24/29

The setting of the farm is also compromised by the altered outbuildings associated with the farmhouse. The installation of the overhung, metal, garage door in the central bay of the south elevation of the bank barn has resulted in a loss of integrity of design and building materials of the barn. The original, hinged, wooden, wagon doors, which were formerly located in the center bay of the upslope side of the barn, are characteristic features of a Sweitzer bank barn. Finally, the early-twentieth century, frame garage immediately south of the dwelling has suffered a loss of integrity of design as a result of the modern addition to its north elevation.

Bank Barn, south elevation (outsheds),

View NE

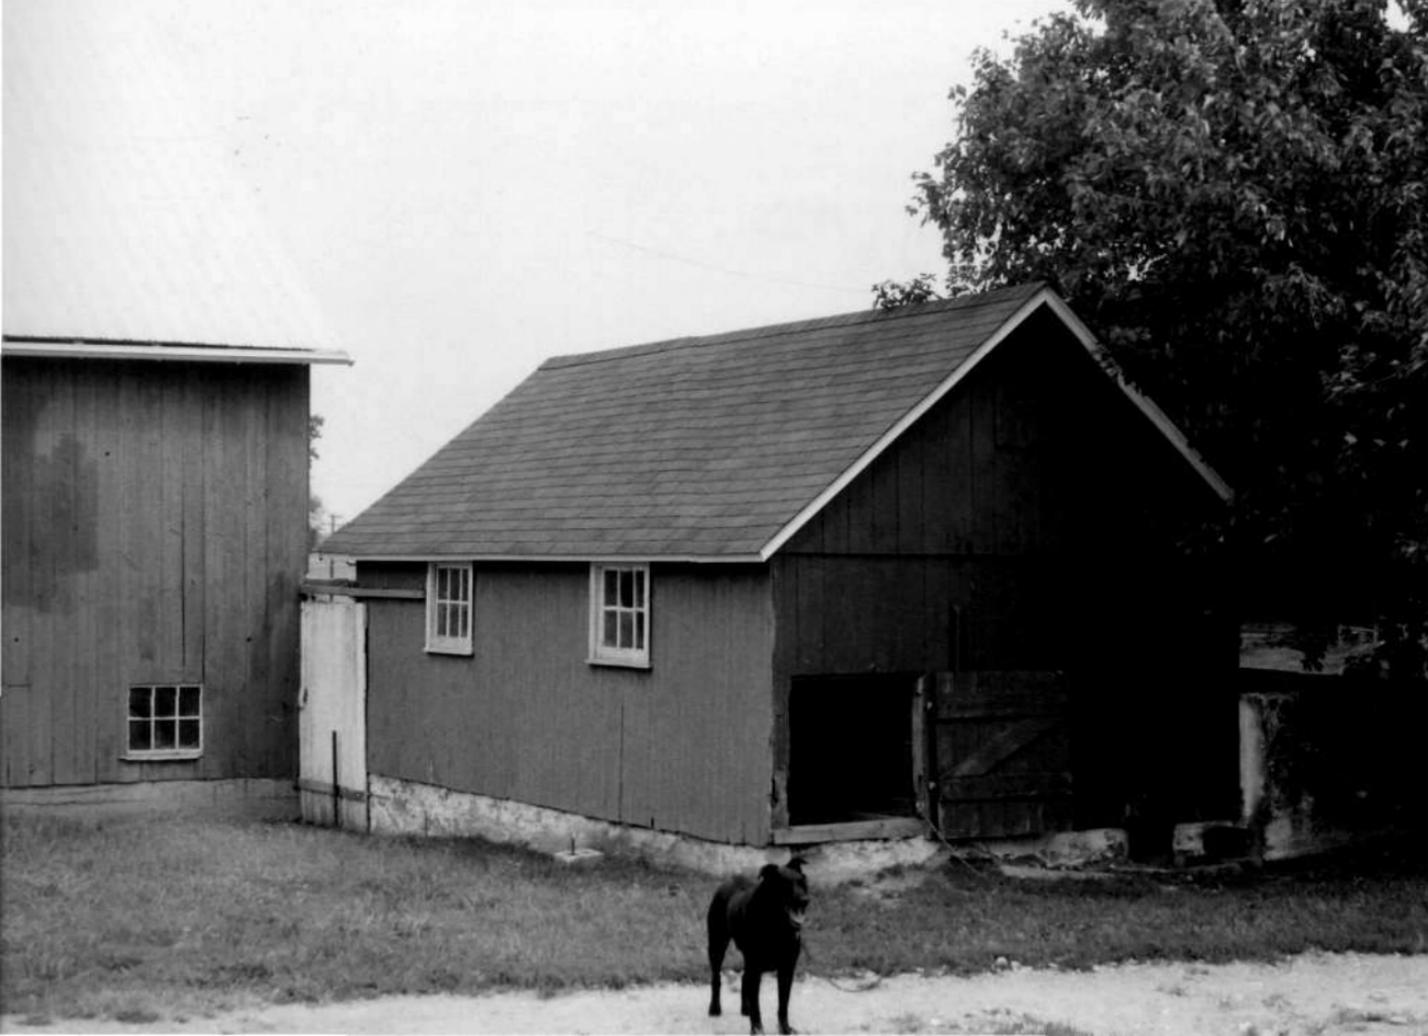
25/29

Frame Shed + pig pen, view NE

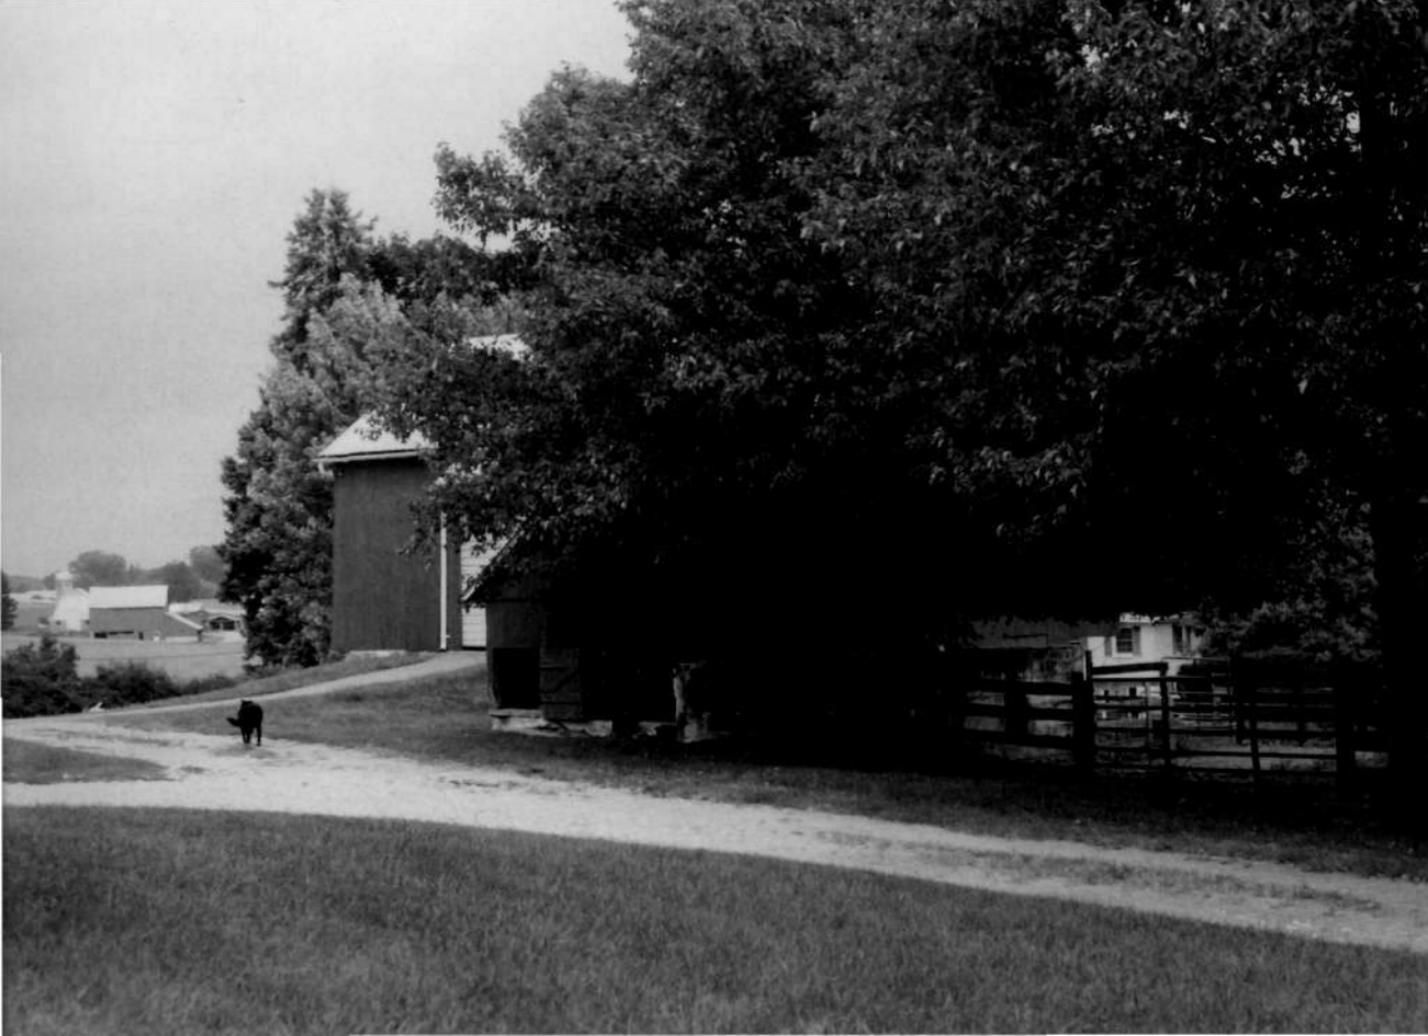
26/29

Frame shed + pig pen, view NW

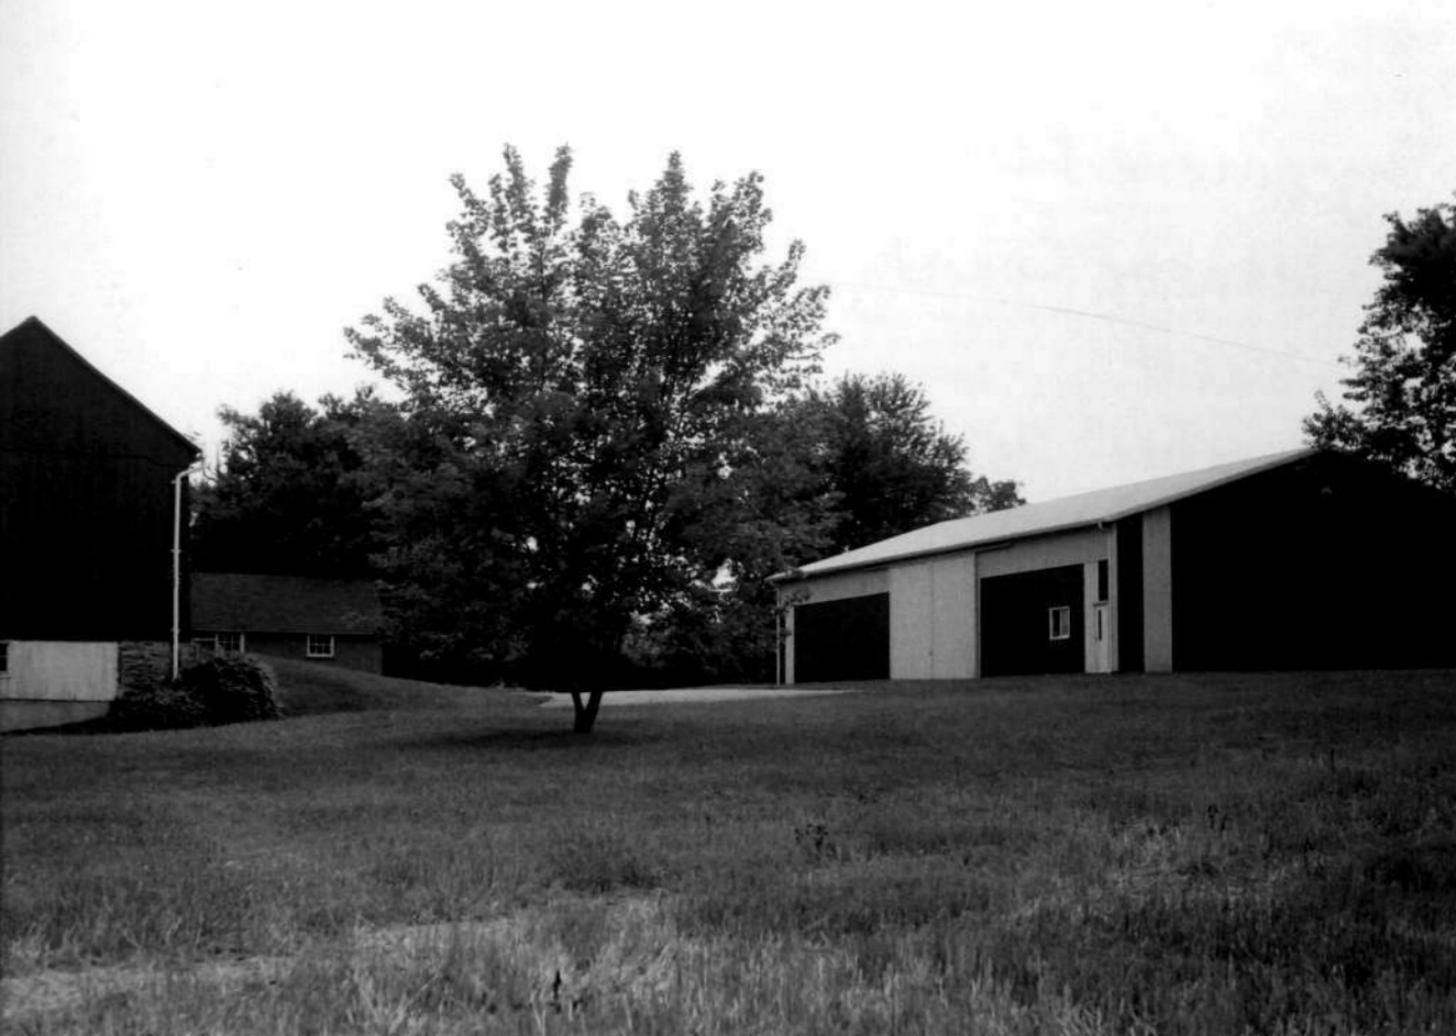
27/29

Barn, shed, and pole Barn, view east.

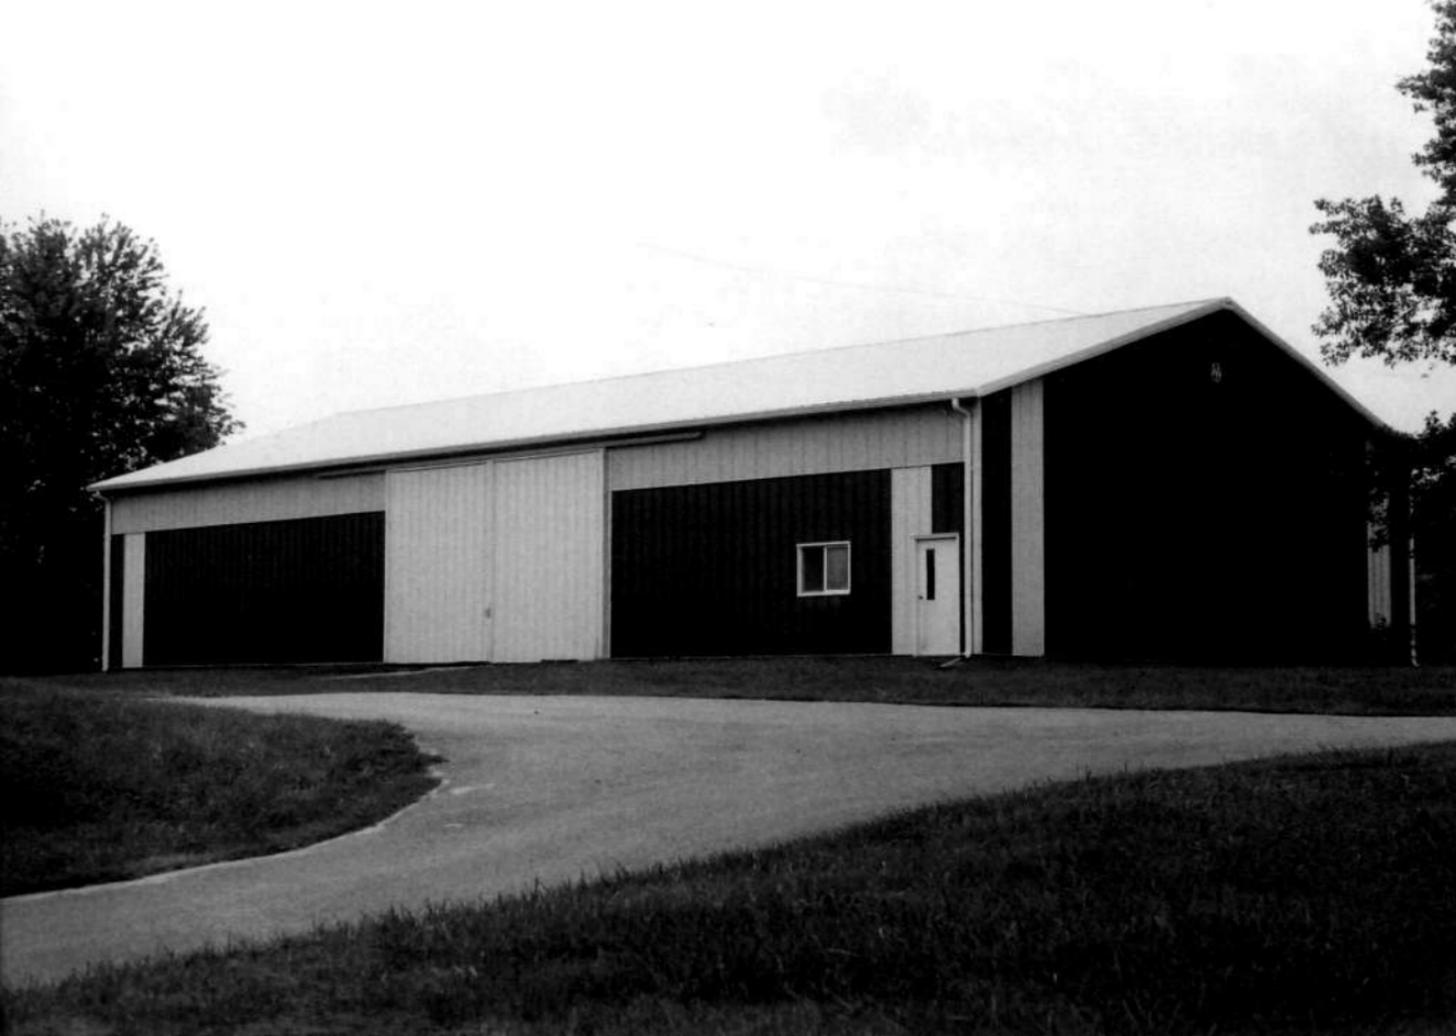
28/29

Pole Barn, NW corner, view SE.

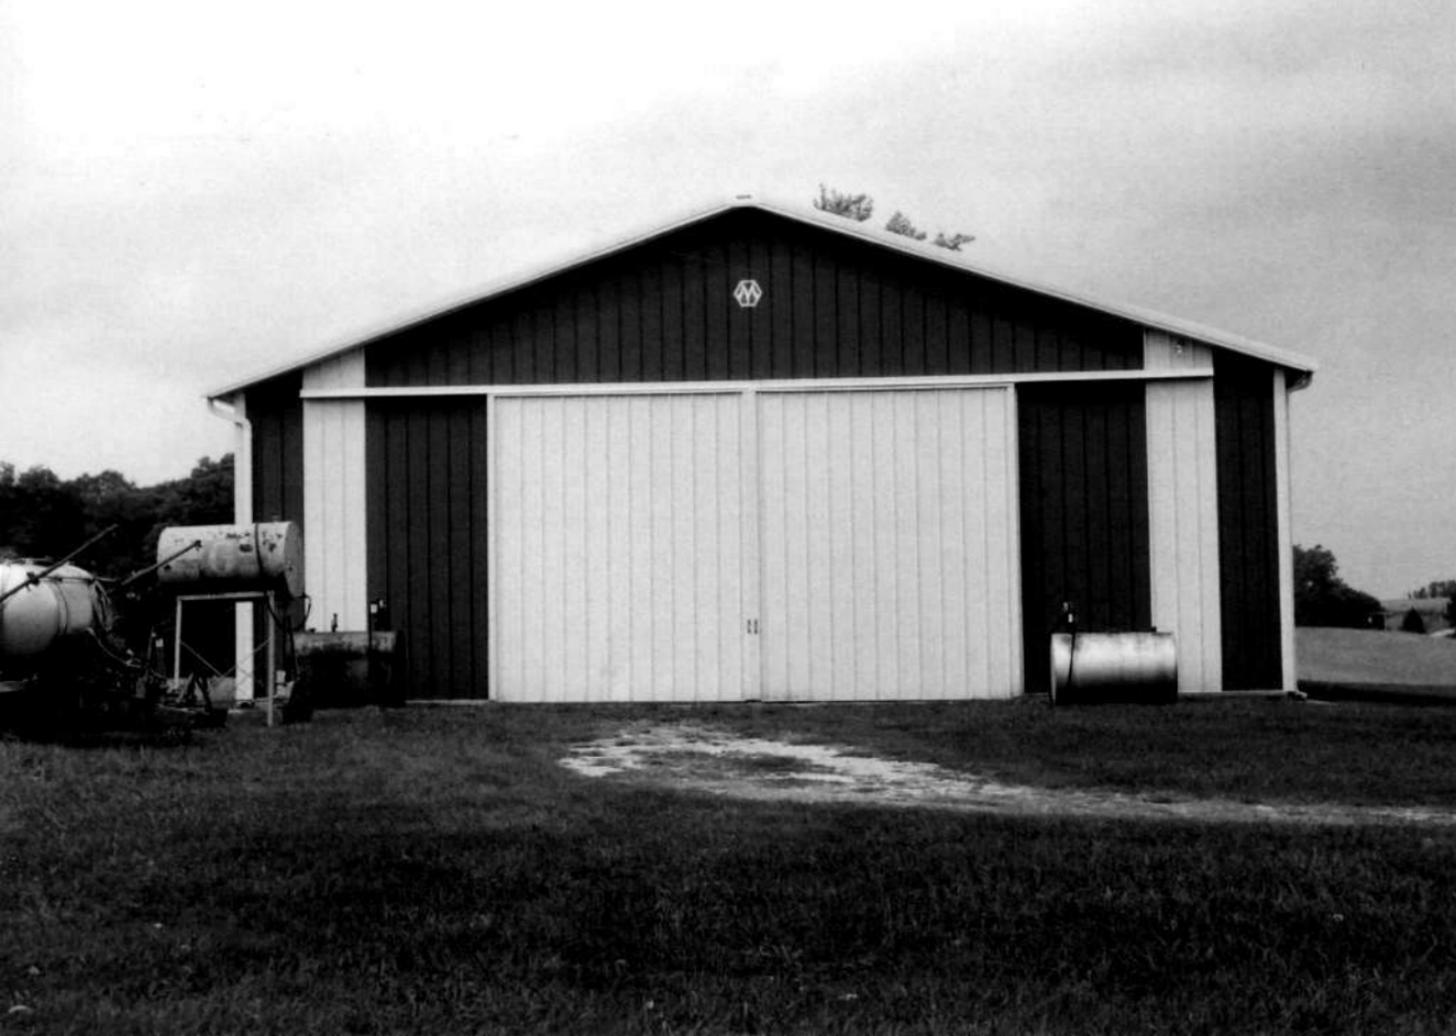
29/29

Pole Barn, east elevation, view west
