**MARYLAND HISTORICAL TRUST
DETERMINATION OF ELIGIBILITY FORM**

Property Name: Millie's Delight Inventory Number: F-3-250
 Address: 1322 Rocky Springs Road City: Frederick Zip Code: 21702
 County: Frederick USGS Topographic Map: Frederick
 Owner: Millie's Delight, LLC Is the property being evaluated a district? ___yes
 Tax Parcel Number: 2110 Tax Map Number: 402 Tax Account ID Number: 101955
 Project: Millie's Delight Subdivision Agency: U.S. Army Corps of Engineers
 Site visit by MHT Staff: X no ___yes Name: _____ Date: _____
 Is the property located within a historic district? ___yes X no

F-3-250

MHP # F-3-250
MILLIE'S DELIGHT
FREDERICK, FREDERICK
COUNTY, MARYLAND
USGS QUAD:
FREDERICK
1:24000

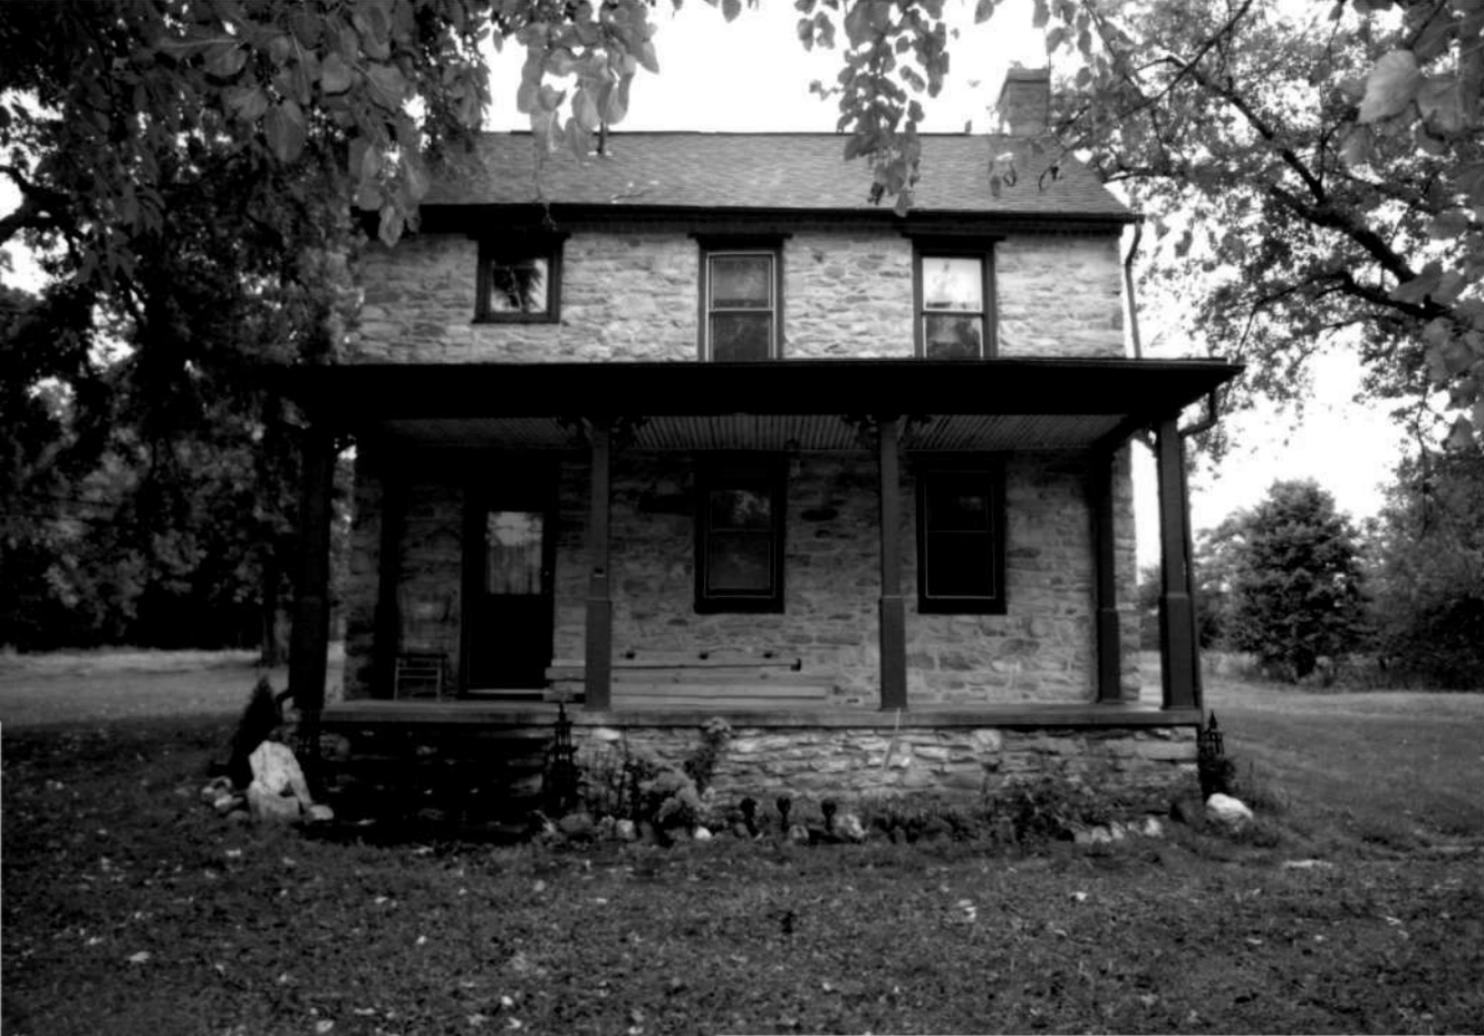
Photo 1 of 11

The three-bay north elevation features one-over-one-light, double-hung, windows set in wood frames with wood sills and lintels. The windows appear to be replacement units. Vinyl storm windows were installed over the windows. The second floor window of the east bay is smaller than all other windows on the elevation and consists of a single-light, wood casement. The main entrance contains a two-panel, single-light, wood door, with a four-light transom, in the east bay. The full-elevation, open porch features a flat roof supported by four square posts with decorative jigsaw brackets. Porch roofing materials are not visible. The porch floor is poured concrete and the ceiling is narrow wood board nailed to the ceiling joists. Stone steps lead to the porch, which rests on a stone foundation. The stonework on the porch foundation is different, in terms of the size of the stone and color, from that of the original block of the dwelling; there is a clear joint between the house and the porch on the east and west elevations. An opening in the gable end of the east elevation of the principal block features a louvered vent. No other openings are located on this elevation. Metal bulkhead doors provide basement access on the south elevation of the principal block. The west elevation of the principal block is blind.

F-3-3-250_2009-09-17_001 – Dwelling, north elevation

North elevation of house, looking south

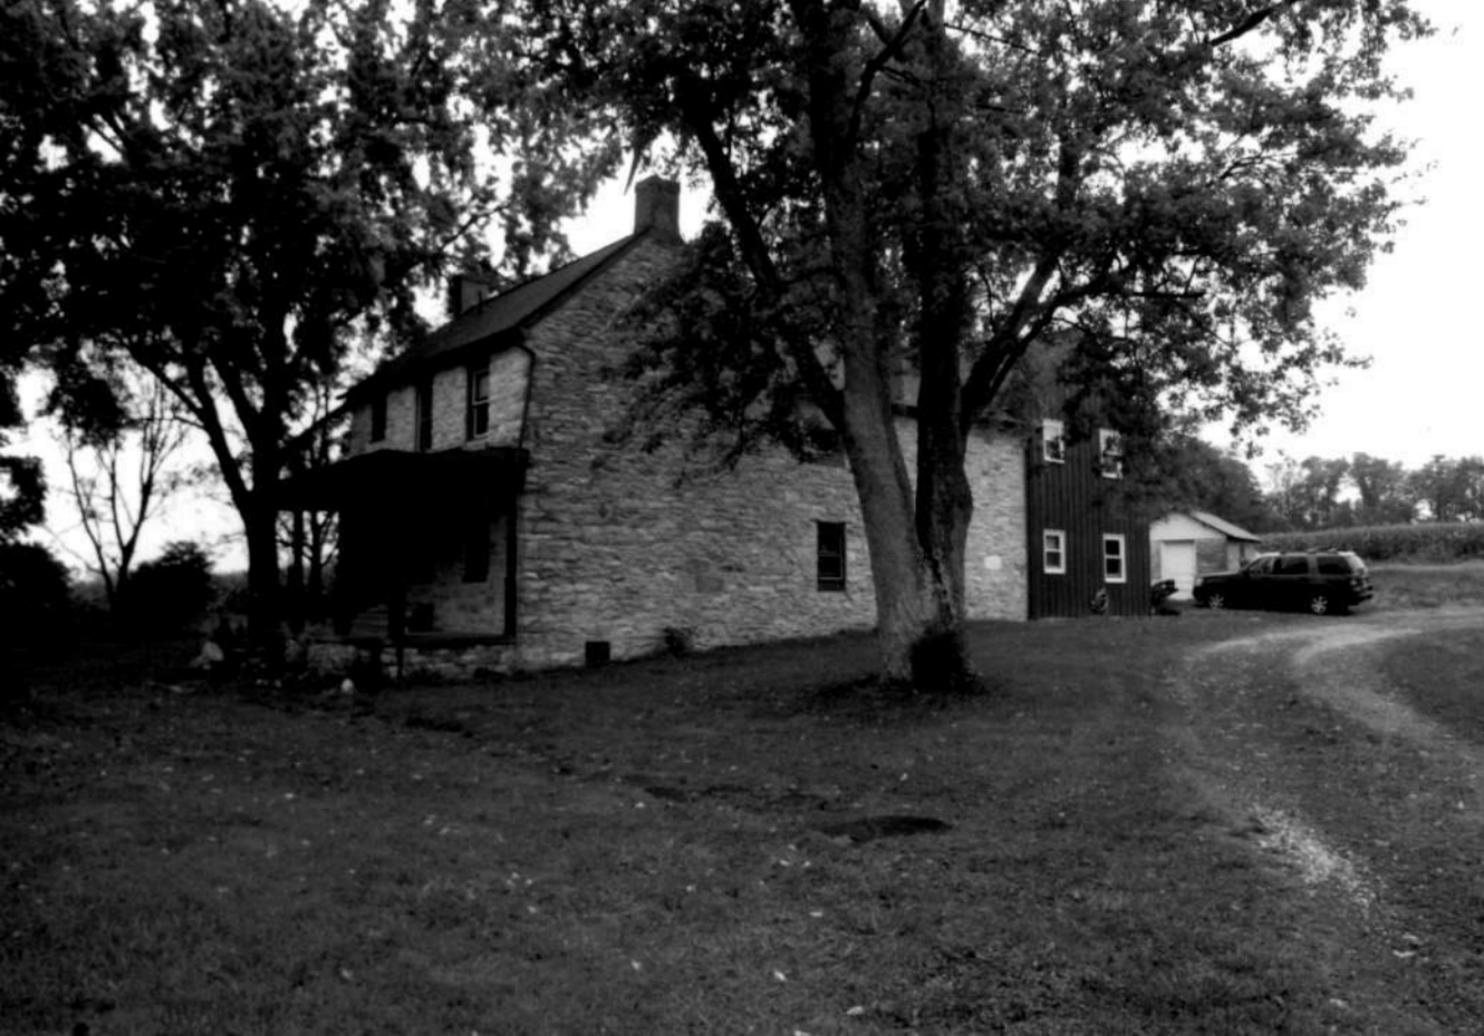
Photo 2 of 11

F-3-3-250_2009-09-17_002 – Dwelling and outbuilding, view north and west

View n+ W of house and out building

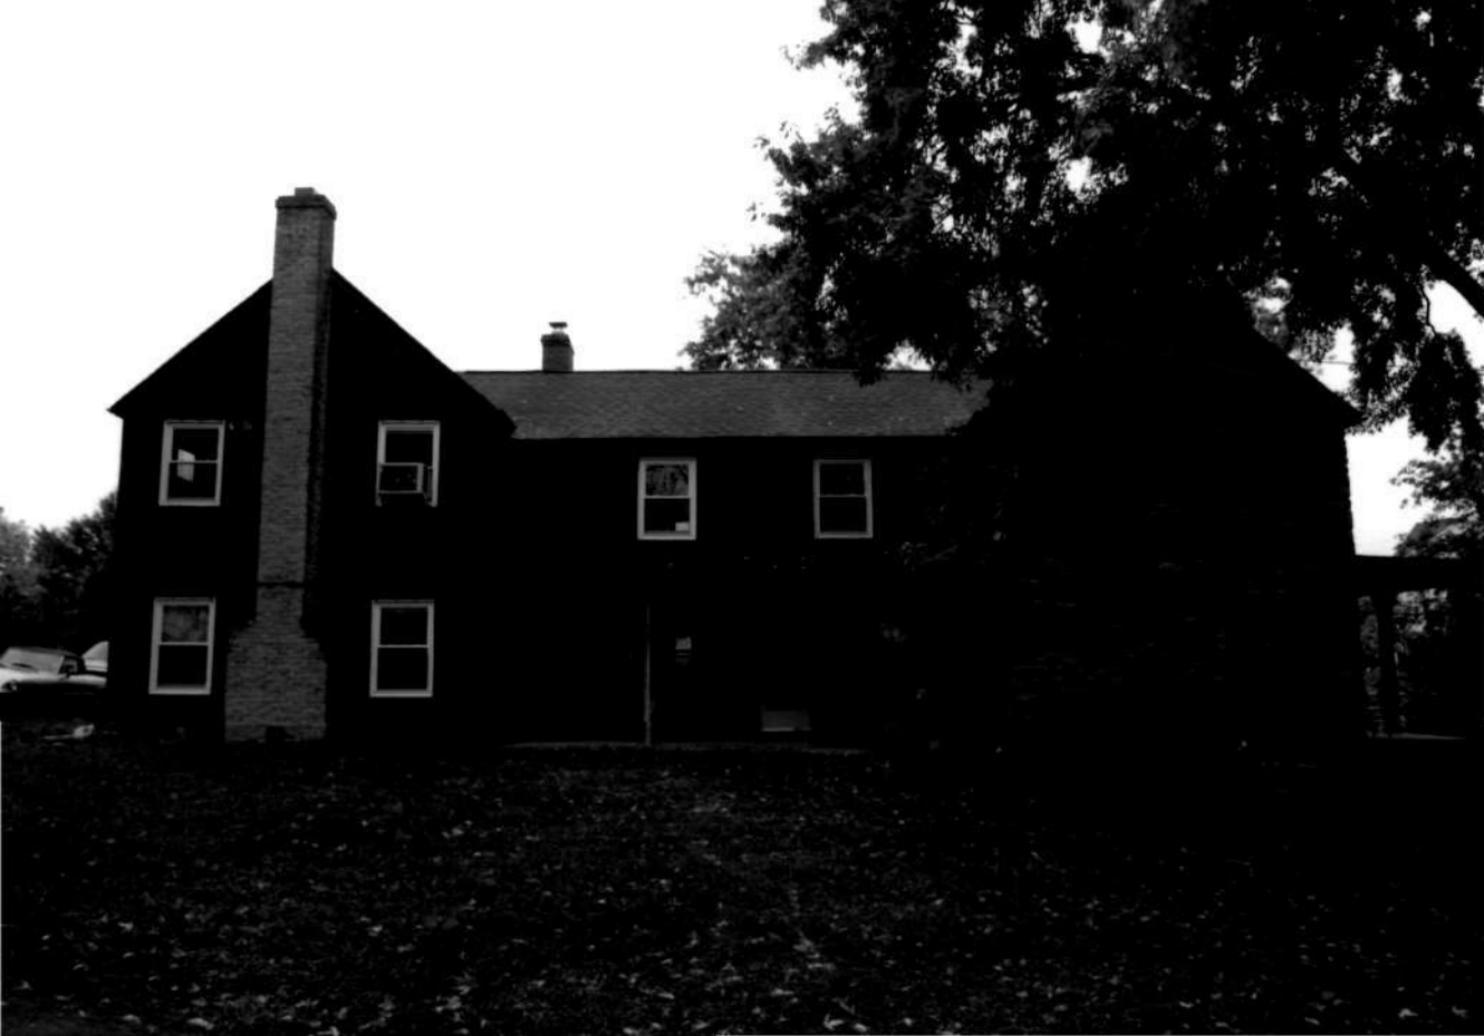
Photo 3 of 11

The ell's two-story east elevation is three bays on the first floor and two bays on the second floor. Cladding materials on the east elevation are board-and-batten wood siding. An off-center, three-panel, one-light door is flanked by one-over-one-light, double-hung, vinyl-sash windows. Door materials could not be determined. Second floor windows are larger than those found on the first floor. A one-story, three-bay porch runs the length of the ell on the east elevation. Wood posts support the porch's shed roof, which is sheathed in asphalt shingles. The porch has a poured-concrete floor. The ell's two-bay, west elevation was completed in stone and features one-over-one-light, double-hung windows. Sash could not be determined due to the presence

of vinyl storm windows. Observation suggests that the windows have been altered; the window openings appear larger than the existing windows.

F-3-3-250_2009-09-17_003 – Dwelling, east elevation

East elevation of house, looking north west

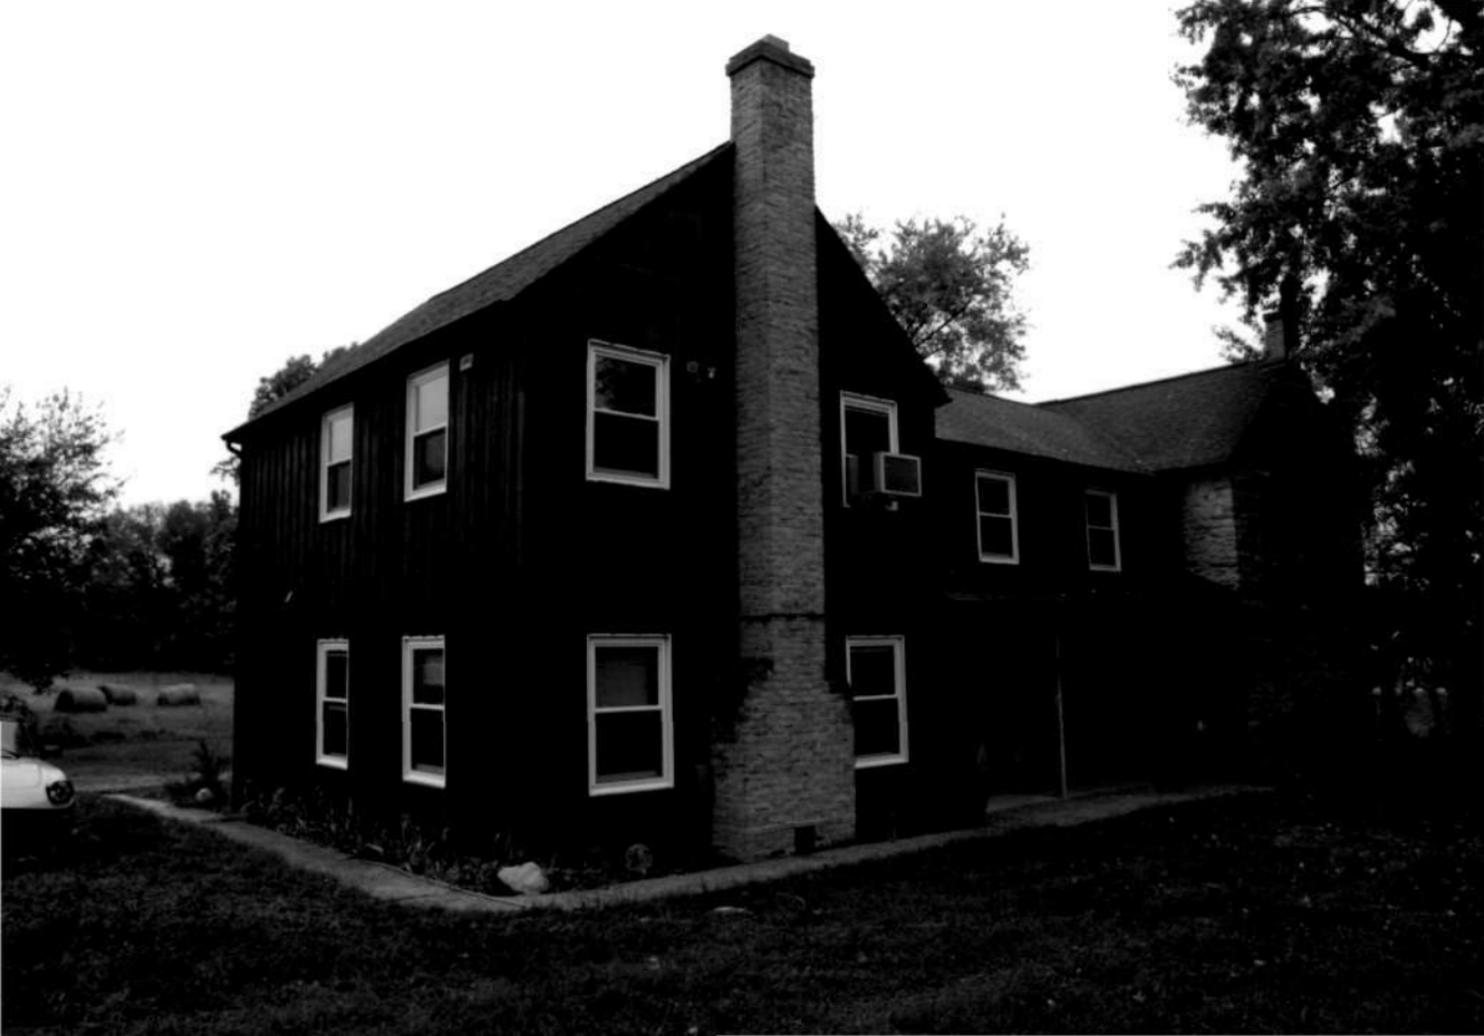
Photo 4 of 11

A two-story, wood-frame addition clad in board-and-batten siding was constructed on the ell's south elevation. Visual observation suggests the addition was constructed during the last quarter of the twentieth century. The addition terminates in a side-gable roof sheathed in asphalt shingles. One-over-one-light, double-hung, vinyl-sash windows on the first and second floors of the east elevation flank an exterior brick chimney. The two-bay south elevation contains windows that are similar to the windows found on the east elevation. The west elevation is two bays, and also features one-over-one-light, double-hung, vinyl windows on the first and second floors. The windows in the northern bay are smaller than those in the southern bay. A louvered vent is located in the gable. The addition's north elevation contains a multi-panel wood door that opens onto the east elevation porch.

F-3-3-250_2009-09-17_004 – Dwelling, south elevation

South corner of house, looking north

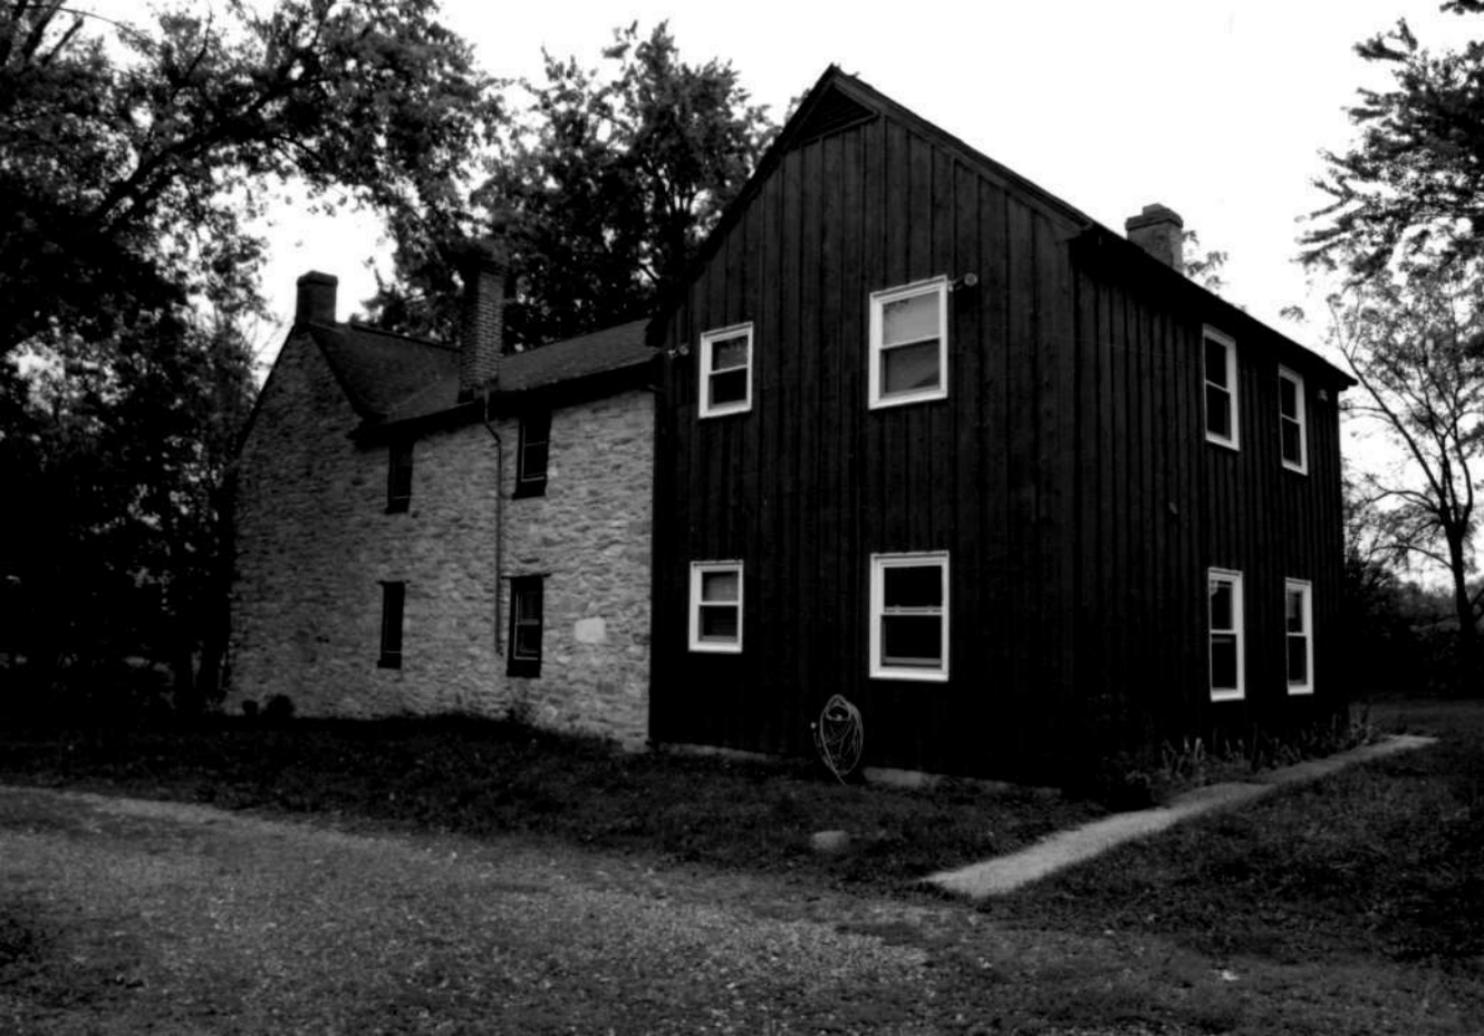
Photo 5 of 11

F-3-3-250_2009-09-17_005 – Dwelling, west elevation

West elevation of house, looking east

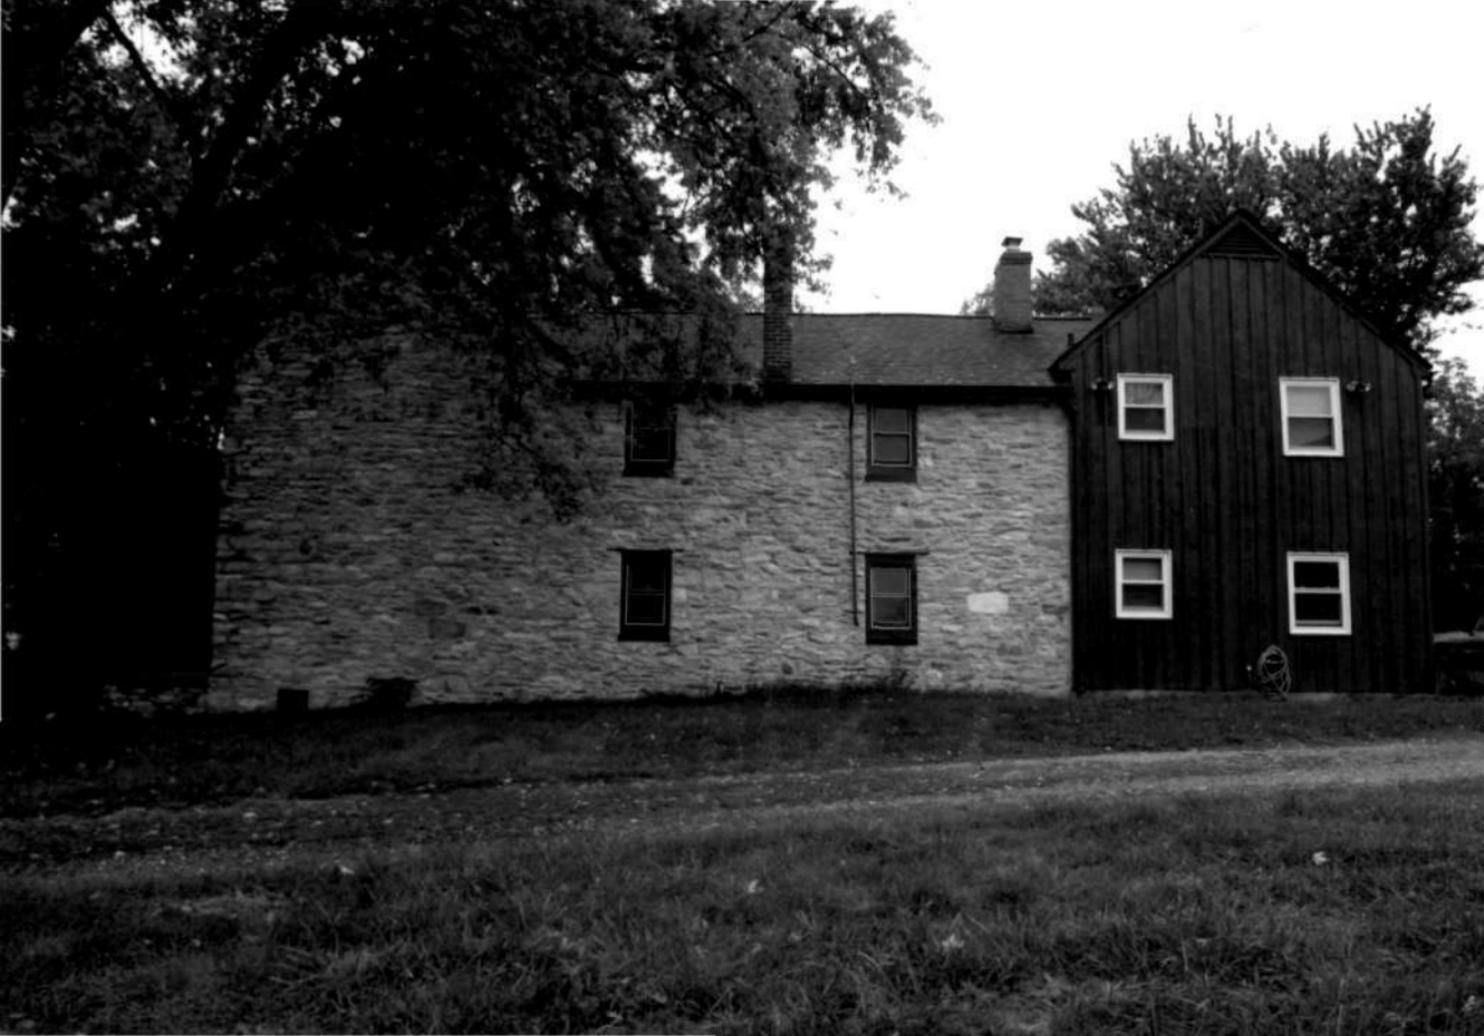
Photo 6 of 11

F-3-3-250_2009-09-17_006 – Dwelling, west elevation

West elevation of house, looking east

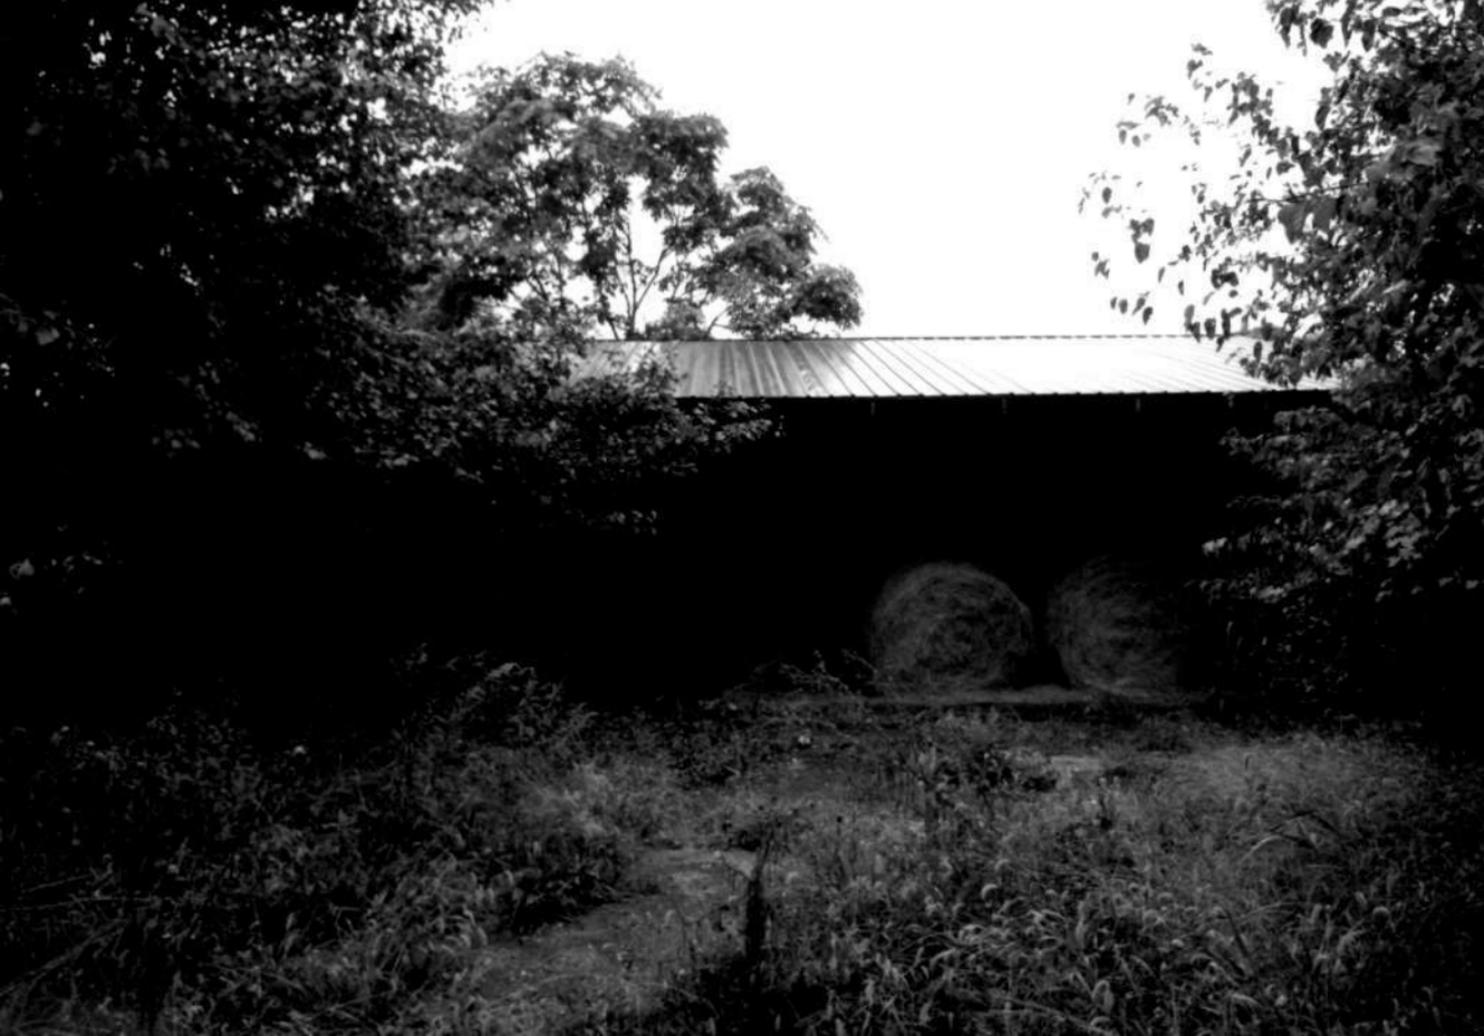
Photo 7 of 11

A barn is located southwest of the dwelling. The stone lower level of the barn and the earthen ramp on the west elevation suggest the building originally was constructed as a bank barn. A prefabricated metal, side-gable roof was appended to the original ground level of the barn. One window opening is located on the north elevation; the opening is covered in plywood. The west and north elevations are covered in overgrown vegetation; one window opening located on the west elevation is covered in plywood and is visible from the barn's interior. All roof framing has been replaced with prefabricated wood trusses. The building currently is used to store hay.

F-3-3-250_2009-09-17_007 – Barn, east elevation

east elevation of barn, looking west

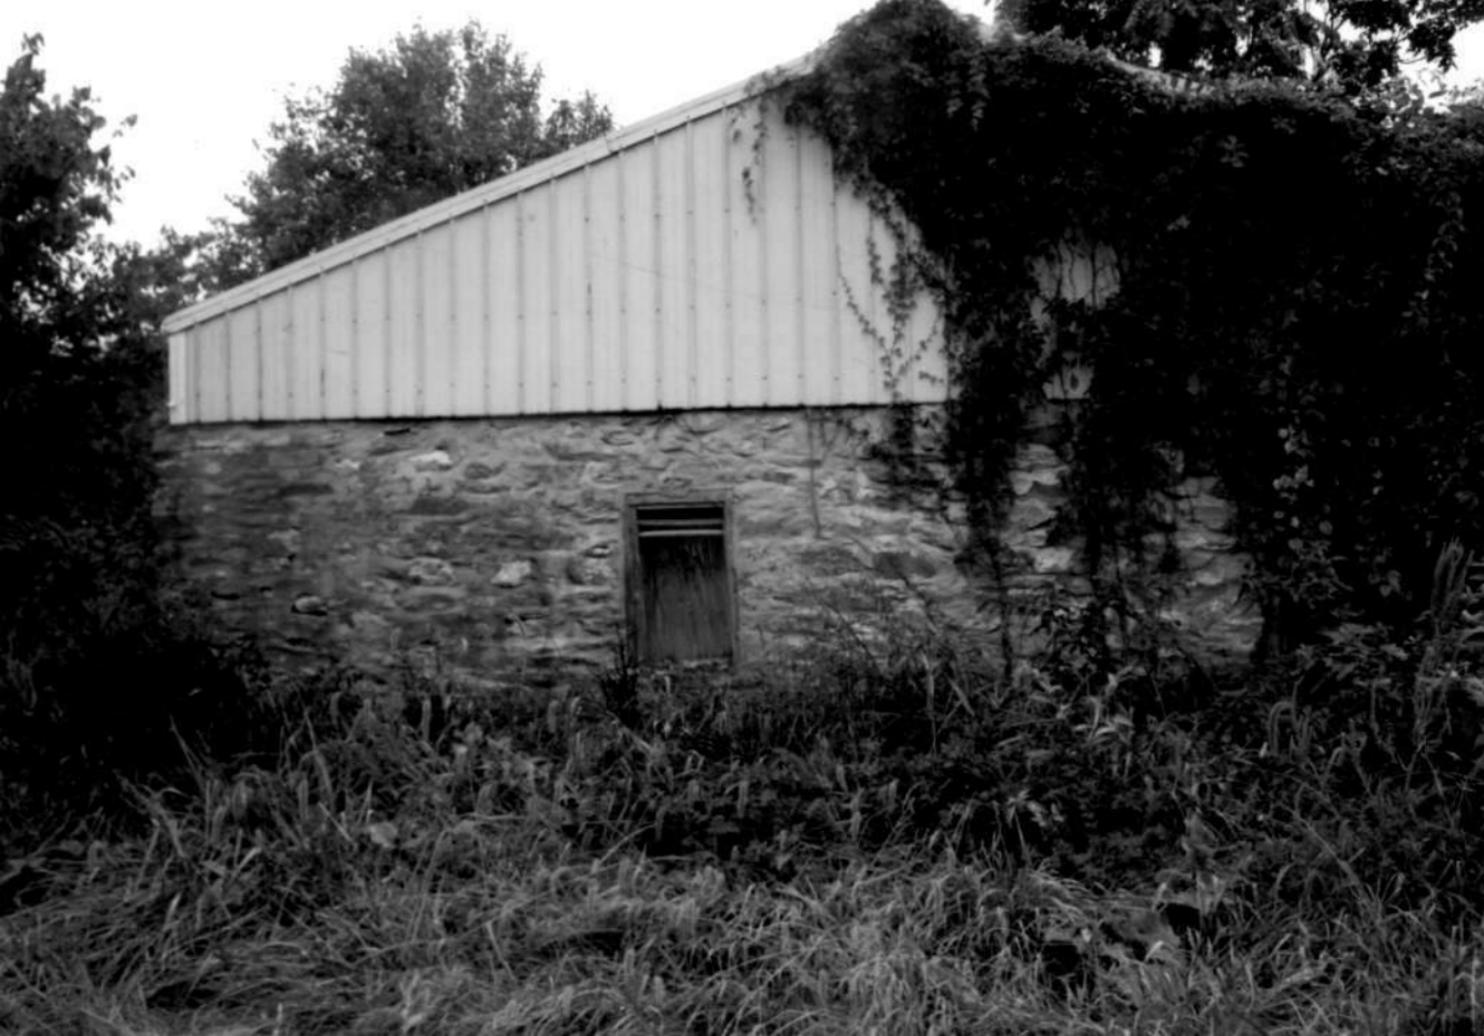
Photo 8 of 11

F-3-3-250_2009-09-17_008 – Barn, north elevation

North SE elevation of barn, looking southwest

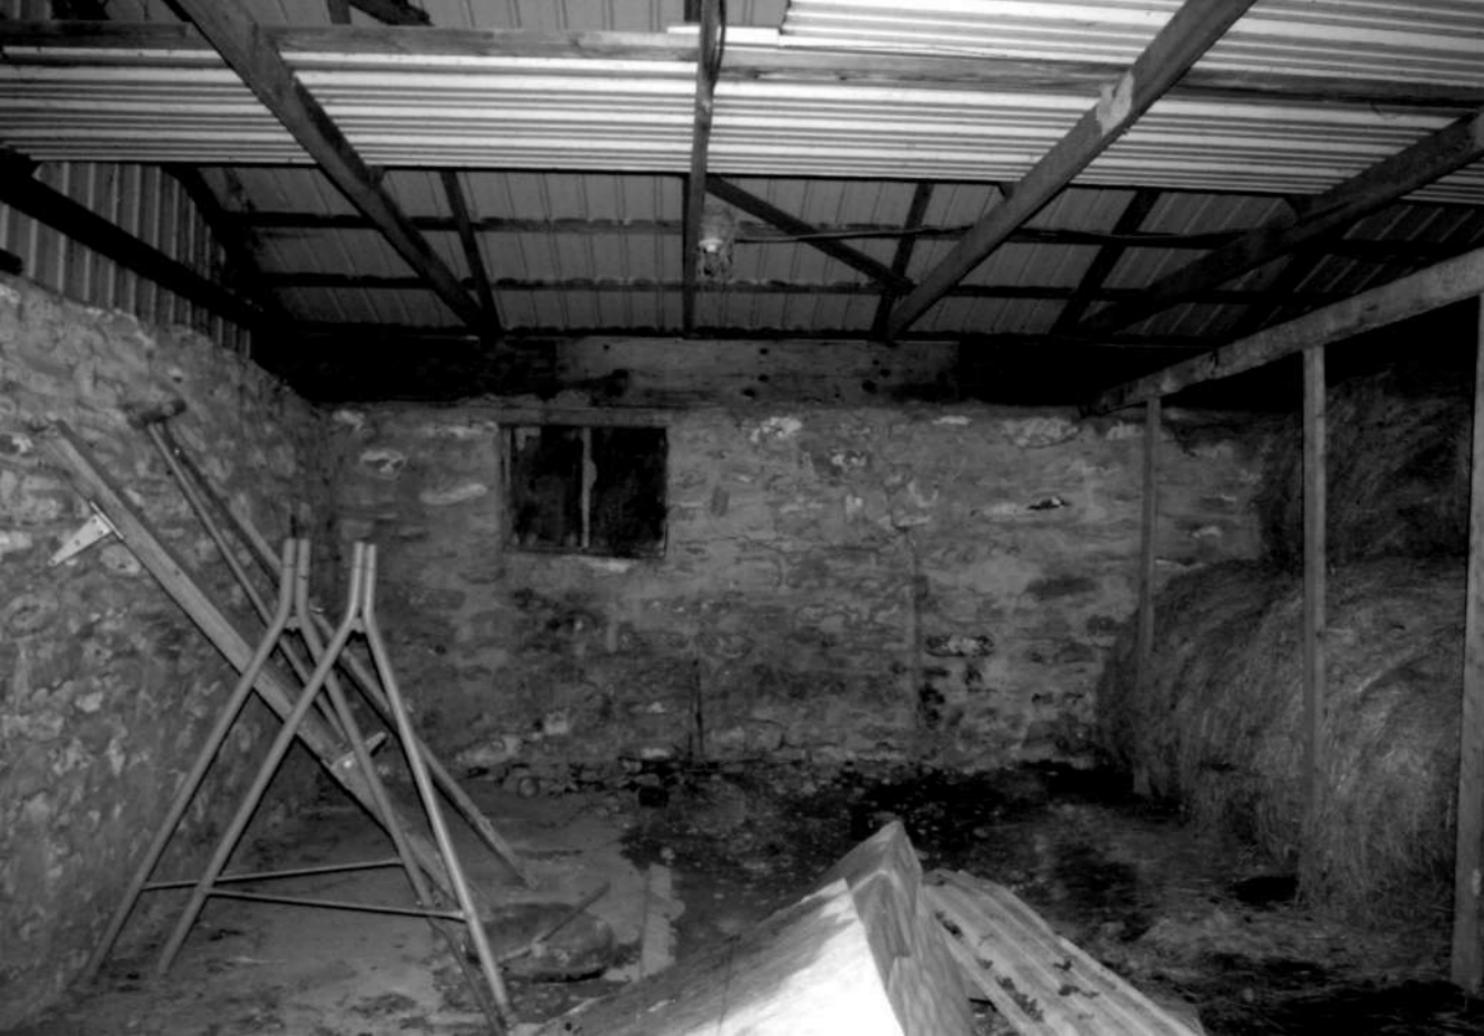
Photo 9.tif

F-3-3-250_2009-09-17_009 – Barn, interior looking west

Interior of barn, looking WEST

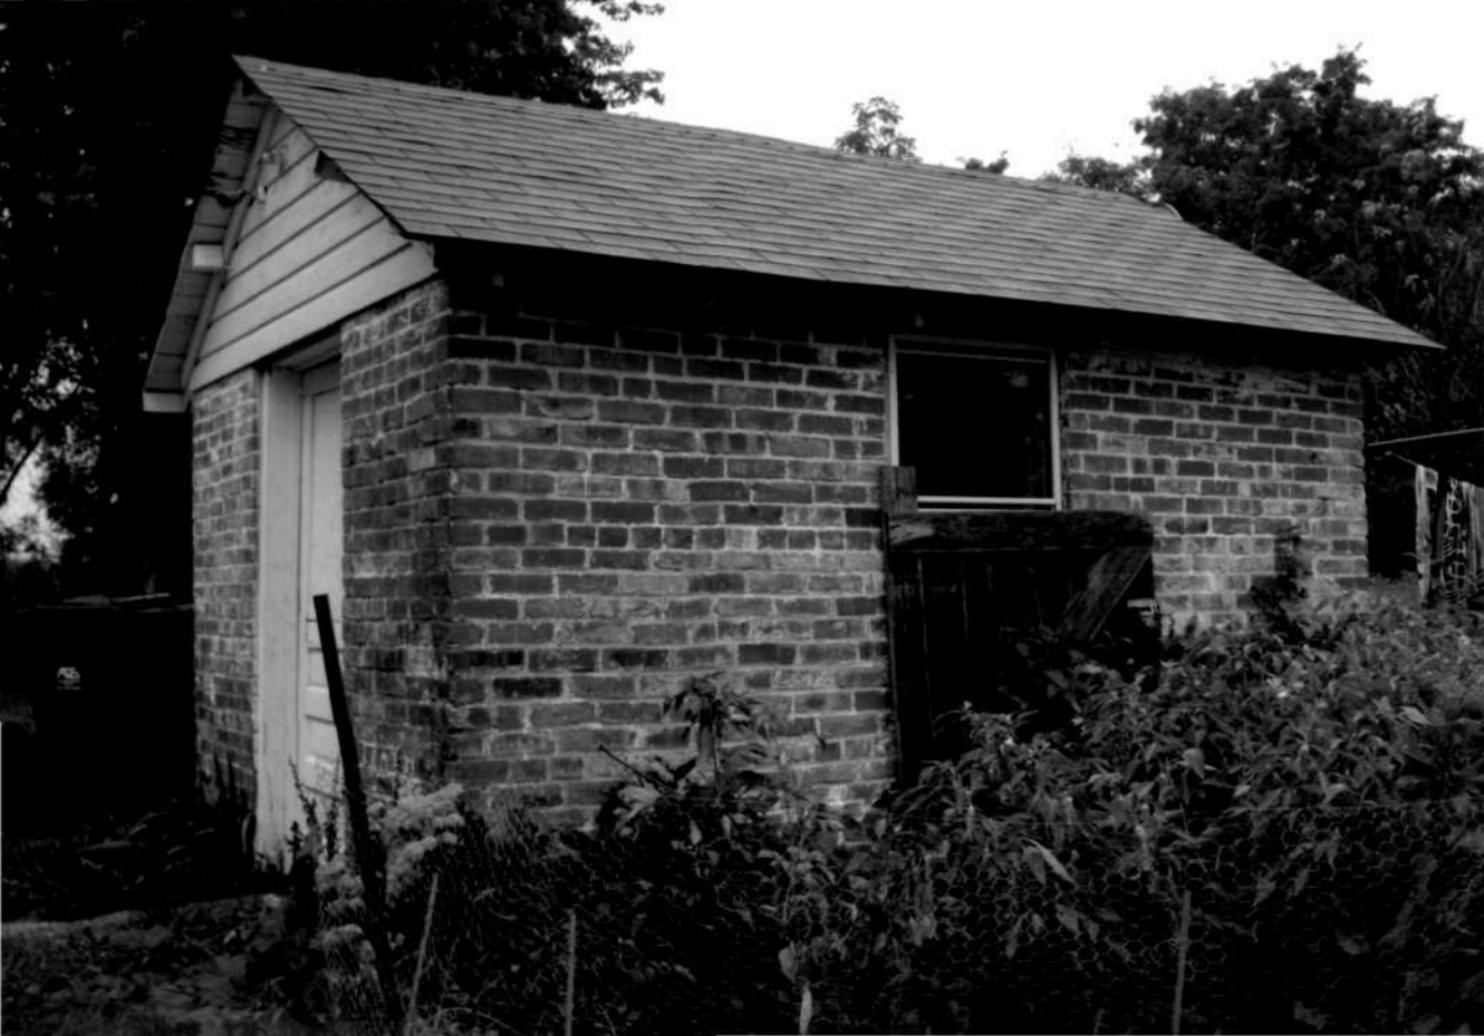
Photo W & F"

An early twentieth-century single-story brick outbuilding is located south of the dwelling. The front-gable building occupies a rectangular footprint and faces north. Roofing materials are asphalt shingles. The brickwork is completed in an irregular bond; wood lap siding is located in the gable ends. Three openings are located on the building. A three-panel, one-light wood door is centered on the north elevation. The window opening in the door has been covered in plywood. The window opening on the west elevation features a vinyl storm window; no framing for the window is extant. The east elevation contains a vinyl storm window in a wood window frame. The south elevation is blind. Currently, the building is used for storage.

F-3-3-250_2009-09-17_010 – Outbuilding, north and west elevations

outbuilding, north & west elevations

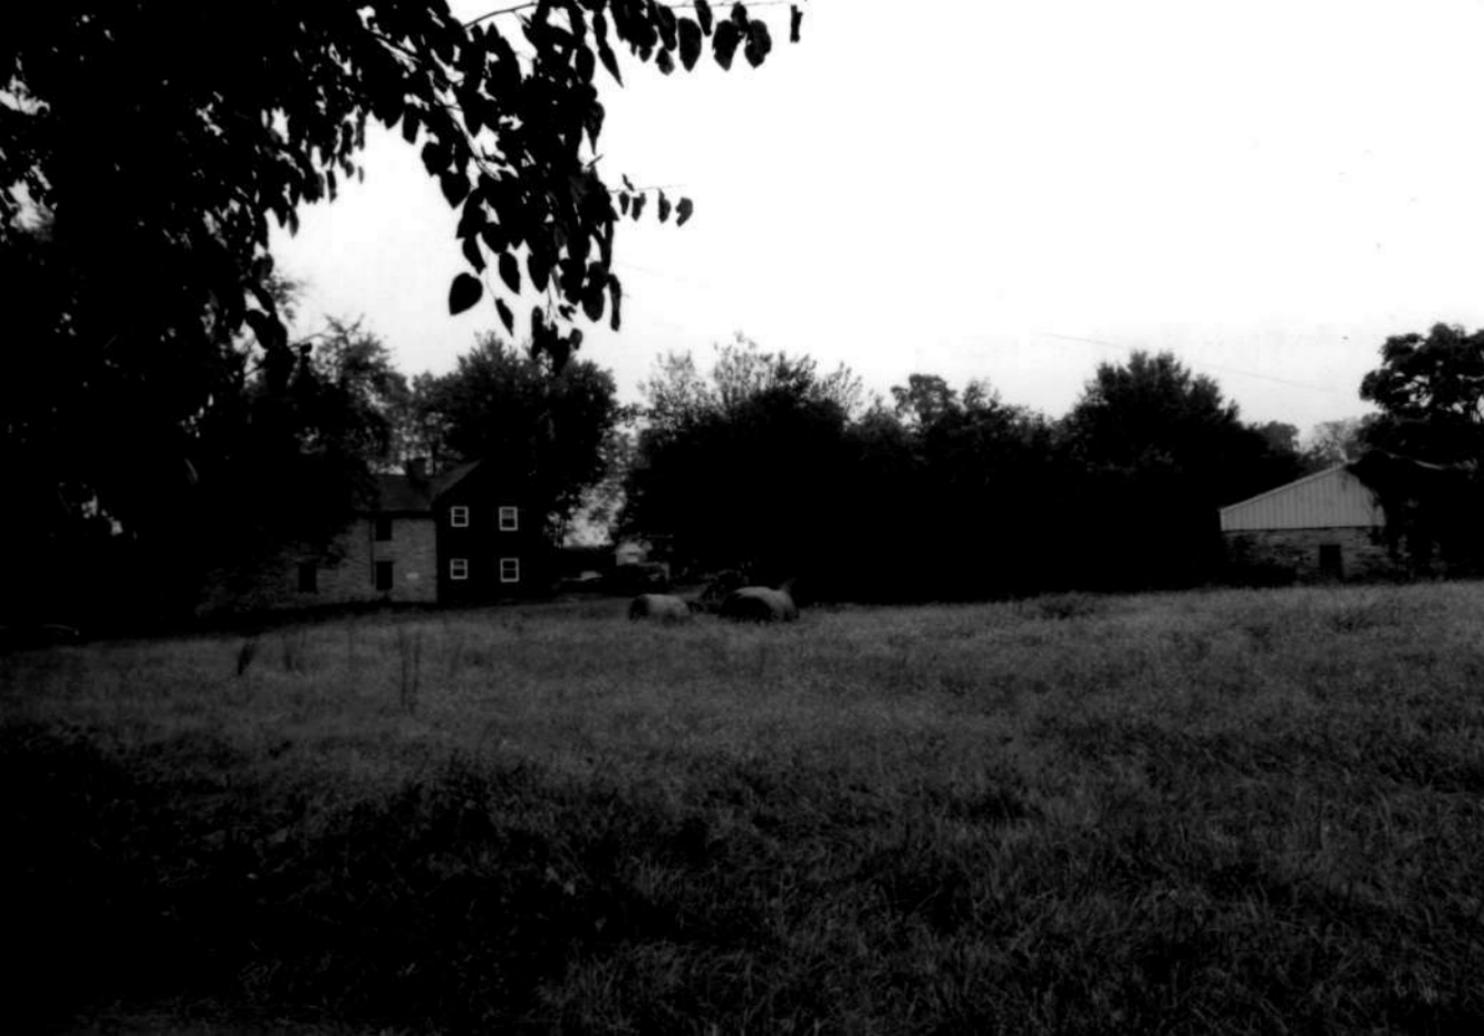
Photo 11 of 11

Millie's Delight does not retain sufficient integrity of design, workmanship, association, feeling, setting, materials, or location to merit consideration for inclusion in the National Register of Historic Places. Late twentieth-century suburban-style residential development is located immediately to the northeast of the property; additional development is located to the east and north. These residential neighborhoods have compromised the property's setting, feeling, and association. While the

F-3-3-250_2009-09-17_011 – Setting, looking southeast of complex

View southeast of complex
