Capsule Summary

Survey No.: T-1132

Name: Strausburg Residence

Maryland Historical Trust
State Historic Sites Inventory Form

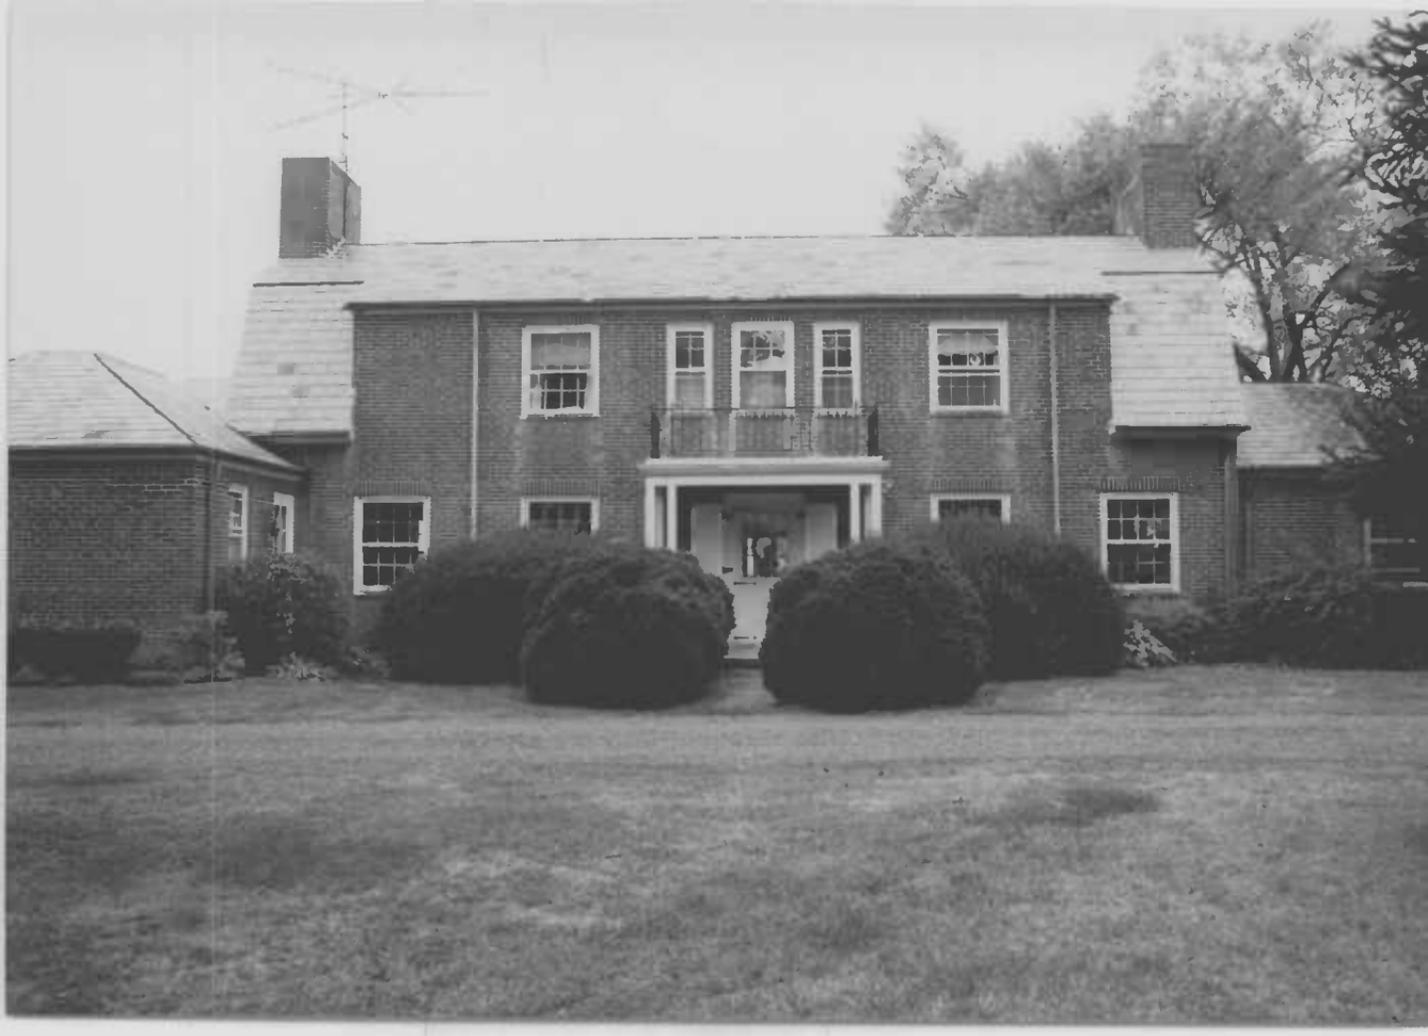
1 of 21

Main House, East Facade

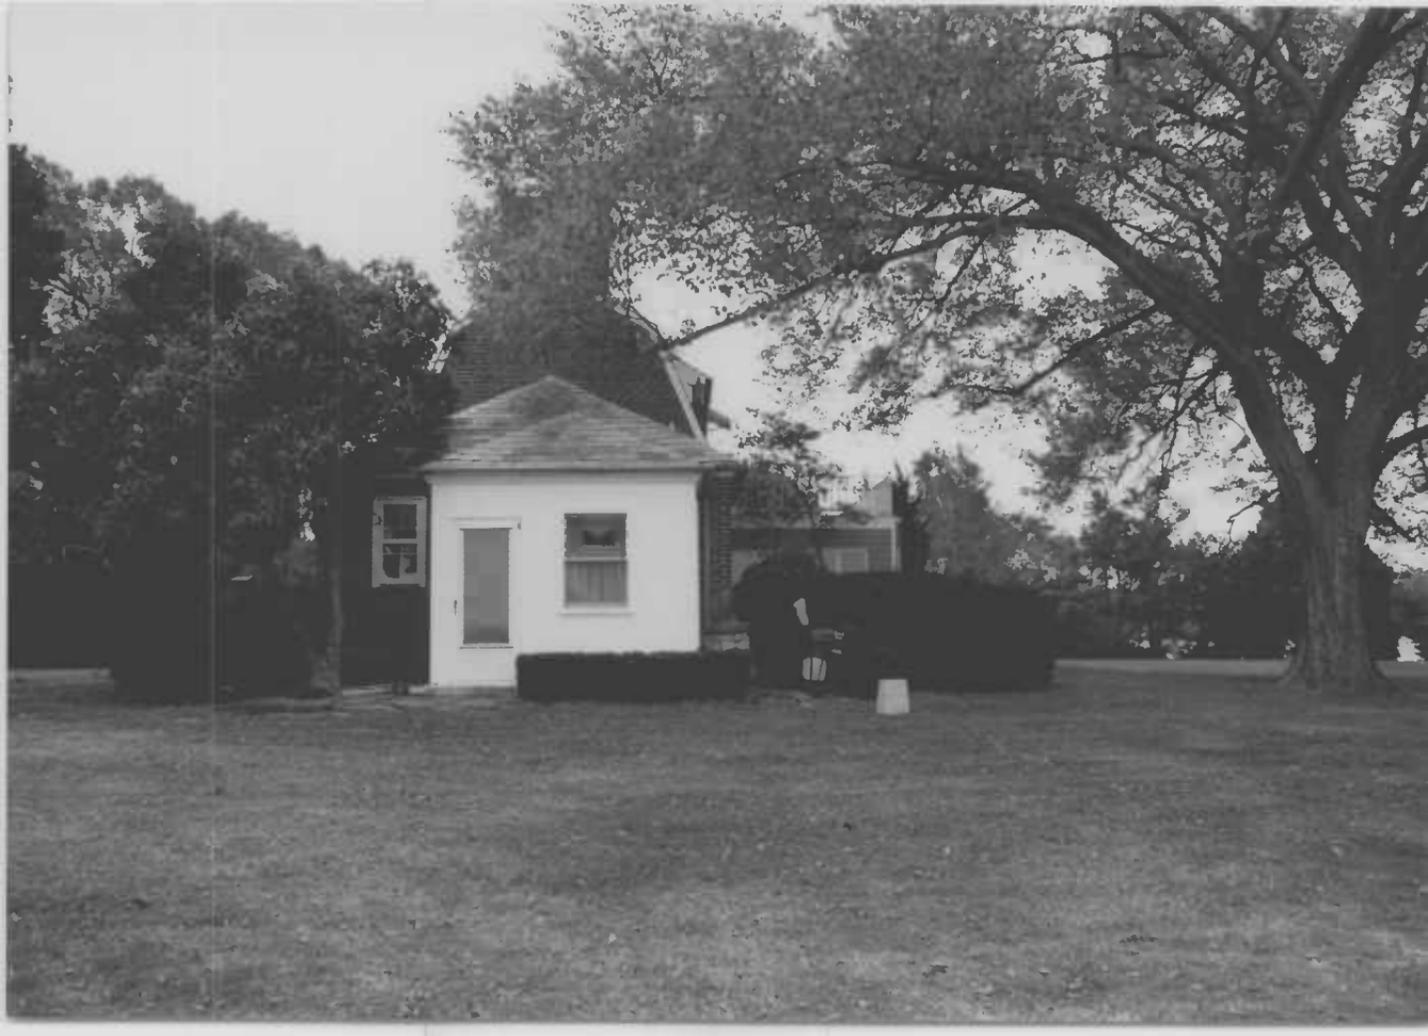
2 of 21

Main house, north elevation

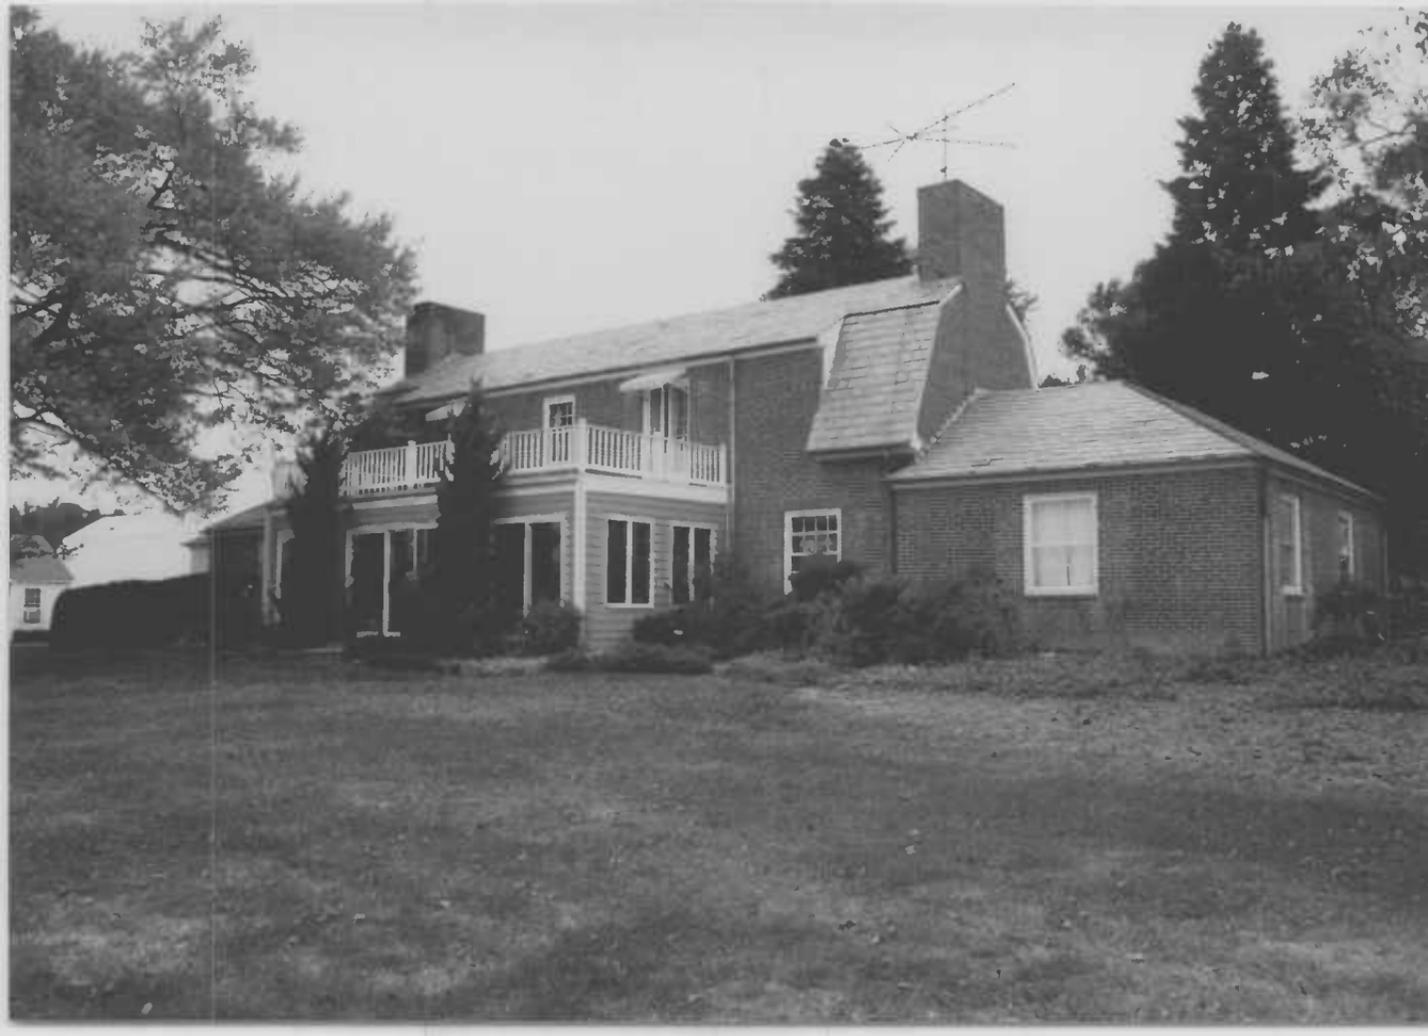
3 of 21

Main house, west elevation

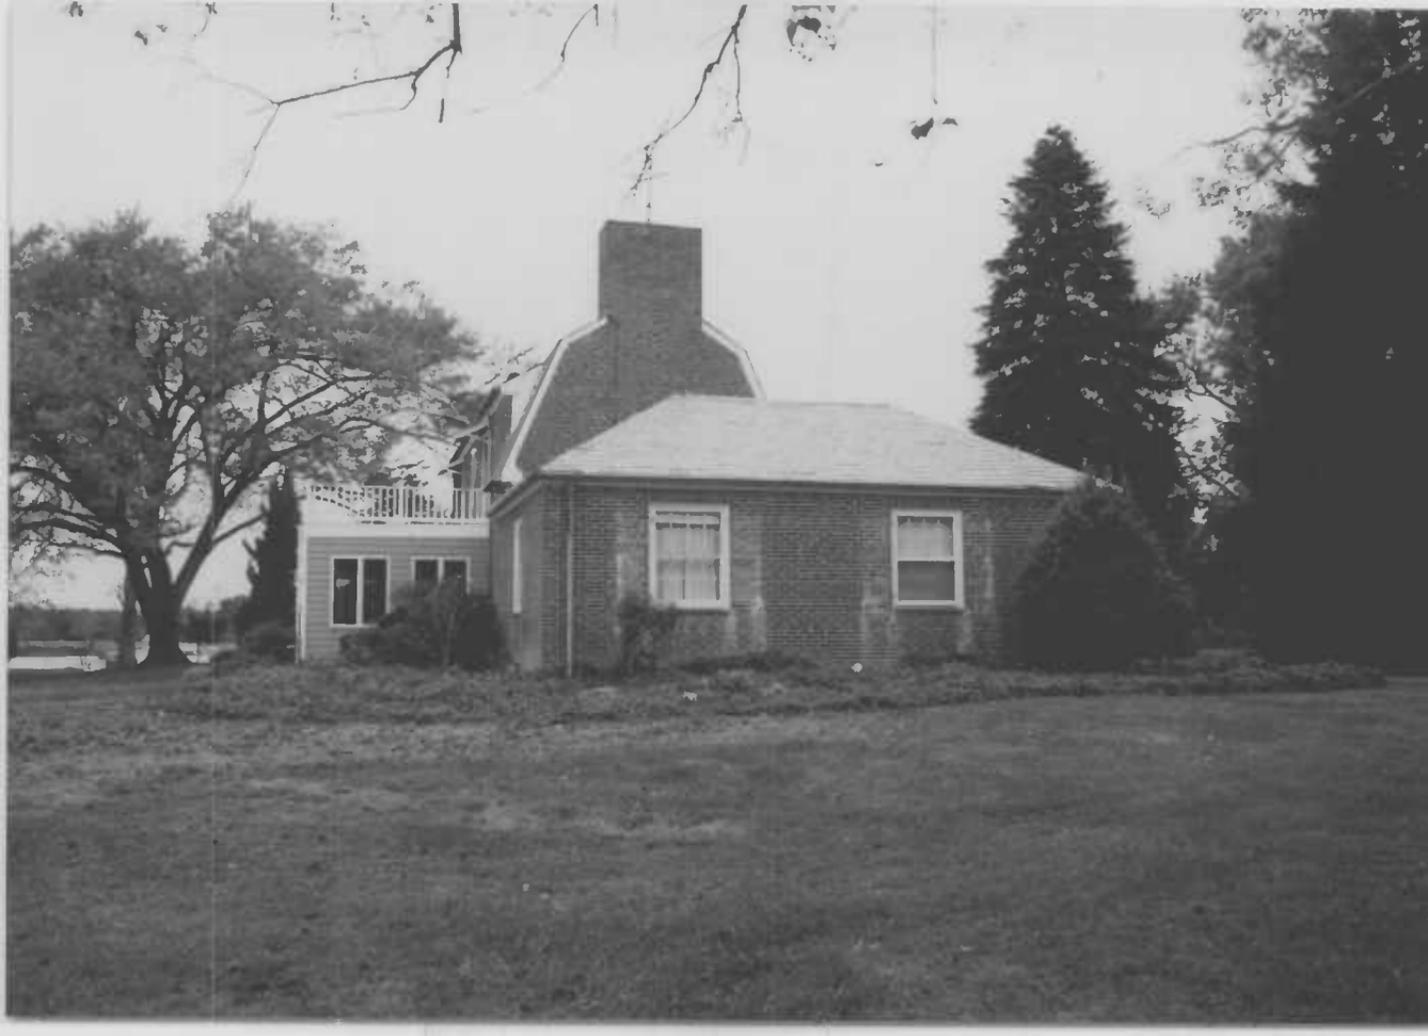
4 of 21

Main house, south elevation

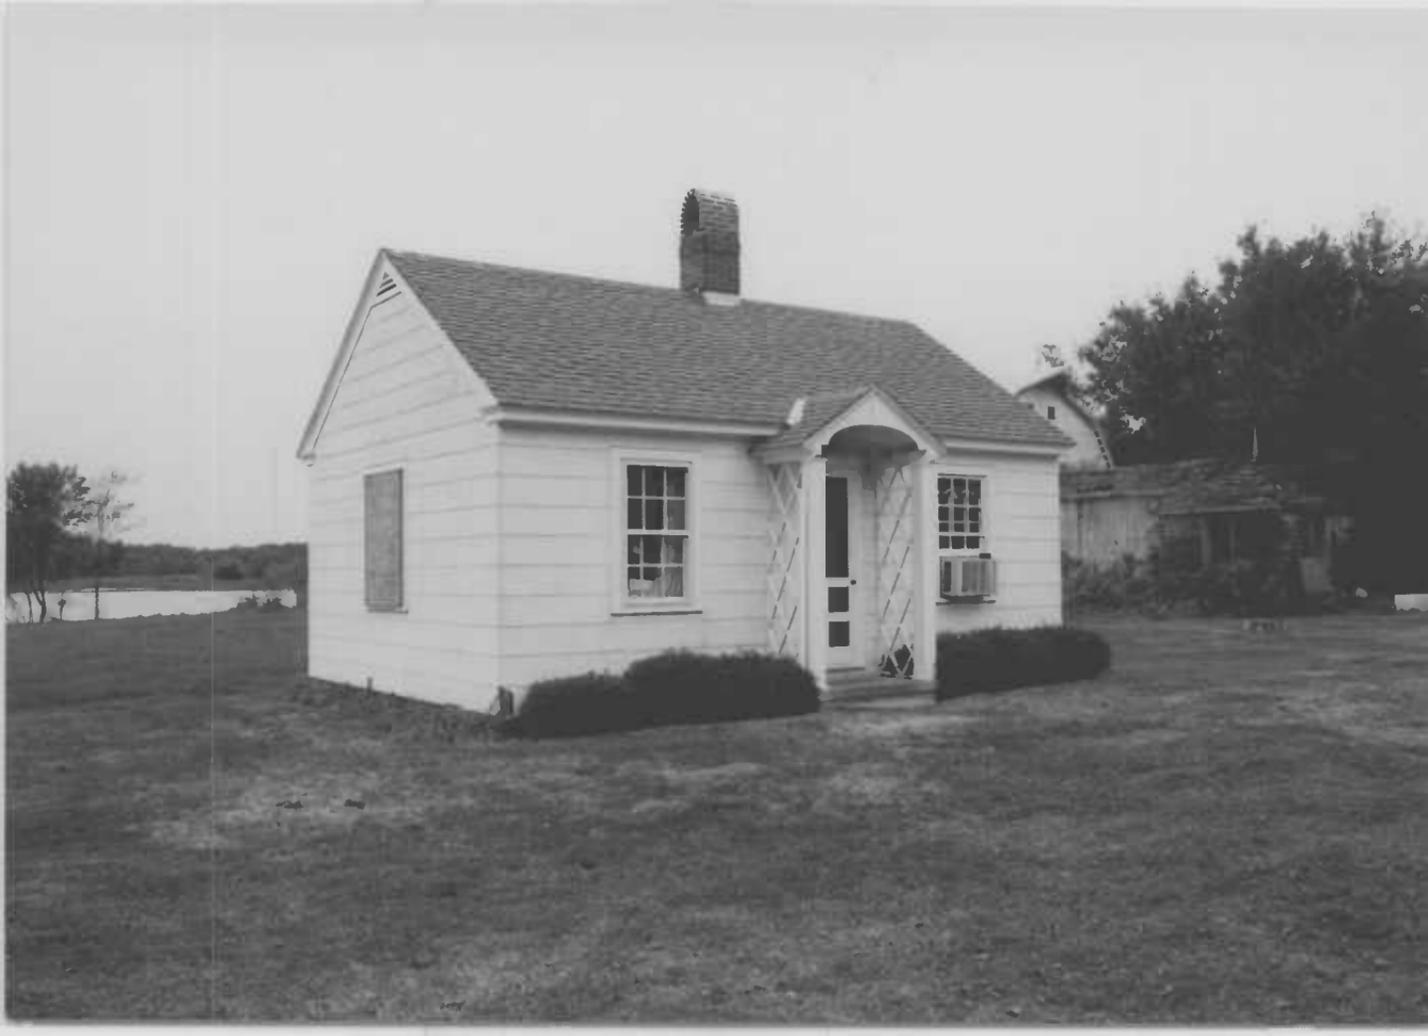
5 of 21

An in-ground swimming pool is located northwest of the main house. A small, uninhabited, guesthouse is located north of the main house. The single-story guesthouse has a lateral gabled roof with an interior chimney, offset slightly to the east. The roof is covered in asphalt shingles. The gabled central entrance on the south facade is flanked by six-over-six double hung windows. A second entrance and bulkhead are located on the east elevation. A single six pane casement window is on the north elevation. A window opening on the west elevation is boarded over. The building rests on a concrete block foundation and is clad in asbestos shingles.

Guesthouse, looking NE.

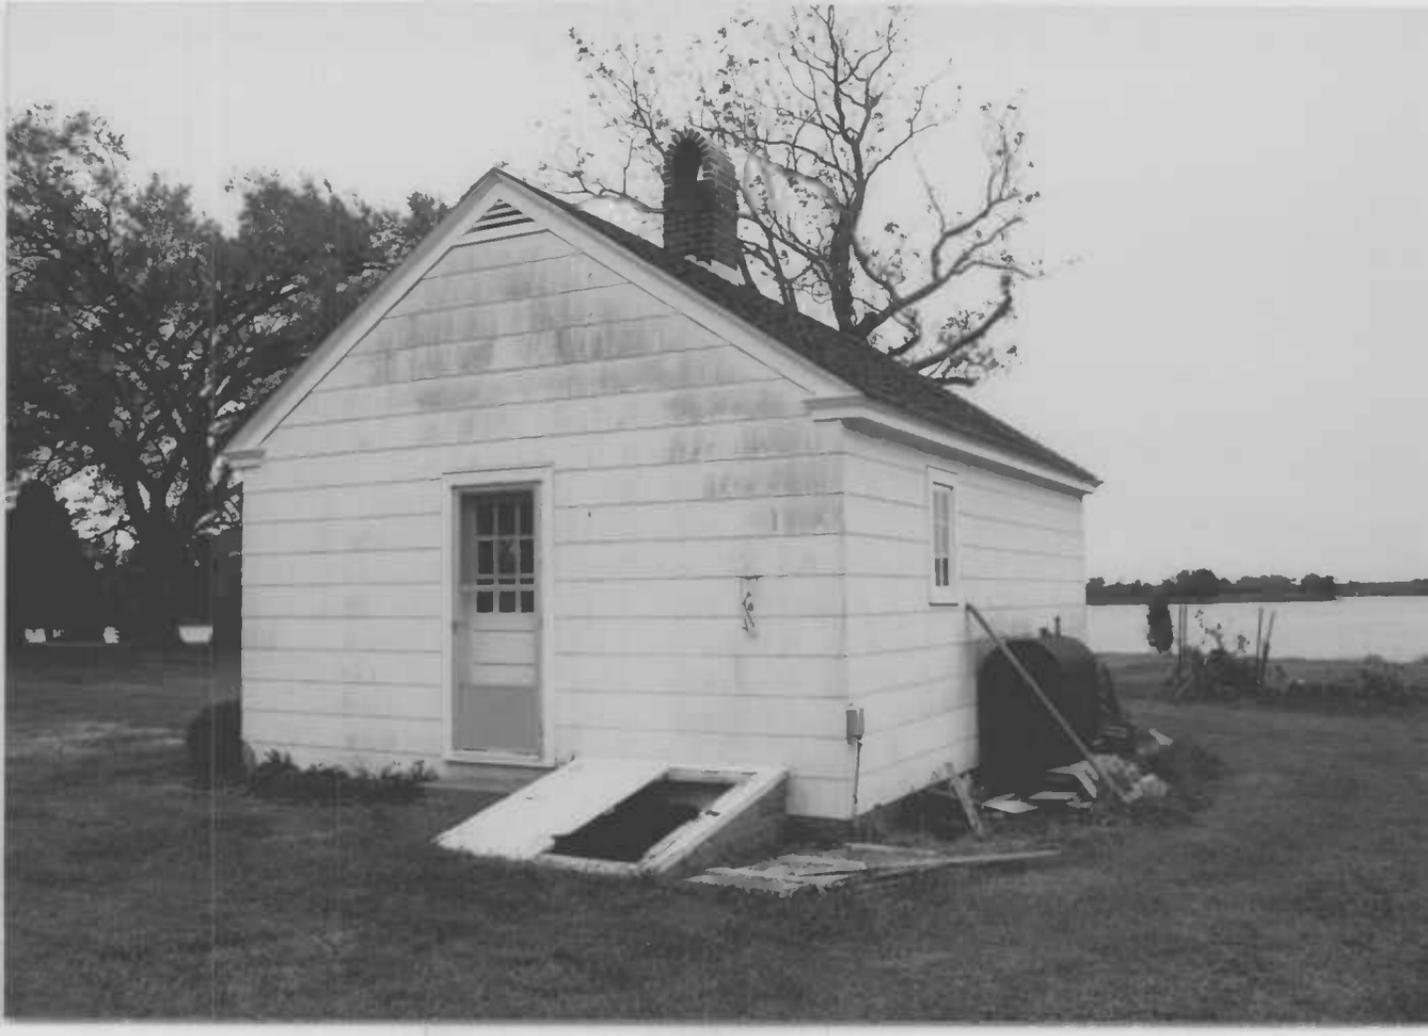
6 of 21

Guesthouse, looking SW

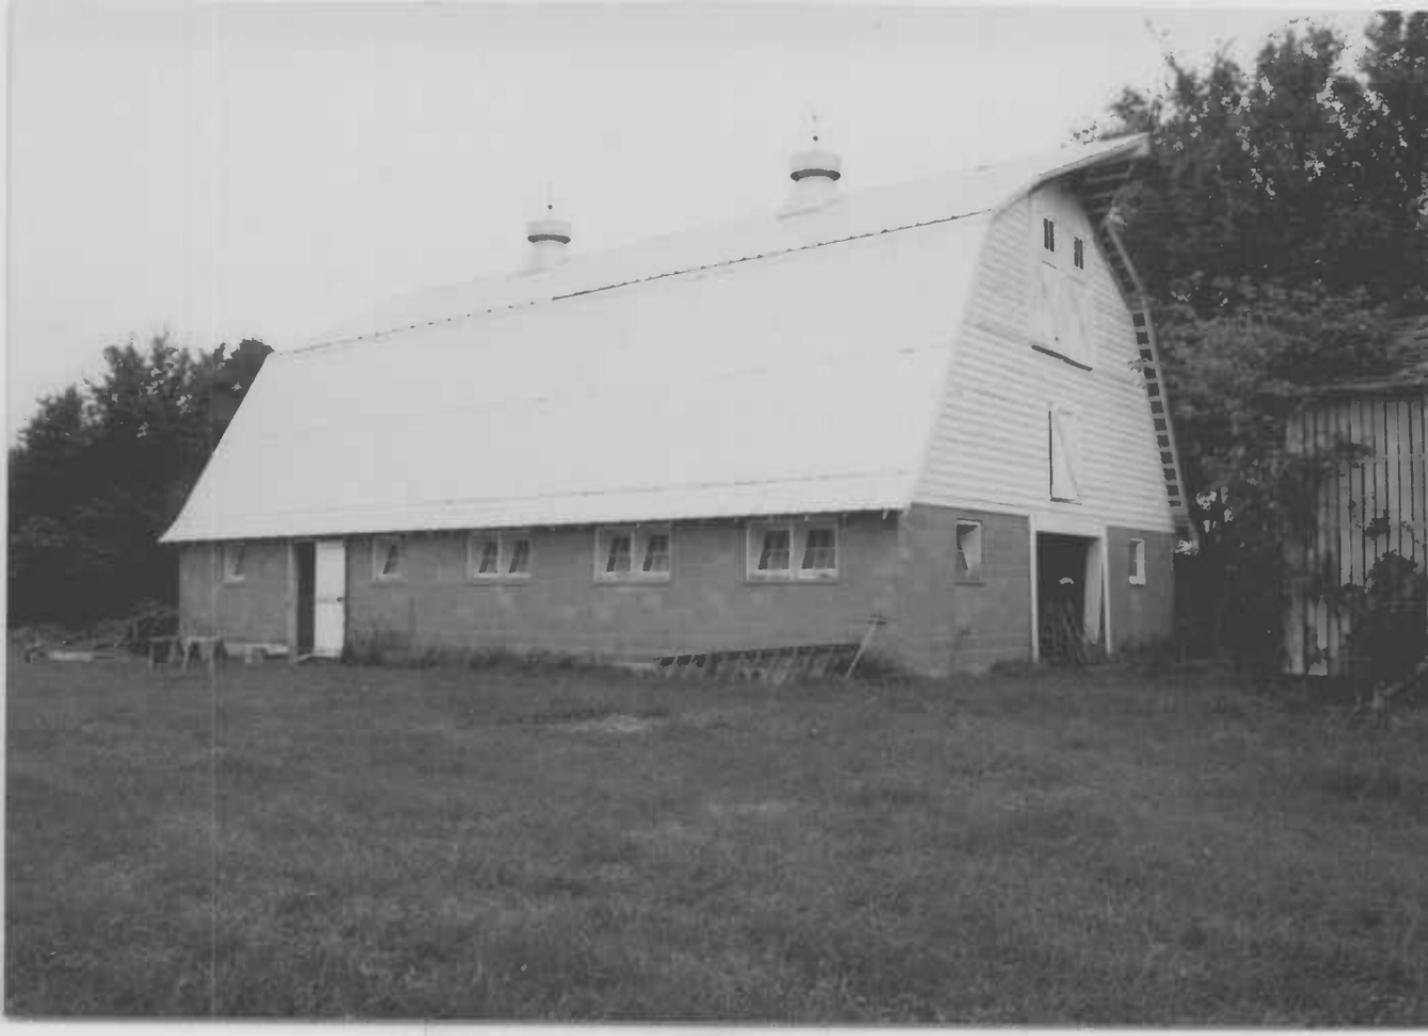
7 of 21

A large three-story gambrel roofed barn is located north of the corncrib. The foundation of the barn is poured concrete, and the first floor walls are concrete block. Hopper-like windows line the first floor of the east and west elevations. The windows are slanted inward and are hinged at the bottom. Central entrances are located on the north and south elevations. Hay doors are located over the central entrances. A third floor hay door and hood are located on the south elevation. Two metal ventilators top the corrugated metal roof. Wood clapboards cover the gambrel ends of the north and south elevations. Two unidentified collapsed outbuildings are located south and east of the barn.

Barn, looking NE

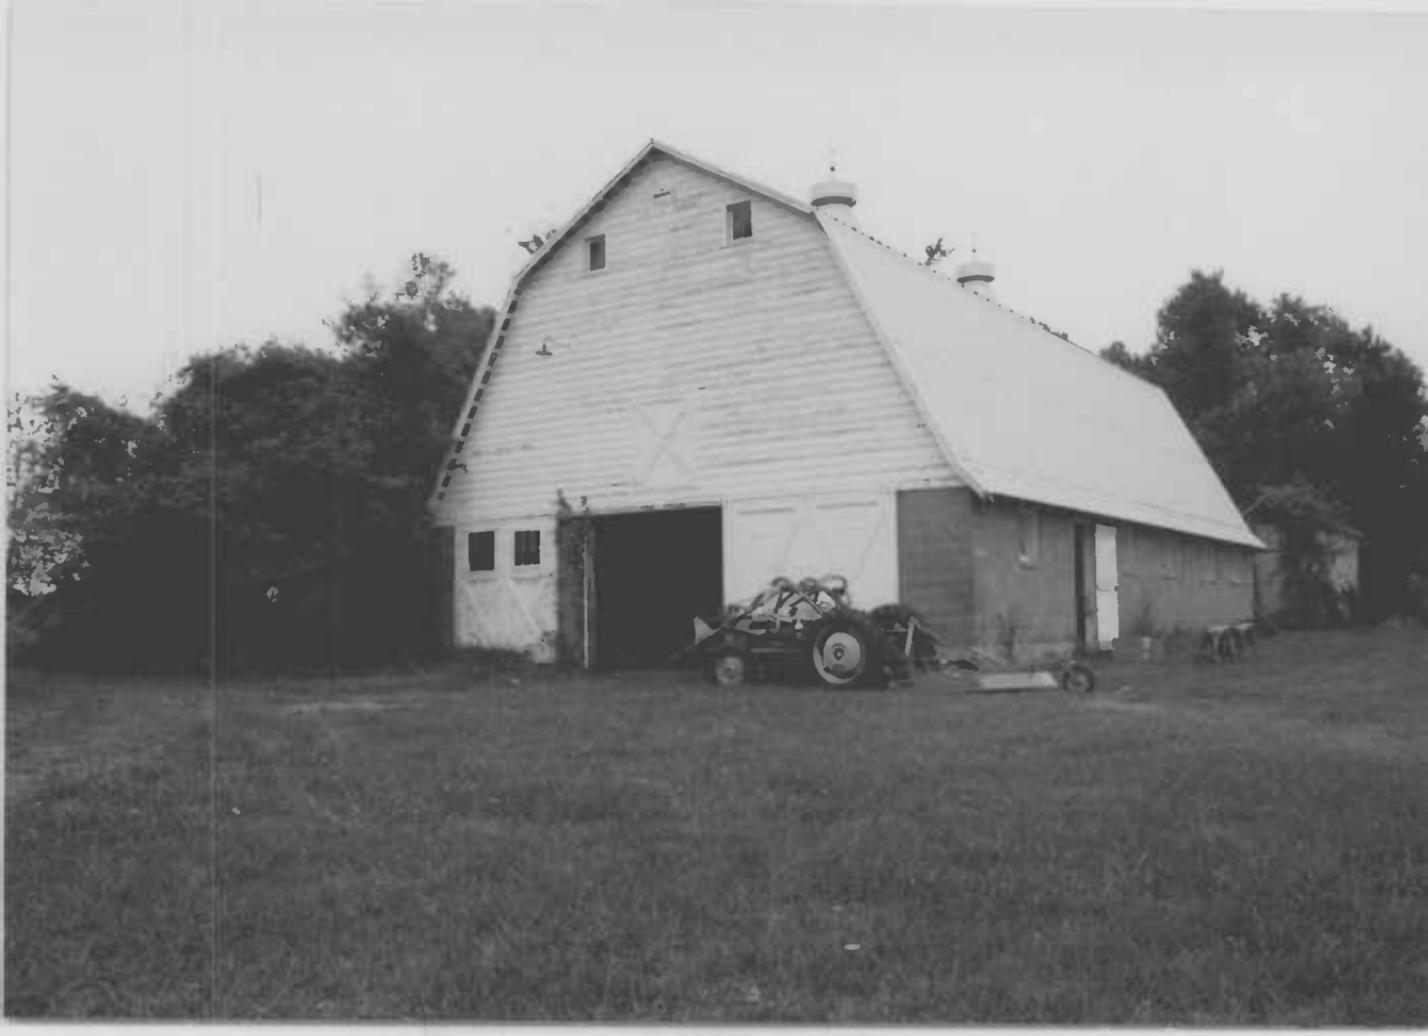
8 of 21

Barn looking SE

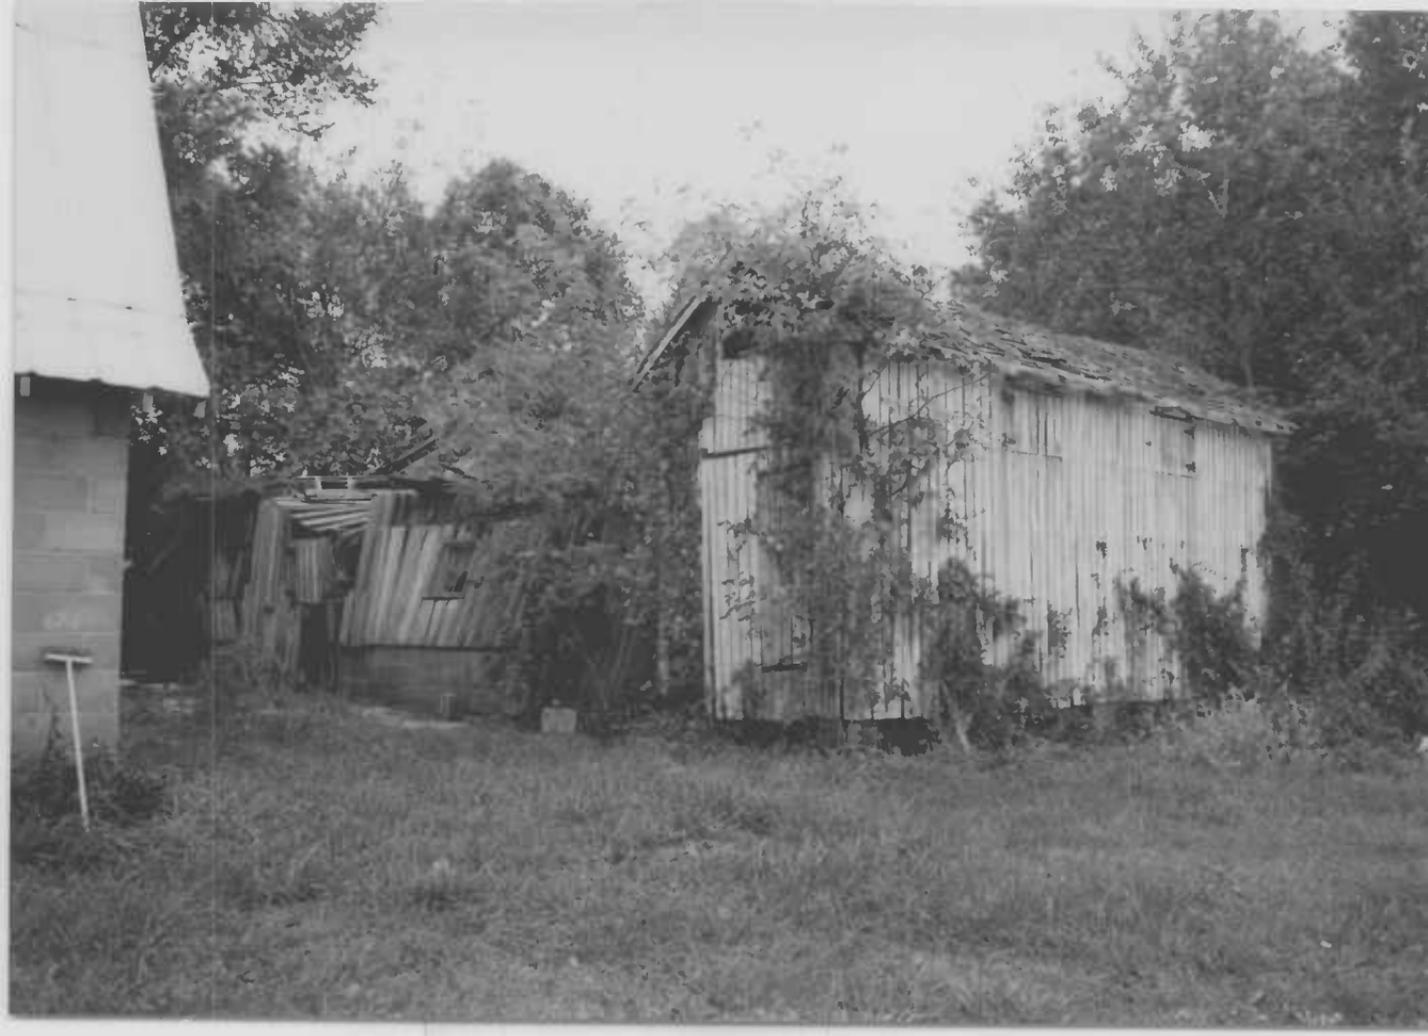
9 of 21

Northwest of the garage is a gabled corncrib. The building is roofed with wood shingles and has horizontal slats. An entry door is on the north elevation. Two small loading doors are located under the eave on the east elevation.

Corn Crib, looking SE

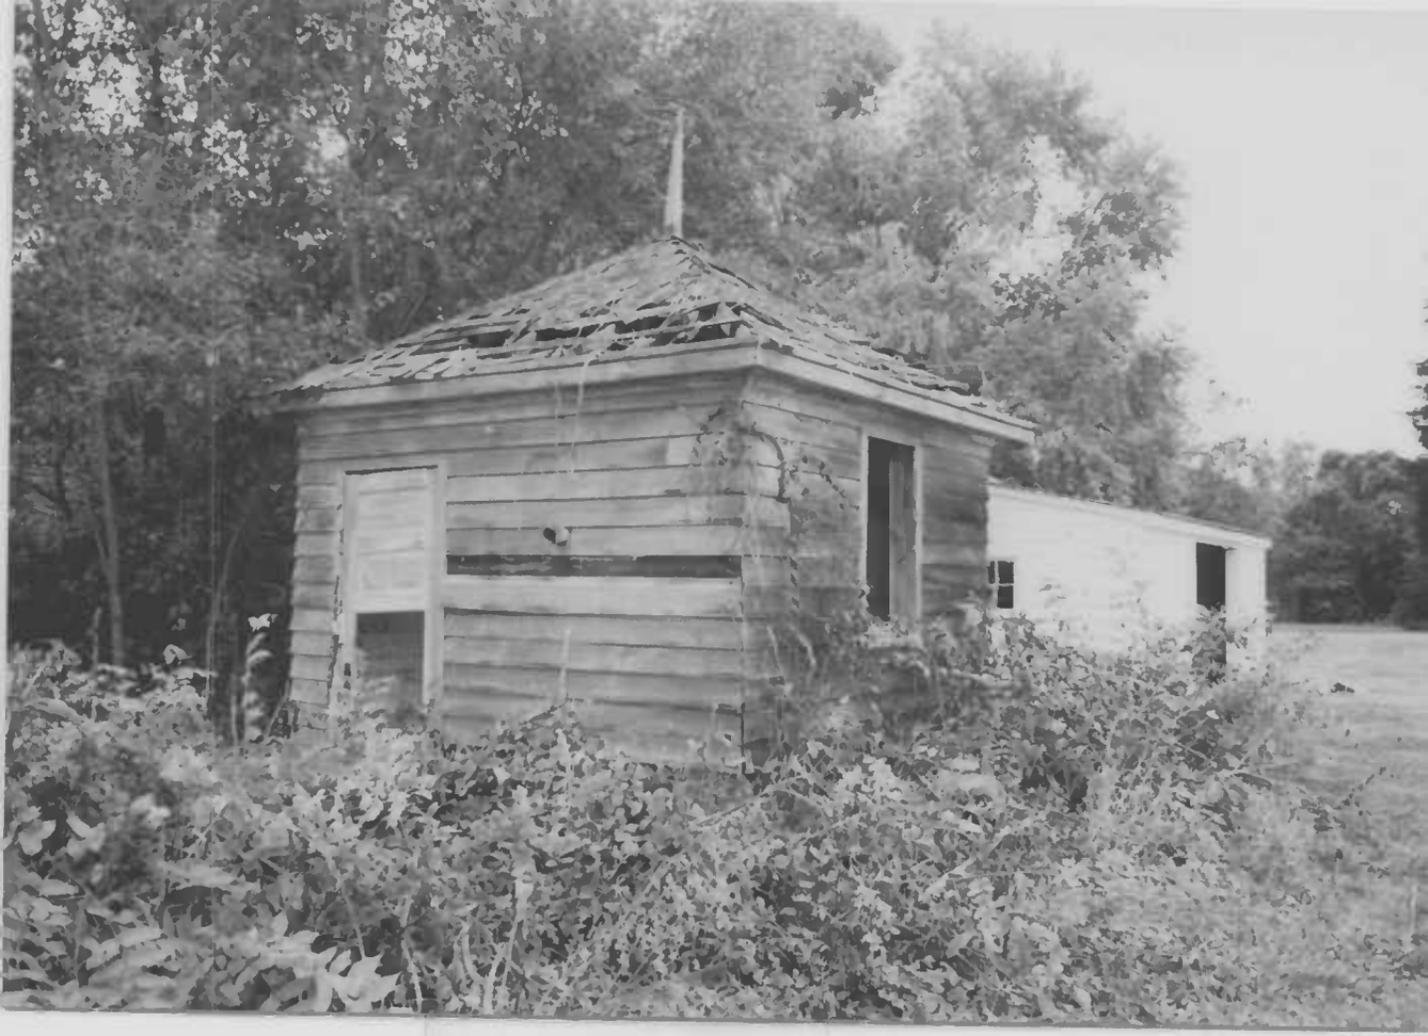
10 of 21

Outbuilding, looking SE

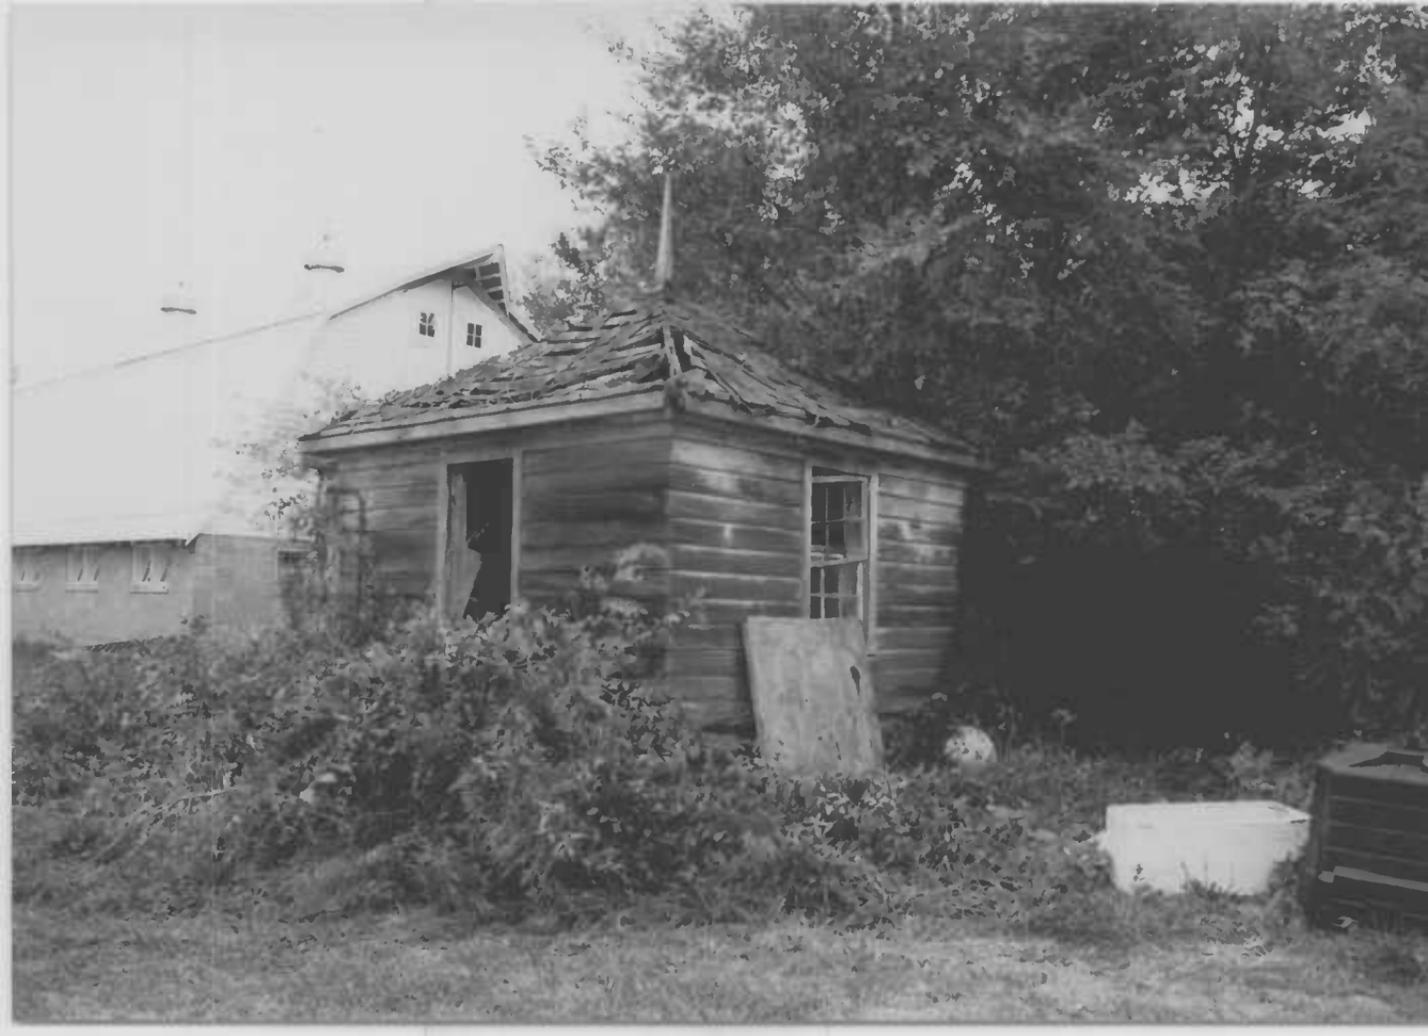
11 of 21

Outbuilding, looking NE

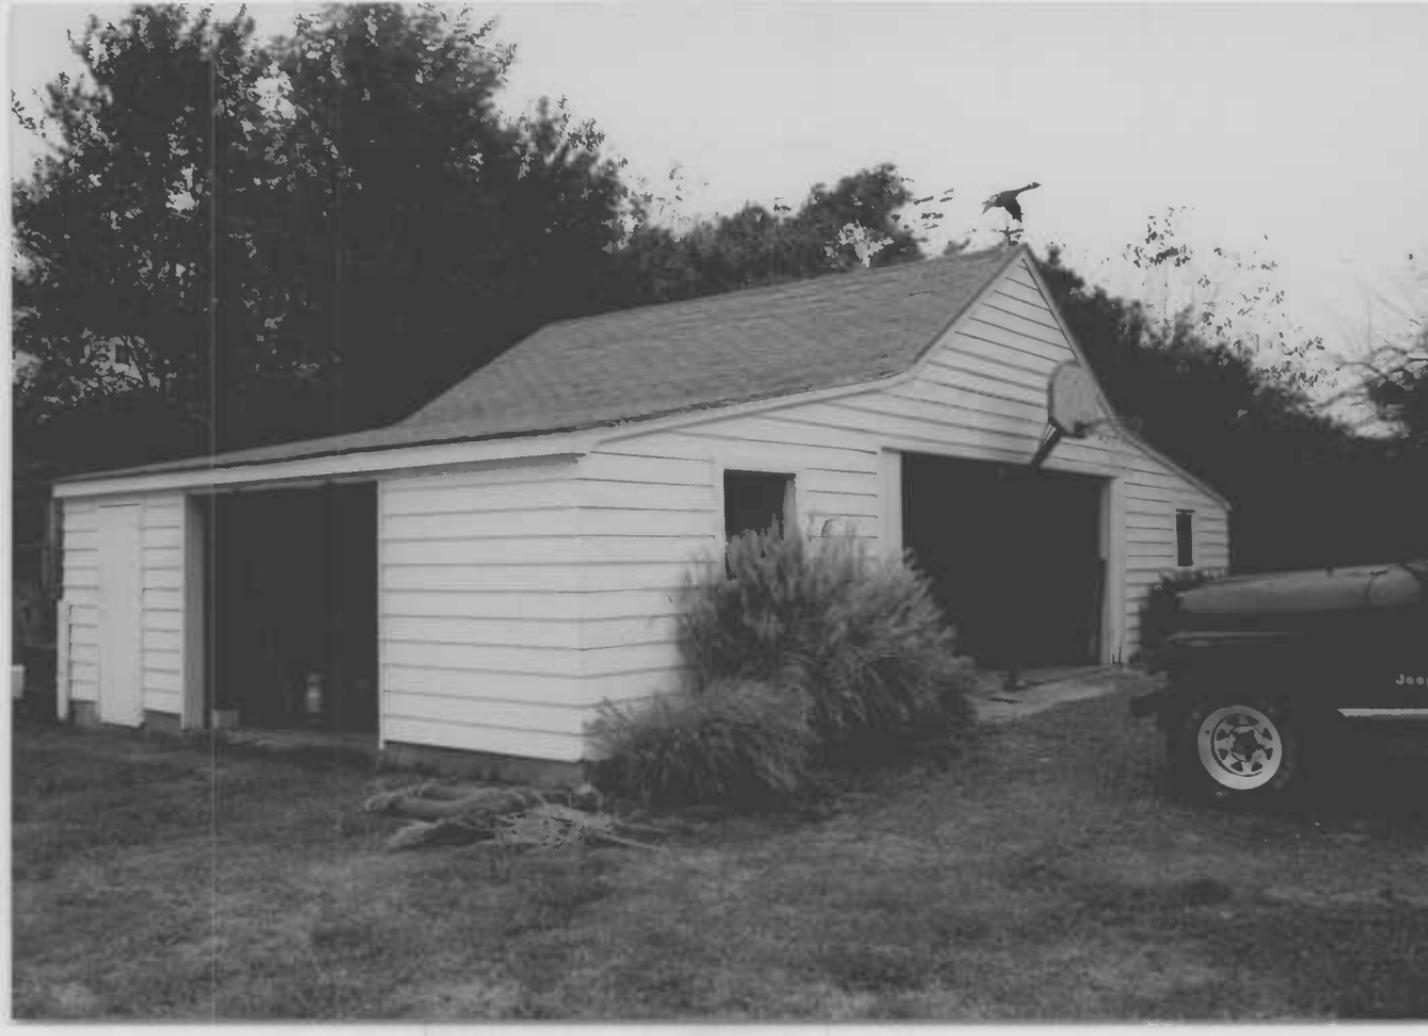
12 of 21

A three bay front-gabled garage is southeast of the pyramidal roof outbuilding. On the south elevation of the garage is a large opening for automobiles, supported by a metal post. Shed roof additions are on the east and west elevations. The building is covered in German siding and is roofed in asphalt shingles.

Garage, looking NE

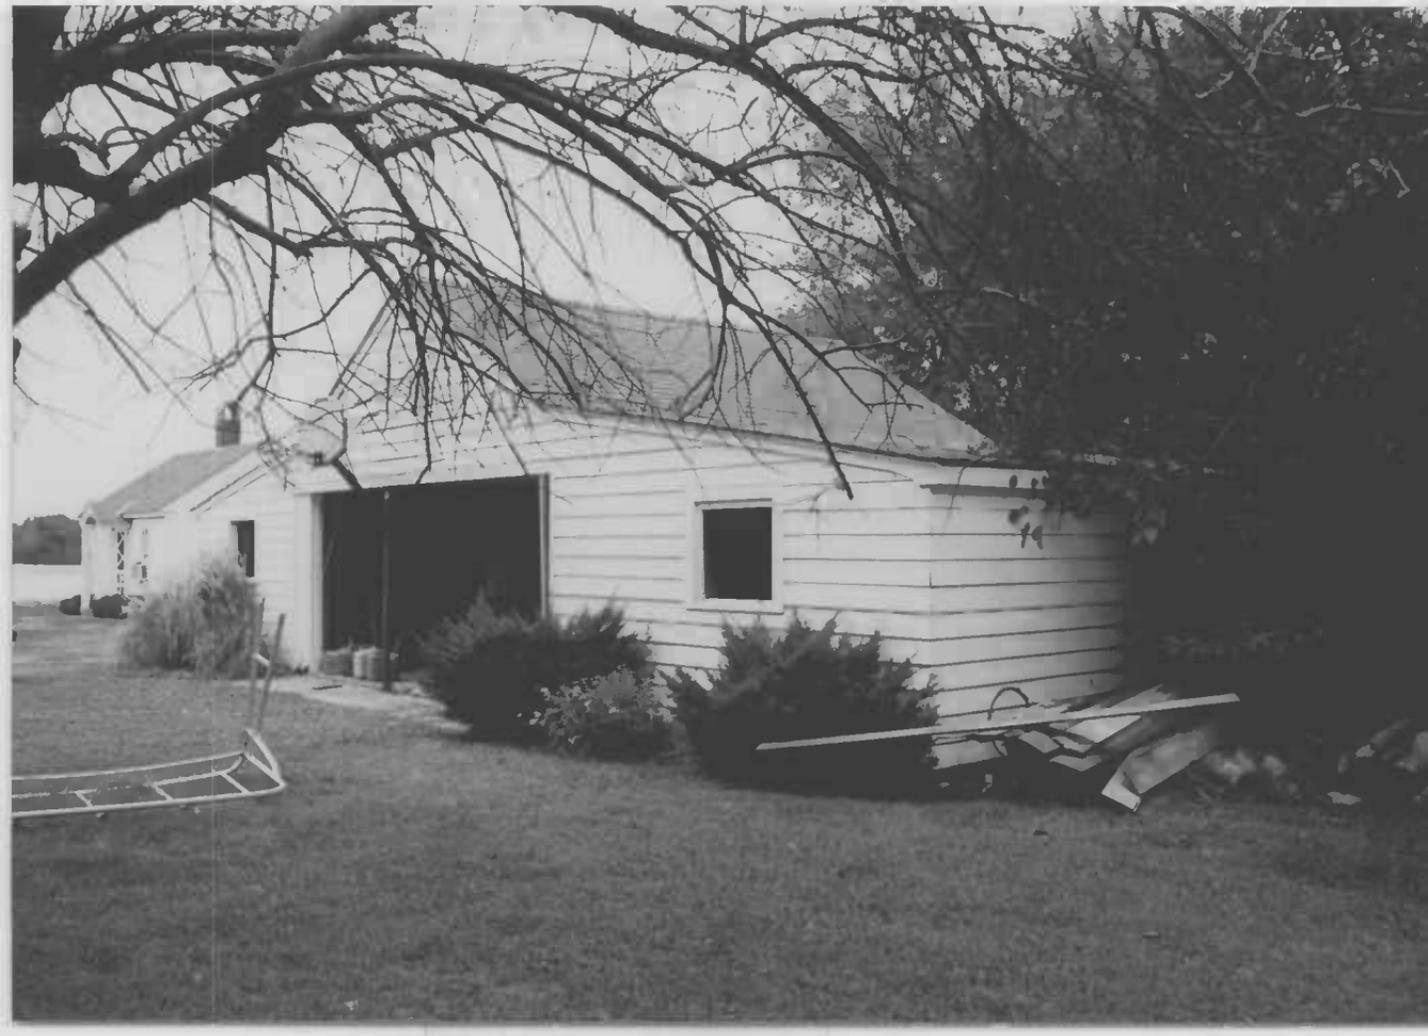
13 of 21

Garage, looking NW

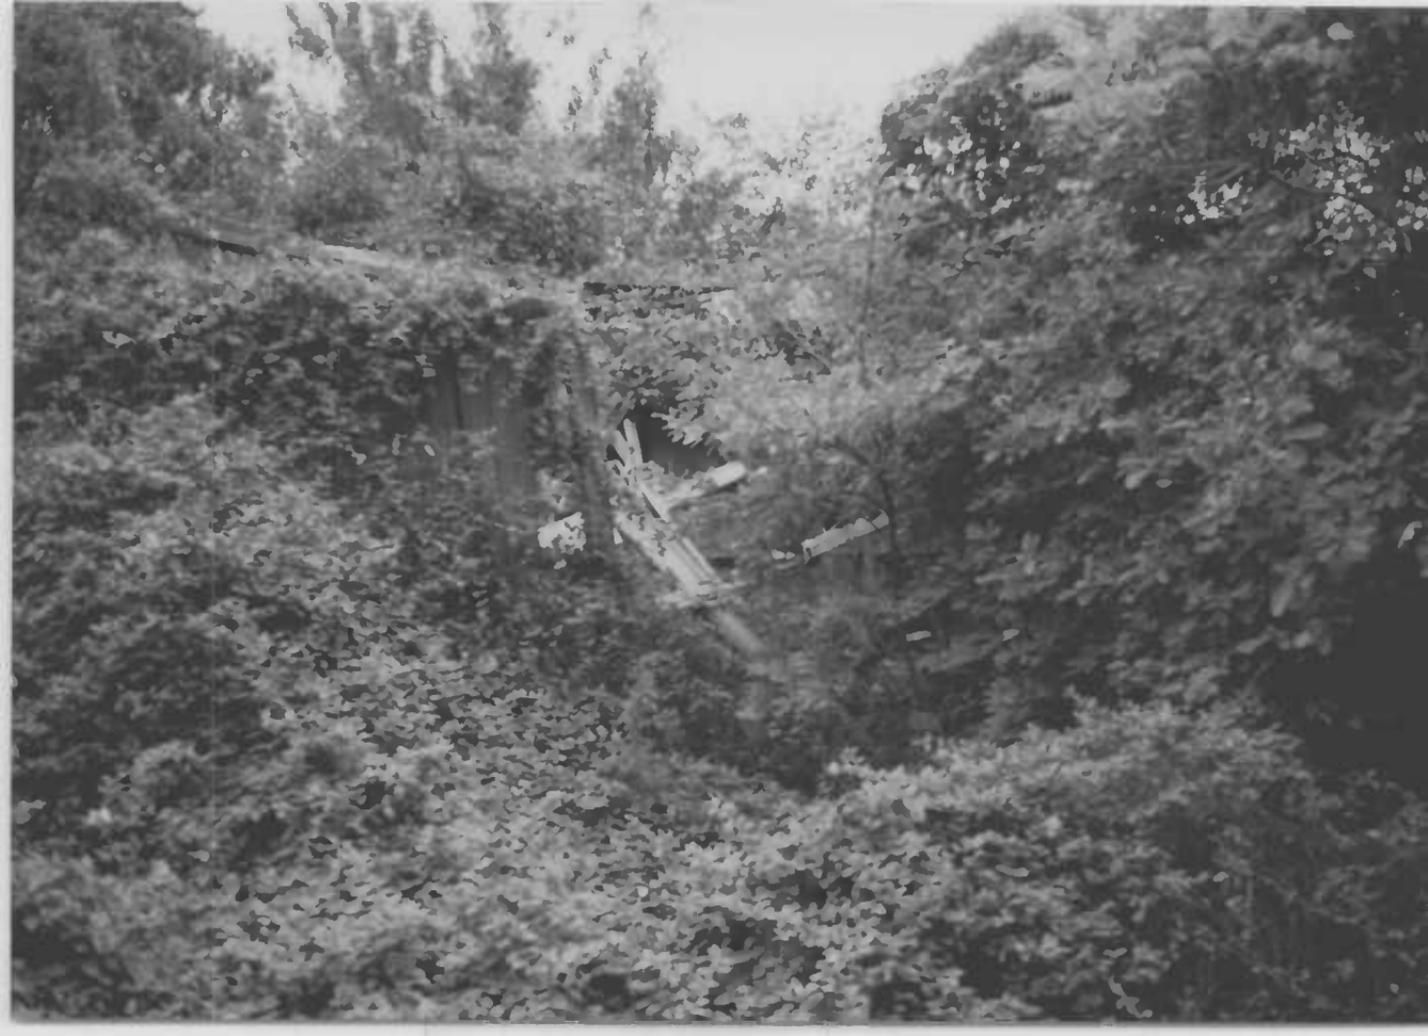
14 of 21

Collapsed outbuilding, looking south

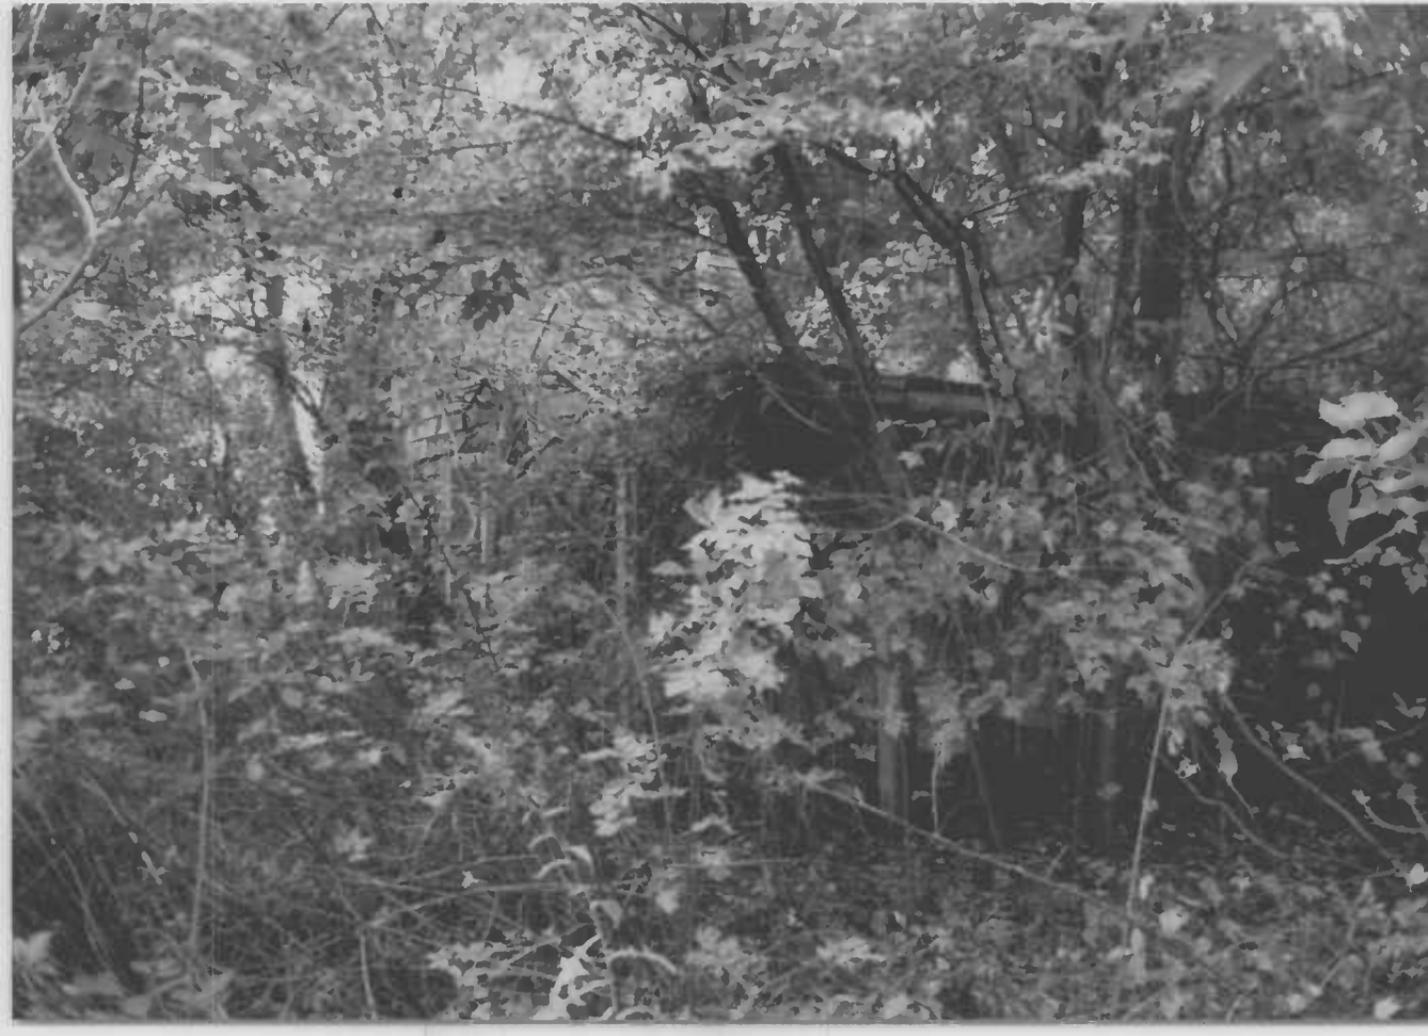
15 of 21

An abandoned house located north of the barn was reported by the owner to have been a "slave house," moved from the nearby Rolles Range Farm. Unless the building was extensively renovated, this seems unlikely. The one-and-one-half story lateral gabled, wood framed structure has a rear shed roofed addition and rests on concrete block piers with parged bricks in-between the piers. Paired gabled dormers with six-over-six double hung windows are located on the east and west roof lines. There is a central chimney on the main block, and an exterior chimney on the east elevation of the shed addition. The house is clad in wood shingles and is covered in asphalt shingles.

"slave house", looking NW
