Capsule Summary

Survey No.: T-1132

Name: Strausburg Residence

Maryland Historical Trust
State Historic Sites Inventory Form

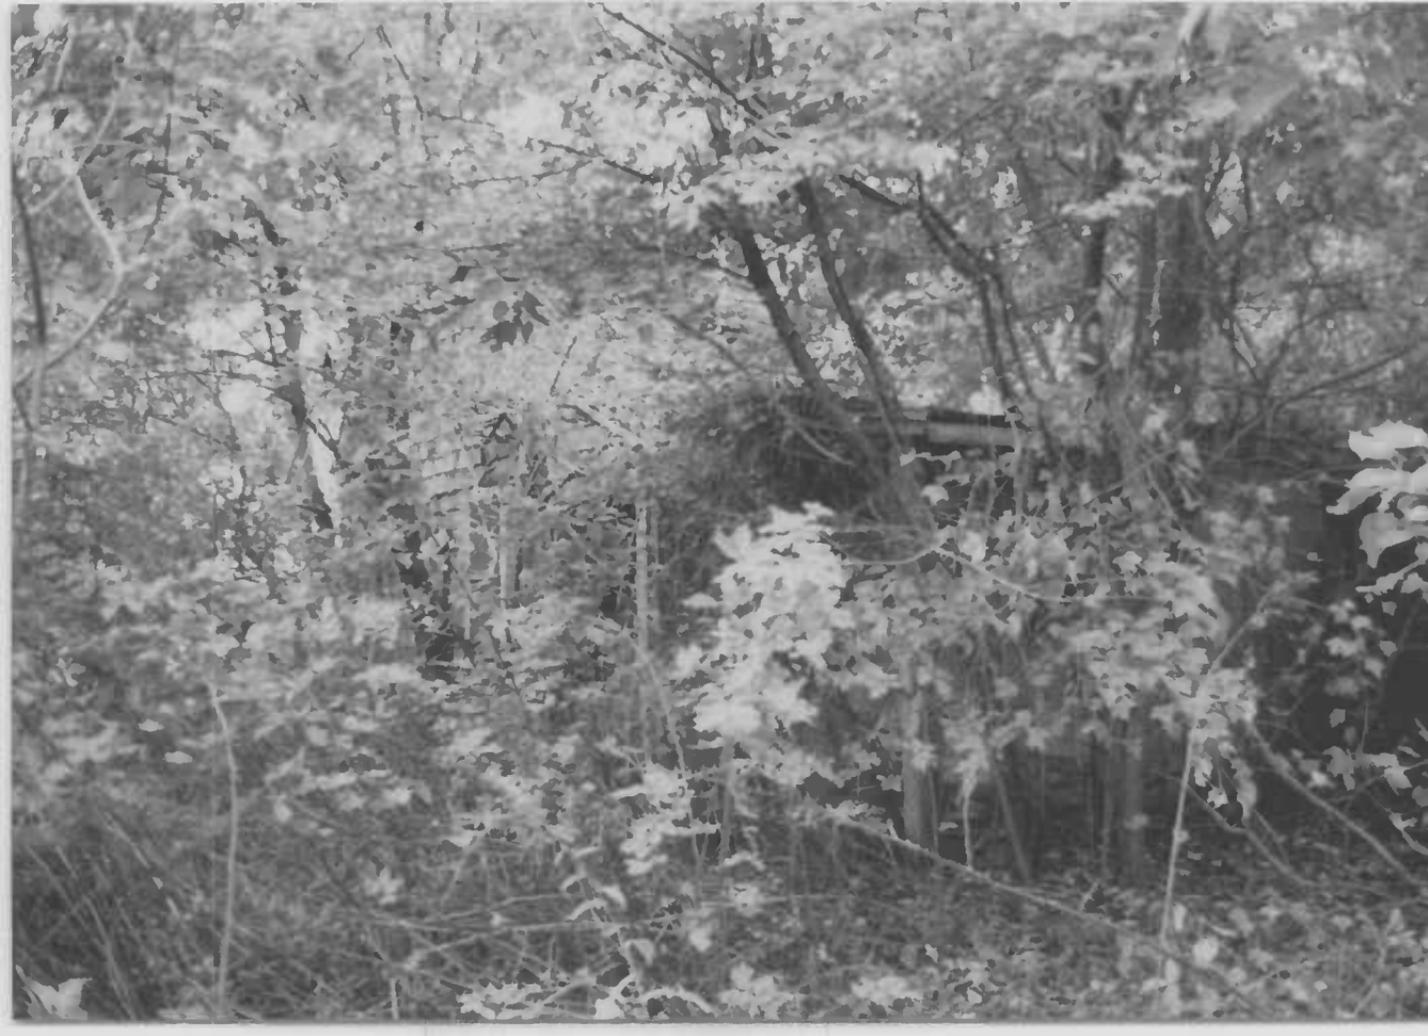
16 of 21

An abandoned house located north of the barn was reported by the owner to have been a "slave house," moved from the nearby Rolles Range Farm. Unless the building was extensively renovated, this seems unlikely. The one-and-one-half story lateral gabled, wood framed structure has a rear shed roofed addition and rests on concrete block piers with parged bricks in-between the piers. Paired gabled dormers with six-over-six double hung windows are located on the east and west roof lines. There is a central chimney on the main block, and an exterior chimney on the east elevation of the shed addition. The house is clad in wood shingles and is covered in asphalt shingles.

"slave house" looking NW

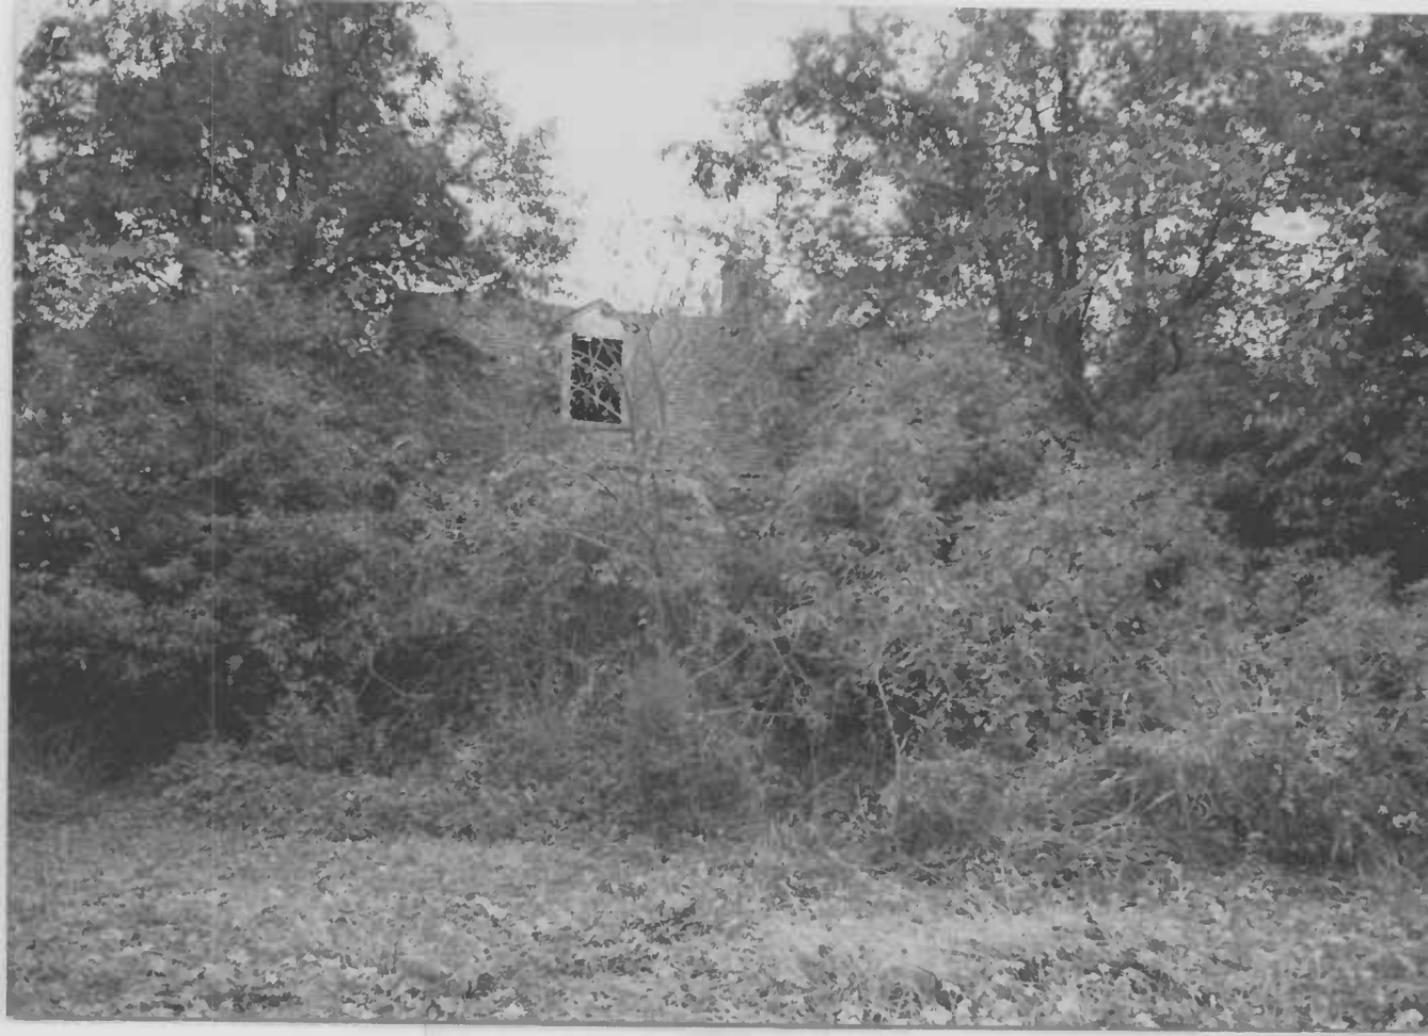
17 of 21

"slow house", looking east

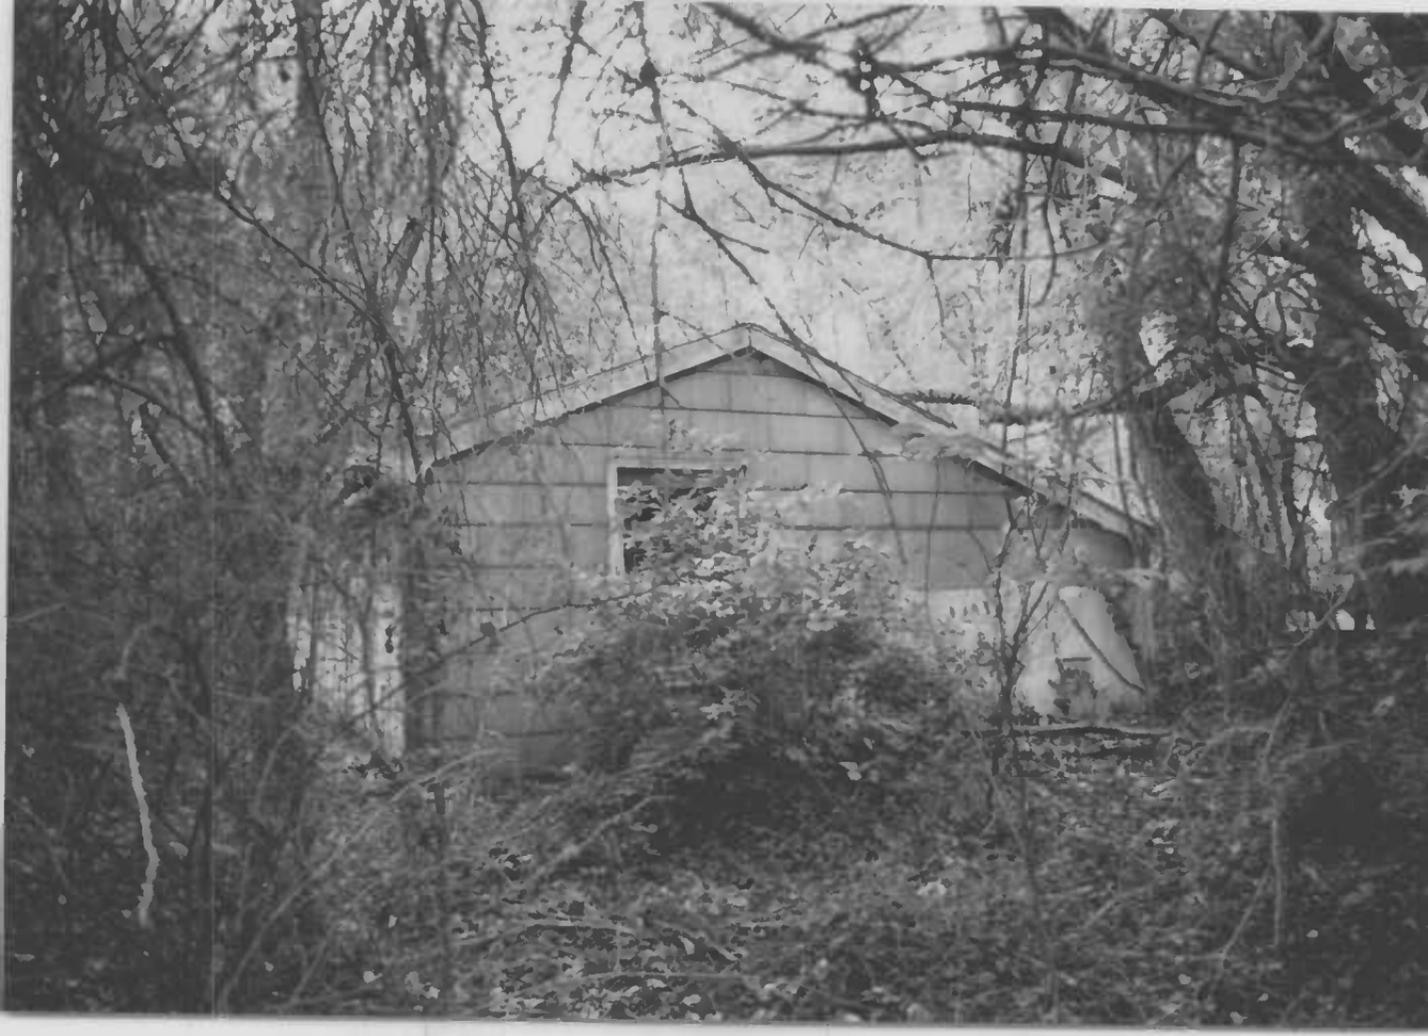
18 of 21

Outbuilding, looking west

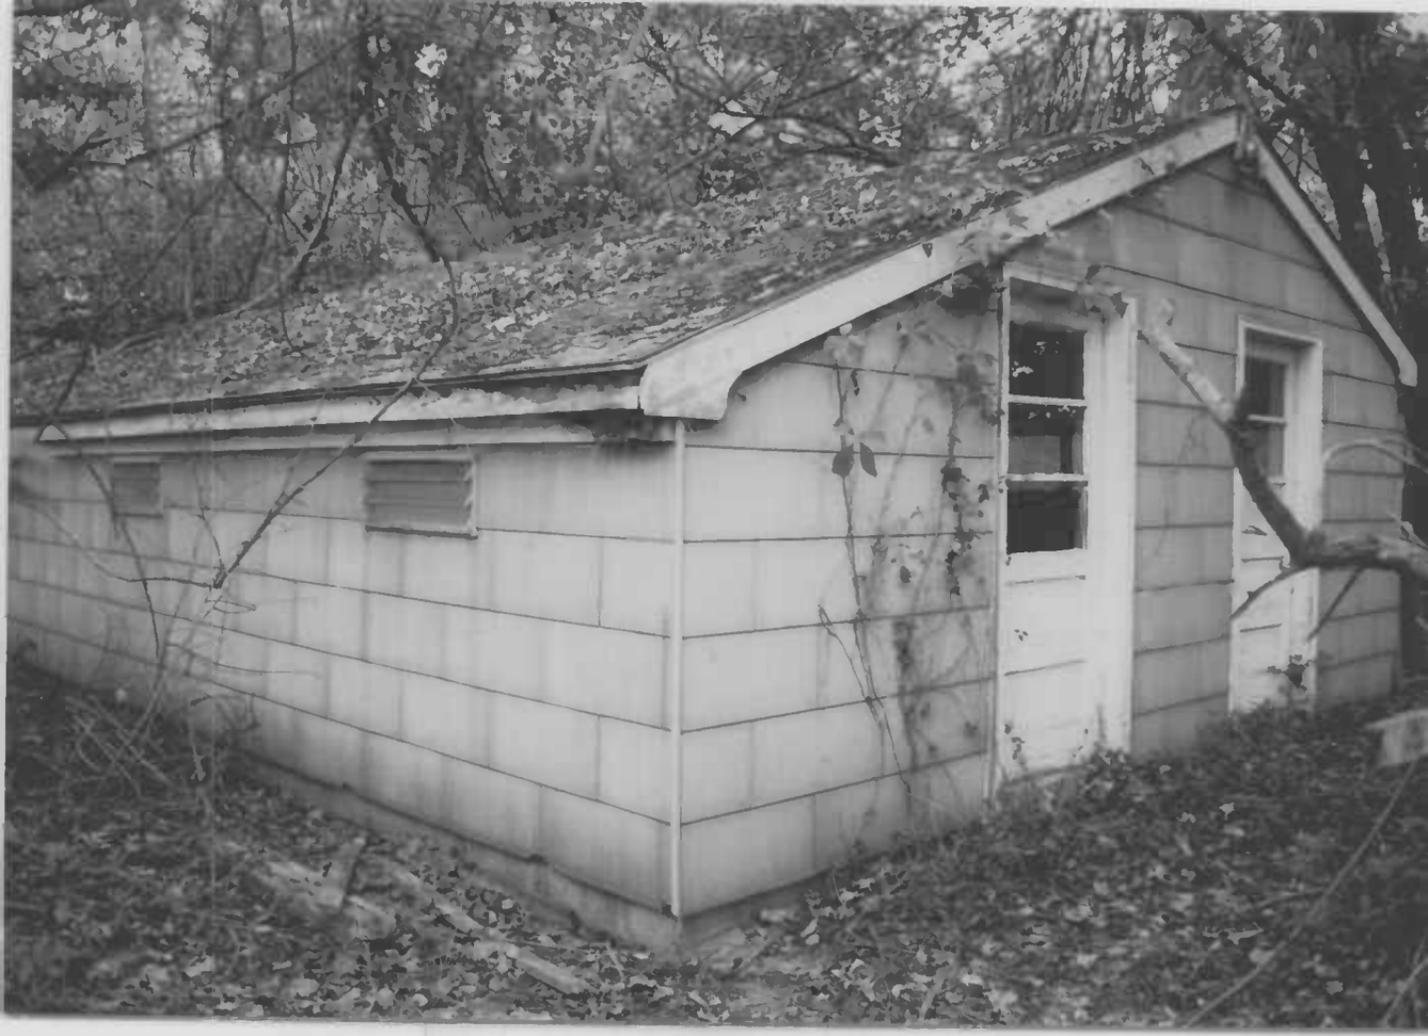
19 of 21

Outbuilding, looking SE

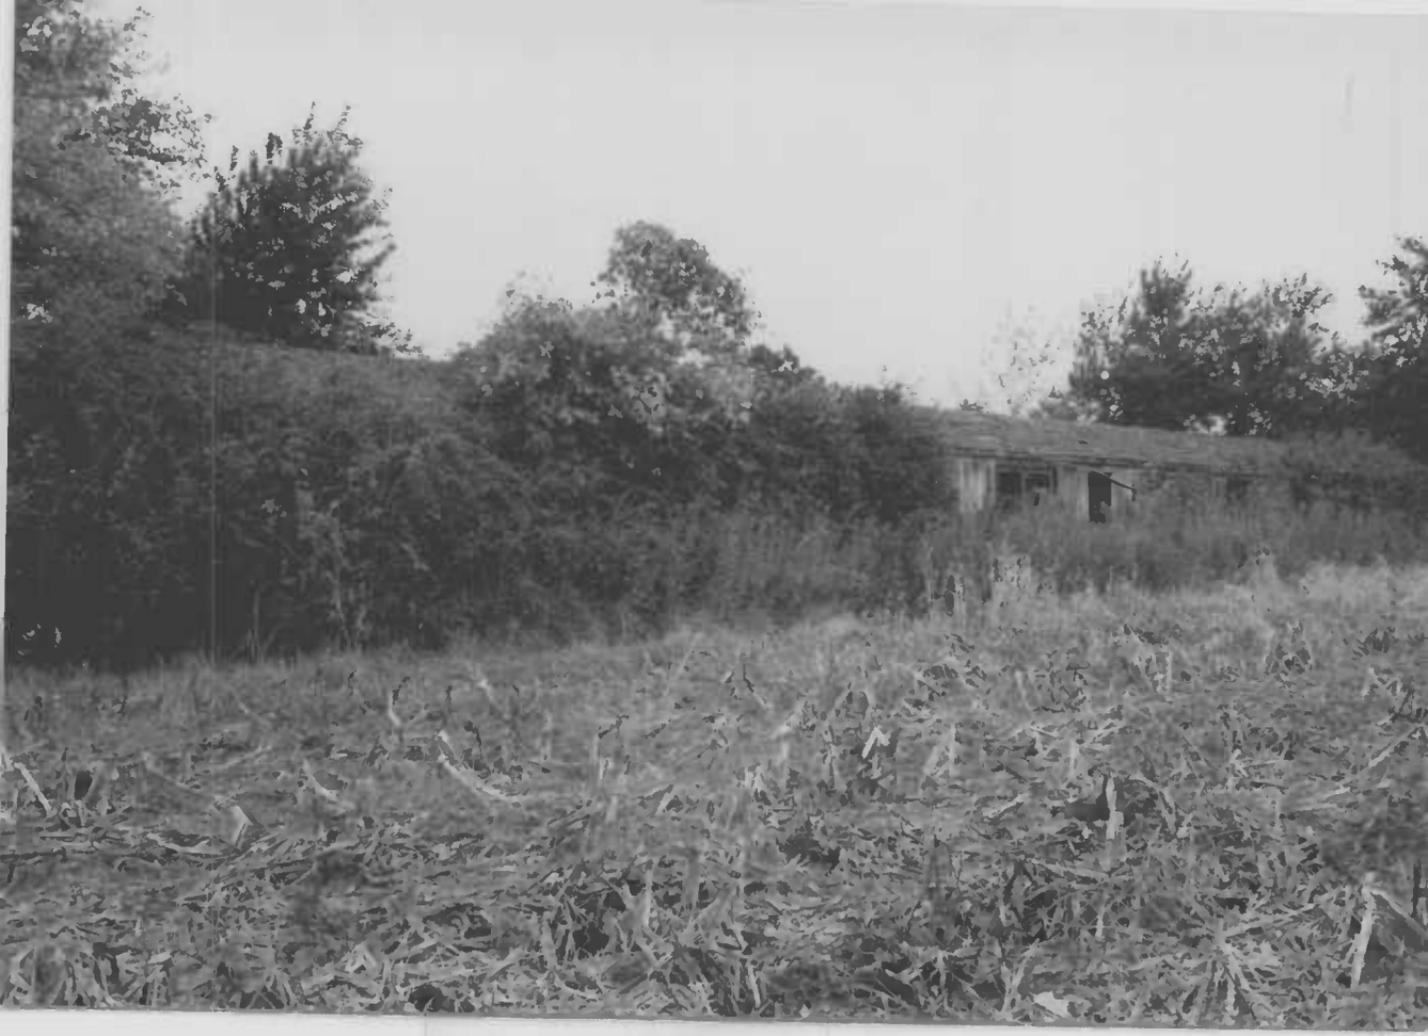
20 of 21

Processing² outbuilding, looking NE

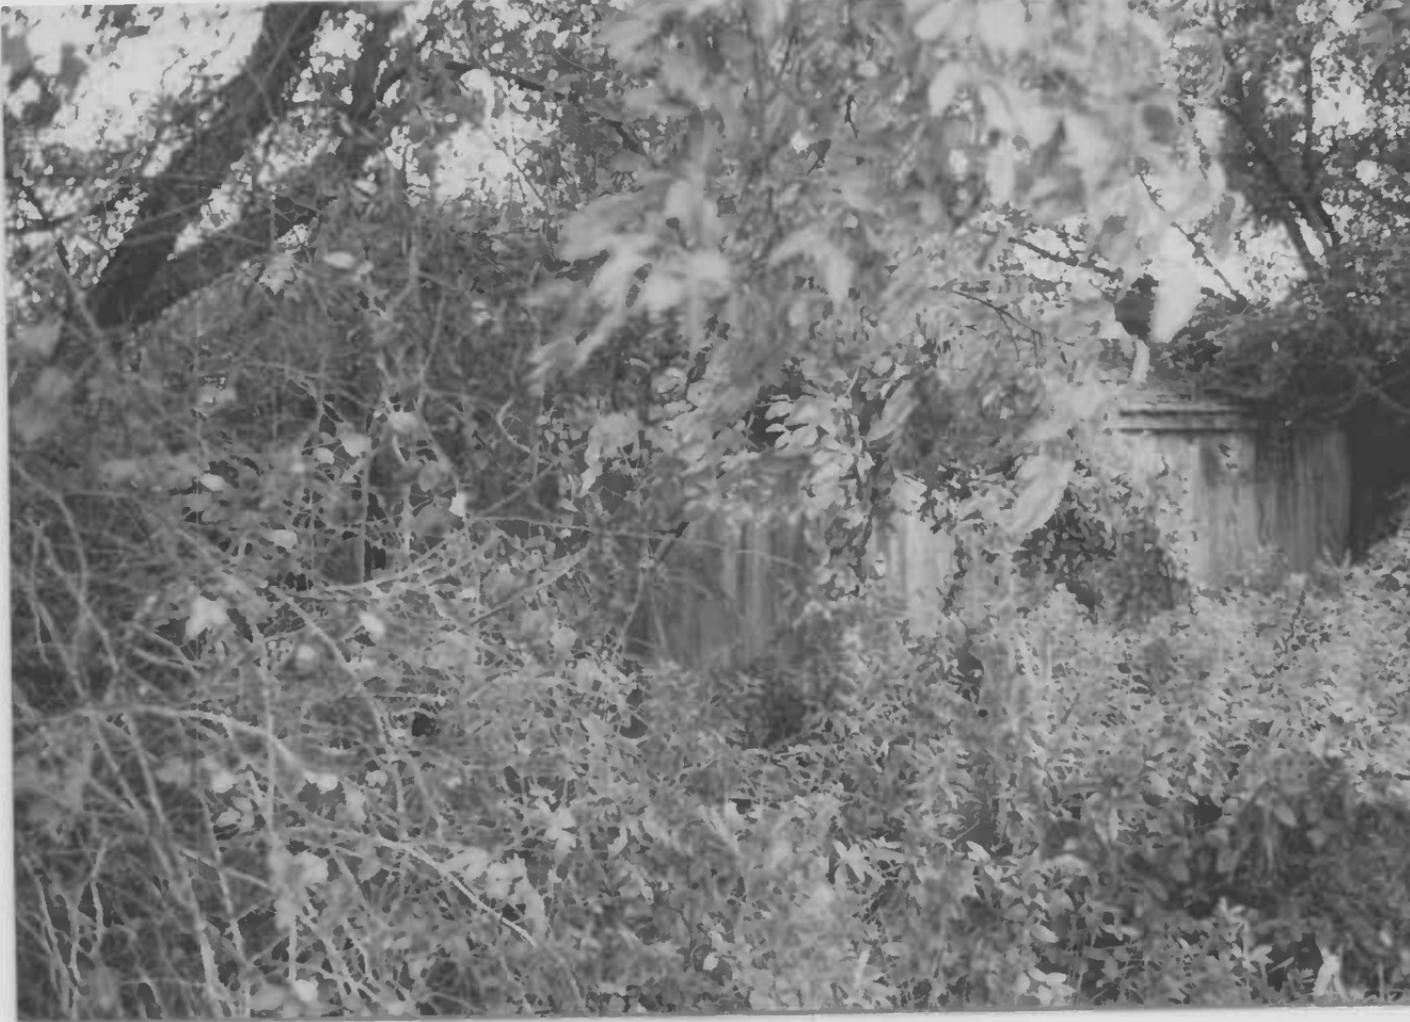
21 of 21

Processing? outbuilding, looking w
