CAPSULE SUMMARY
Paca-Carroll House (AA-677)
St. John's College, Annapolis

Maryland Inventory of Historic Properties Form

Inventory No. AA-677

Paca-Carroll House, St. John's College, Annapolis
Continuation Sheet

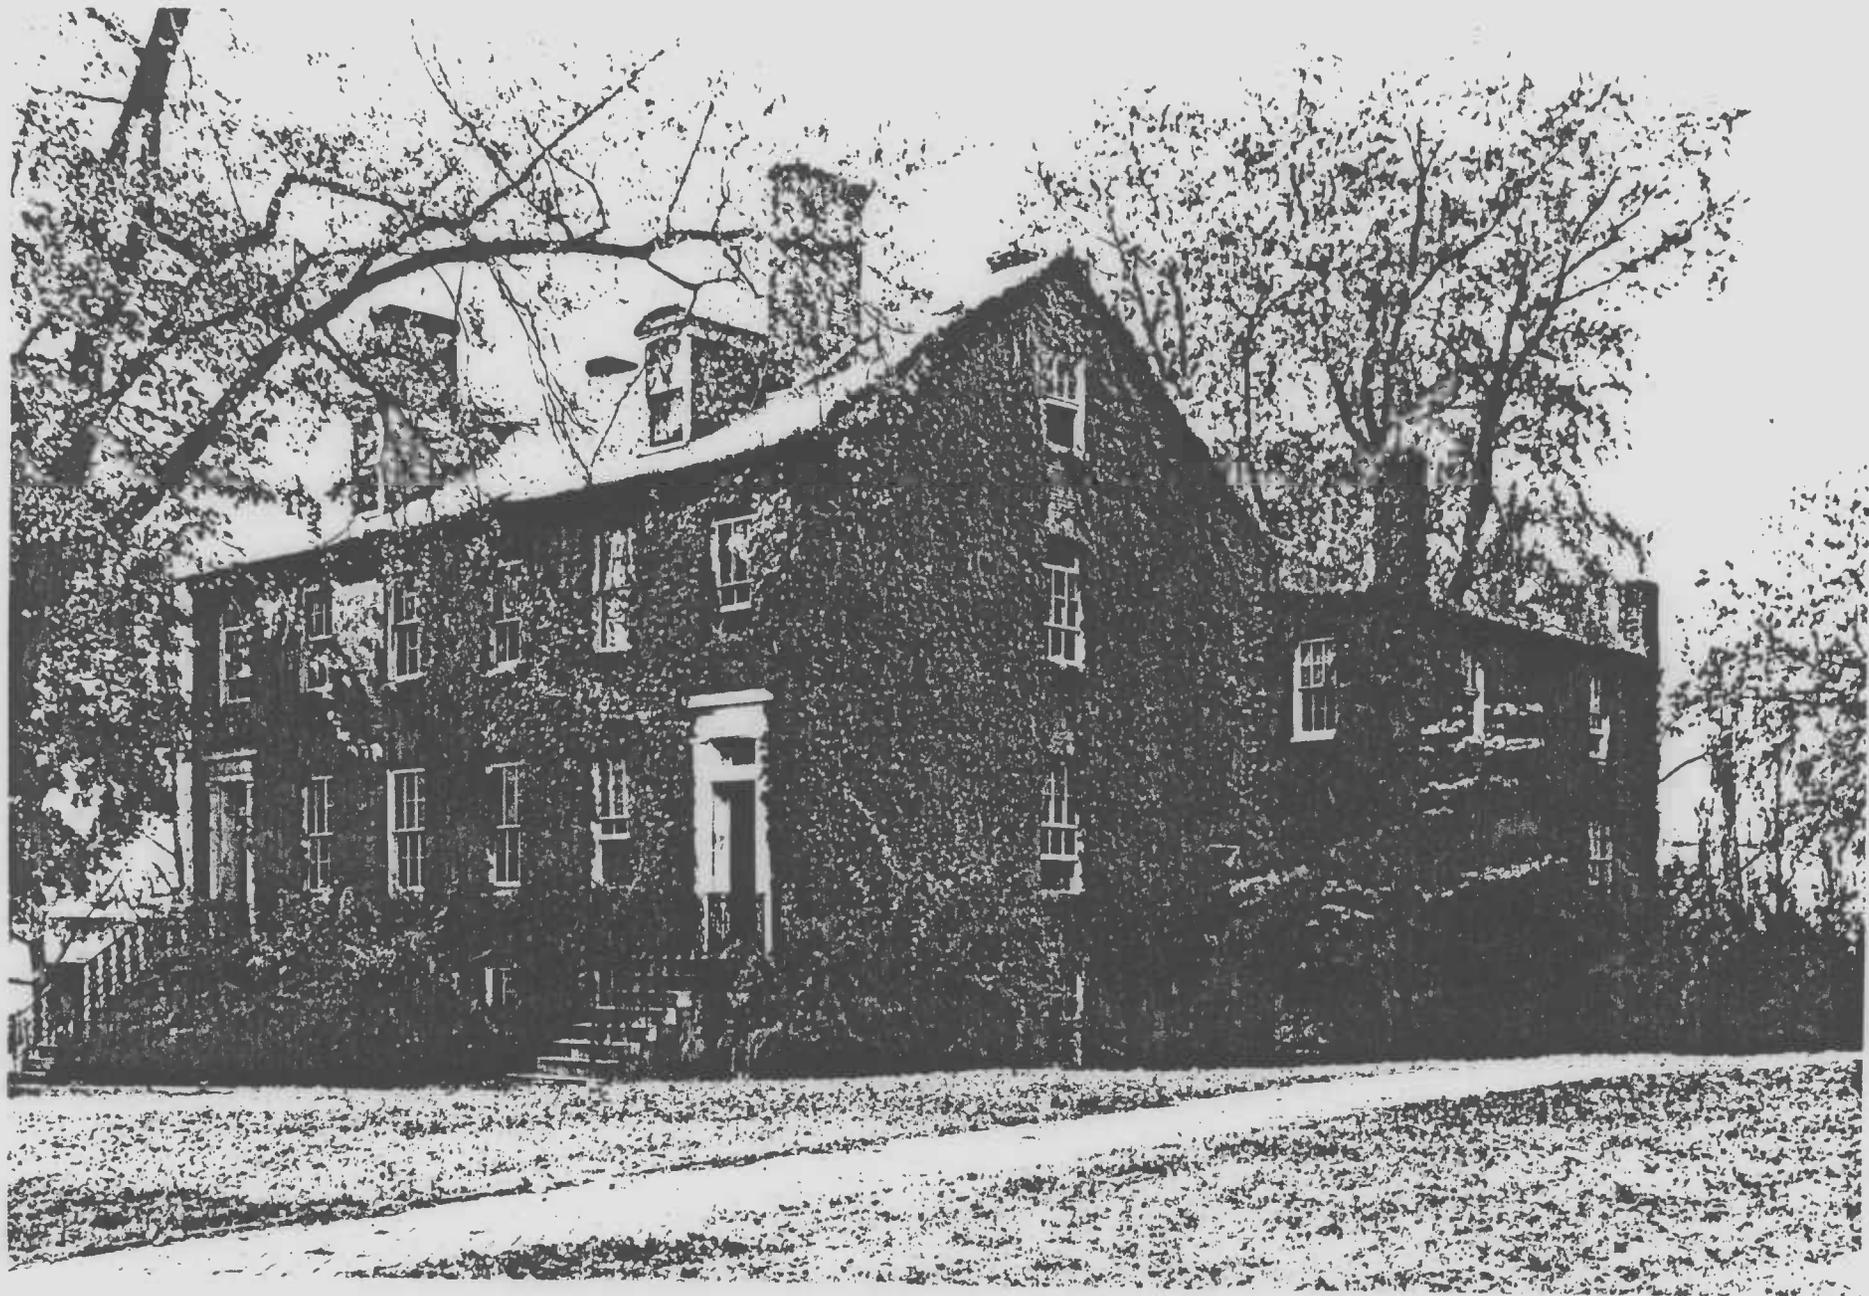
2. Paca-Carroll House from the east, 1936 (Pickering photograph from the Historic American Buildings Survey). Note the original cast and wrought iron railings on the two staircases, now missing. By 1936 the window shutters had all been removed. The rear wing is two full storeys in height but vines obscure any evidence of its being raised to that height.

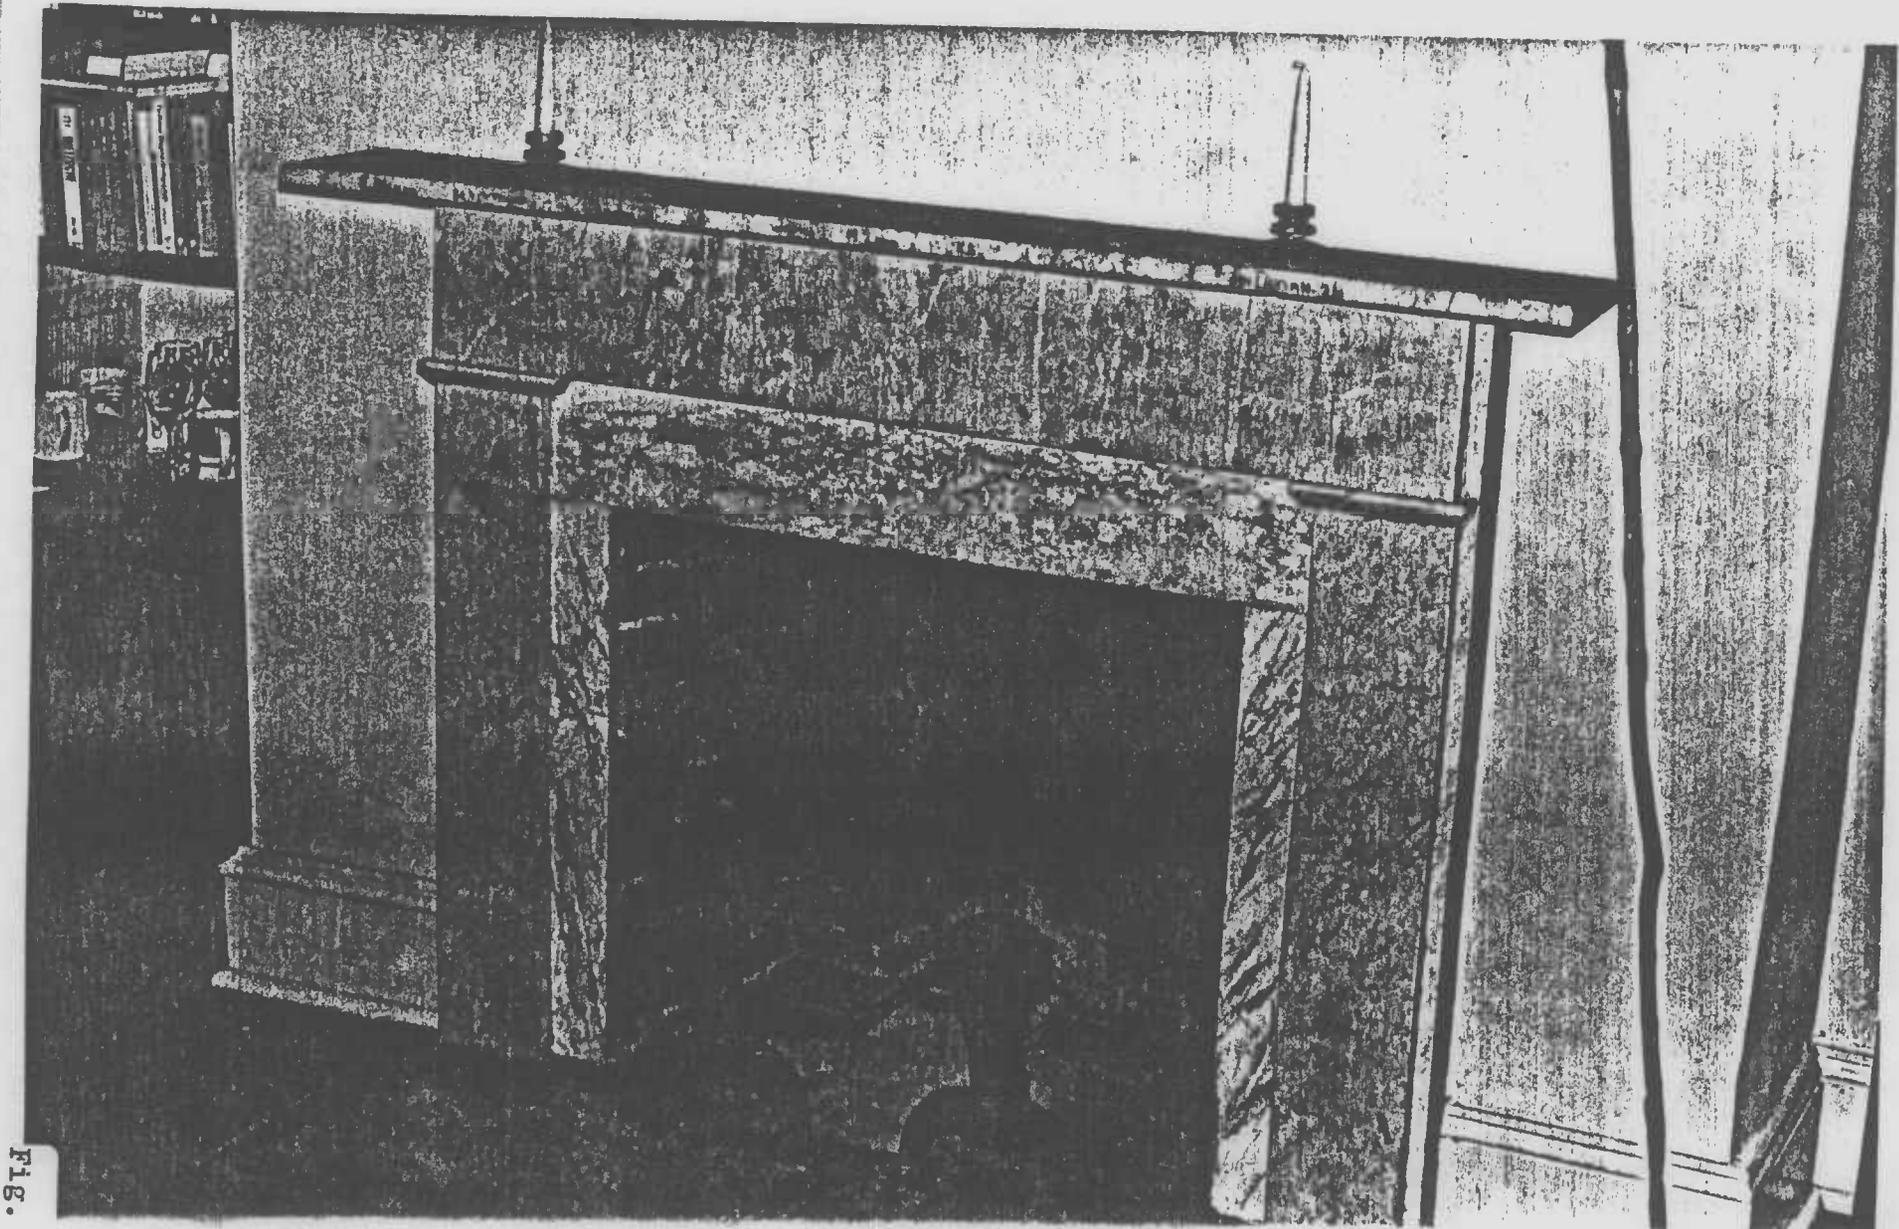
FIG.

7. South room, southwesterly house (Carroll), second storey: mantel. This marble mantel is typical of the second storey and the student who occupied this room recently has cleaned it of many layers of paint. The baseboard cap on the left is original but the one on the right is replacement material.

**South rm., southwesterly house,
second storey, mantel
April 1979
Photo by J. T. Wollon, Jr.**
