1. STATE Maryland
 COUNTY Baltimore
 TOWN Lutherville VICINITY
 STREET NO. 300 W. Seminary Ave.

HISTORIC AMERICAN BUILDINGS SURVEY
INVENTORY

2. NAME College Manor

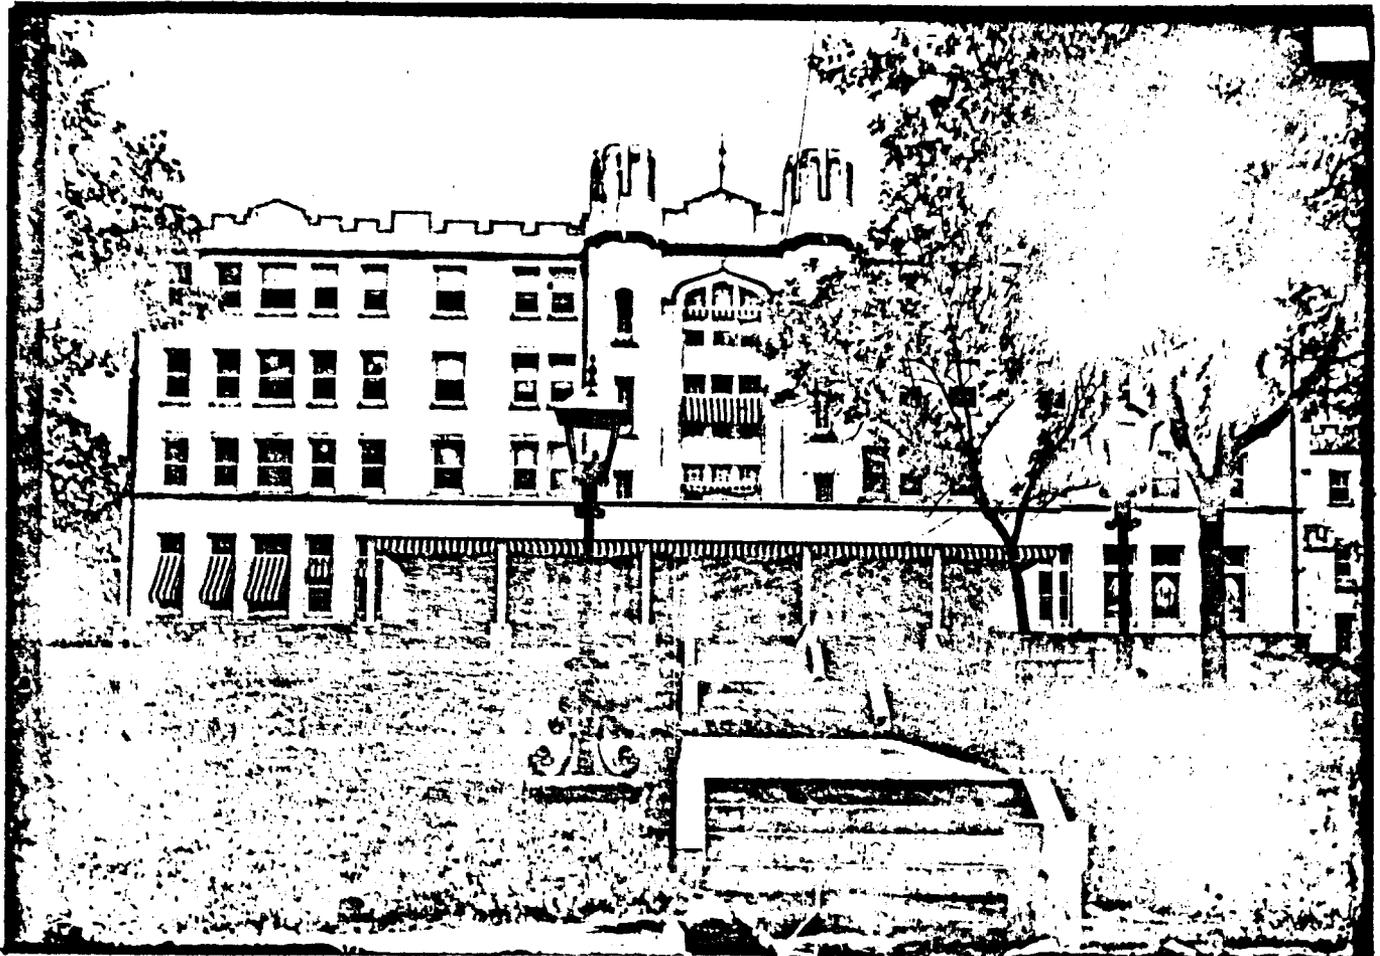
An early view of the post-1911 college building.

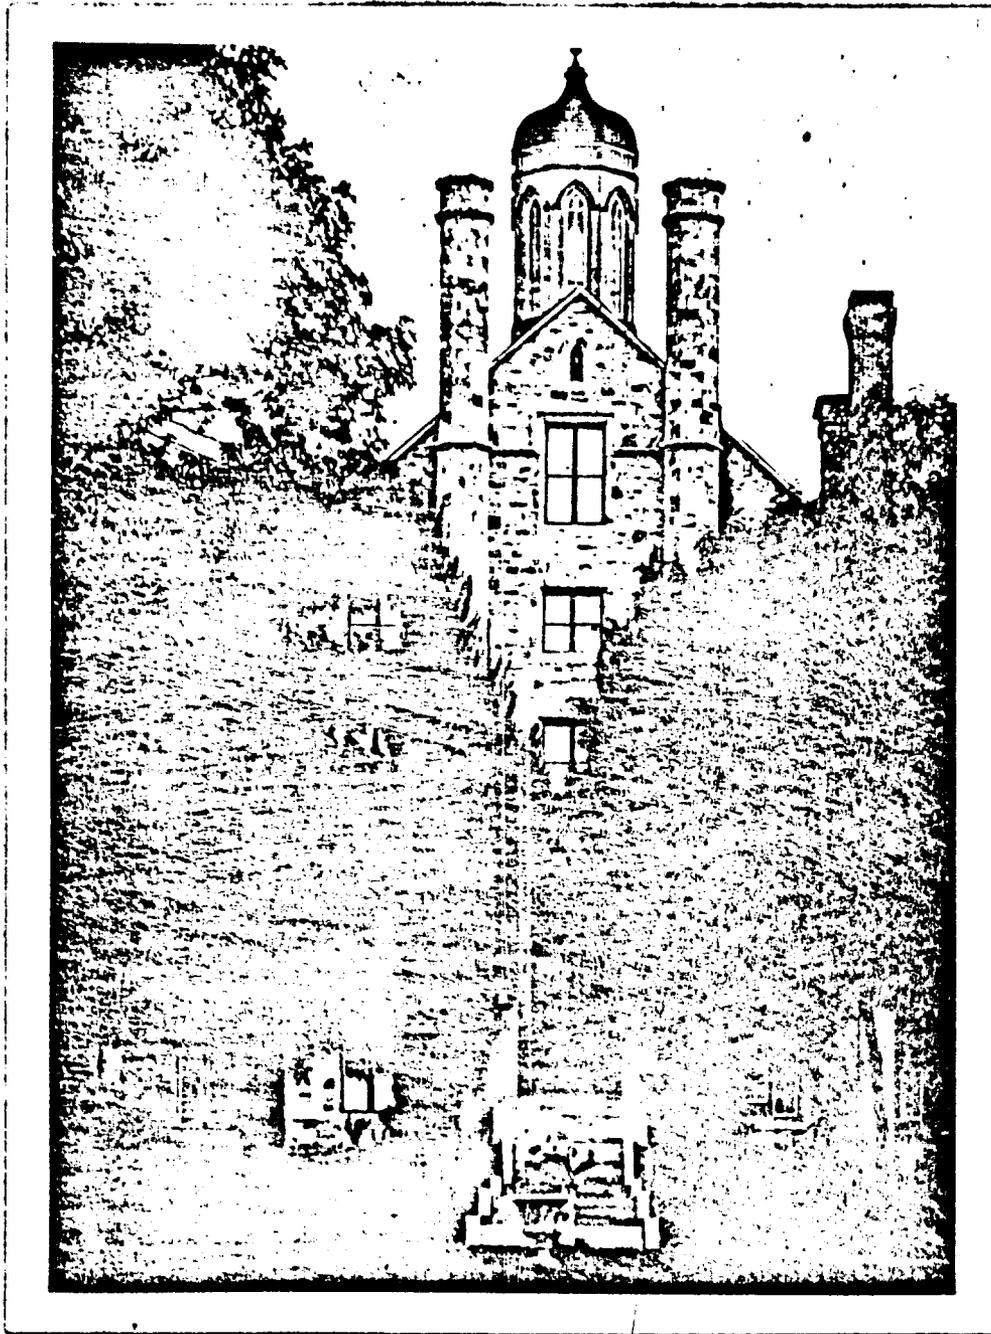
College Manor, Sheet 4.

An early view of the original Lutherville Female Seminary Building before the 1911 fire.
