BA-2369

HISTORIC PRESERVATION CERTIFICATION APPLICATION—PART 1

ROCKLAND: "THE CHIEF MILLER'S HOUSE"

Description of Physical Appearance.

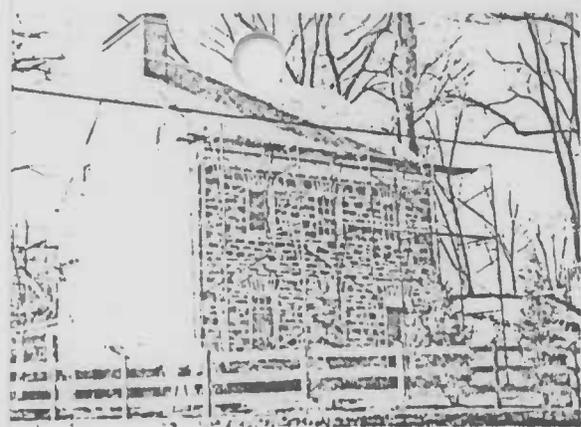
PHOTO 1: FALLS RD. ELEVATION

The walls of the stone building are composed of uncoursed and roughly squared stone masonry from Butler, Maryland, 12-16" thick. The Falls Road facade is divided into (3) bays. (3) windows on the second floor and (2) windows and (1) door on the first. (2) small square windows flank the chimney on the Old Court Road side. The north elevation has (1) small square window and (1) typical second floor window. First floor windows are 9 over 6 double hung, and second floor windows are 6 over 6. Window openings are surmounted by large, flat stone arches. Hardware on wood frames indicate shutters were present. Shutters will be re-hung during renovation. The existing front door (Falls Road) has been hacked and chopped and presently has a 2'-6" x 2'-6" piece of glass in the middle.

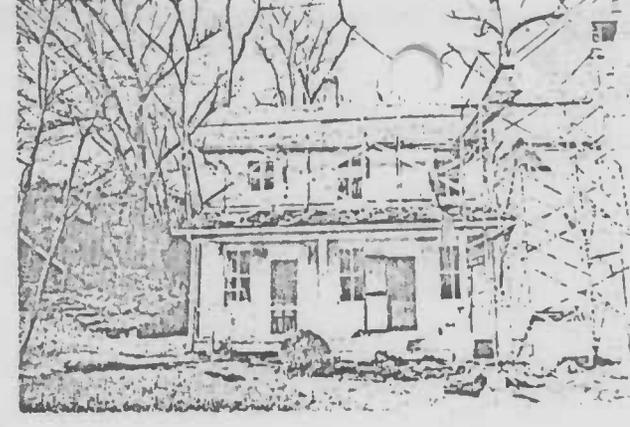
PHOTO 3: FRAME ADDITION

The (2) story wood frame addition is clad in 9" white clapboard. There is a 6'-0" x 21'-0" wood porch fronting Old Court Road. The windows are predominately 2 over 2 double hung (9), with small, square casements (3) on the second floor. Hardware indicates shutters were on all windows. Shutters will be rehung. Existing doors (2) are in fair to poor condition. The original roof was again cedar shingles. Renovation will re-install the cedar shingle roof.

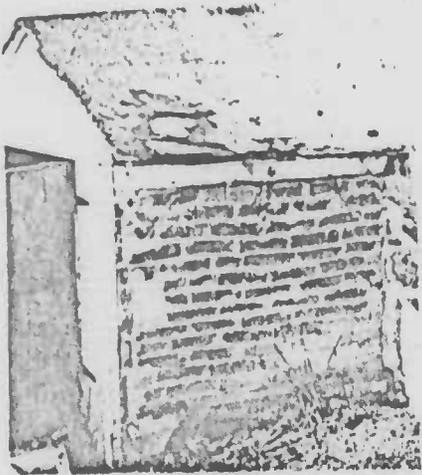
PHOTO 8: COAL CHUTE SHED

A set of stone steps between the stone building and wood frame addition allows access to basement from Old Court Road side. The door at the bottom of the stairs has been replaced with polyurethane. Also on the Old Court Road side is a coal chute with brick and plywood shed.

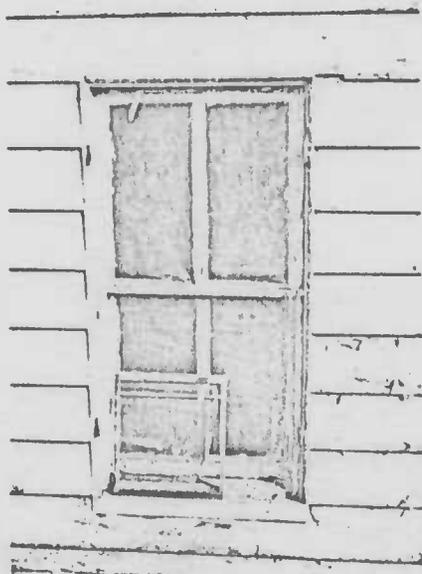
PHOTO 12: "TYPICAL" WOOD FRAME ADDITION WINDOW.
