Property/District Name: Bridge CE108 Liberty Grove Rd Survey Number: CE-1488

Project: Proposed bridge replacement Agency: F/coe

MARYLAND INVENTORY OF HISTORIC BRIDGES
HISTORIC BRIDGE INVENTORY
MARYLAND STATE HIGHWAY ADMINISTRATION/
MARYLAND HISTORICAL TRUST

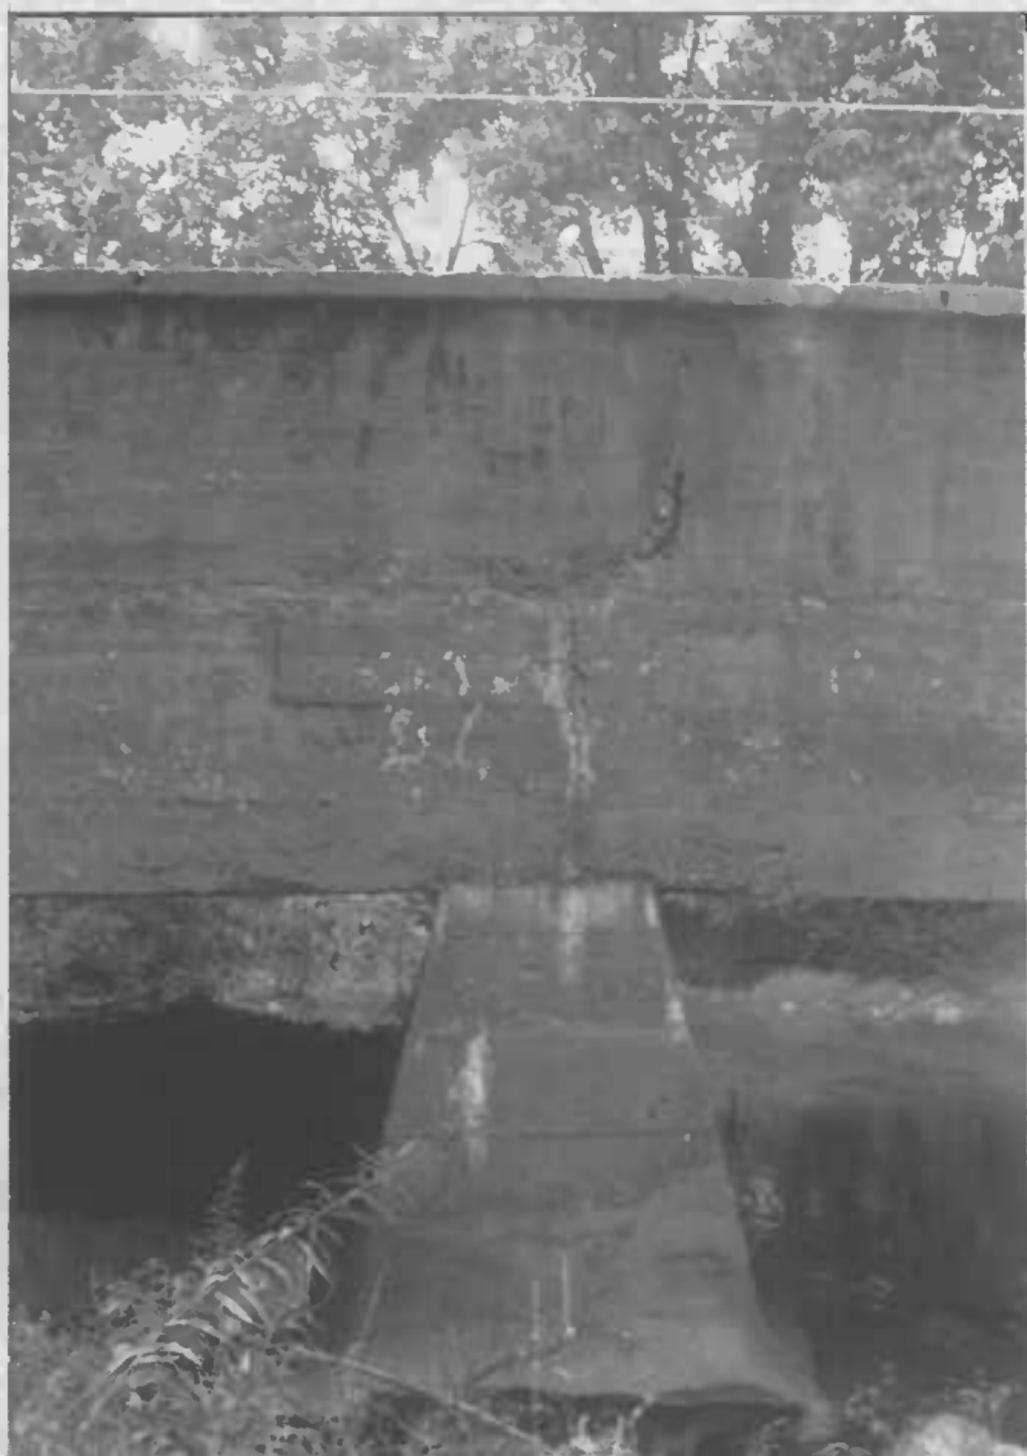
to Liberty Grove Road Bridge

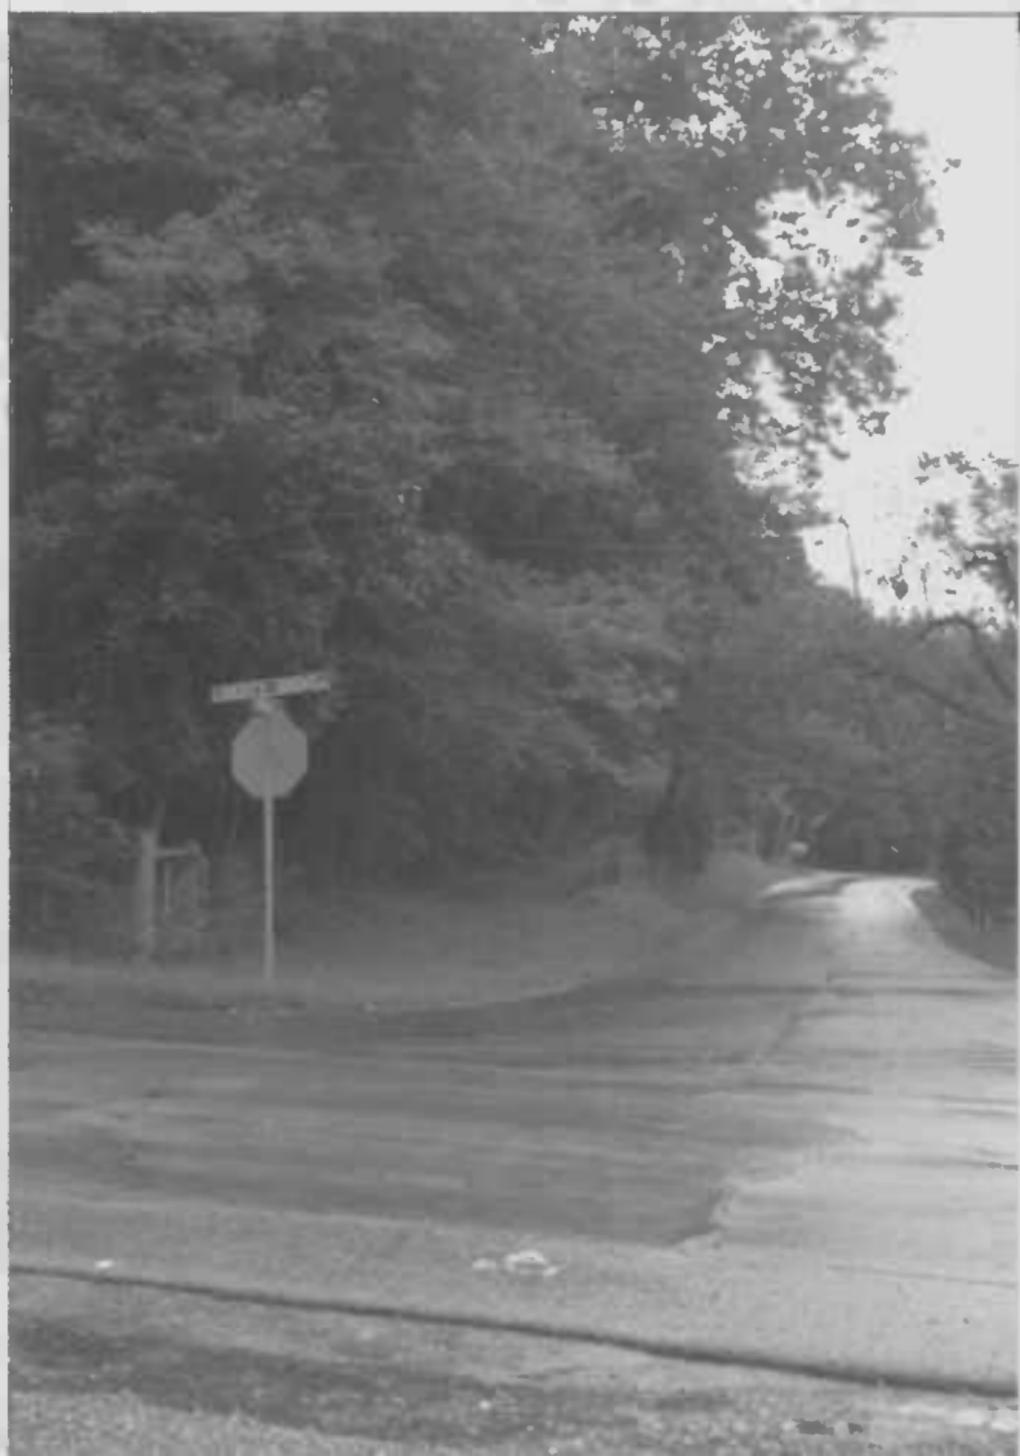
1. CE 1978
2. Liberty Grove Road Bridge
3. Cecil County
4. Hacie Webb
5. September 1996
6. P.A.C. Sperry Company Towson Md 21284
7. Liberty Grove Road over Basin Run
North of Basin, abandoned RR
8. 4 of 13

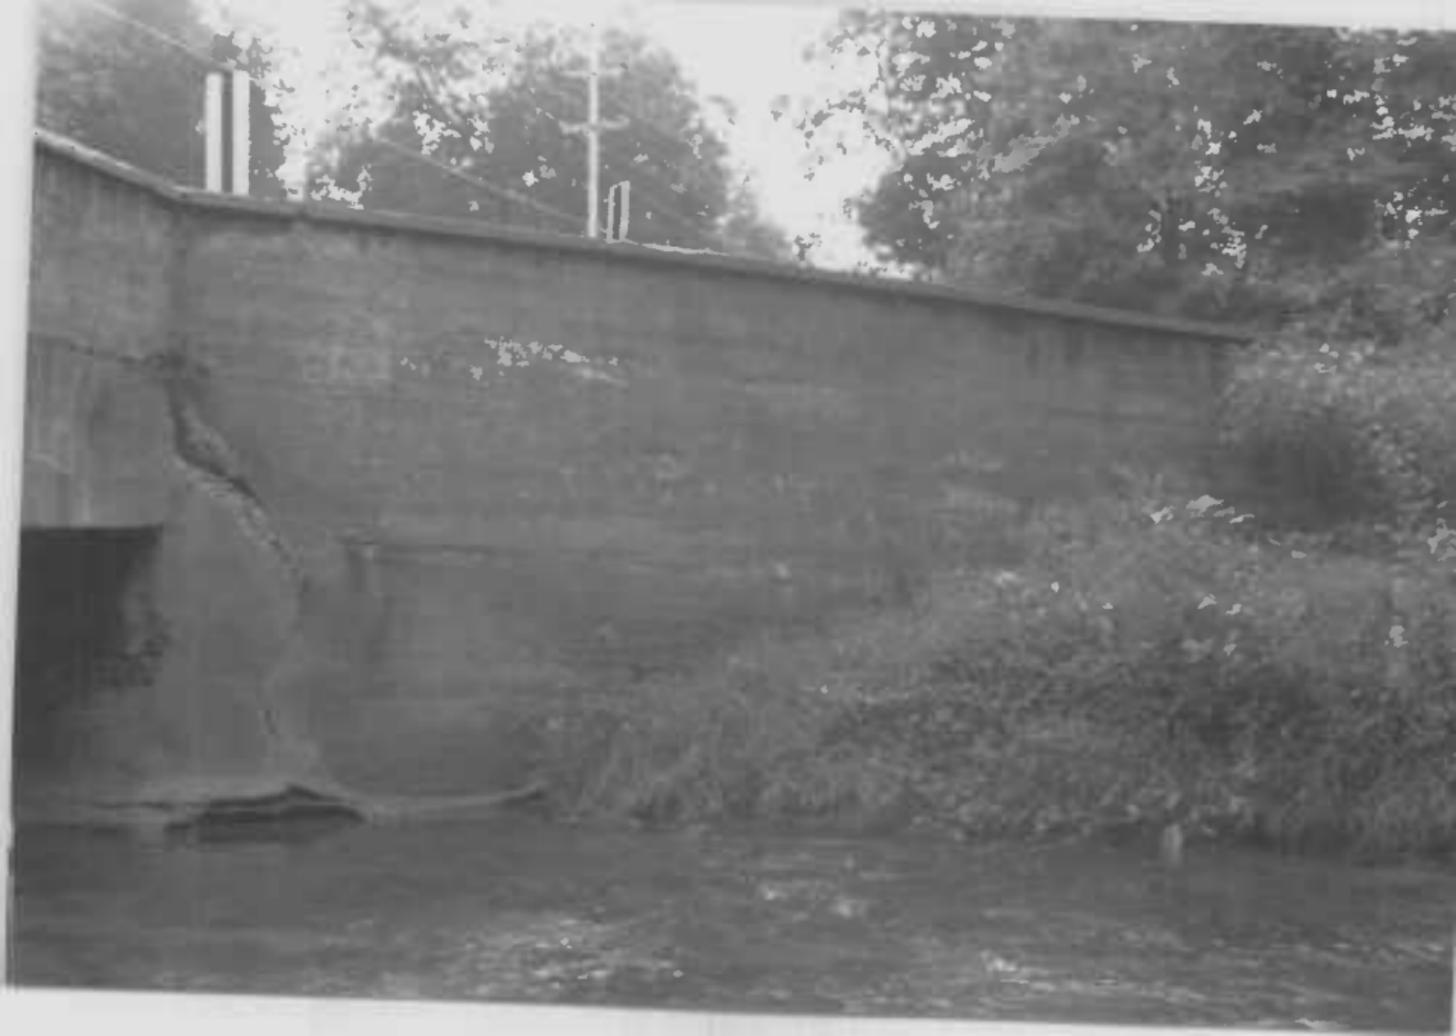
Liberty Grove Road over Basin Run

North East
