HISTORIC PRESERVATION CERTIFICATION APPLICATION
REQUEST FOR CERTIFICATION OF COMPLETED WORK

1023MD

Burgess Tenant House HO-338
8454 Main Street
Ellicott City, MD 21043
Part 3 Application

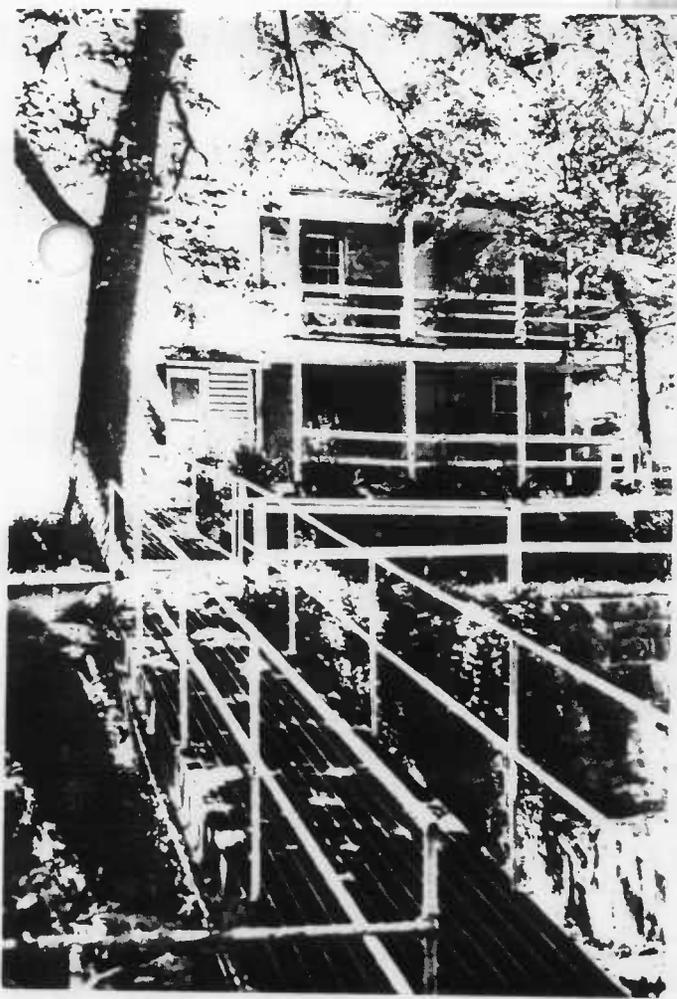
Fig A Early 19th c stone house
with Victorian wood addition to left.
Looking across from millrace (south
elevation)

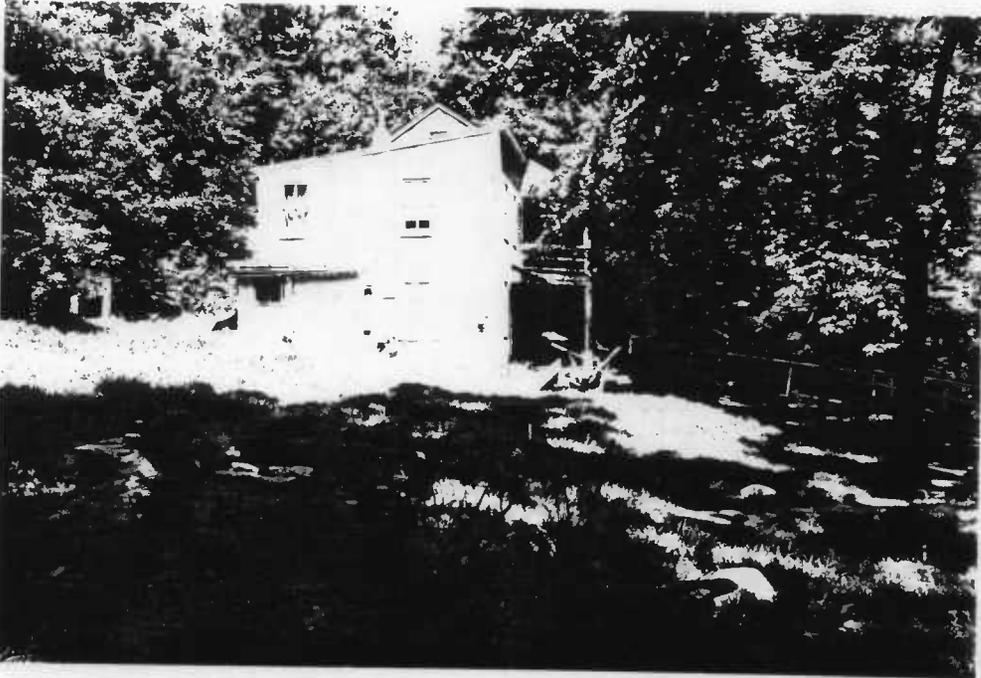
Fig B West elevation showing Victorian
wood addition and recent mud room.
Foundations in foreground are remains
of a small kitchen or storage building

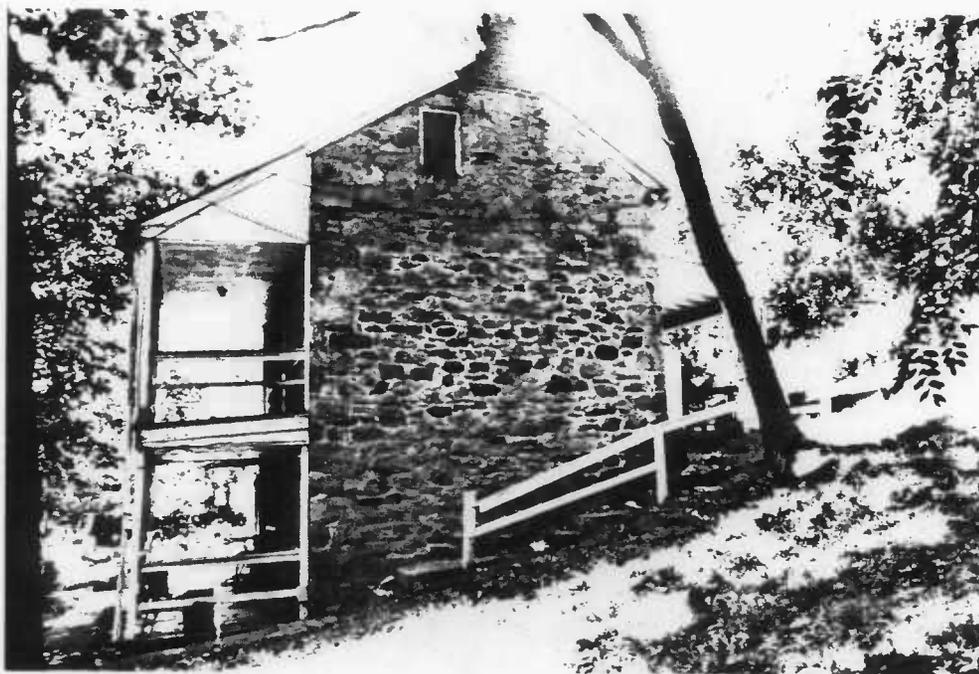
Fig C East elevation showing two-story front porch and one-story rear porch.

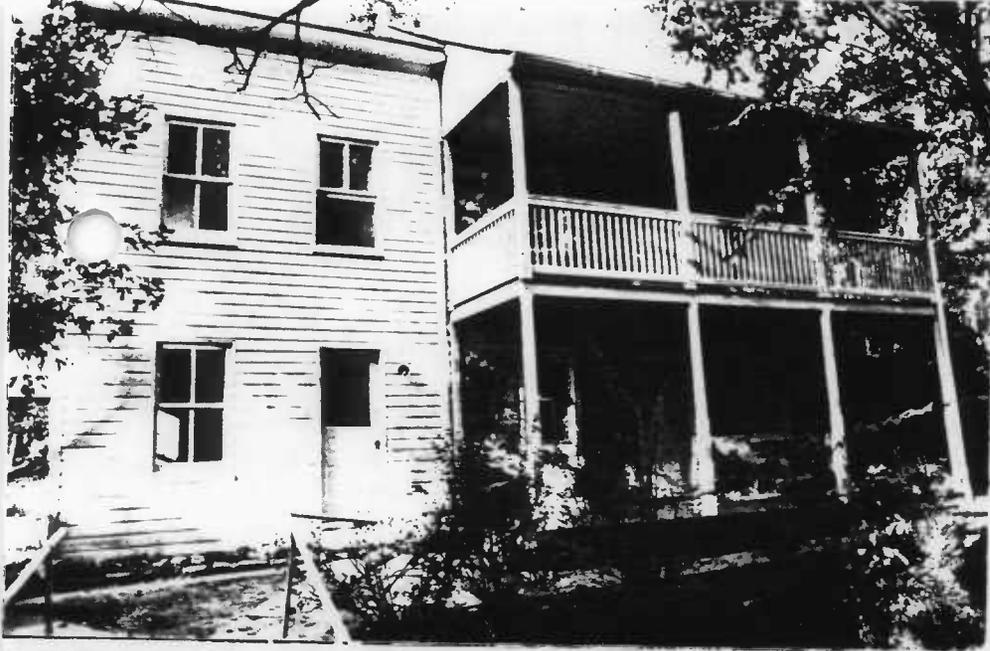
Fig. 1 Front Facade -- porch posts and railings rebuilt based on hist. photo. Doors and windows repaired and along with siding repainted. No site work around the tenant house was done.

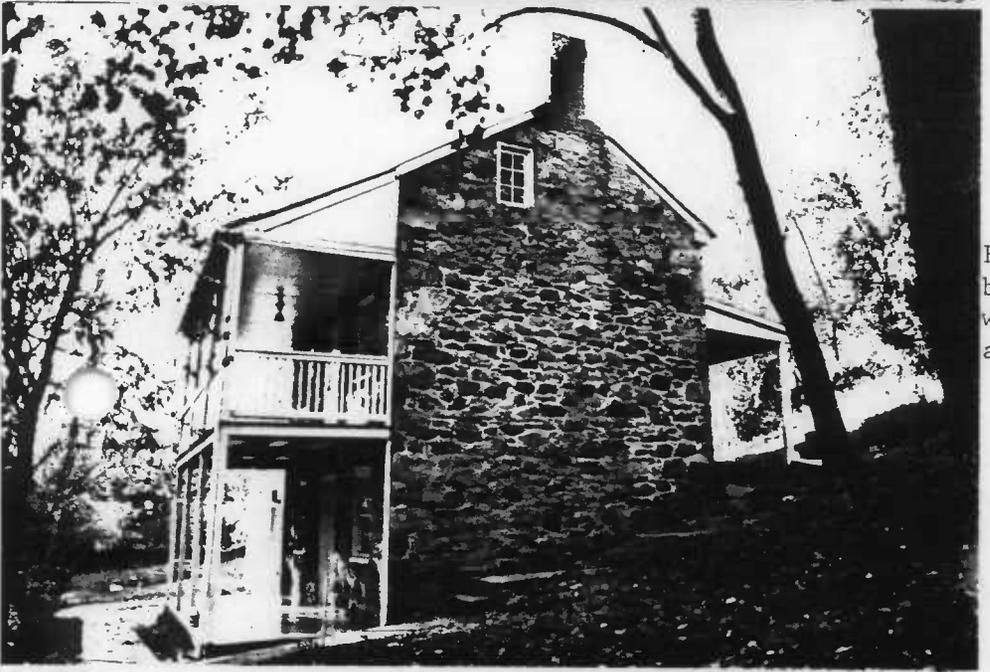
Fig. 2 Window screen and wood rail by side steps removed. Chimney work was not done -- chimney exists as pre-rehab. East side elevation.

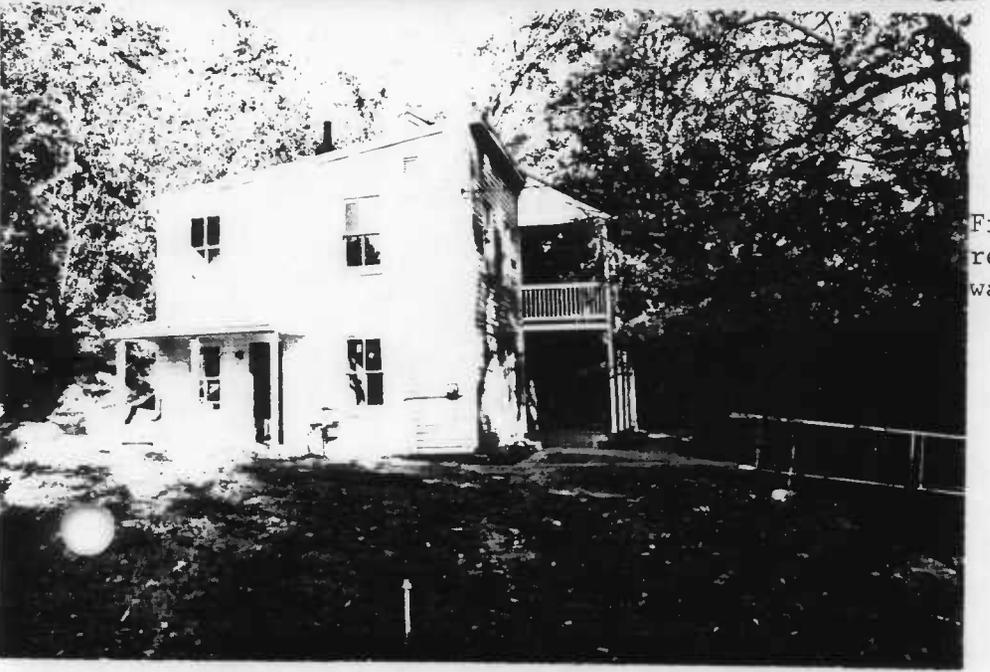
Fig. 3 Mud room porch enclosure of recent vintage was removed. Siding was repainted. West side elevation

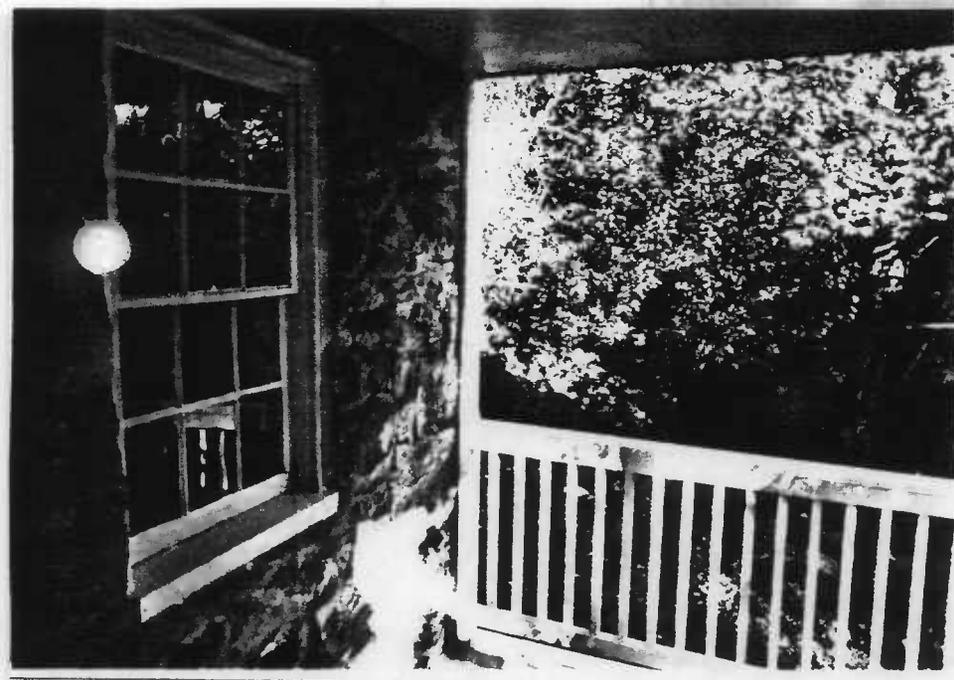
Fig. 7 Front elevation -- second floor. Original windows retained and repaired throughout the bldg.

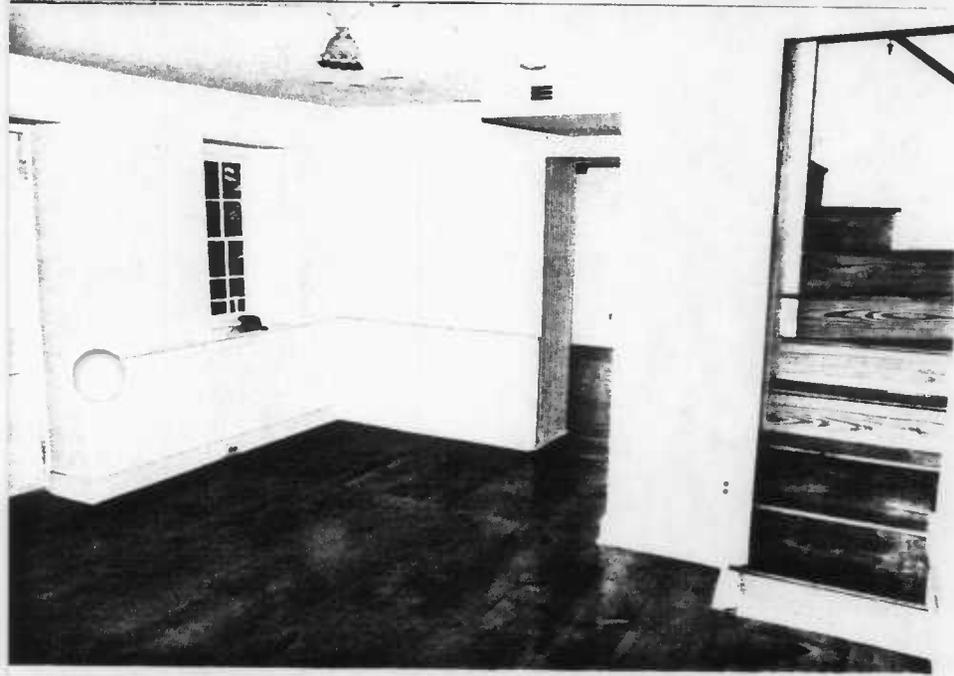
Fig. 8 Living room on first floor. 1950s partitions removed. Floors patched and refinished. Wainscoting retained. Walls are a mix of plaster sections and drywall depending upon pre-rehab condition and new work required. Stairs and doors retained and repainted.

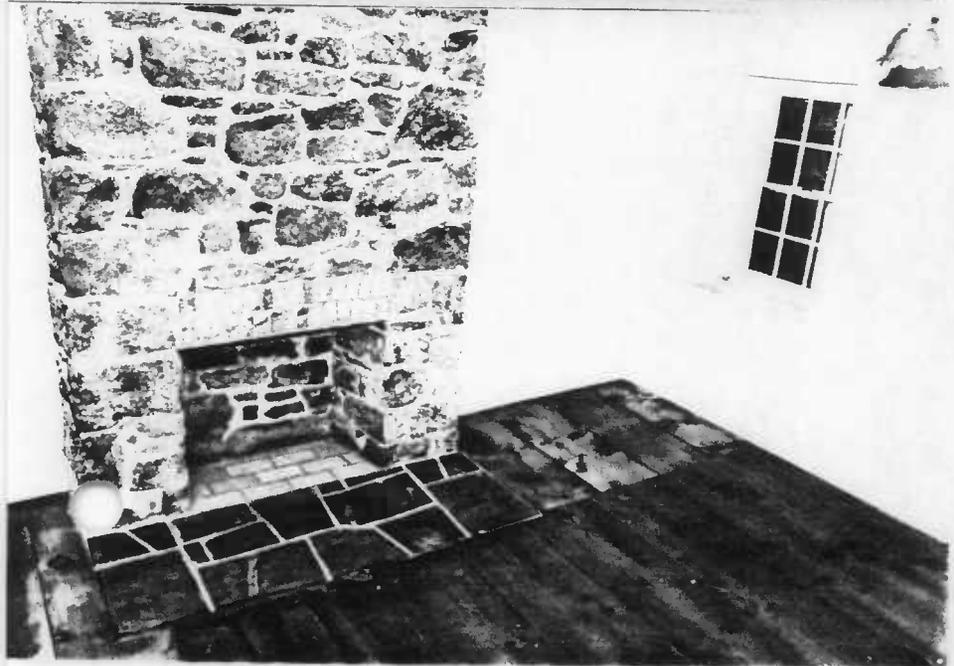
Fig 9. Living room on first floor. 1950s partitions removed along with 1920s alterations. Existing fireplace was restored by removing 1920s enclosure. Stone was repointed using soft mortar as existed.

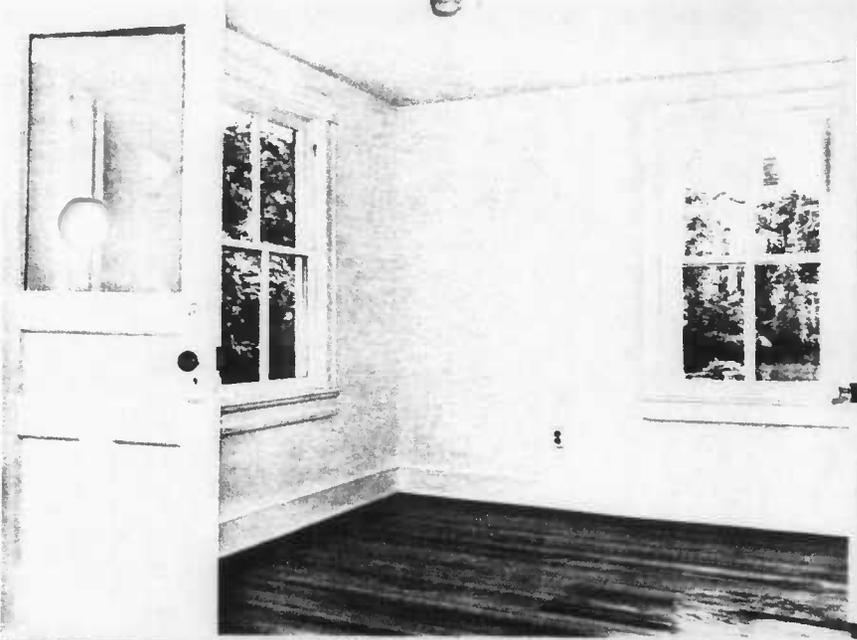
Fig. 10 Victorian wing--first floor
Front door retained; new drywall
replaced patchwork of drywall and
plaster. Floors refinished; window
and door trim saved and repainted.

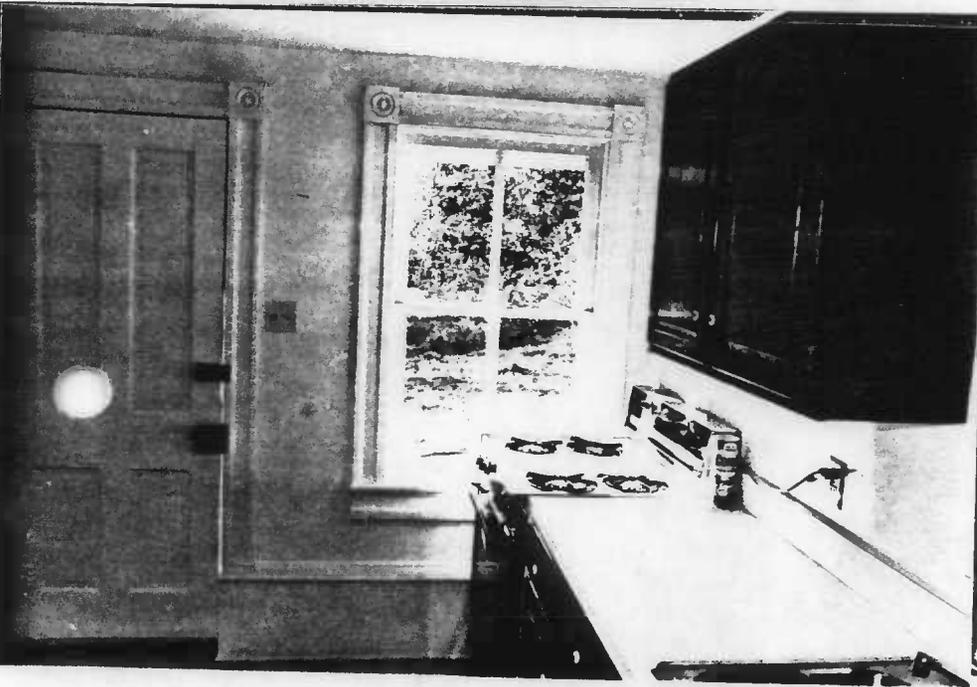
Fig. 11 Victorian wing--first floor
rear portion. New kitchen installed.
Existing door and window onto mudroom
retained and now visible from exterior.

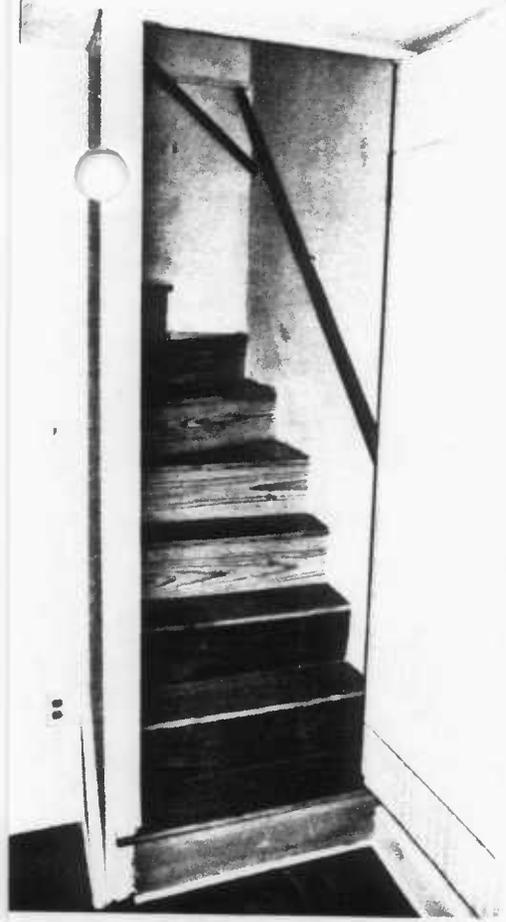
Fig. 12 Stairs from first floor of stone house to second floor retained. A number of the treads were replaced due to damage, wear and rot. Existing door retained.

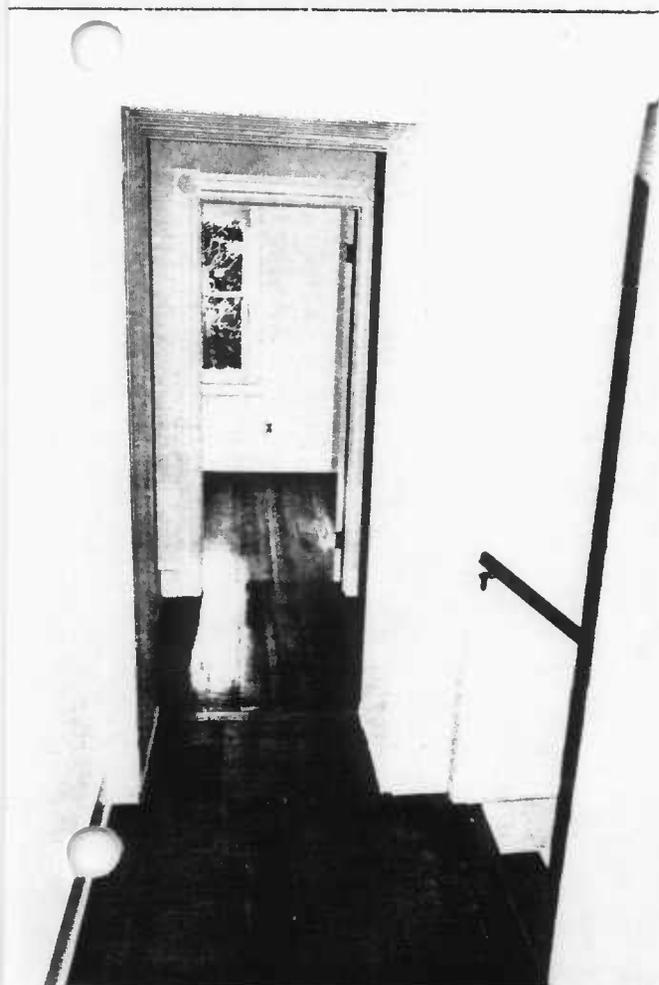
Fig. 13 Stairhall on second floor of stone house. Floor refinished and 1950s alterations removed; walls repaired and reconstructed. Looking from stairs to Victorian wing.

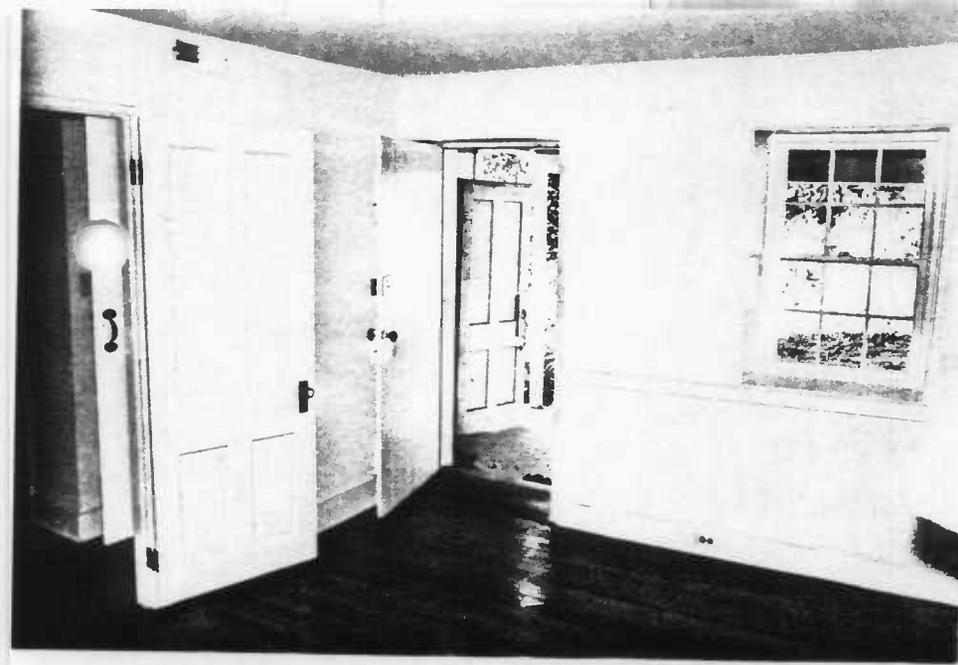
Fig. 14 Second floor of stone hse. Later partitions removed; fireplace, floors, trim and wainscoting repaired and restored. Door onto back is original and was retained along with all historic interior doors. Stairs to attic reoriented to stair hall by turning bottom several steps 90 degrees.

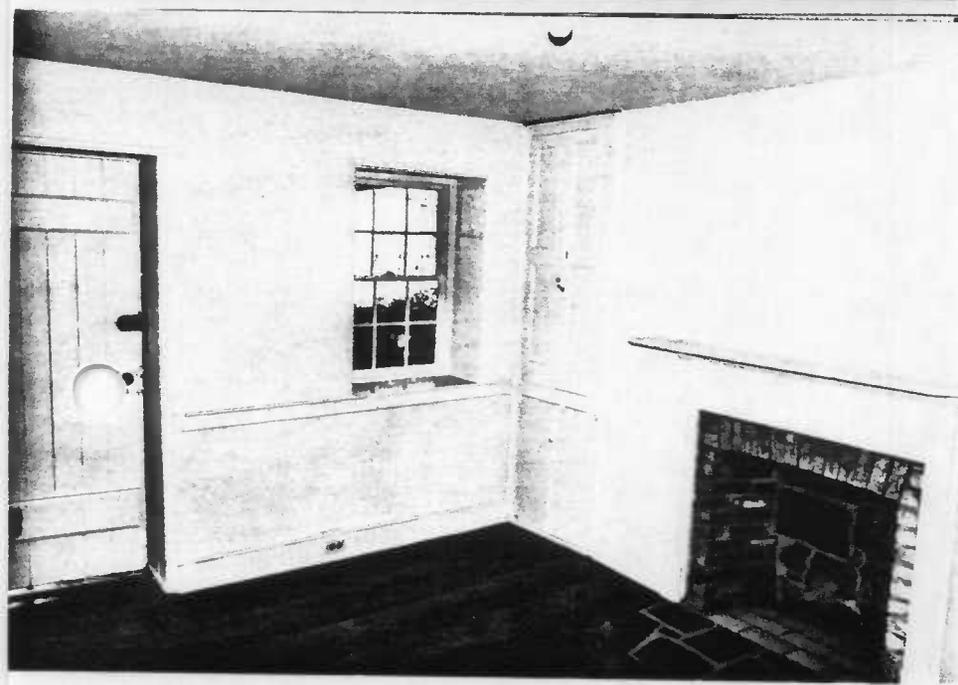
Fig. 15 Second floor of stone hse. Existing fireplace restored.

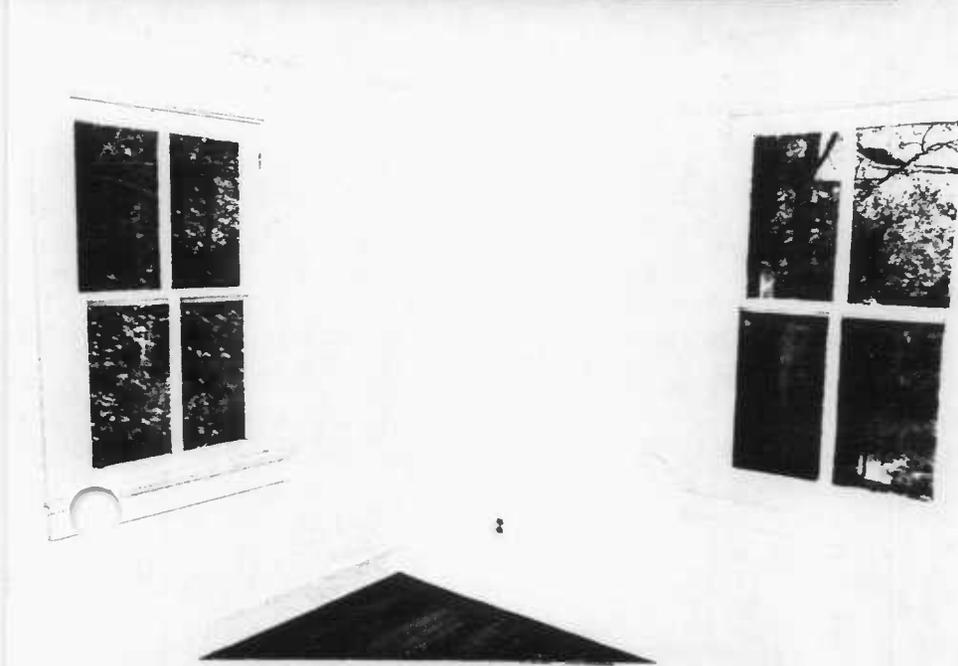
Fig. 16 Second floor of Victorian wing--front room. Existing windows and trim restored; room restored to full size.

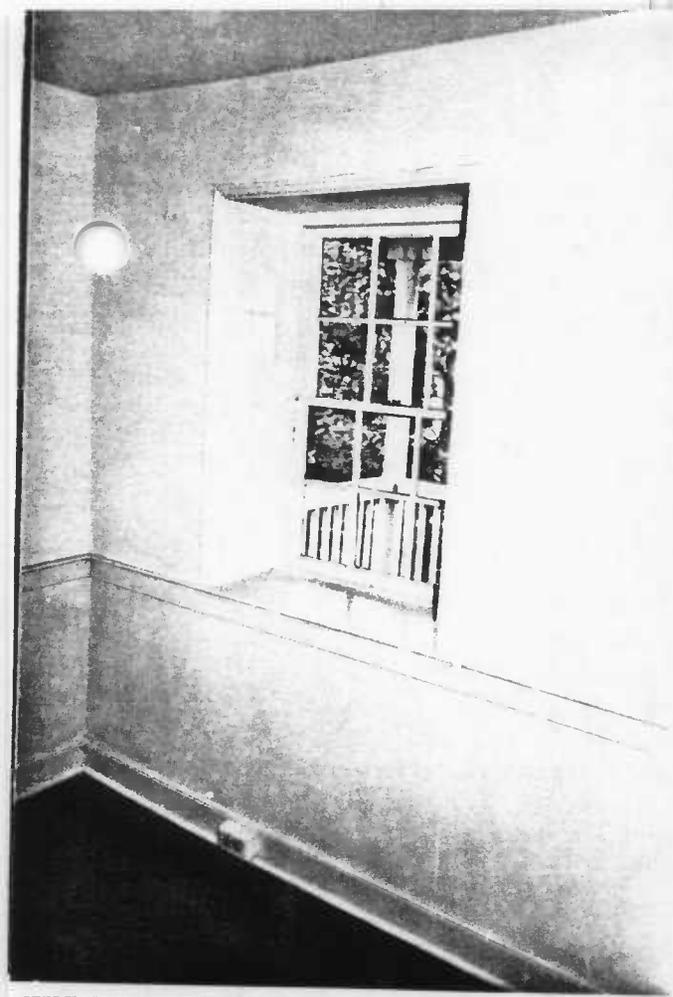
Fig. 17. Second floor of stone house looking to front, showing historic window and trim detail which was retained.

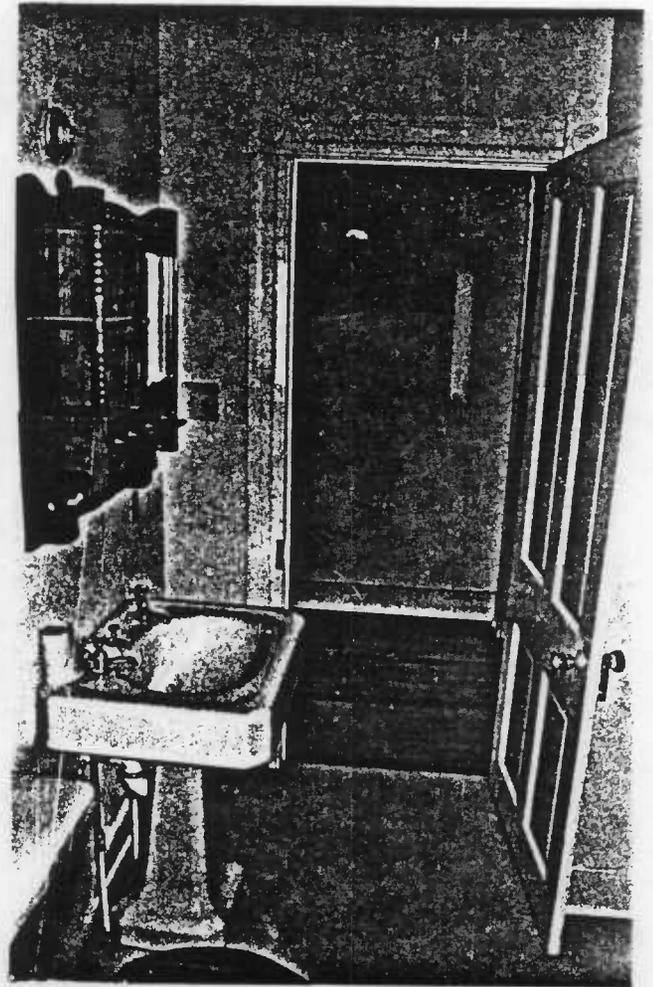
Fig. 18 Victorian wing on second floor showing new bath.

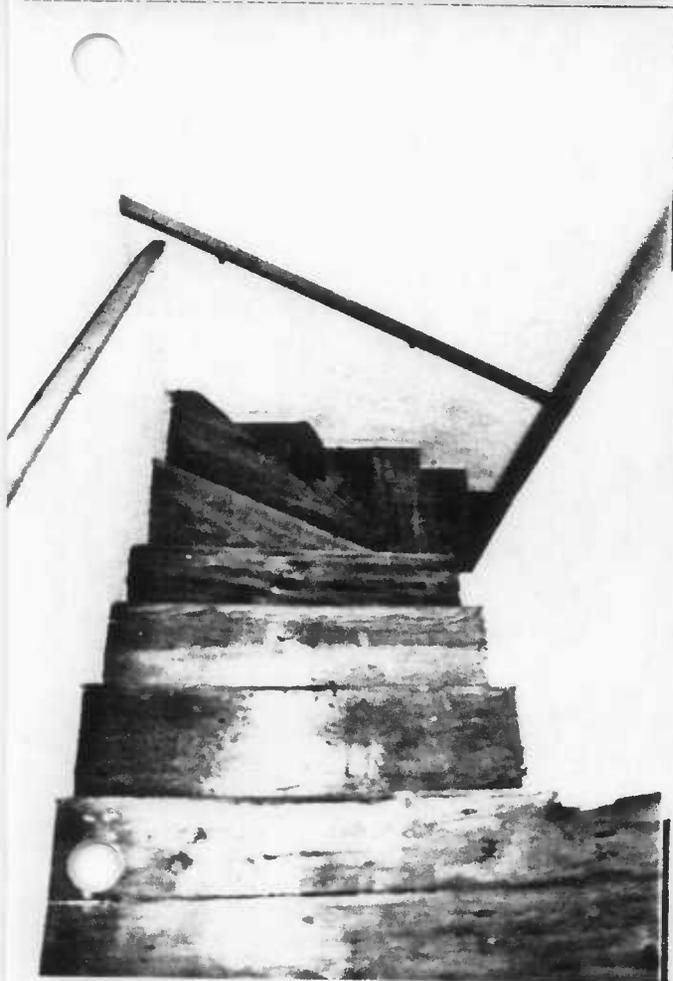
Fig. 19 Stairs from attic to the second floor. All steps shown in view are original and were restored in existing location. Only bottom several step not shown in this view were turned 90 degrees.

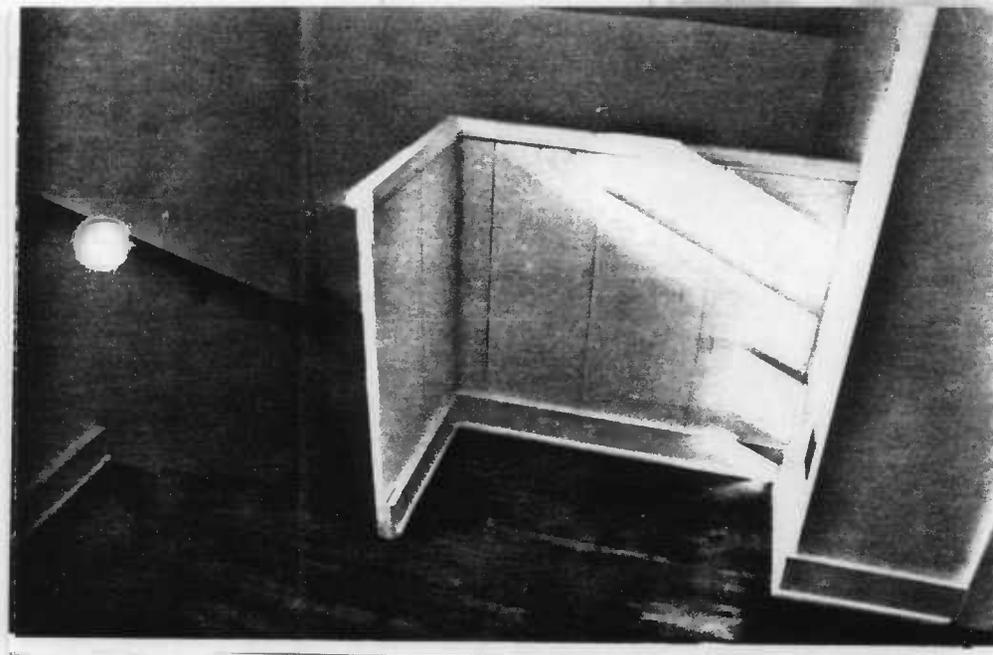
Fig. 20 Top of stairs in attic of stone house showing historic detailing which was retained. Floors were refinished.

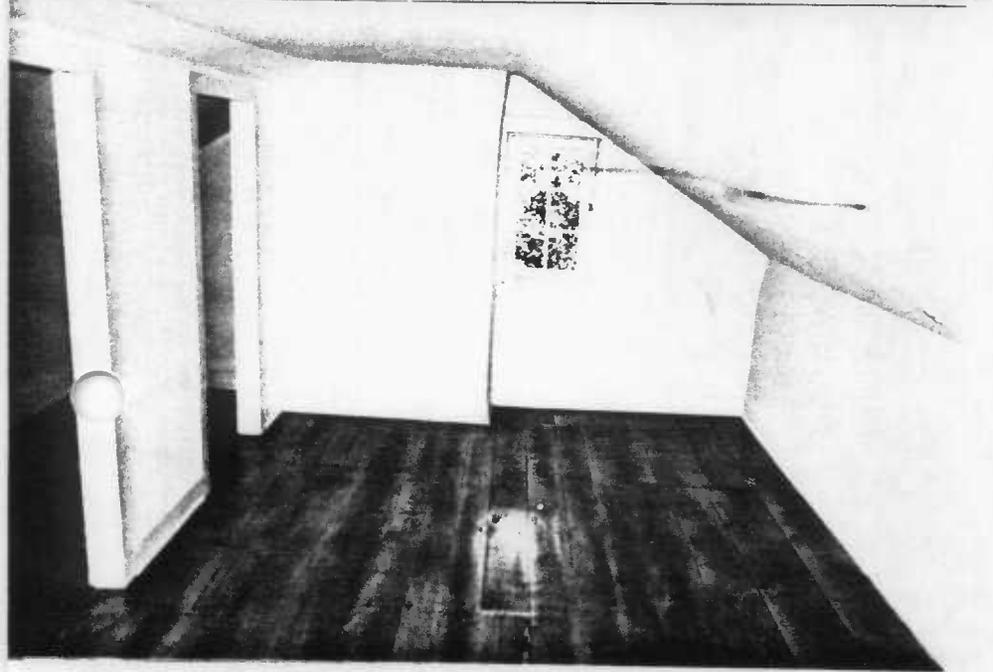
Fig. 21 Attic of stone house
Later center partition was removed
New left side wall was installed for
contemporary closet space. Fire-
place stack shown to left of restored
window. Floors were refinished.
