STMA-201162  
UNDERWOOD  
Charlotte Hall  
Private

COMMON: Underwood 1901625304

### "UNDERWOOD"

A Restoration and Modernization

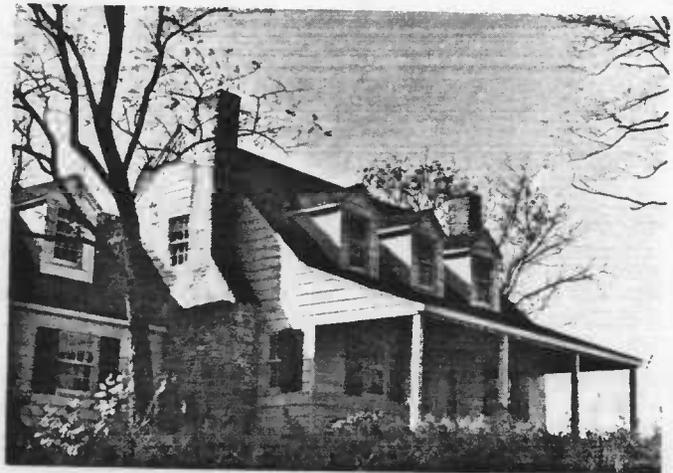
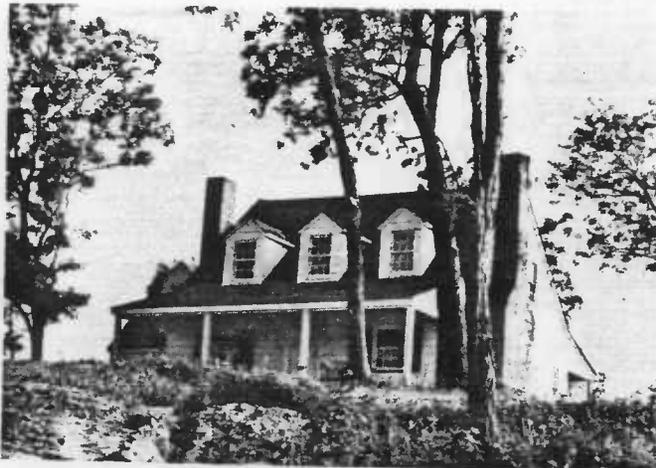
AFTER RESTORATION

The porches front and rear were replaced using new material but following the original pattern. The kitchen was replaced using new material. It was necessary to enlarge the kitchen slightly in order that space might be provided for a first floor bathroom and furnace room. A third chimney was added to accommodate the modern furnace. This was laid with old brick and in the position indicated by the outline of the sills as having been the location of one of the missing chimneys. As now constructed this chimney has no fireplace although one could be added later.

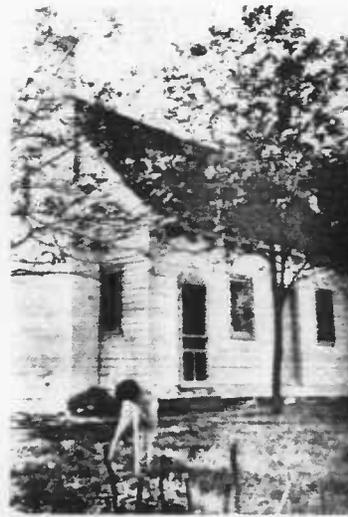
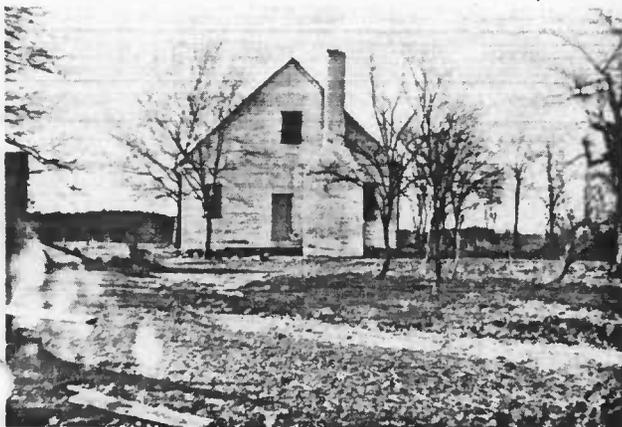
BEFORE RESTORATION

"Underwood" at one time appeared to be, and in many respects was, in an advanced stage of dilapidation. Its main roof was in fair condition, but the porches and kitchen had partially collapsed. They were removed and discarded as beyond salvage. Much of the woodwork exposed to the elements was also in bad repair, however, the basic structure was for the most part sound.

The softness of the oyster shell mortar over a long period of time had allowed the stone foundation to crumble and the sills to settle. The first step was to level the outside sills and rebuild the foundations. The interior sills were then leveled and new boxing of stone and concrete installed to contain the hearths of the two existing fireplaces. Bracing members were added to strengthen and stabilize the first floor joists. New sub-flooring was installed and the fireplaces themselves and dampers were installed in the chimneys to prevent the loss of heat. The dampers were placed well up in the chimneys and so arranged that no part of their operating mechanisms are visible.

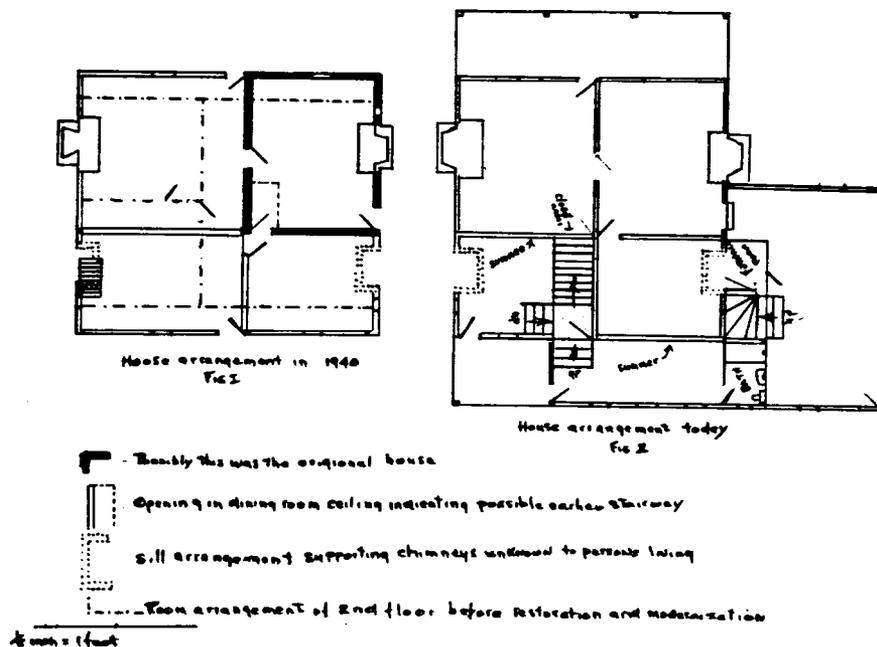
Fig III

The figures below reflect the original arrangement and the reconstructed interior.

*Broken line indicates possible original house*

was necessary to change the room arrangement on the second floor to accommodate this new bath and to provide a more appropriate means of access to the second floor. The ladder stairway was removed and a new stairway provided.
