INVENTORY FORM FOR STATE HISTORIC SITES SURVEY

Methodist Protestant Rectory

Alice Shea Residence

QA-240

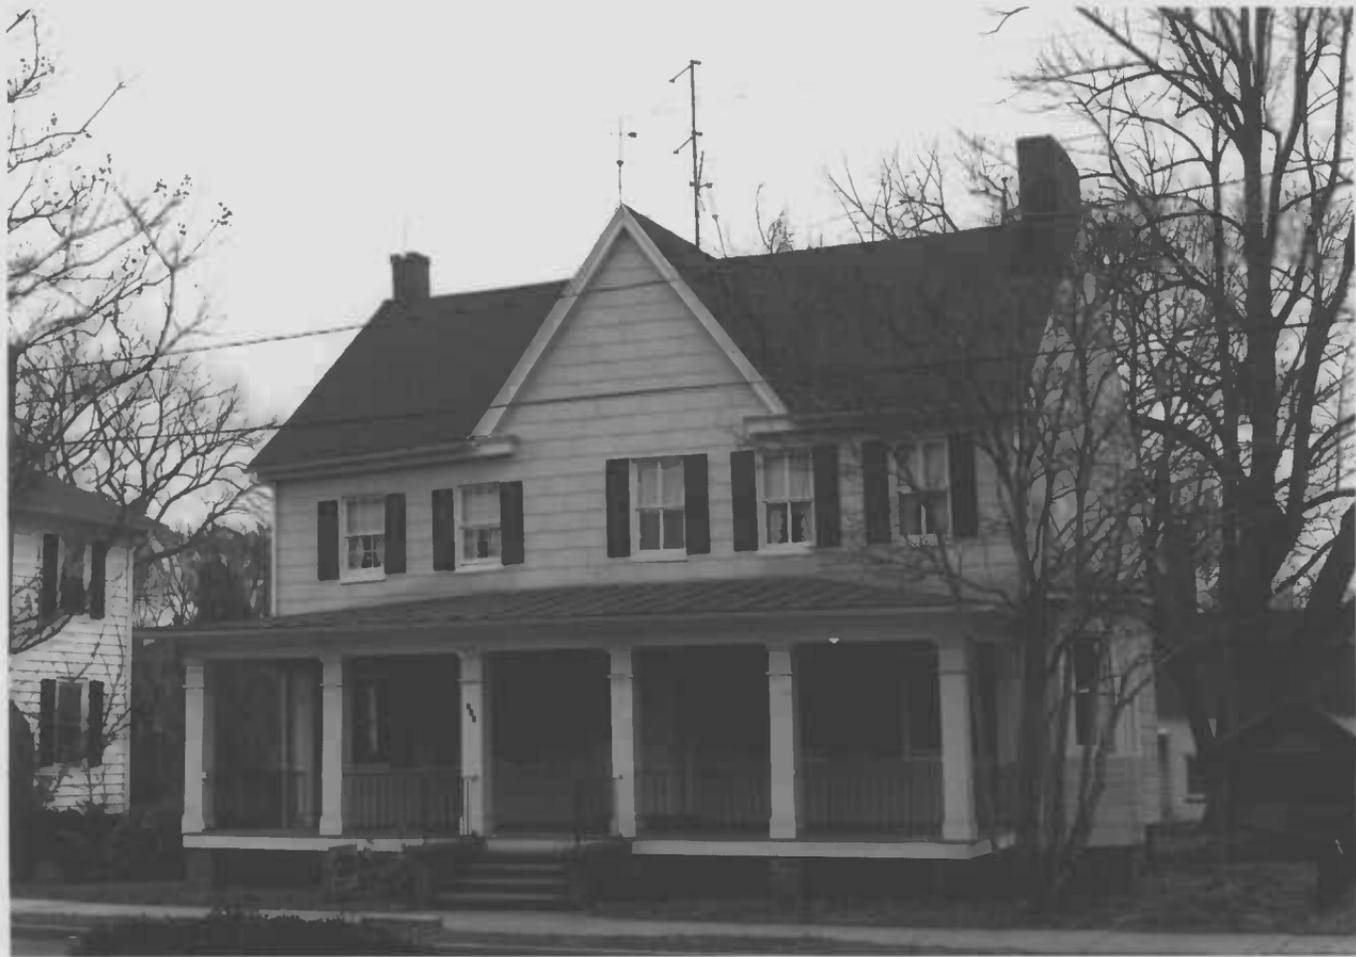
West facade

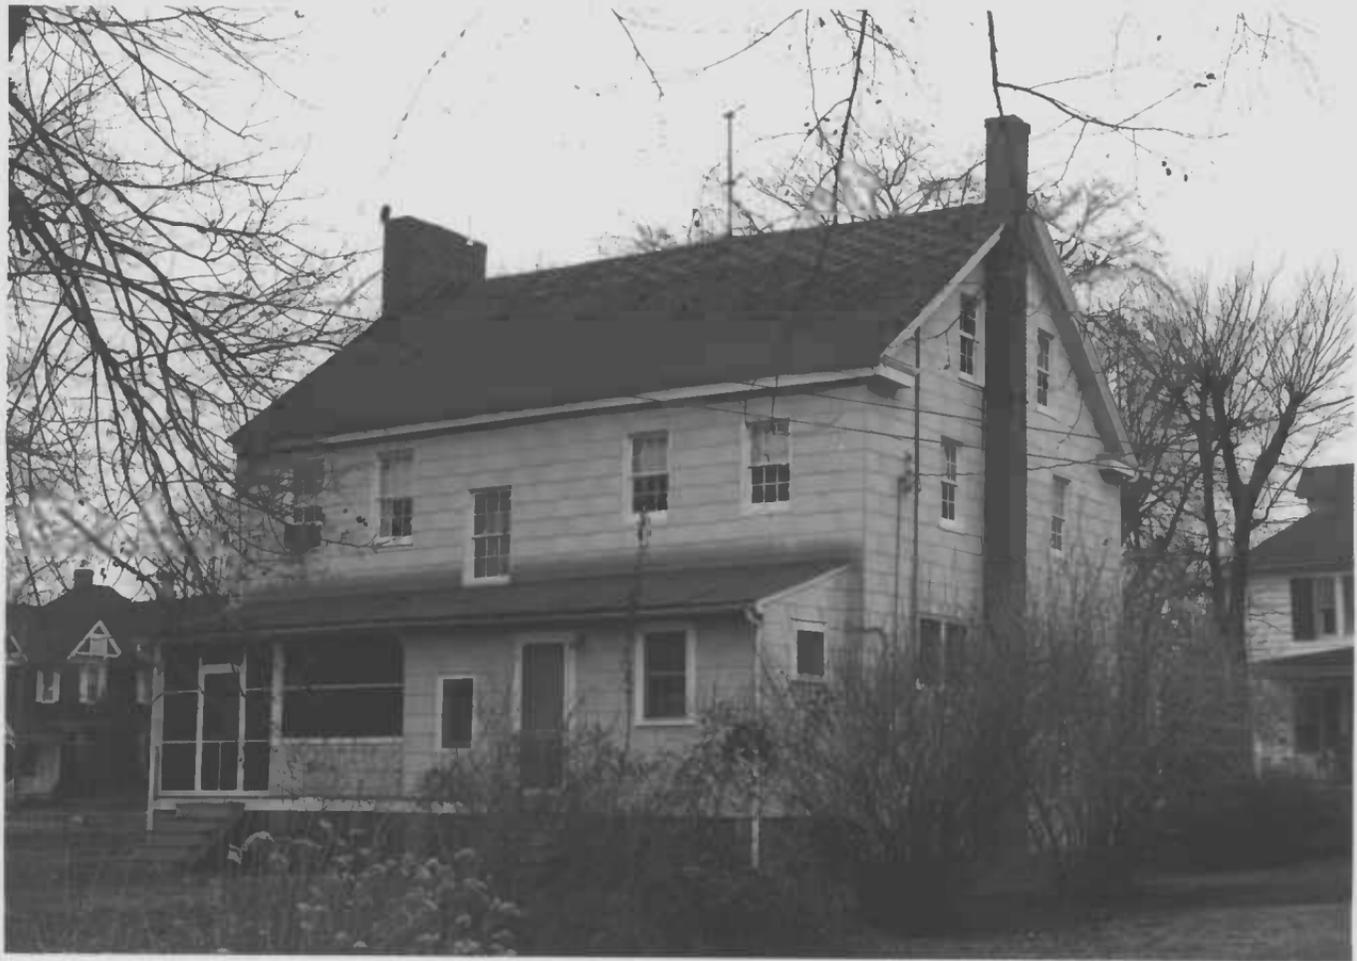
Shea House
205 South Liberty Street
Centreville, Maryland
Orlando Ridout V 1980
Rear facade
