Susquehanna State Park

MIHP # HA-2036/CE-1528

7. Description

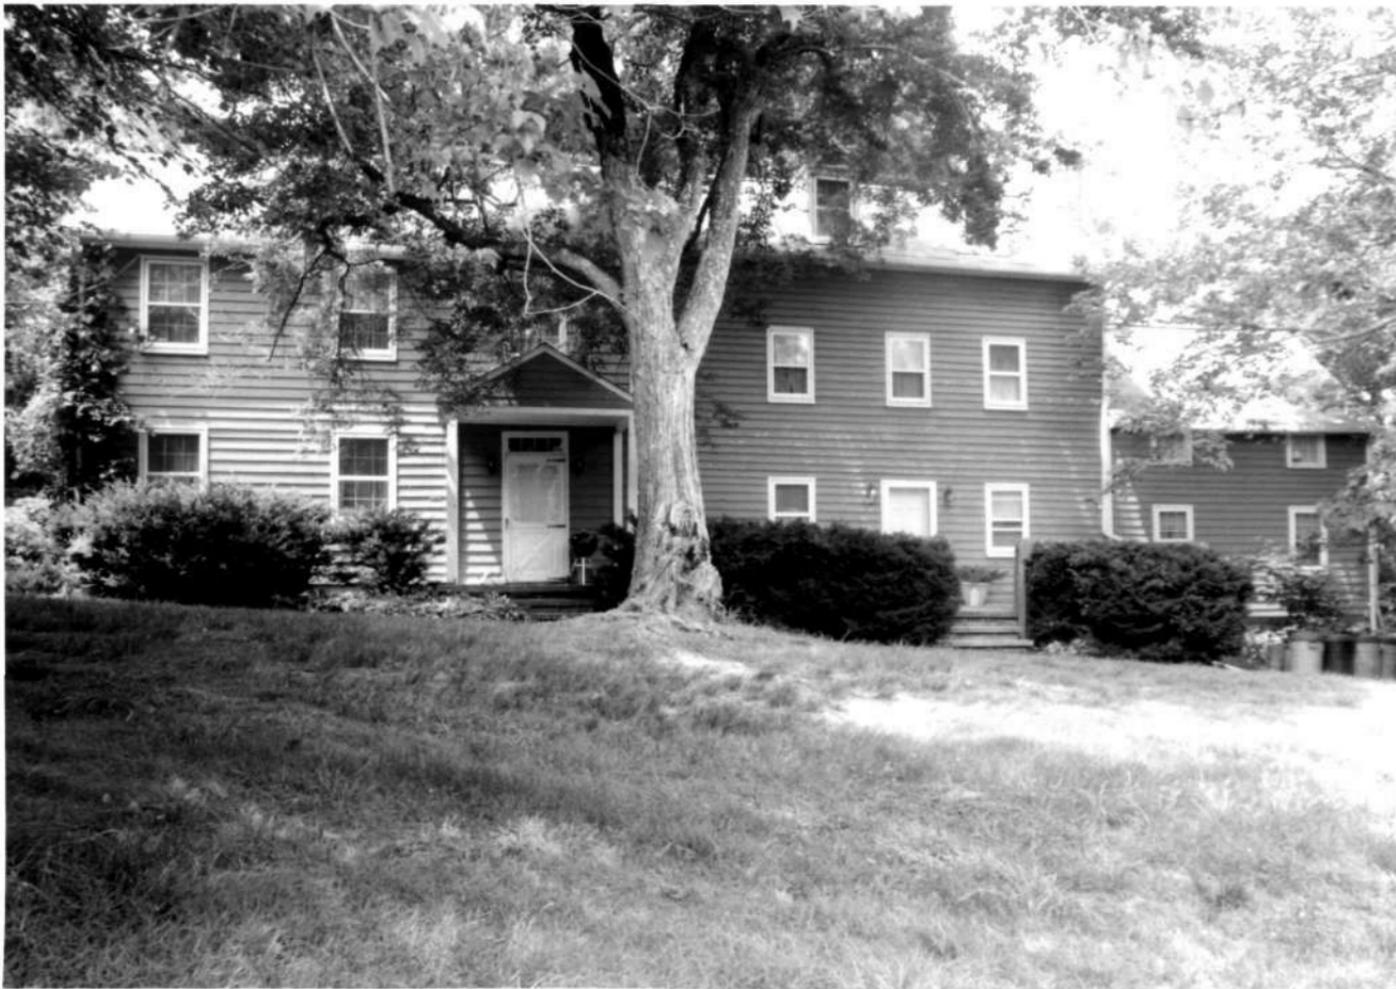
6/31

The JAMES STEPHENSON HOUSE (former Gatewood Property) (MIHP # HA-570), located at 633 Craig's Corner Road, was constructed during the late eighteenth century; a ca. 1797 construction date was assigned by Weeks (1996:269). The building and associated outbuildings are located in middle of agricultural acreage and oriented in a linear pattern along the dirt entry road. The wood-frame, two-story house is an example of a telescopic form with three distinct sections, two sections are three bays and the easternmost section is two bays. Each section of the building rests on a fieldstone foundation. The walls are clad with horizontal weatherboarding. The easternmost section is one-and-a-half stories. The west wall of this section has a wide brick chimney. A second brick chimney projects from the west gable end of the building. The gable roof is sheathed in asphalt roll and features a box cornice along the south and north elevations. Plain raking boards outline the gable ends. The doorway is located in the end bay of the three-bay western section of the house and contains a six-panel wood door and transom. The door and window surrounds feature beaded moldings. The windows are wood-frame, six-over-six-light, double-hung units. The overall condition of the house is good. The exterior cladding exhibits peeling paint, as do the window frames. The roof gutters are bent and bowed and need to be repaired. In general, the gutters need to be cleaned of vegetation and debris. The wood posts on the front porch exhibit the beginning signs of deterioration at their bases. Broken wood window frames were noted on the north side of the house. These window frames should be repaired and repainted. The large brick chimney stack on the east end of the two-story section of the building is leaning outward away from the two-story building. This appears to be a structural problem and should be monitored carefully; a structural engineer should be consulted.

J. Stephenson Hse (HA-570), looking N

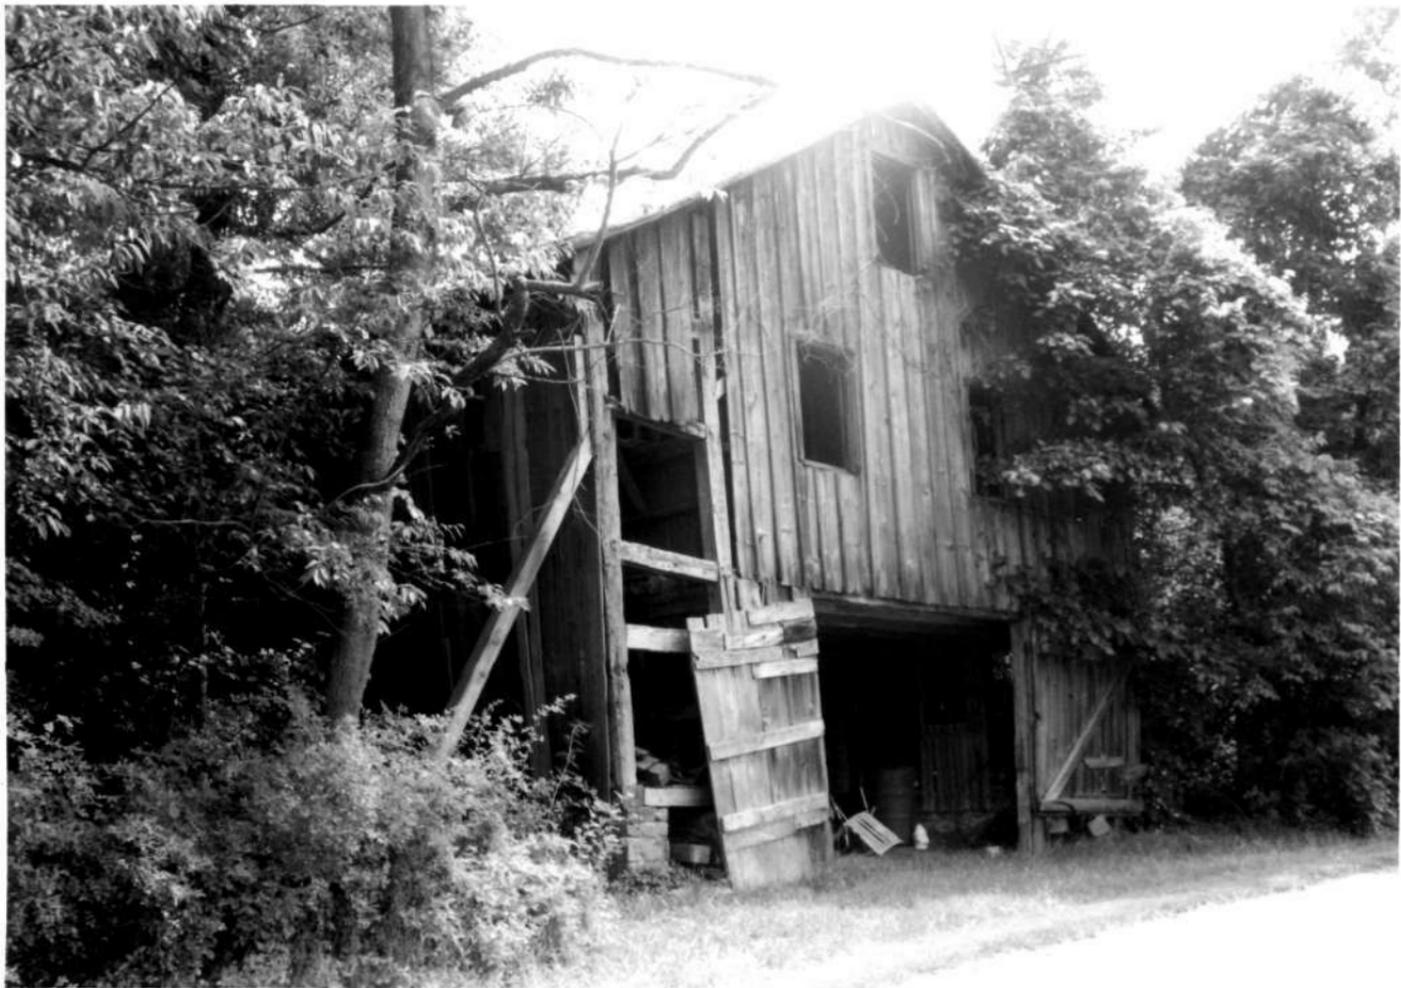
7/31

A ca. 1860 corncrib/wagon shed is located east of the house. The two-story building contains a center aisle for wagons that is flanked by cribs on either side. The board-and-batten wood walls are supported on stone piers. The gable roof is sheathed in standing-seam metal and exposed rafter ends. The condition of this building is poor. It has a pronounced lean and is structurally failing. Water damage was noted on the stone pier foundation. The mortar is failing. The wood cladding is missing boards and general deterioration of the wood siding was noted. The roof sheathing is failing and exhibits holes.

Stephenson cornerrib (HA-570), looking SW

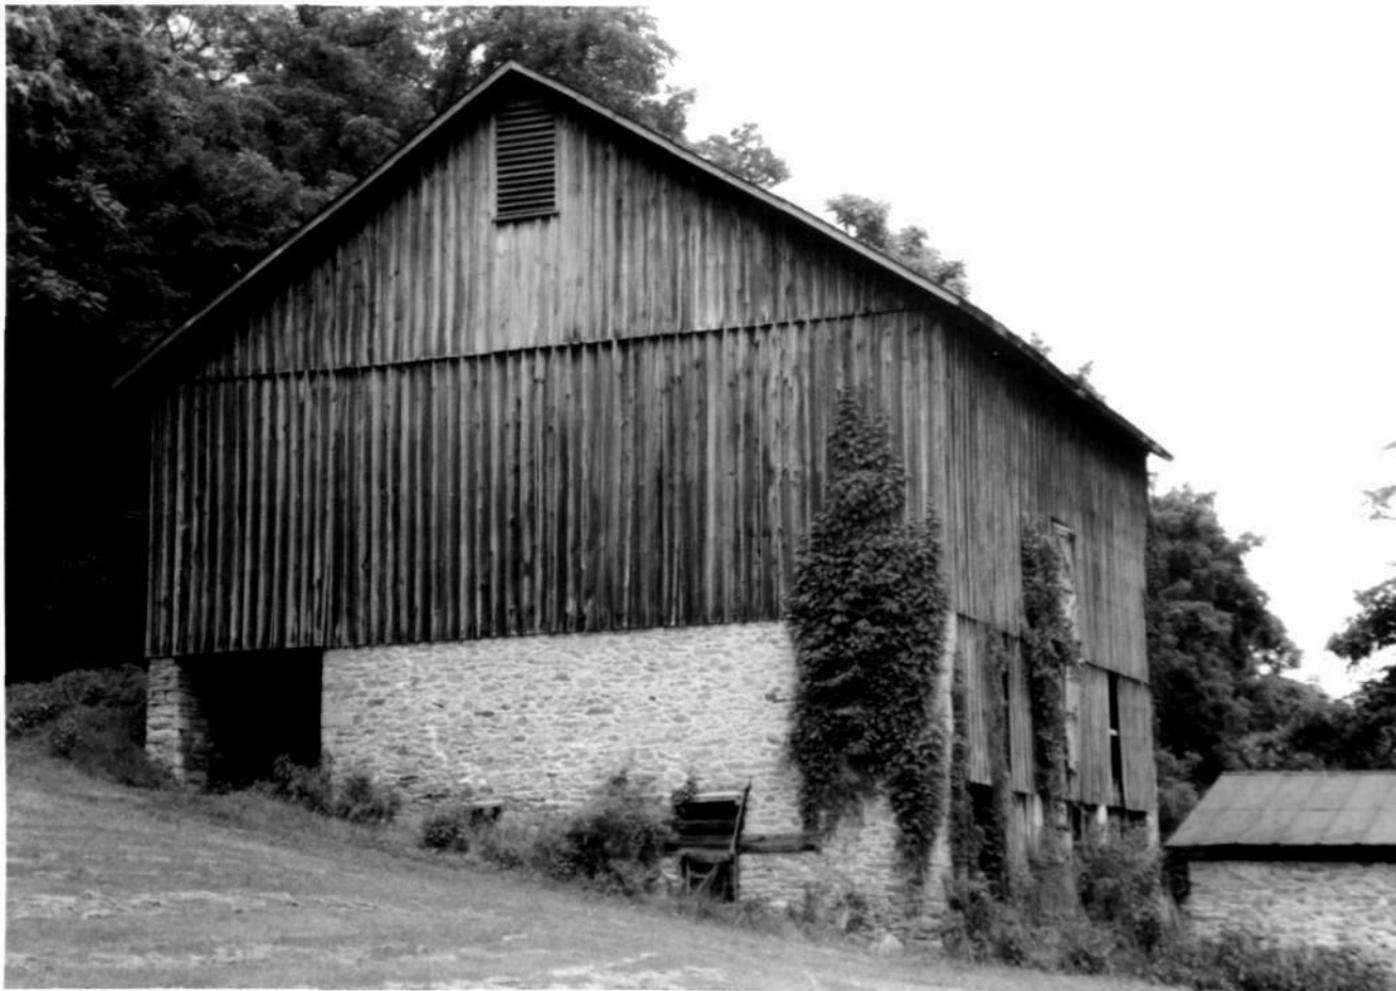
9/31

The large ca. 1880 bank barn (MIHP # HA-580) rests on coursed rubble stone sidewalls at the foundation level. The corners of the foundation walls have quoins. The upper portion of the barn is wood frame clad with board-and-batten siding. The side gable roof is sheathed in slate. The upper level of the barn is a three-part plan with a central threshing floor flanked by sunken hay mows. The interior framing comprises three upright posts and end posts that support a pegged tie beam across the width of the barn. This tie beam supports queen posts that support the purlins that support the roof. A ridgepole runs the length of the barn roof. The framing members were circular sawn. The barn is accessed on three levels: a ground level, a middle level, and an upper level. The ground level is accessed from the south elevation and served as animal pens. This elevation does not have a forebay. The middle level is accessed by the lower farm road that passes under the bank north of the barn foundation walls. This passage is wide enough for a wagon to unload hay into the sunken hay mows. The upper level is the threshing floor and is accessed on the north elevation across a wood ramp into the barn. The door on the north elevation is a sliding wood door. The walls have louvered openings. The barn is in fair condition. Deteriorated mortar was noted in the stone foundation walls. The louvered openings in the foundation walls and in the upper walls exhibit deterioration. Overall, the board and batten siding on the exterior walls exhibits signs of deterioration. Some elements are missing. The roof has some loose and missing slates. Some sagging beams in the barn framing may indicate structural problems.

A one-story animal pen is located south of the bank barn. Constructed ca. 1880, this four-bay rectangular building has coursed rubble stone walls along the west and south elevations; the north bay is enclosed with vertical board siding. The east elevation is open. The saltbox roof is sheathed with standing-seam metal. The animal pen is in fair condition. The animal pen exhibits missing mortar and water damage in its stone walls. Some cracking in the mortar joints of the walls also was noted. The sheet metal roof is rusting and is pulling away from the roof, allowing water into the pen. The animal pen is overgrown with vegetation, which should be removed.

and animal pen
Eightrupp barn (HA-580), looking NE

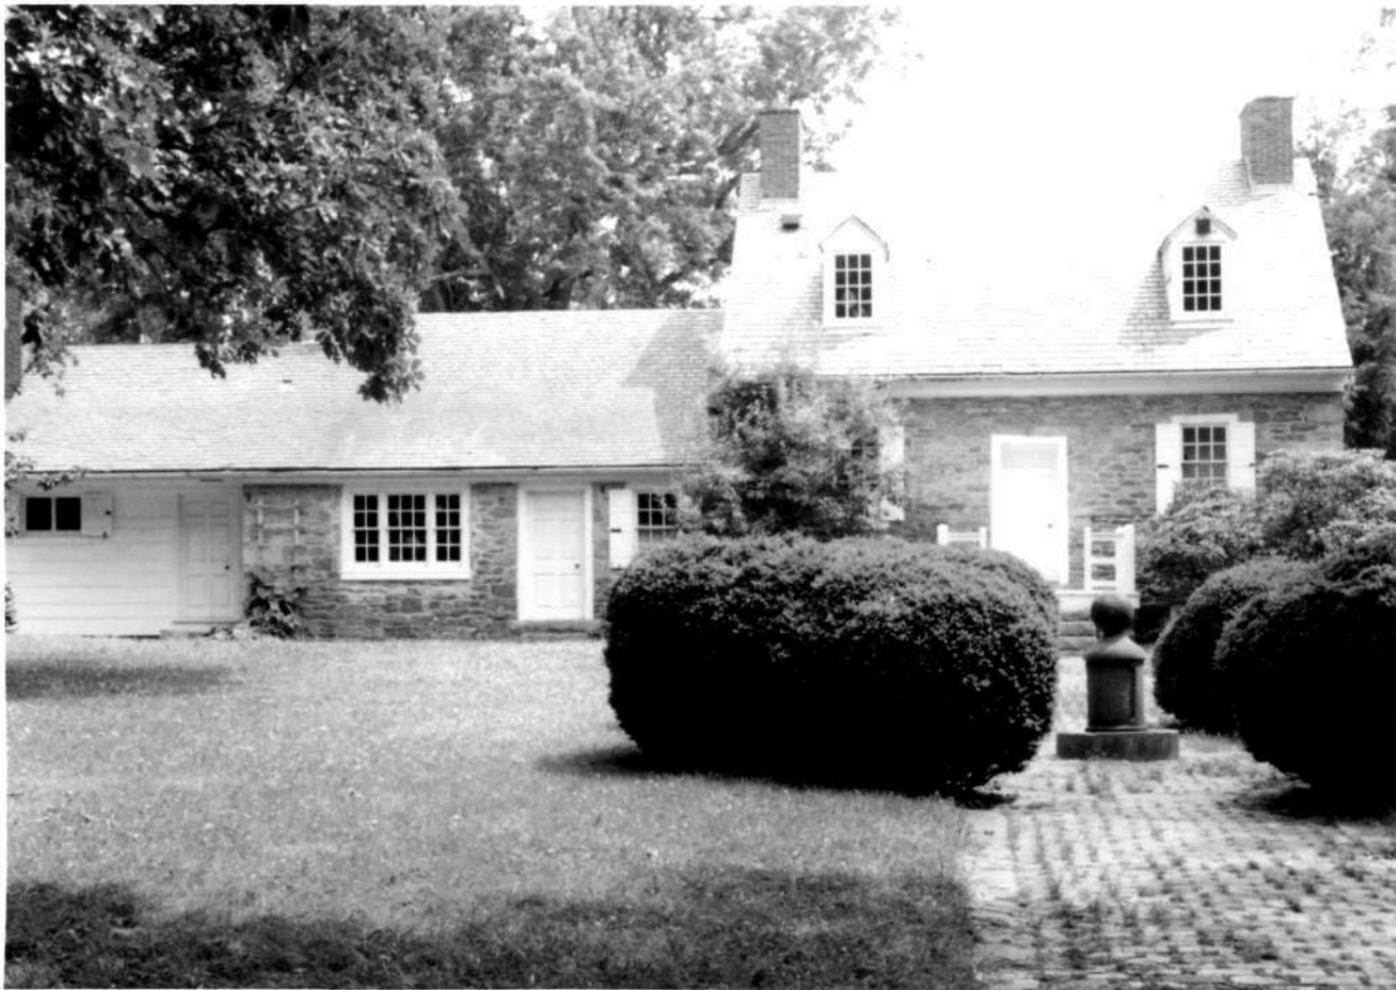
10/31

Land of Promise (the Former Paul Farmhouse) (MIHP # HA-575), located off Quaker Bottom Road at Steppingstone, is a telescope house consisting of three connecting sections, two of which are stone and one that is frame. Each section of the building rests on a low stone foundation. The exterior walls of the three-bay, one-and-a-half story main section and the one-story, three-bay wing are uncoursed rubble fieldstone. The gable roof is sheathed in slate. The eave has a projecting box cornice that separates two sets of moldings. Each stone section has central doorways. The main doorway in the one-and-a-half story section contains a six-panel door flanked by full length, louvered shutters. Two identical windows flank the main entry. The windows are wood frame, six-over-nine-light units and with three-panel wood shutters. The windows in the one-story stone section are six-over-six-light and four-over-four-light units. The one-story, two-bay frame kitchen wing was constructed ca. 1950 and is clad in wood lap siding. The kitchen wing was designed by architects Wrenn, Lewis and Jencks (Wollon 1996:136). The house is in good condition. Some slate shingles were missing along the rear roof. Paint failure was noted on the rear dormers. Rising damp was noted along at the rear elevation.

Land of Promise (HA-575), looking S

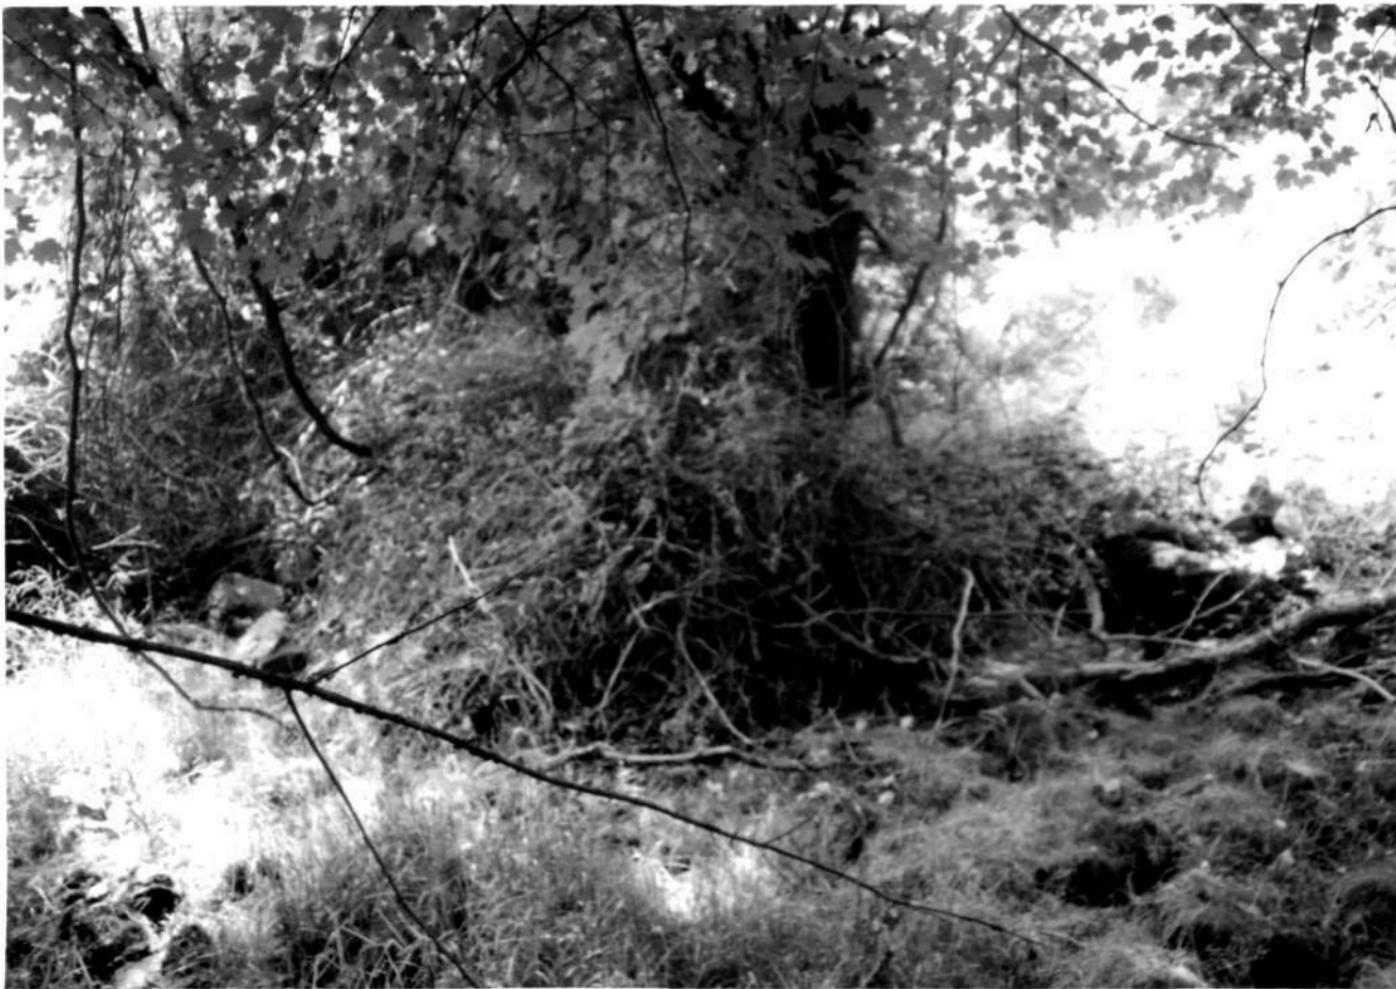
15/31

The Daneker property also contains the William Silver Springhouse (MIHP # HA-386). The springhouse is located in a swale north of the Daneker barn. The swale is currently overgrown by a thick bramble patch. The one-story, stone springhouse appears to have been knocked over and the stones scattered. It probably was associated with an earlier occupation of the property, not the twentieth-century farmstead. Only two to three courses of stone from the foundation are left standing. The building no longer has integrity of design, setting, materials, workmanship, feeling, or association. The William Silver Springhouse is now a ruin.

Silver Springhse (HA-386), looking W

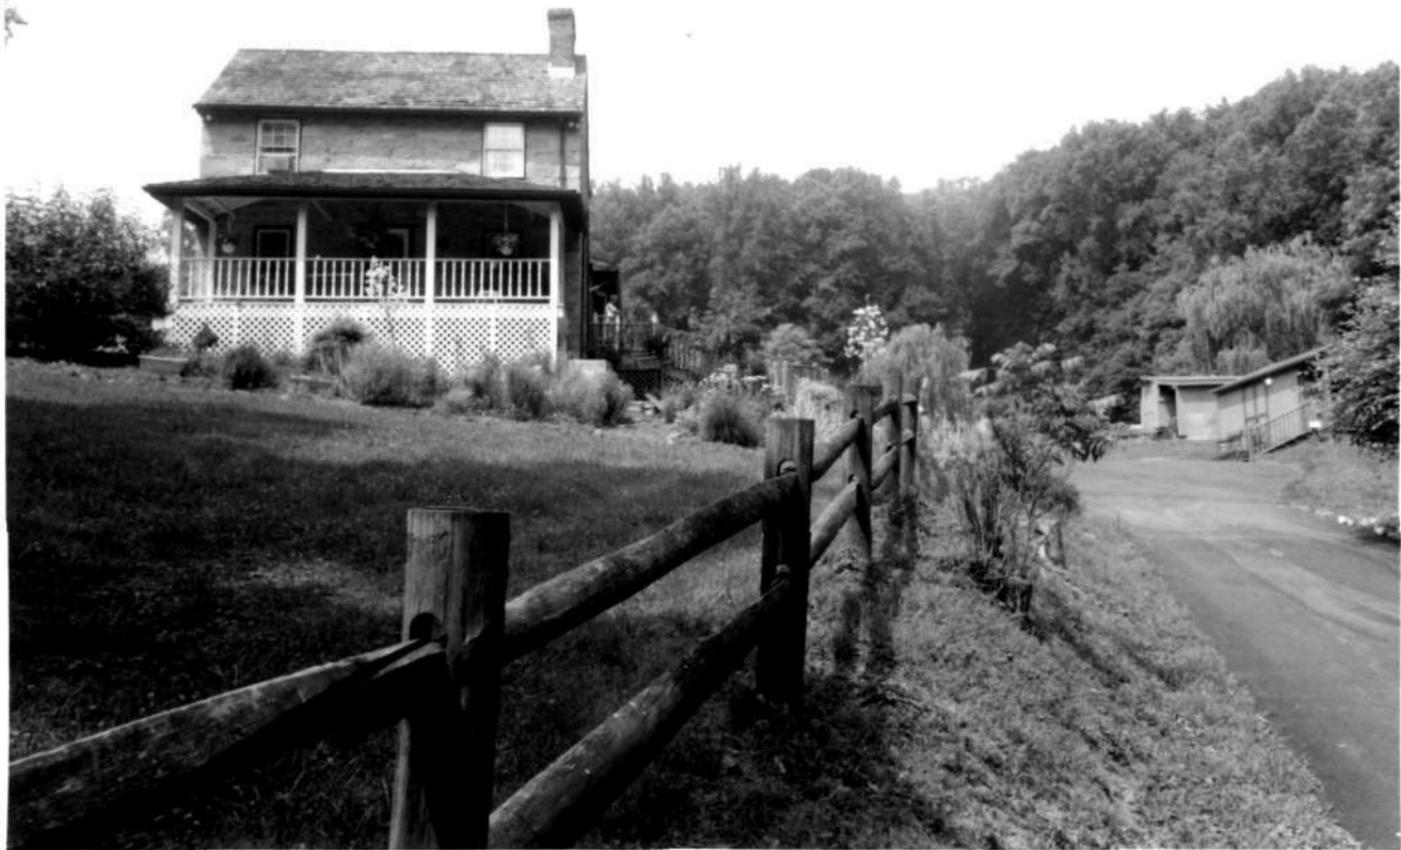
21/31

The JOHN ARCHER STONE HOUSE (MIHP # HA-573), constructed ca. 1800, is sited on a slope off Rock Run Road. The two-story, three-bay by one-bay, rubble stone house has a full basement and a stone water table. The stone walls feature large stone quoins. Doorways to the basement and first floor occupy the center bays of both floors and contain three-panel wood doors; the door on the first story is a replacement (Curry 2002). The window and door openings have simple wood casings. The windows were all replaced during the renovation of the building (Curry 2002). The side gable roof is sheathed with wood shingles and has a box cornice on the front elevation. A brick endwall chimney with a corbelled cap projects from the north elevation. A full-façade porch spans the front (east) elevation. The porch is supported by square porch supports. Following MHT surveys conducted in 1976 and 1979, this building entered the MdDNR curatorship program and was renovated. In 1984, Mrs. Curry, the curator, reported that the roof was ruined and all windows were missing. The curators gutted the interior and rebuilt it. A large two-story addition was constructed on the rear of the stone house (Curry 26 June 2002). The trees that once reached to the back of the building were cut and pastures were carved out of woodlands. The springhouse located north of the house is a ruin. The barn foundation, reported as the "bird house ruins" (MIHP # HA-574), was incorporated into a modern outbuilding. Four other various sized sheds on the property were constructed by the curators. The John Archer Stone House is not described in the 1993 Lower Deer Creek Historic District National Register nomination form, but should be considered a contributing resource to the district. The main house is in excellent condition. Minor mortar erosion was noted on the chimney stack.

John Archer Stone Hse (HA-573), looking SW
