SUSQUEHANNA RIVER BASIN COMMISSION

Chemung Subbasin Survey: A Water Quality and Biological Assessment, June - August 2006

The Susquehanna River Basin Commission (SRBC) conducted a water quality and biological survey of the Chemung Subbasin from June to August 2006. This survey is part of SRBC's Subbasin Survey Program, which is funded in part by the United States Environmental Protection Agency (USEPA). The Subbasin Survey Program consists of two-year assessments in each of the six major subbasins (Figure 1) on a rotating schedule. This report details the Year-1 survey, which consists of point-in-time water chemistry, macroinvertebrate, and habitat data collection and assessments of the major tributaries and areas of interest throughout the Chemung Subbasin. The Year-2 survey will be conducted in the Cohocton River Watershed over a one-year period from spring 2007 to spring 2008.

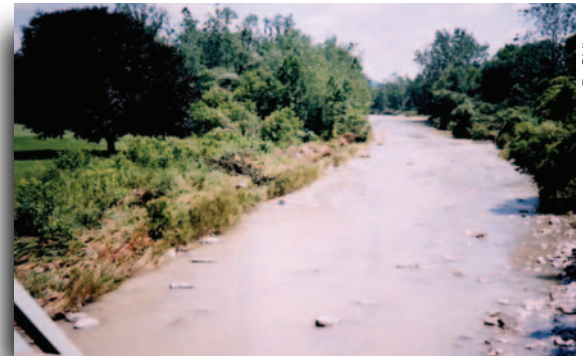
Troups Creek after high water near the PA/NY state line.

in-stream conditions. Troups Creek also was sampled quarterly as part of the Interstate Streams Monitoring Program at the Pennsylvania/New York state line from July 2004 to June 2005. The macroinvertebrate community sampled in July 2004 was rated slightly impaired, and the habitat was supporting. This Interstate Streams Program site was similar in quality to the upstream Subbasin Survey Program site, TRUP 5.8, and also had elevated aluminum and iron, possibly from eroding stream banks (see photograph on page 8).

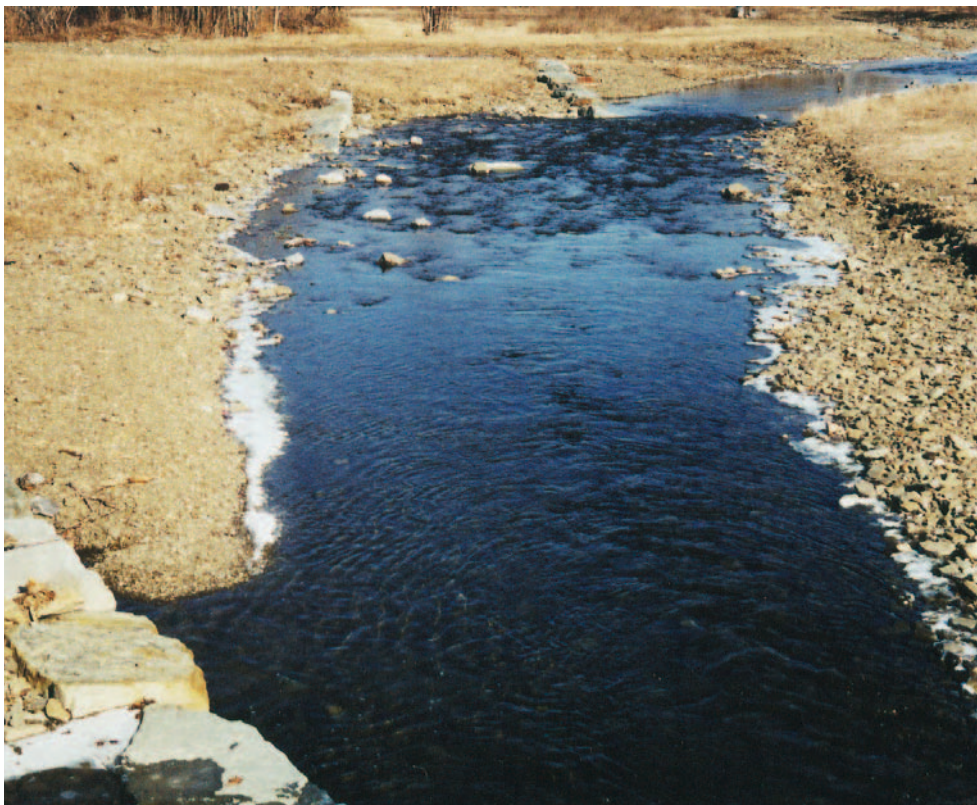
Bentley Creek stream channel restoration project near the PA/NY state line.

Bentley Creek also had nonimpaired biological conditions and “higher” water quality at the mouth in New York State. Conditions at both upstream sites in Pennsylvania were slightly impaired, most likely due to habitat conditions, which were rated nonsupporting at the most upstream site. Dredging, regrading, and other such disturbances were evident in Bentley Creek, resulting in low scores for channel condition, instream cover, velocity/depth, channel flow status, and channel alteration. The water chemistry analysis at the uppermost site indicated high turbidity, total suspended solids, total phosphorus, iron, and aluminum values. The phosphorus and metals were probably from soil particles in this highly turbid sample. Currently, impairment at the upstream sites does not seem to impact the site at the mouth of Bentley Creek, but may in the future.
