WICOMICO AIRPORT WETLAND MITIGATION

Wetland Mitigation Monitoring

3rd Year Phase 1 Annual Report

2nd Year Phase 2 Annual Report

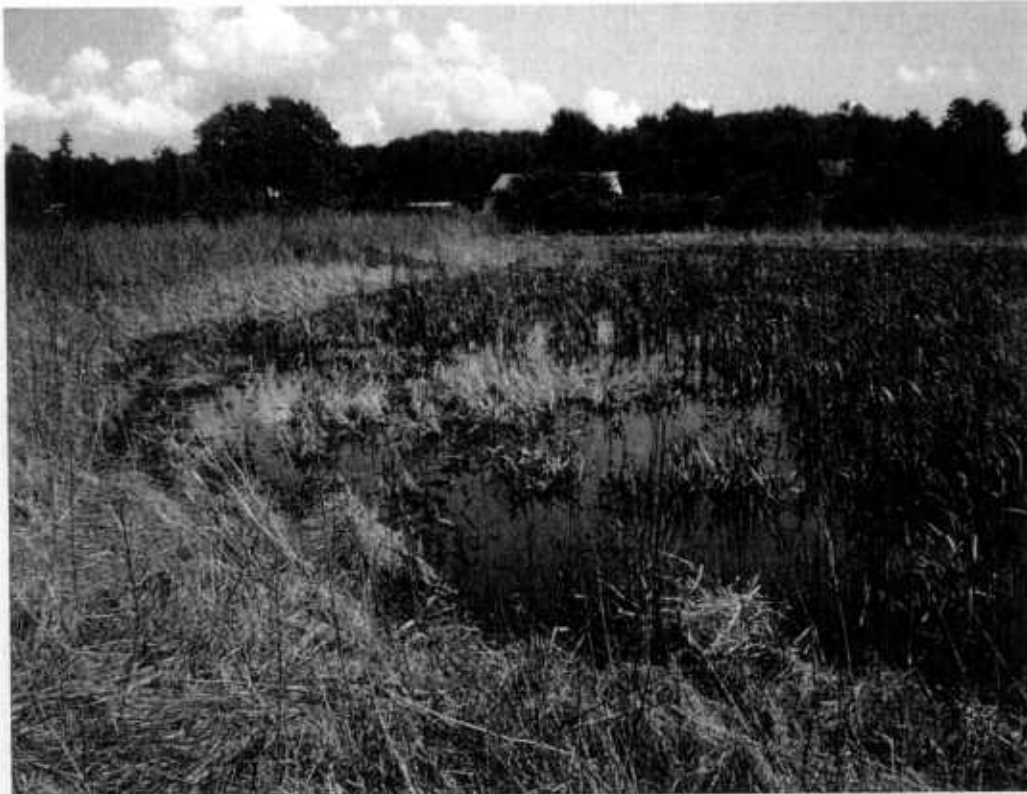
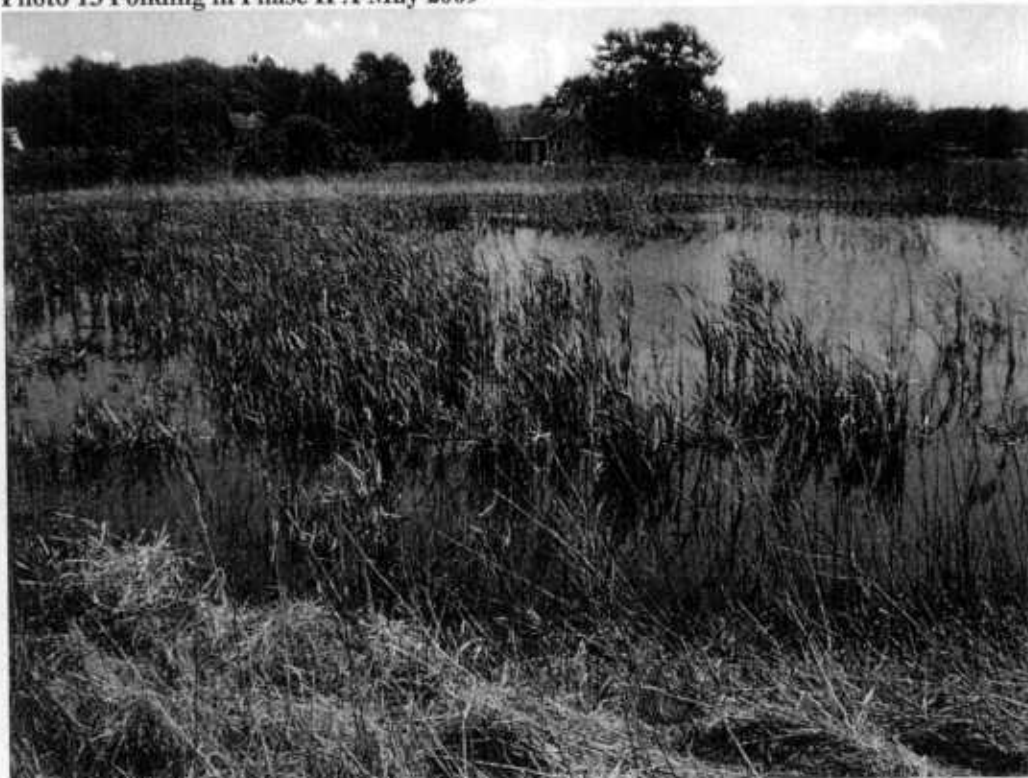
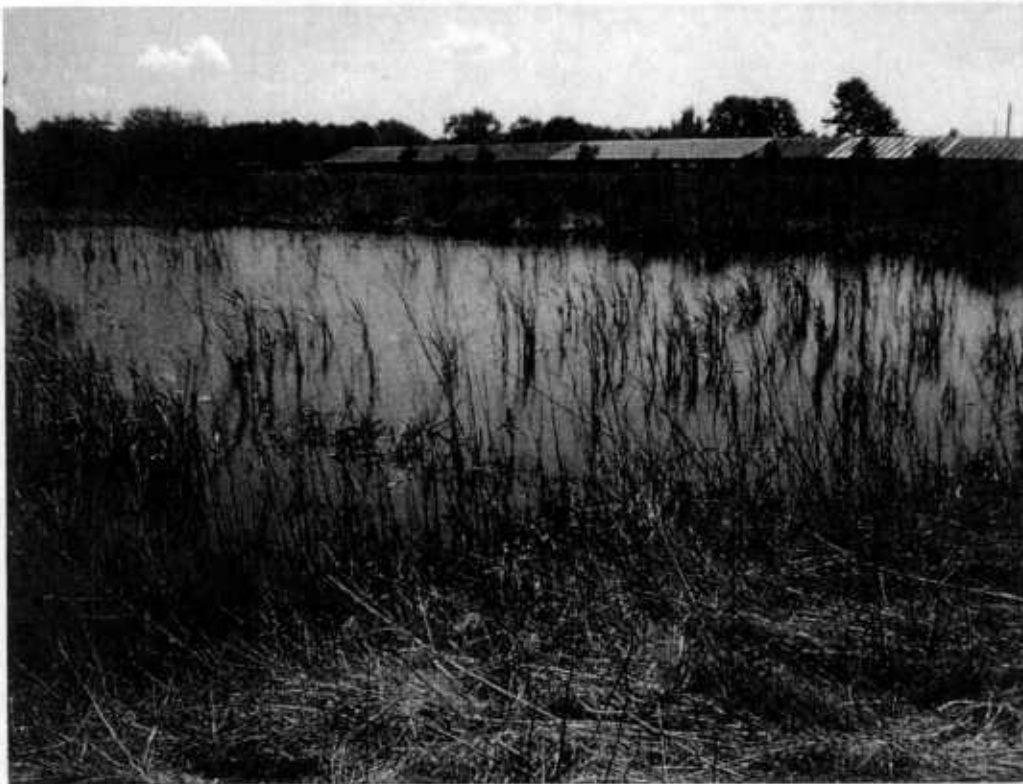
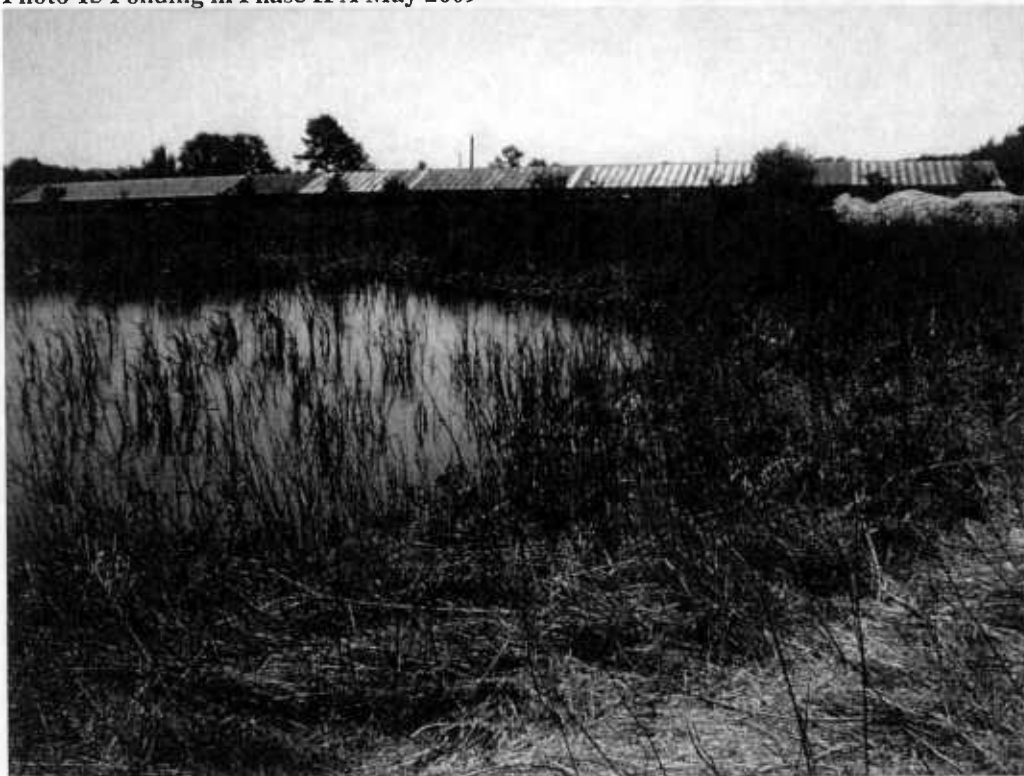
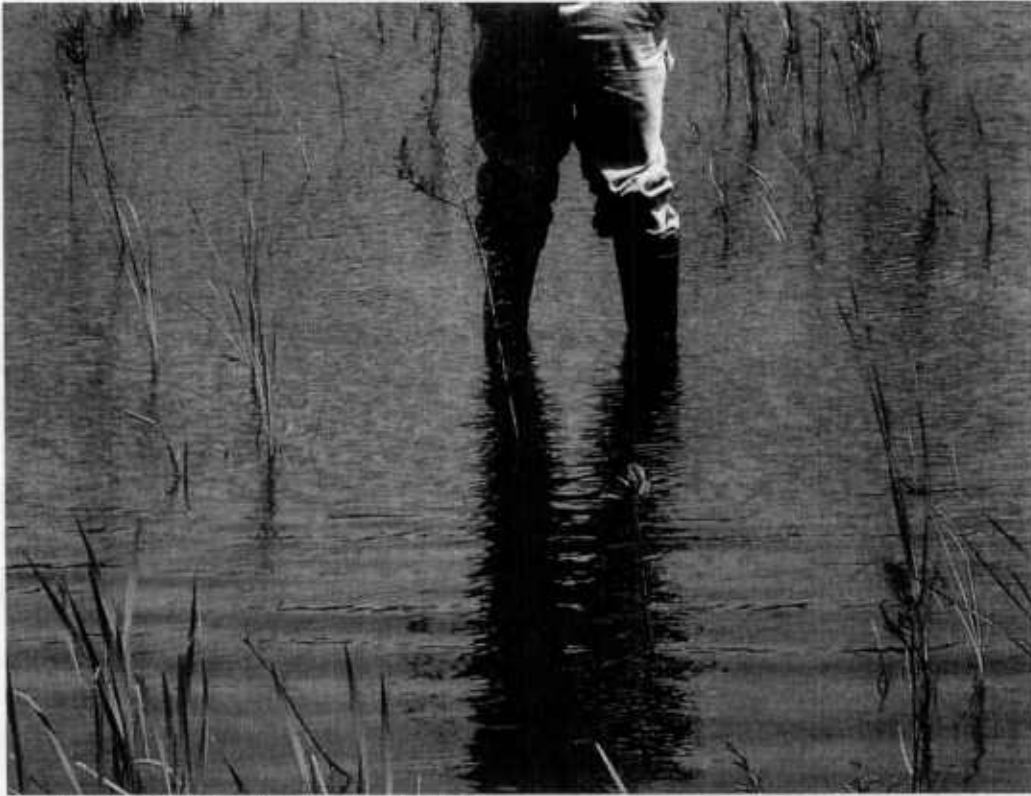
Photo 13 Ponding in Phase II A May 2009

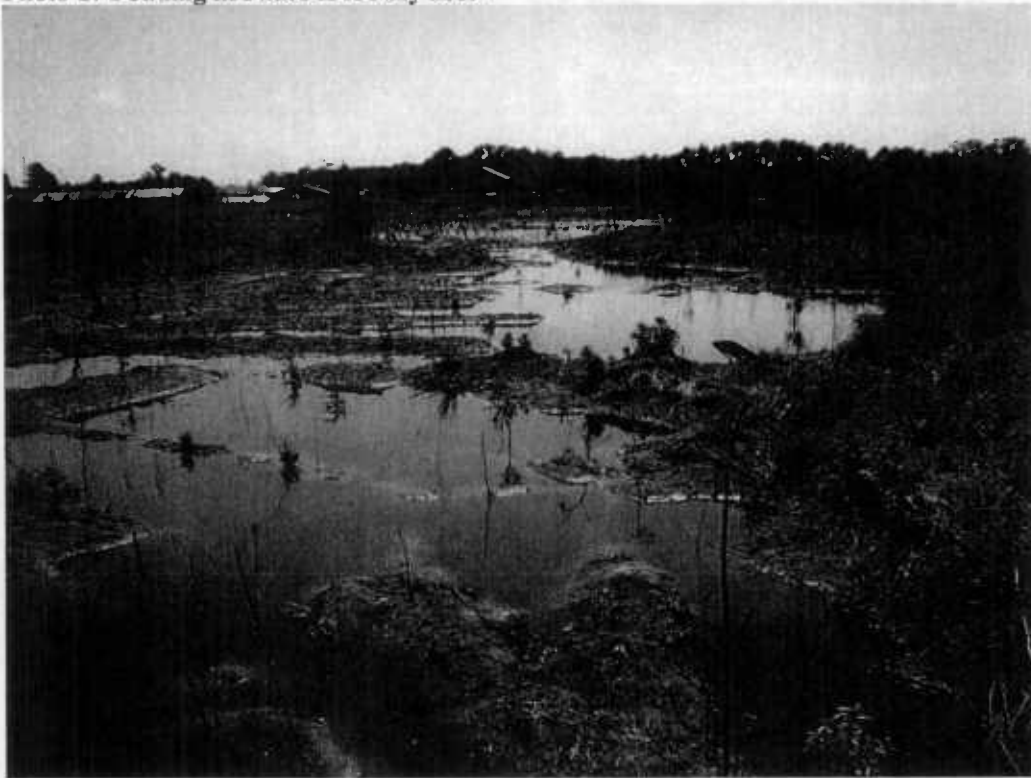
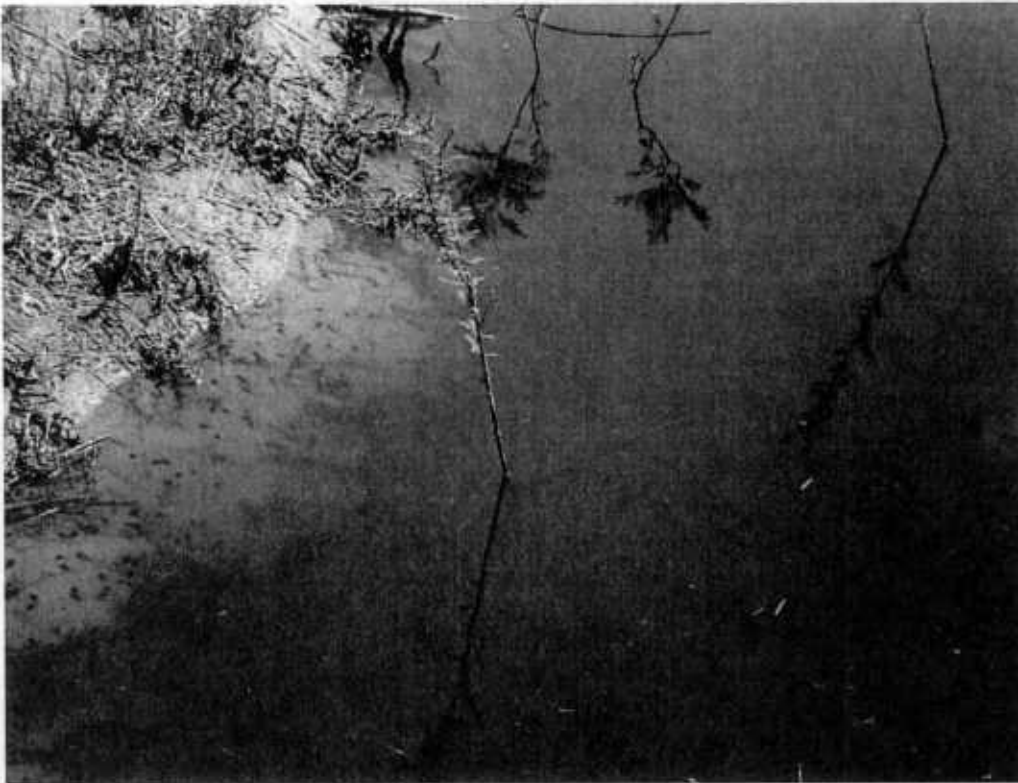
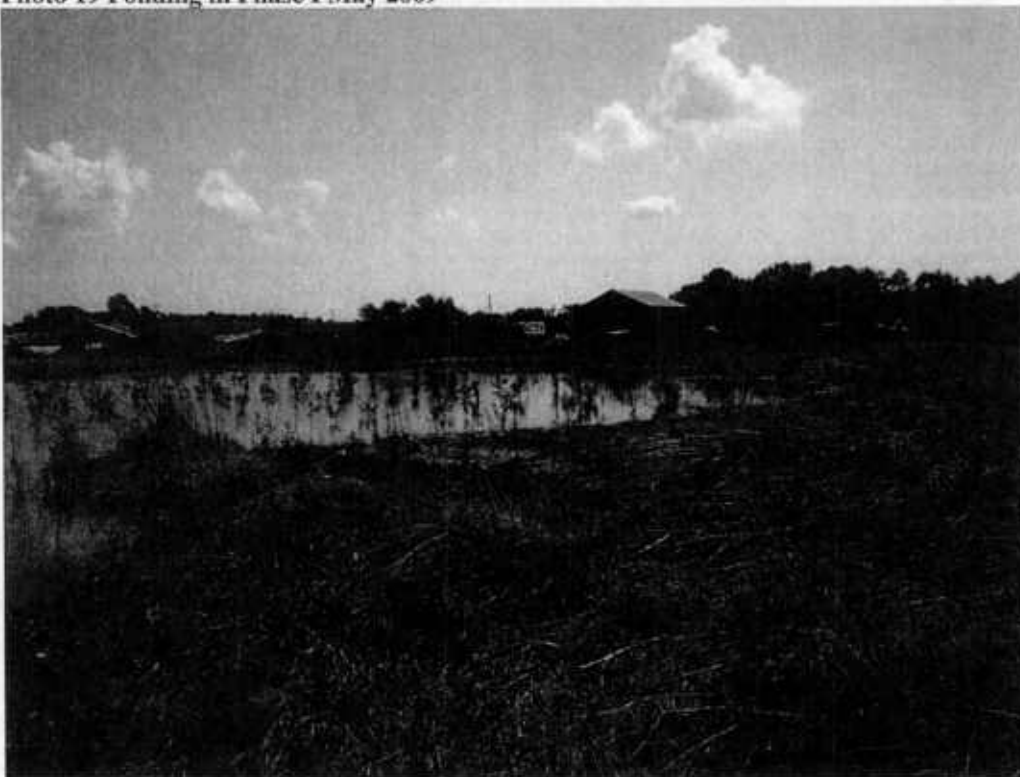
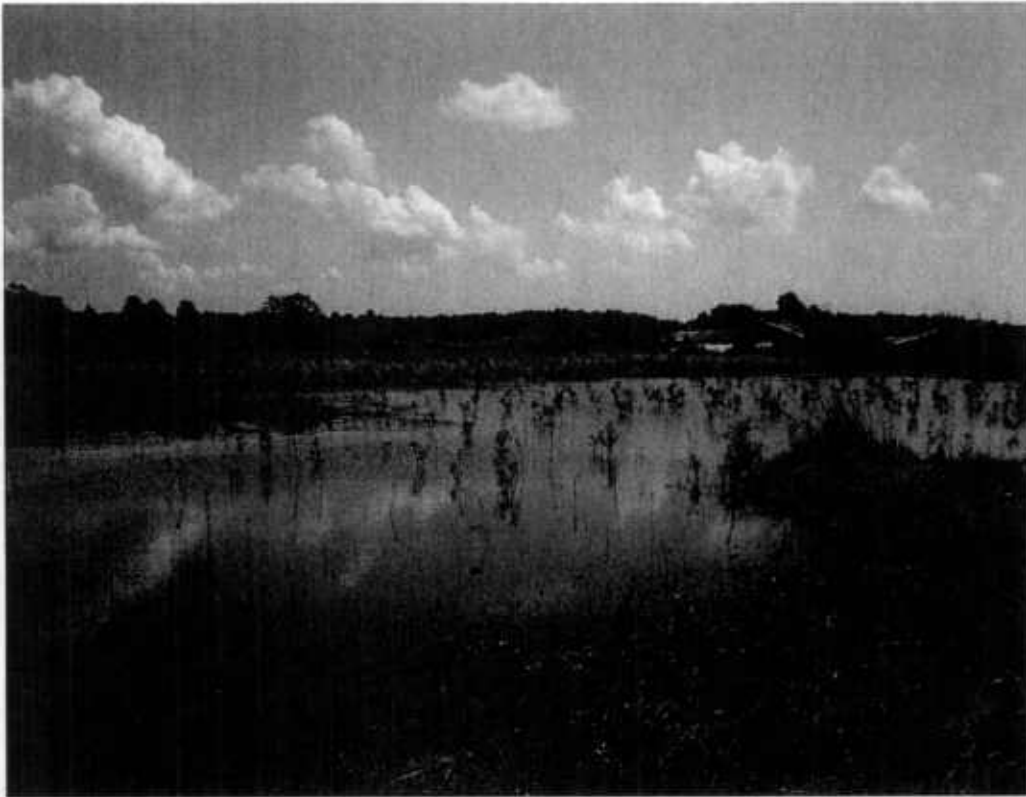
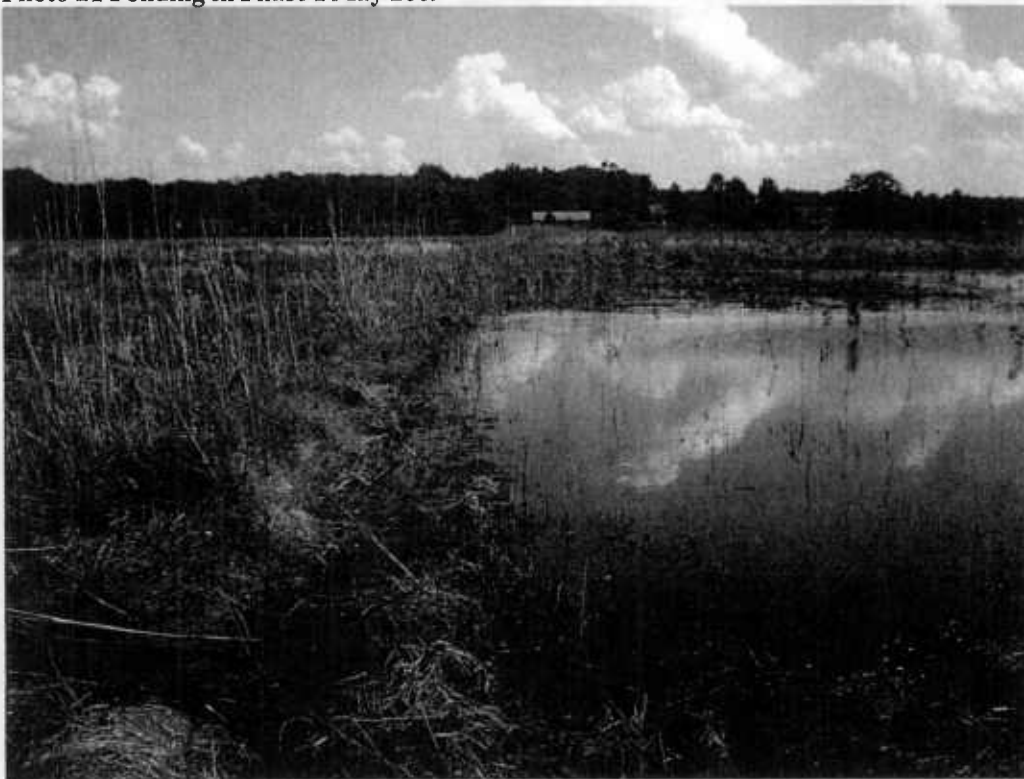
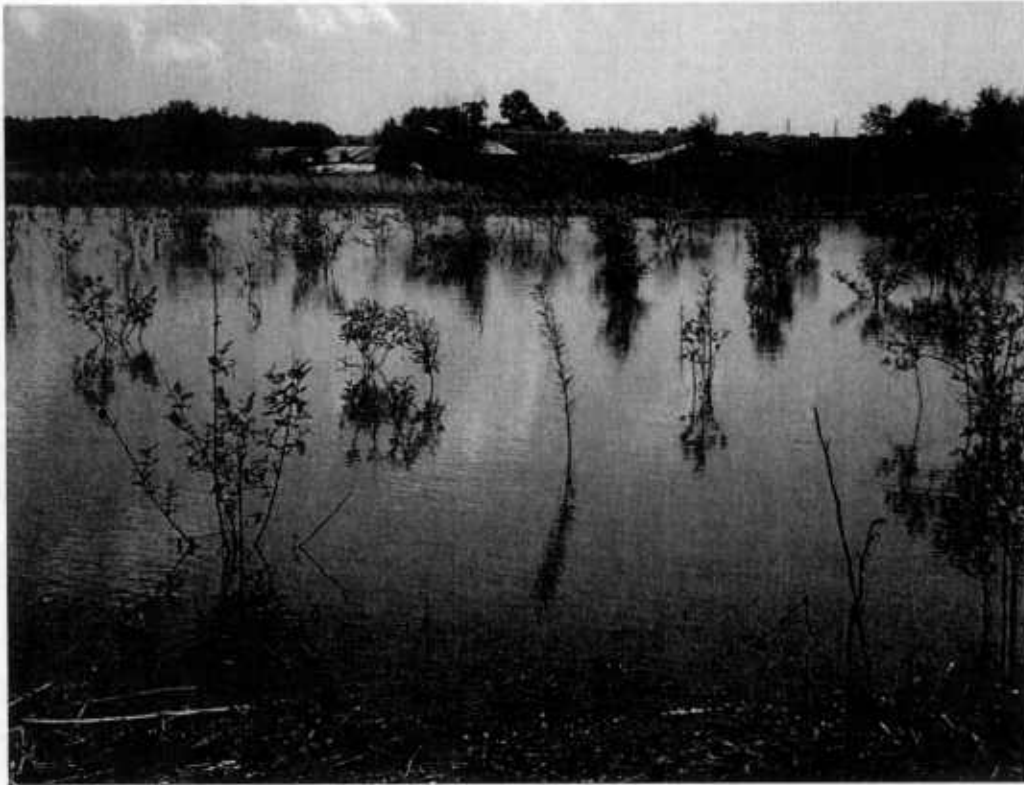
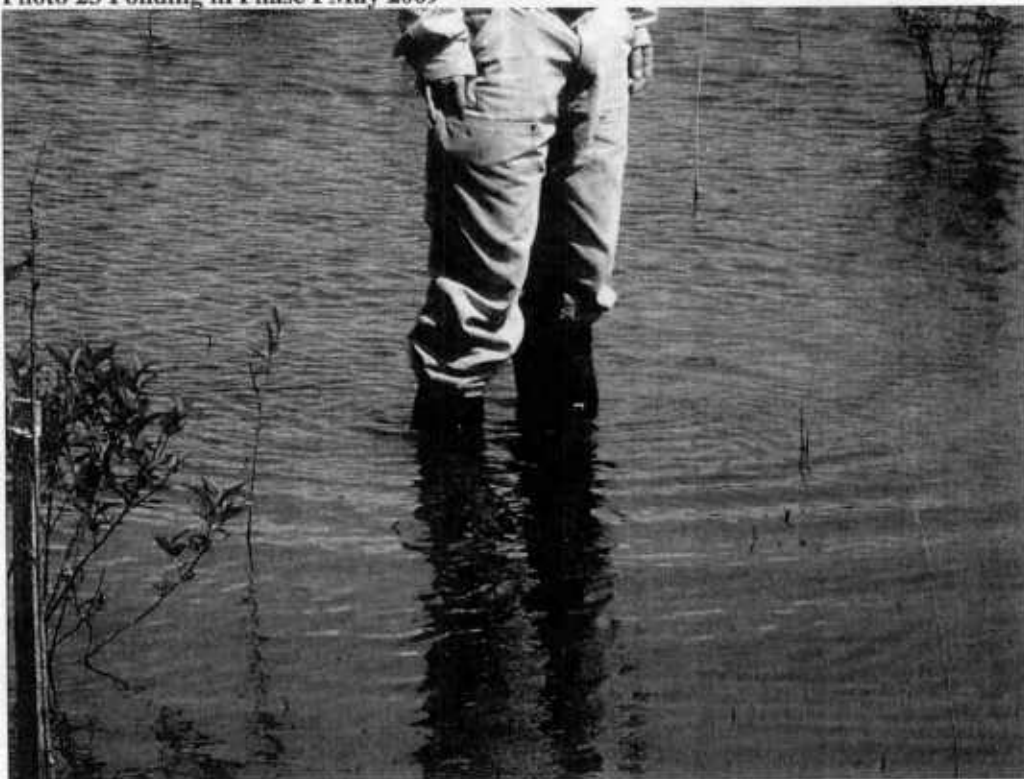
Photo 18 Ponding in Phase I May 2009

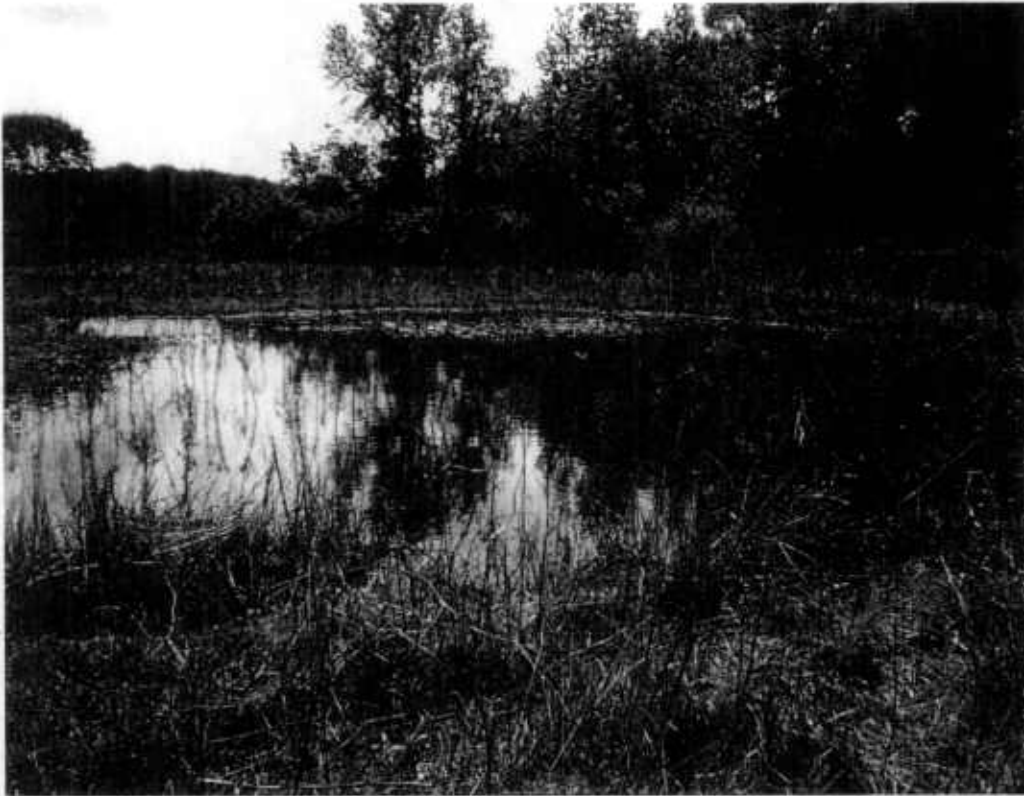
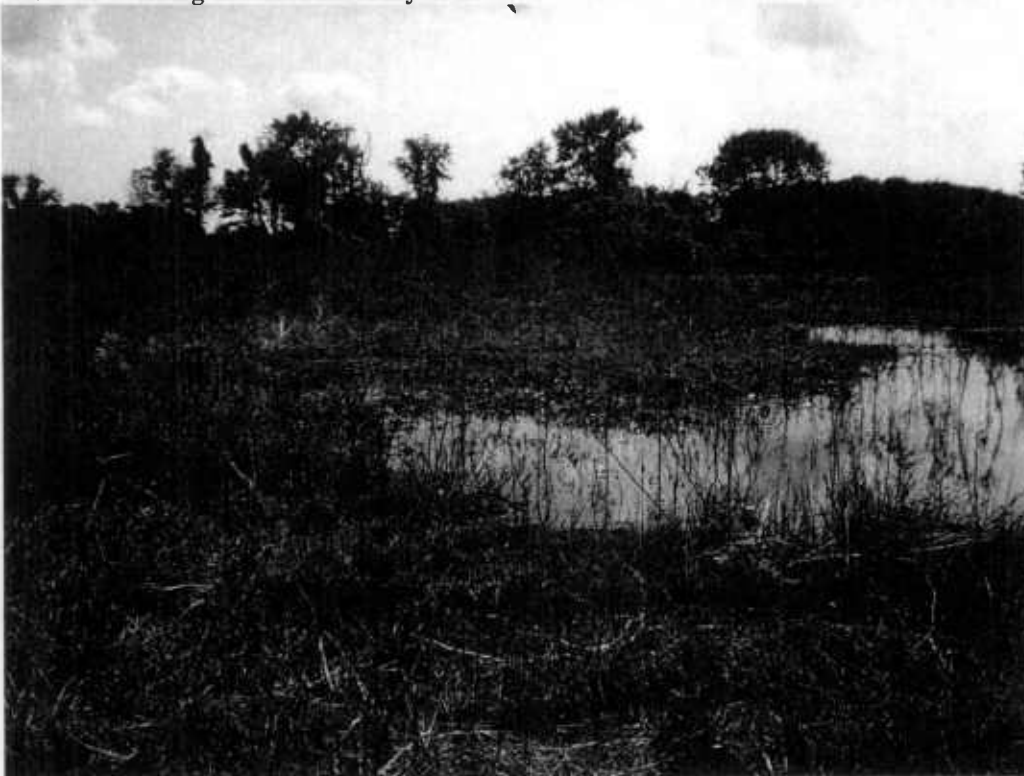
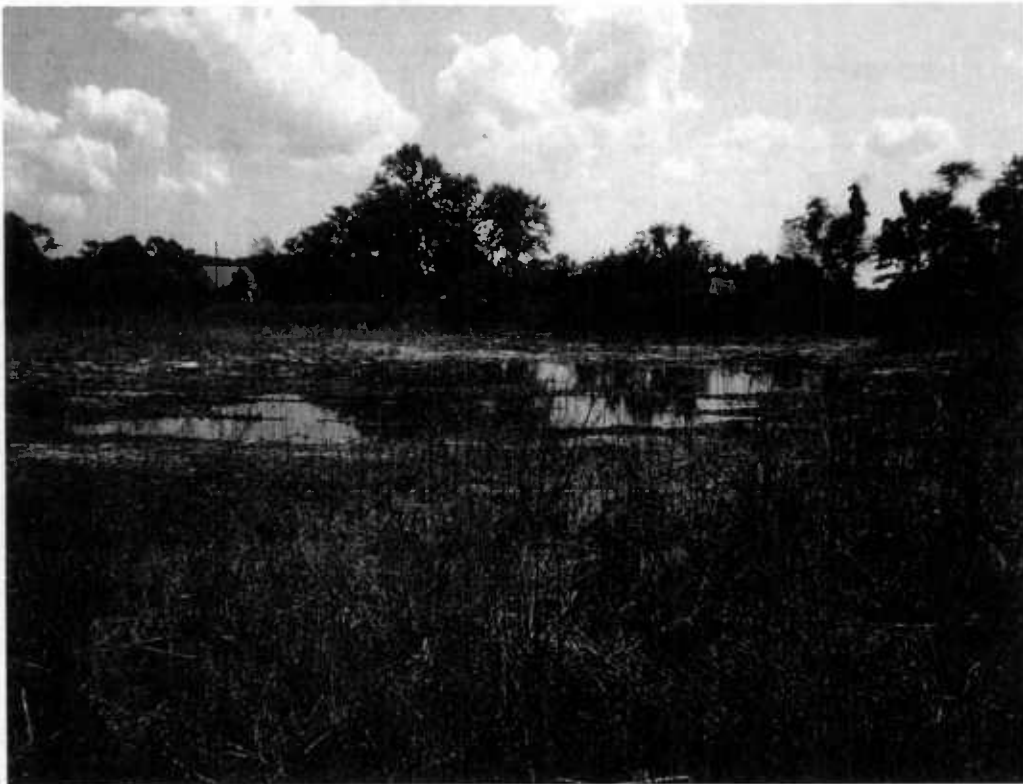
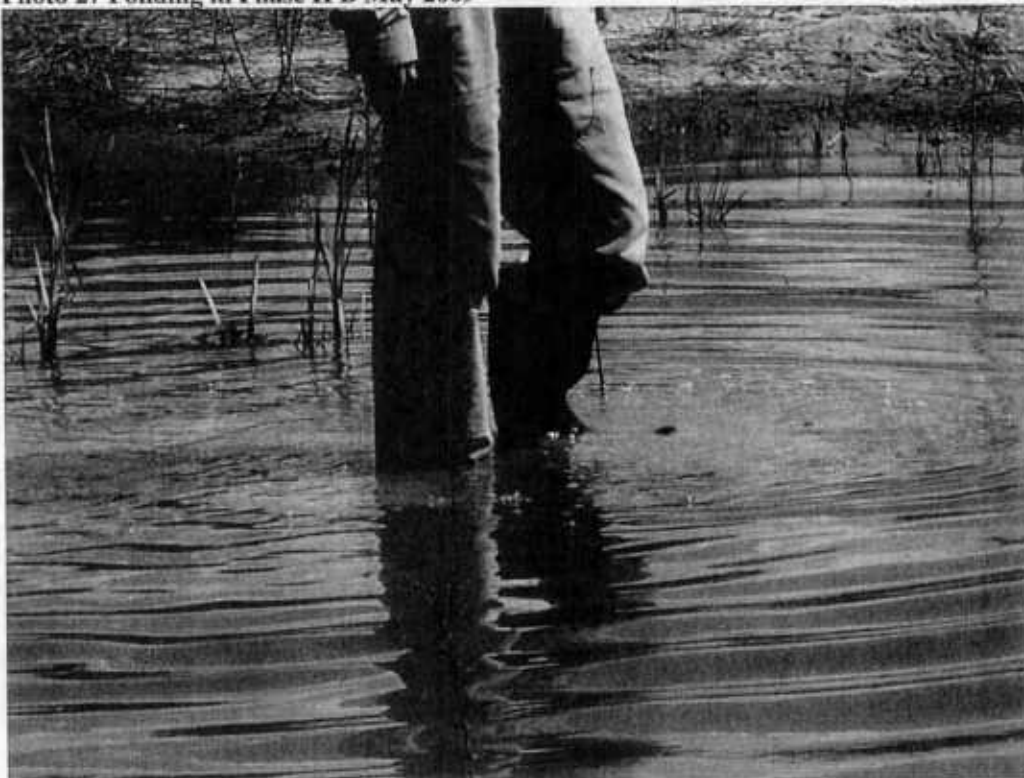
Photo 25 Ponding in Phase II B May 2009

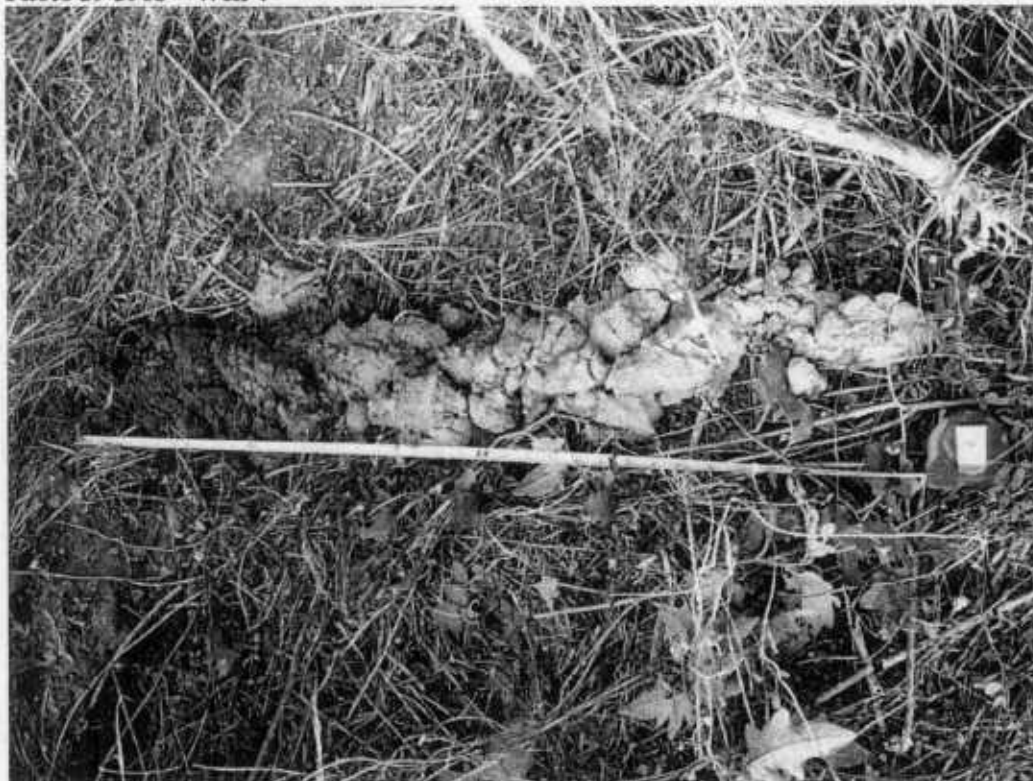
Photo 40 3904 – Well 4 Soil

Soil at Well 4: Similar to 2008, a gley matrix color was observed at a depth of 32" in 2009. The gley matrix color observed at approximately 30" within soil profile in 2008 and again in 2009 confirms the water table is present at a higher elevation in the soil profile for as extended period of time in comparison to 2007 observations. Although the 2007 soil profile was described during the initial mitigation monitoring year for Phase 1, this description was used as an additional reference for Phase 2. The redox concentrations in 2009 were present lower in the profile than in the previous monitoring year, potentially a result of characteristic variability among soil sample locations. In 2009, soil saturation and free water was observed significantly higher in the soil profile. Depth to soil saturation was 36" and 21" and depth to free water was 30" and 18" in 2008 and 2009, respectively. Within the mitigation monitoring timeframe (2008 and 2009), no significant soil characteristics changes were observed within the soil profiles.

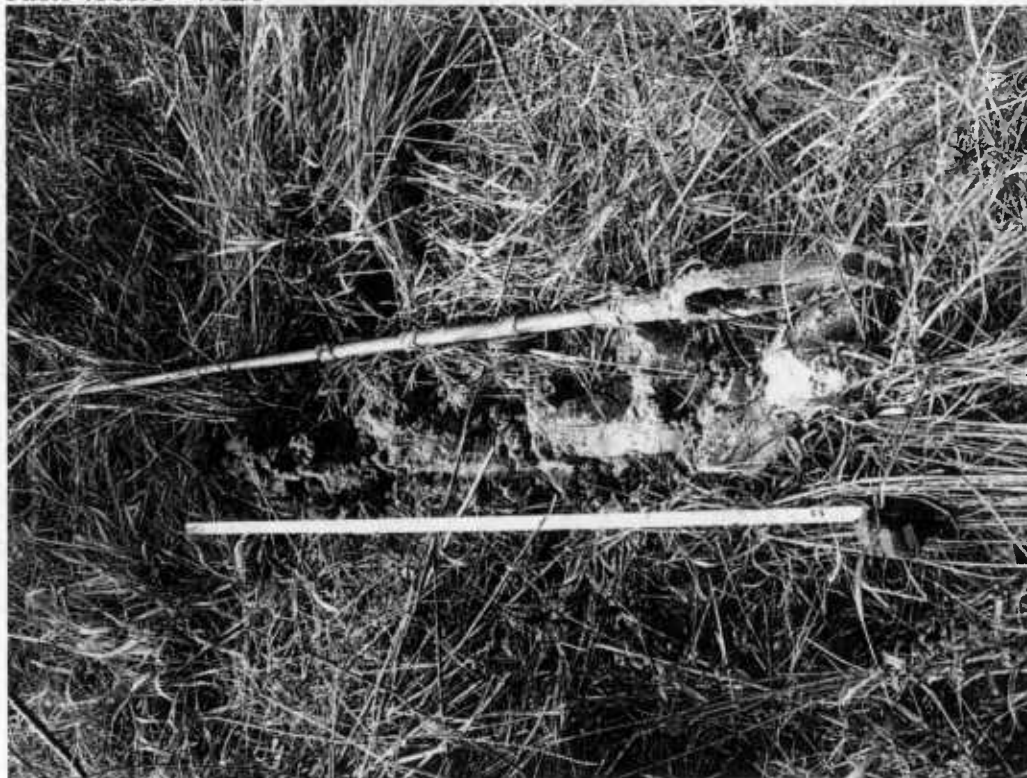
Photo 42 3892 – Well 5 Soil

Soil at Well 5: This year the soil profile exhibited redox concentrations at a depth of 15", approximately 5" higher in the profile than observed in 2008. The gley matrix color also observed higher within the soil profile (depth of 30") than in previous monitoring years. The gley matrix color in 2007 was observed at a depth of 36", while no gley matrix was observed in 2008 due to depth restriction from the auger hole collapsing under saturation. In 2009, soil saturation was observed at a depth of 14" and free water occurred at 20". The soil characteristics and water table observations in 2009 confirm the water table is present at a higher elevation in the soil profile for extended periods of time than in the 2007 and 2008 mitigation monitoring years.

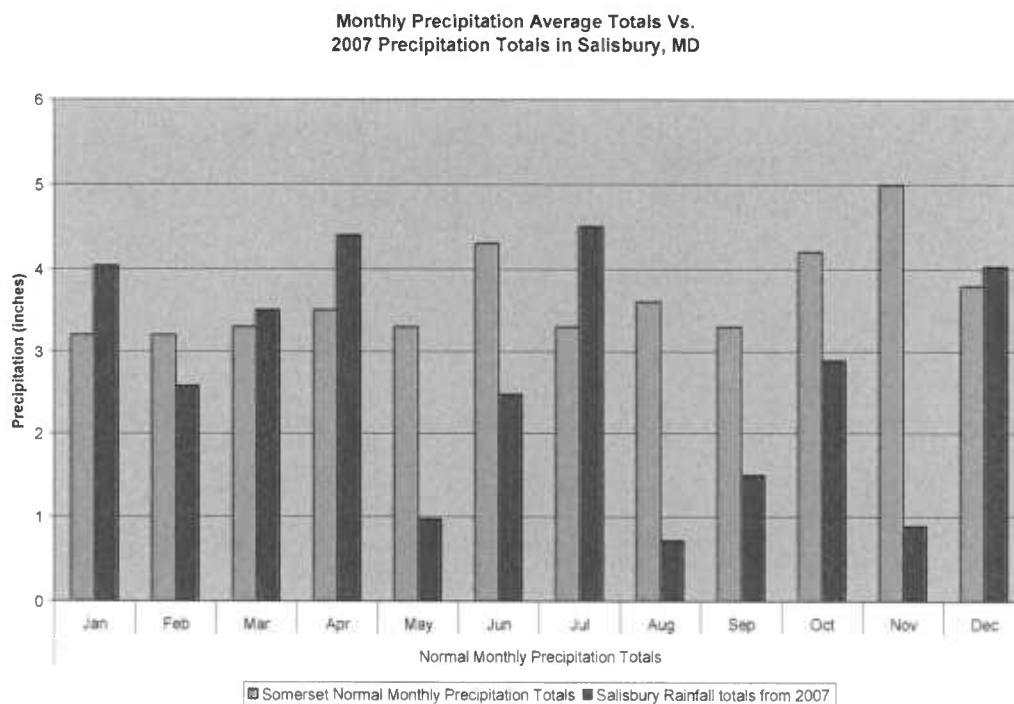
Figure 4. Monthly Precipitation Average (1971-2000) Totals vs. 2007 Monthly Precipitation Totals

The growing season of 2007, was an unusually dry year with only half the amount of the average precipitation from data dating 1971-2000 for Salisbury, Maryland. This year there were two peak rainfall events one on April 15th with 2.42 inches and 1.23 inches on June 4th. Aside from these precipitation events, rainfall during the growing season was almost absent. The groundwater at each of the five wells was found to be at least 2.5 – 4.5 ft. below the surface during the growing season (Figure 5).
