**FINAL CONSOLIDATED REPORT**

**RECONNAISSANCE OF THE PROPOSED  
ENVIRONMENTAL RESTORATION PROJECT  
NEAR BARREN ISLAND  
DORCHESTER COUNTY, MARYLAND**

**MARYLAND ENVIRONMENTAL SERVICE**

August 2002

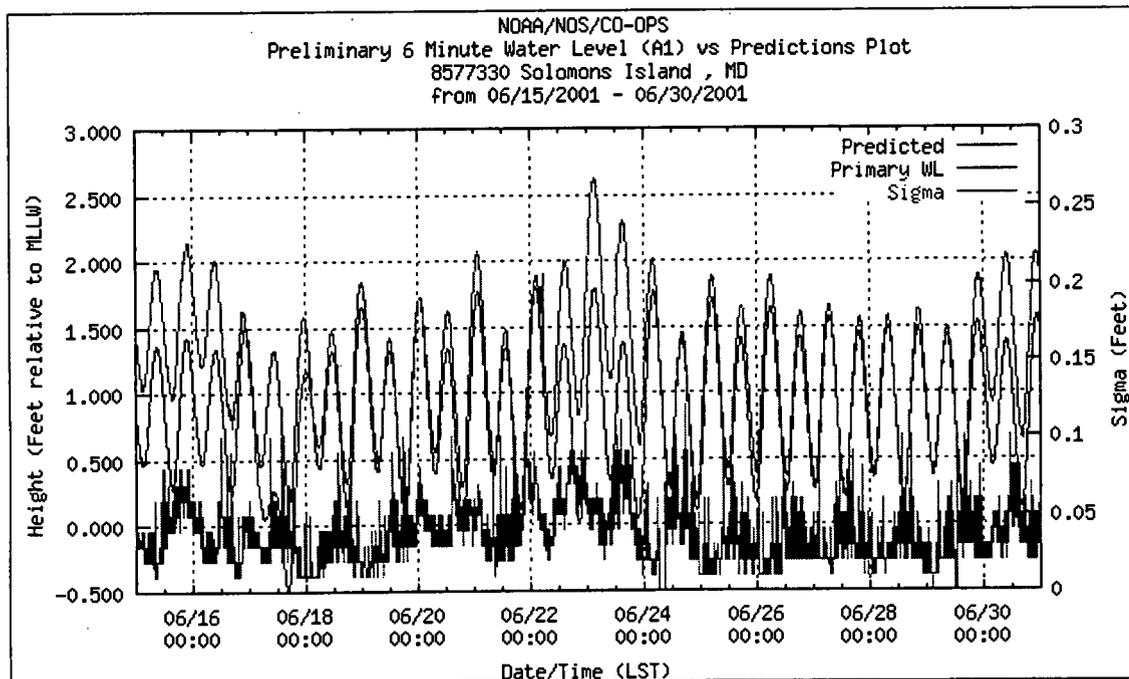
**Figure 5: Predicted and observed (Primary WL) water levels at the Solomons Island, MD NOAA Station for the period beginning June 15, 2001 and ending June 30, 2001.**

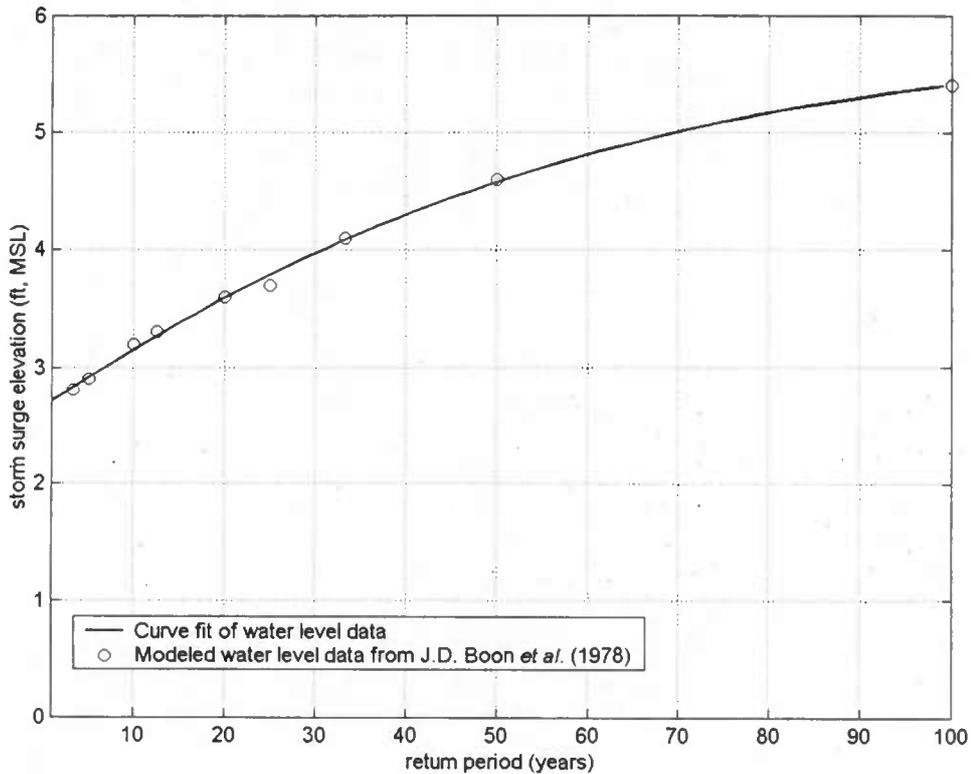
**Figure 6: Modeled storm surge elevations versus return period at Solomons Island, MD. The curve fit provides surge elevations at return frequencies not modeled.**

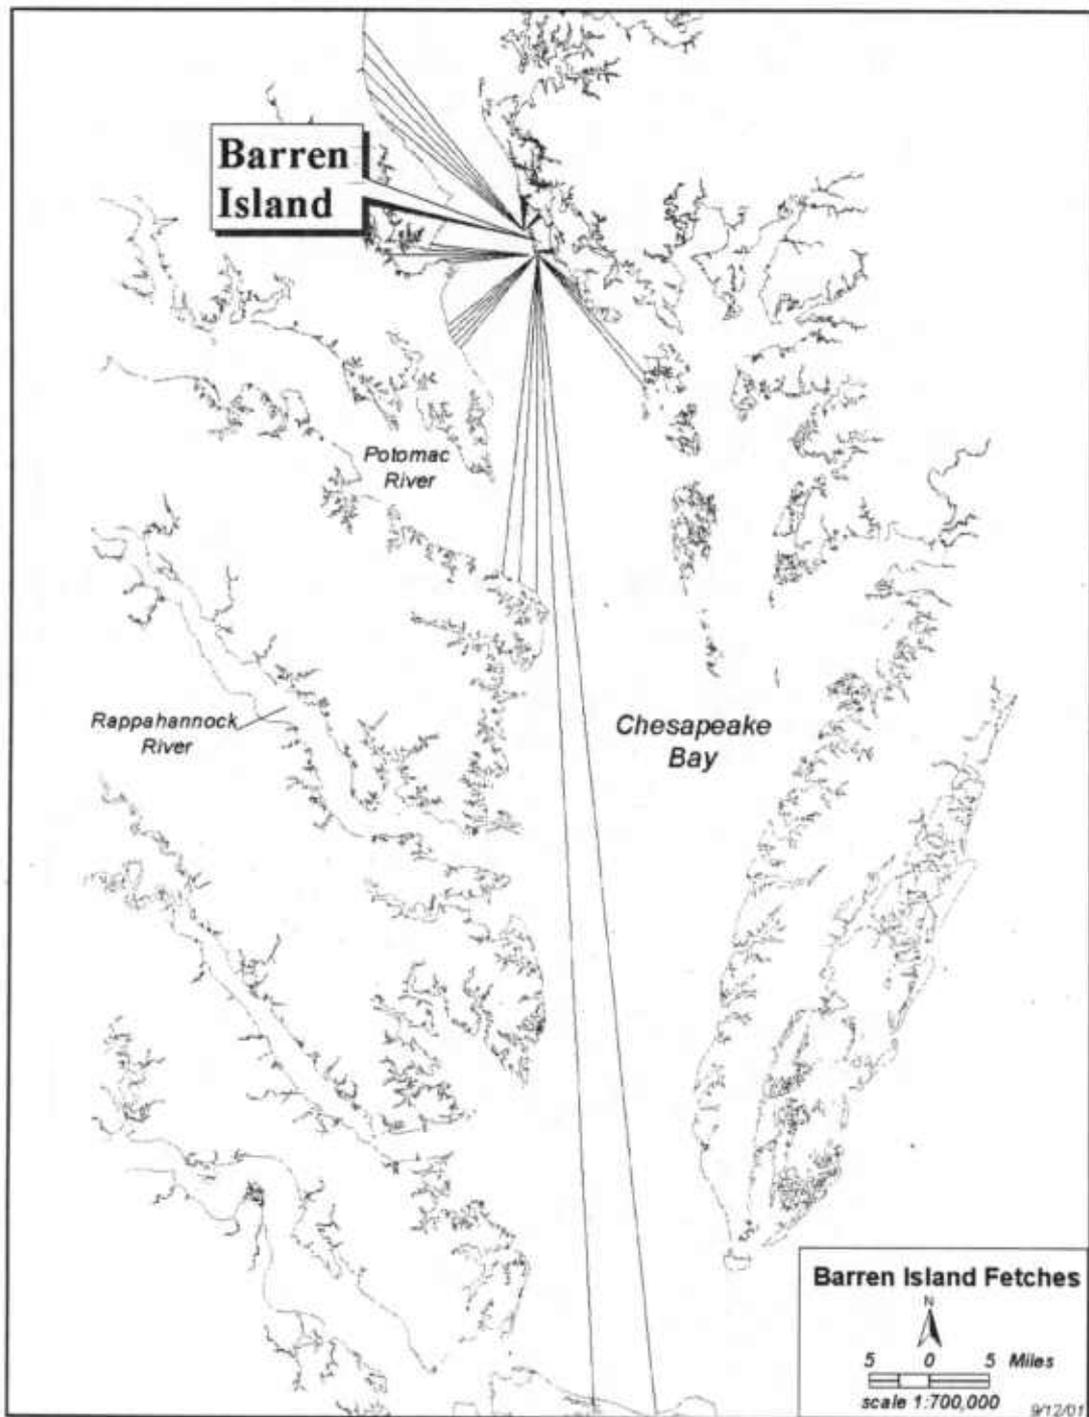
Figure 7: Fetches used to determine average distances and depths for the analysis of wind-waves approaching Barren Island.

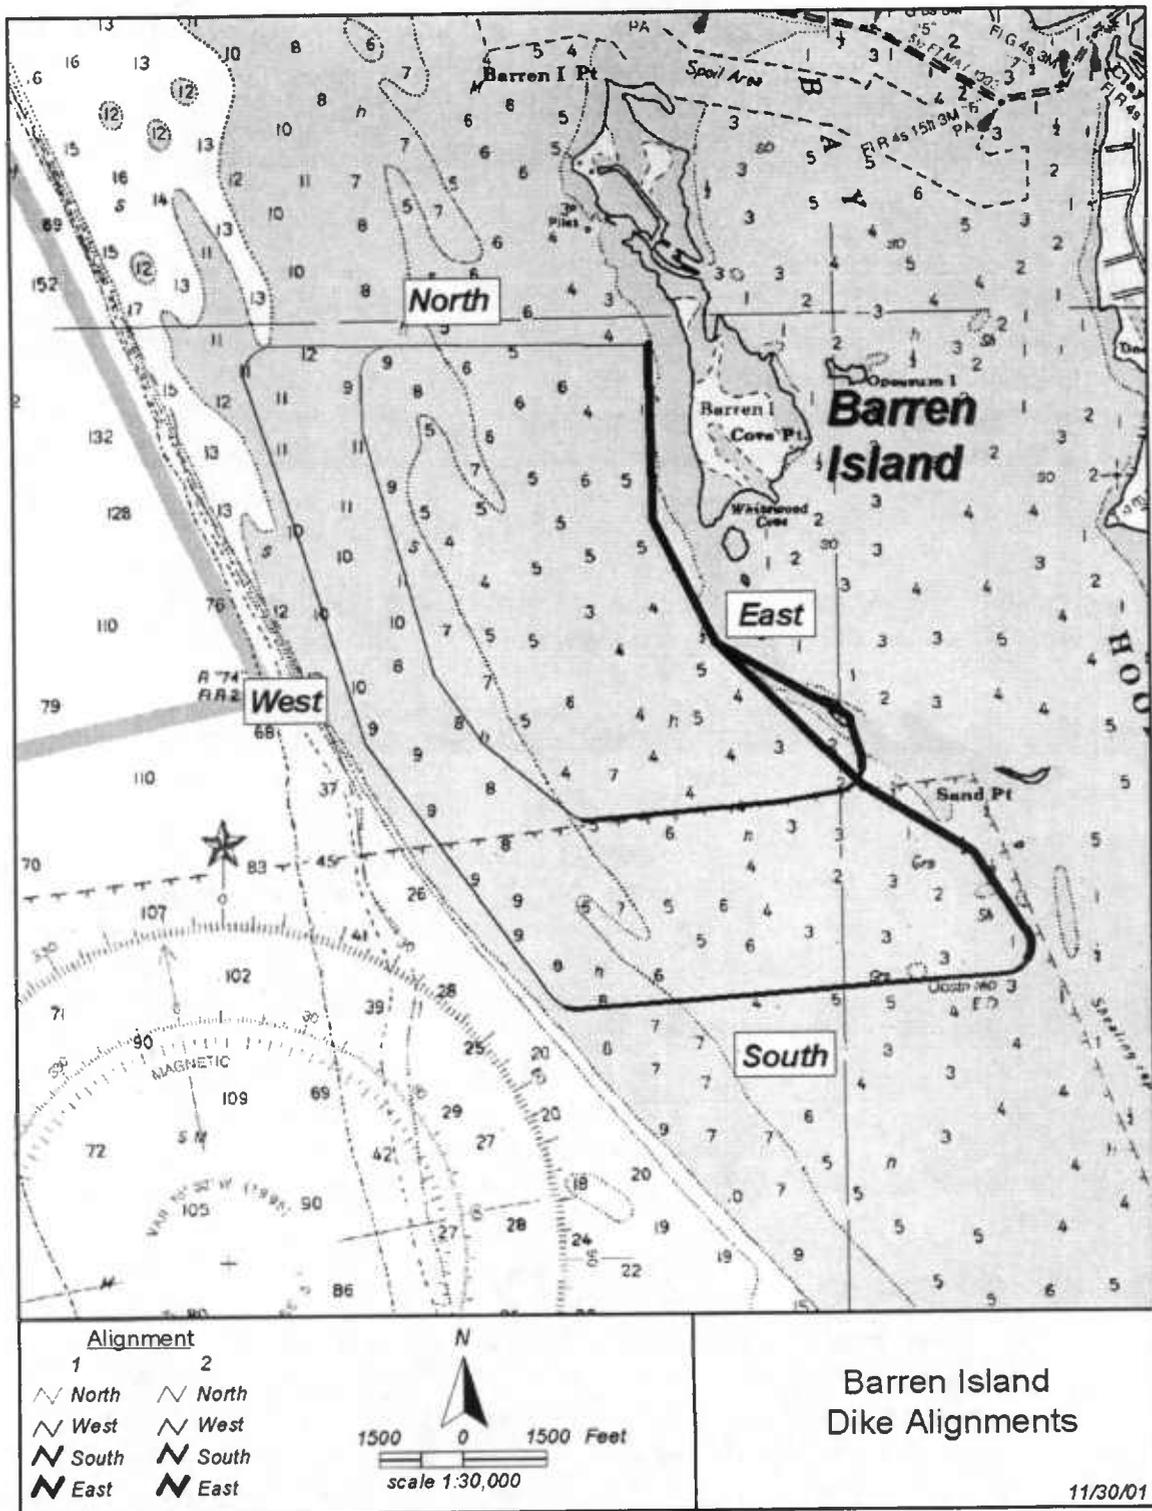
Figure 14: South, West, North, and East dike sections used to determine dike elevations and armor stone sizes.

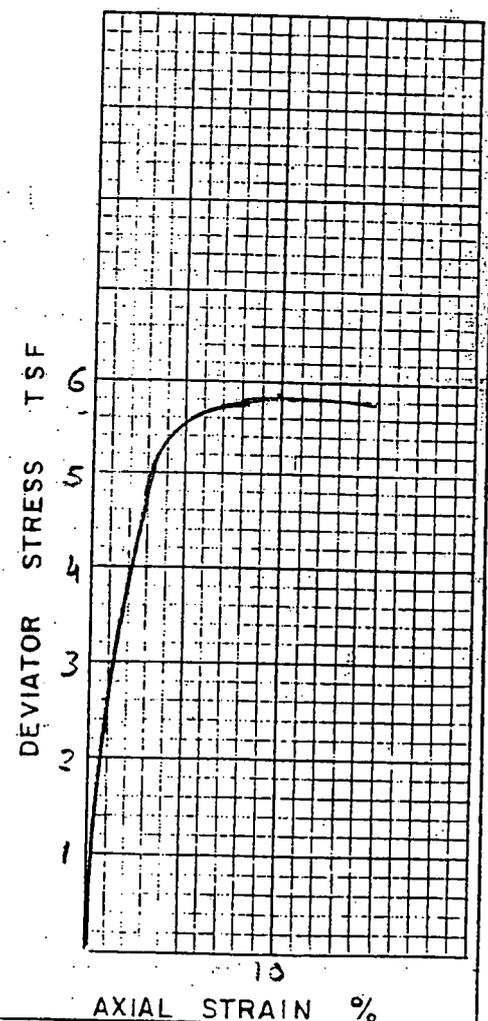
Type of Test		CU	
Type of Specimen		Shelby Tube	
$\phi$	Tan $\phi$	C =	T.S.F.
Description:		Gray Silty Sand	
LL	PI	NP	Sp. Gr.

Project:		Barren Island	
Client:		Roy F. Weston.	
Boring No.	G-11	Samp. No.	"
Depth		28.5-29.5	
<p style="text-align: center;"><b>TRIAXIAL COMPRESSION</b></p>			Date
			11/14/01

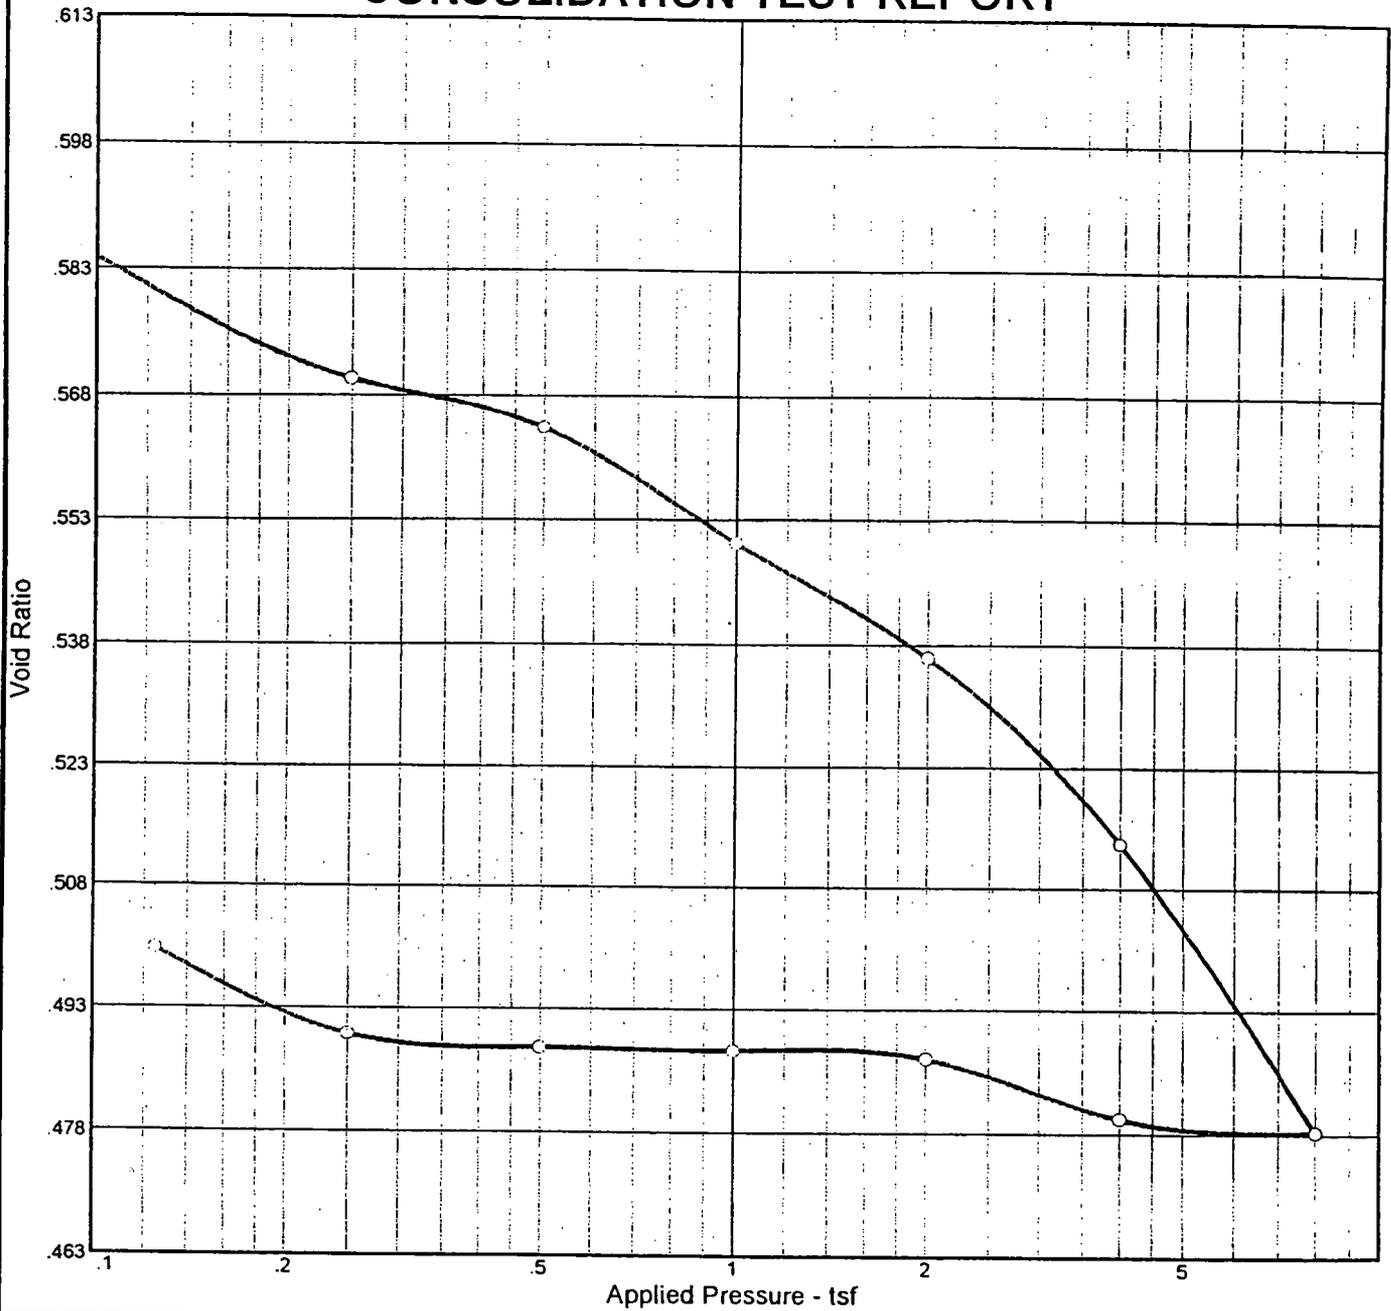
# CONSOLIDATION TEST REPORT

Natural		Dry Dens. (pcf)	LL	PI	Sp. Gr.	Overburden (tsf)	P <sub>c</sub> (tsf)	C <sub>c</sub>	C <sub>r</sub>	Swell Press. (tsf)	Swell %	e <sub>0</sub>
Sat.	Moist.											
93.4 %	21.0 %	102.4	19	16	2.6	0.60	1.88	0.12	0.01			0.584

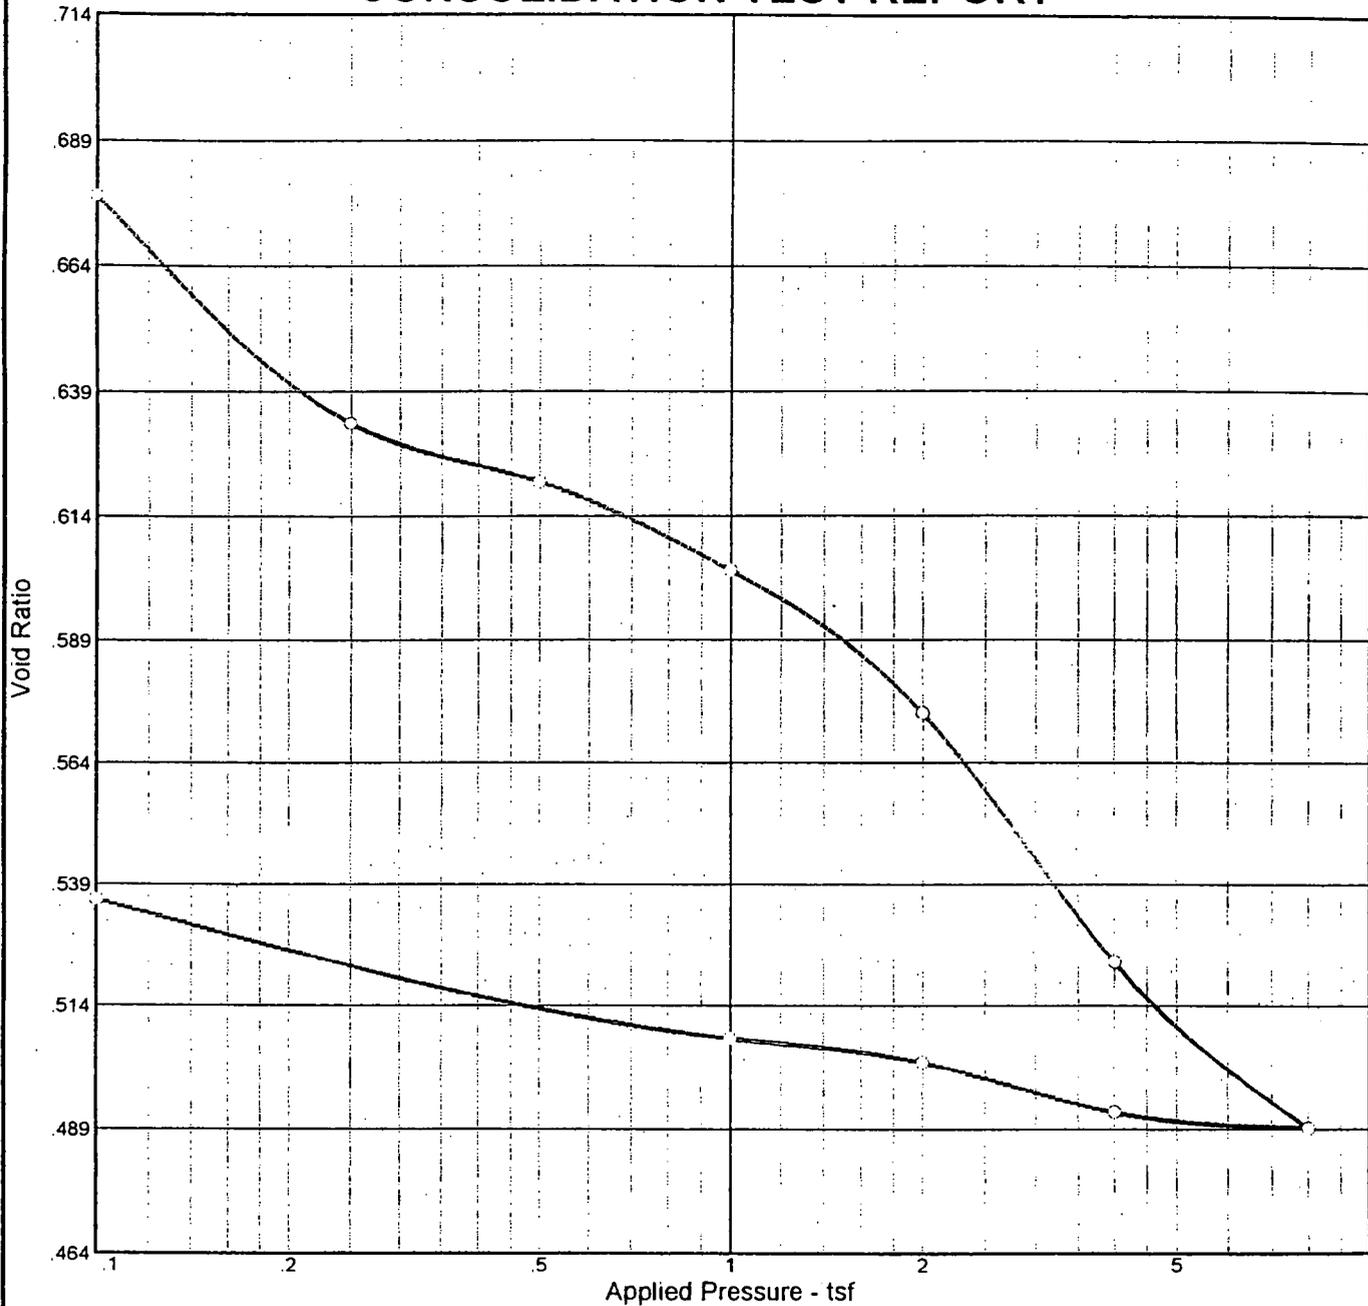
# CONSOLIDATION TEST REPORT

Natural		Dry Dens. (pcf)	LL	PI	Sp. Gr.	Overburden (tsf)	P <sub>c</sub> (tsf)	C <sub>c</sub>	C <sub>r</sub>	Swell Press. (tsf)	Swell %	e <sub>0</sub>
Sat.	Moist.											
97.3 %	25.4 %	96.7	23	18	2.6	0.90	0.41	0.11	0.02			0.678

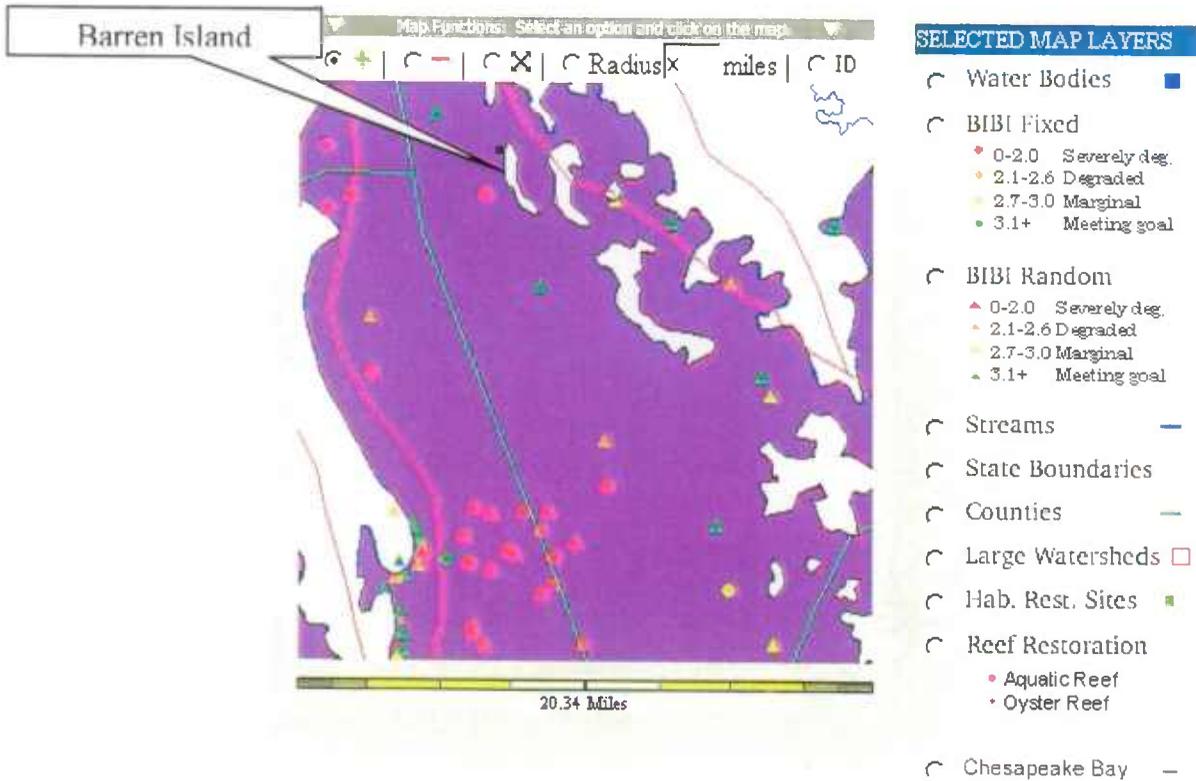
Figure 9. BIBI Sampling Locations and Results Map for the Barren Island Area

The results of the BIBI and target species data appear to conflict with one another on the quality and integrity of the benthic community around Barren Island. It should be noted, however, that the BIBI score for the Barren Island area is based upon a single random sampling location, while six sampling points within 2-miles of Barren Island were used in the target species assessment. The results of the target species assessment may more accurately assess the benthic community in that area due to the larger and more representative sample set.

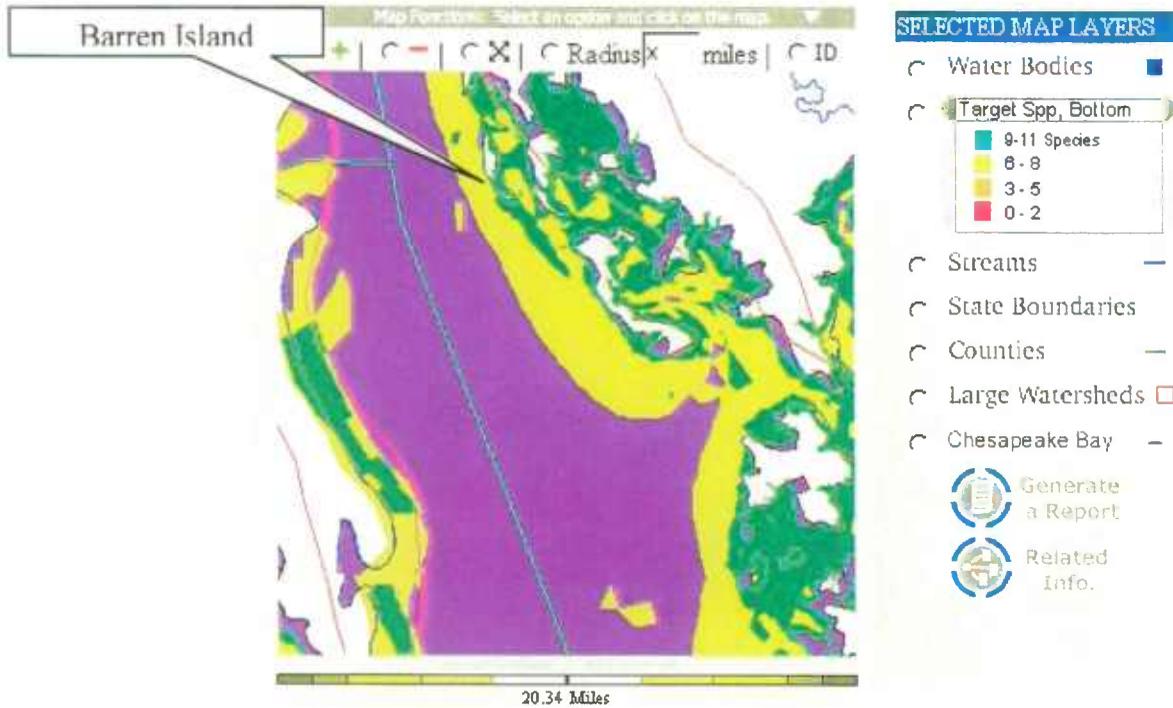
Figure 10. Number of Target Bottom Species in the Barren Island Area

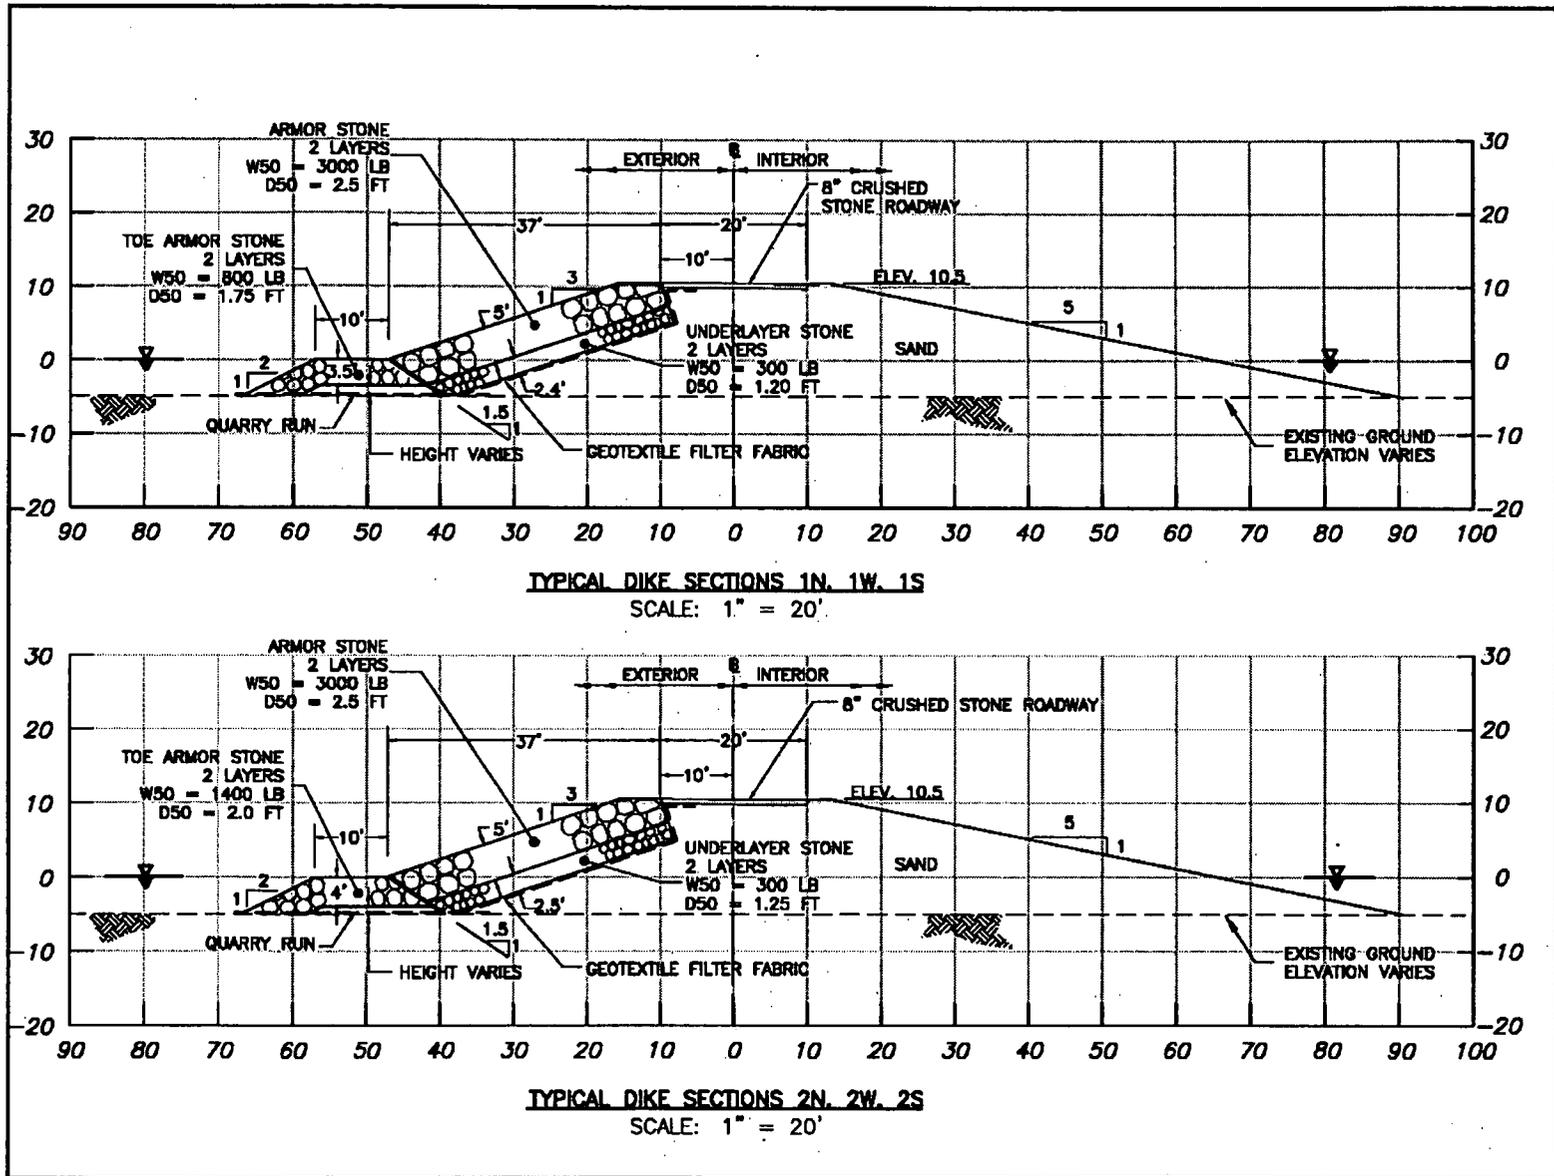
# FIGURE No. 7 - BARREN ISLAND TYPICAL DIKE SECTIONS

Figure 15: Barren Island Typical North, West, and South Dike Sections for Alignments 1 and 2.

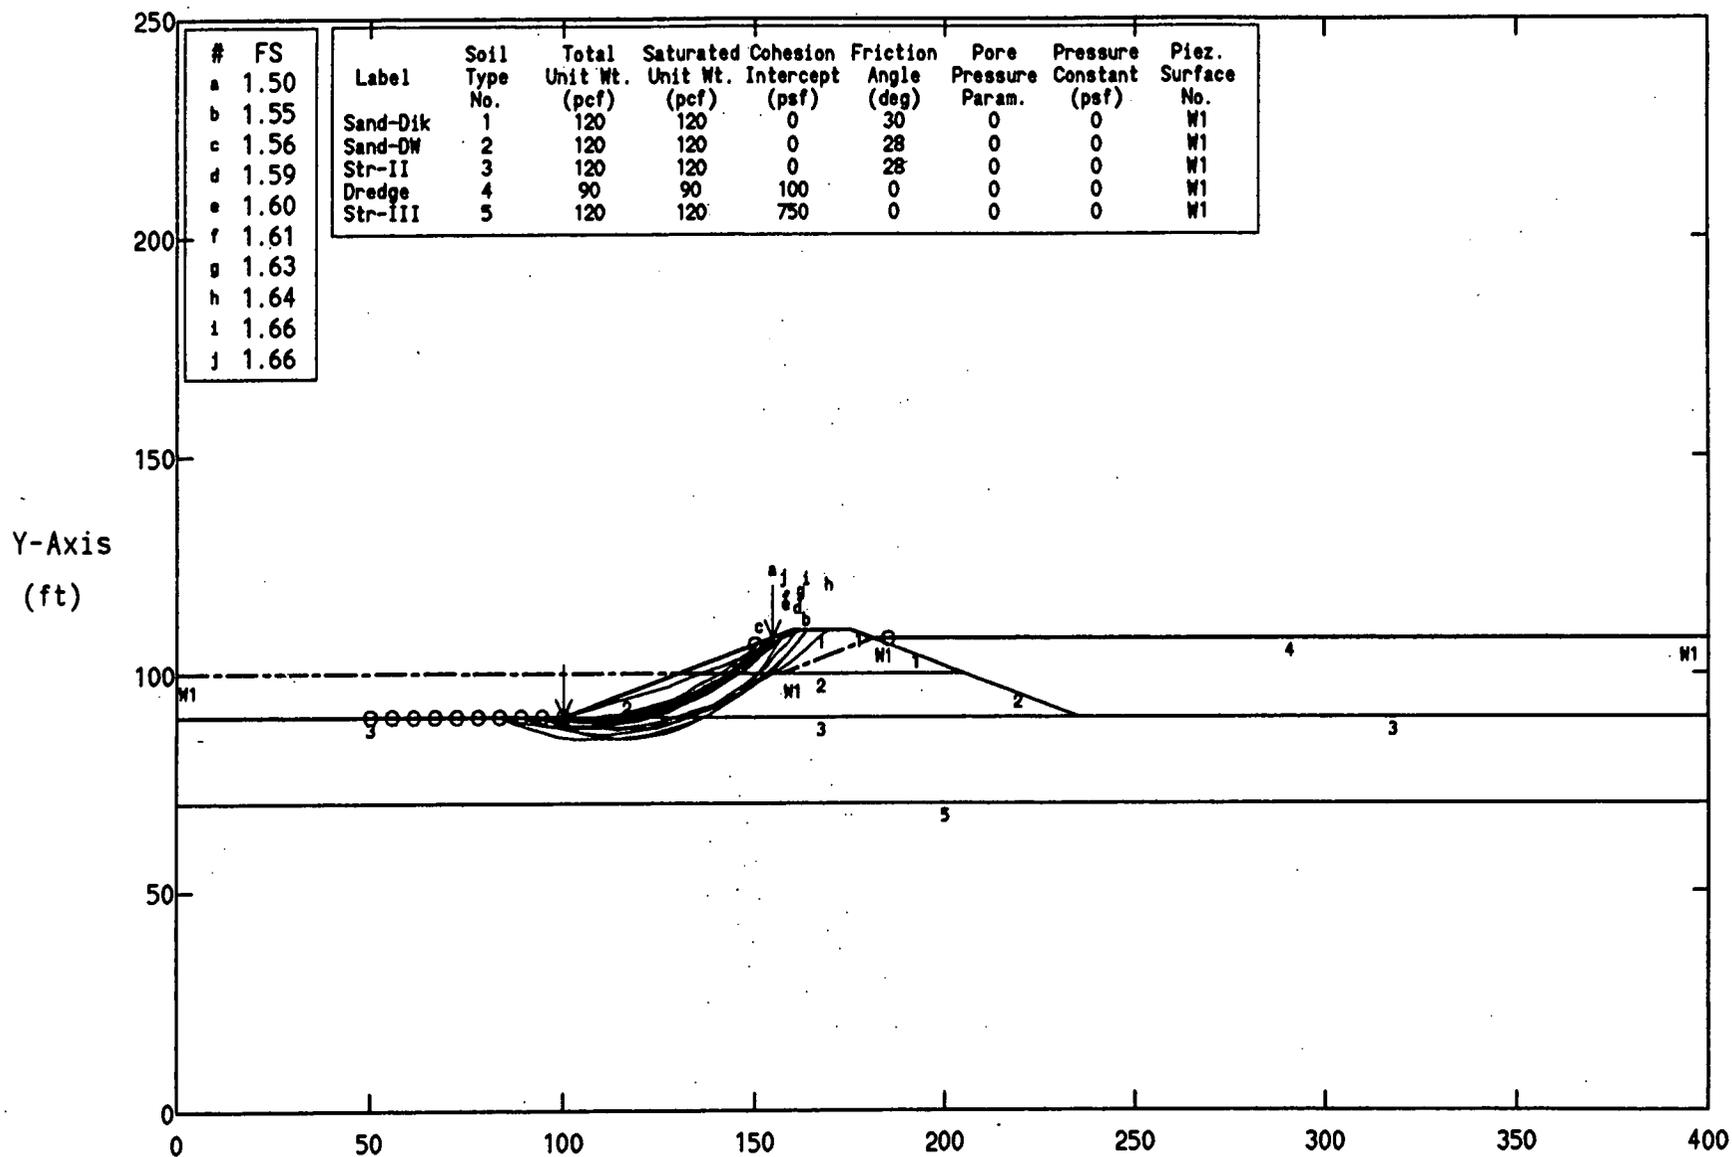
PCSTABL5 FSmin=1.50 X-Axis (ft)  
 Factors Of Safety Calculated By The Modified Bishop Method

Slope stability analyses were conducted using one typical case for the subsurface profile. The Purdue University PC STABL-V program was used to analyze the stability of the slopes. Failures can be analyzed using different approaches, such as the Modified Bishop Method, the Modified Janbu Method and the Spencer Method. For this study, the Modified Bishop method was used (GRS p.11). Shear strength of the foundation was based on the evaluation of Standard Penetration Tests (SPT) blow counts, since the soils in the foundation are mostly silty sands (GRS p.12). The subsurface profiles did not warrant the use of a wedge type of failure, since there are no thin soft layers. Therefore, only circular failures were analyzed (GRS p.13).

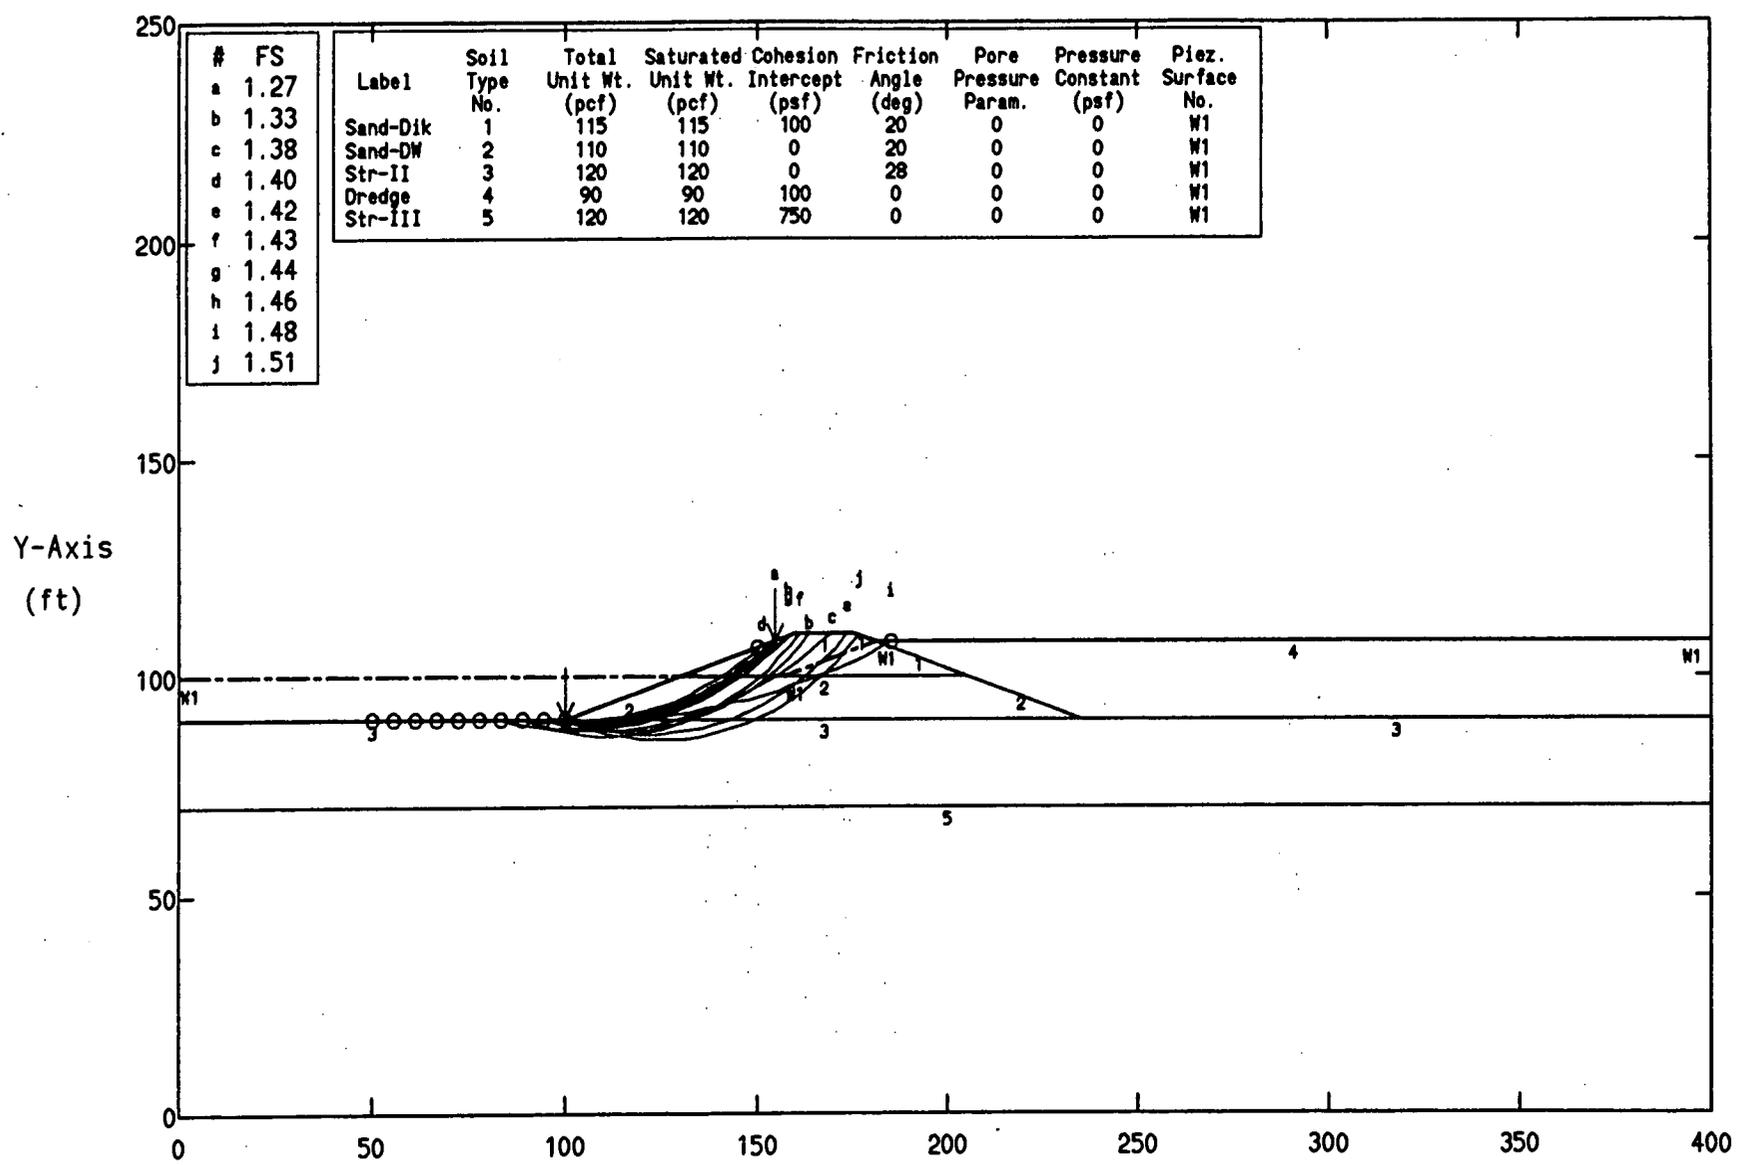
# Barren Island Dike to +10: Case B1: Dike

PCSTABL5 FSmin=1.27 X-Axis (ft)  
 Factors Of Safety Calculated By The Modified Bishop Method

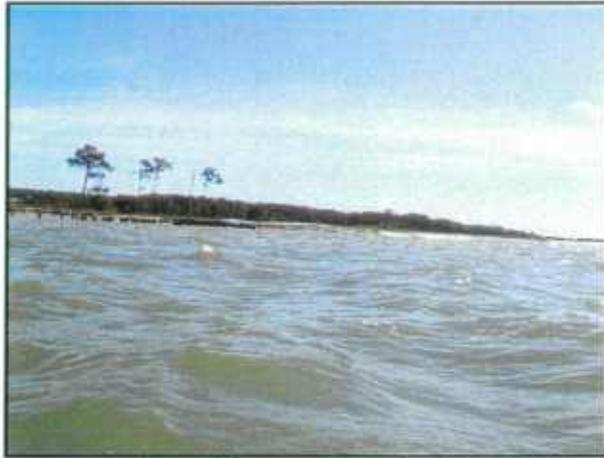
Photo 2. View from Bay main stem, facing south, of the north end of Barren Island and remnants of the hunting lodge and old bulkhead. Note loblolly pine trees dying from salt intrusion.

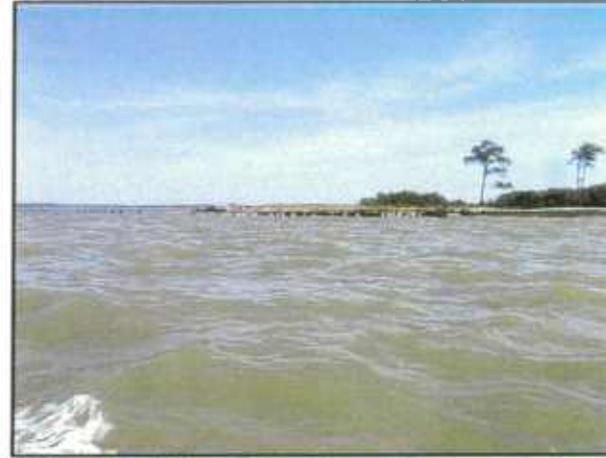
Photo 3. View from Bay main stem, facing northeast, of remnants of old wooden bulkhead.

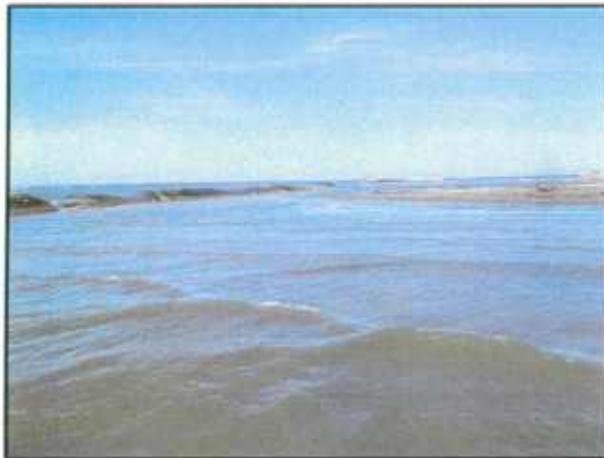
Photo 4. View from west shoreline on Barren Island, facing north, of beach areas and failed geotube site on north end of the island.

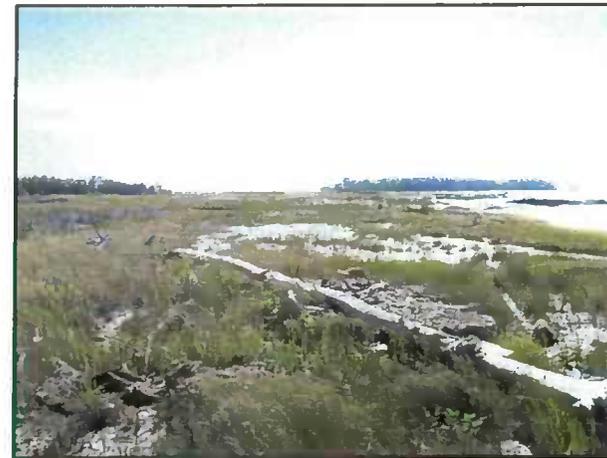
Photo 5. View from west shore, facing south, of restored low marsh areas on north end of island.

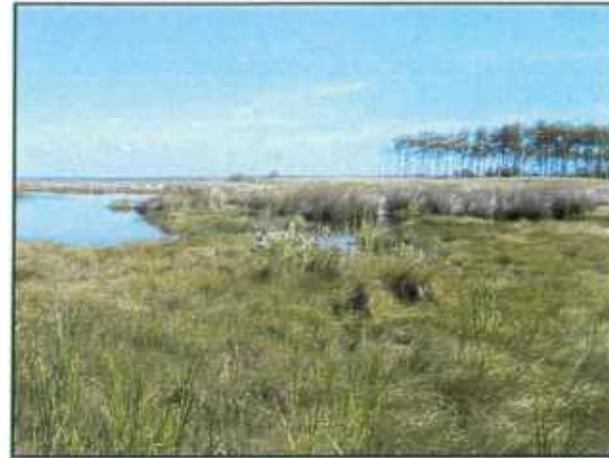
Photo 11. View from east shore, facing east, of low marsh and high marsh along eastern edge of the north end of the island.

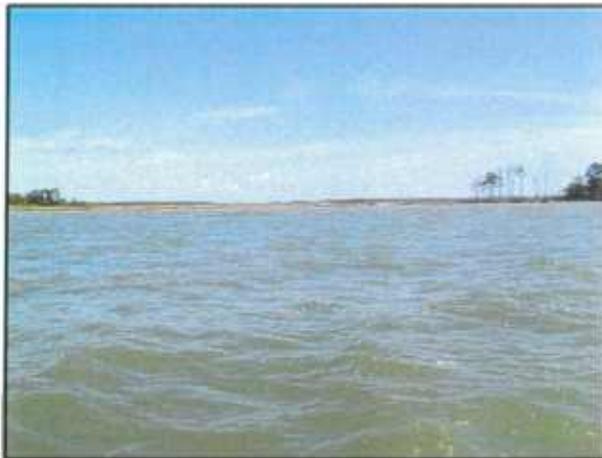
Photo 12. View from Bay main stem, facing east, of low marsh between north and south ends of the island. This area is particularly susceptible to

12/20/01 erosion.

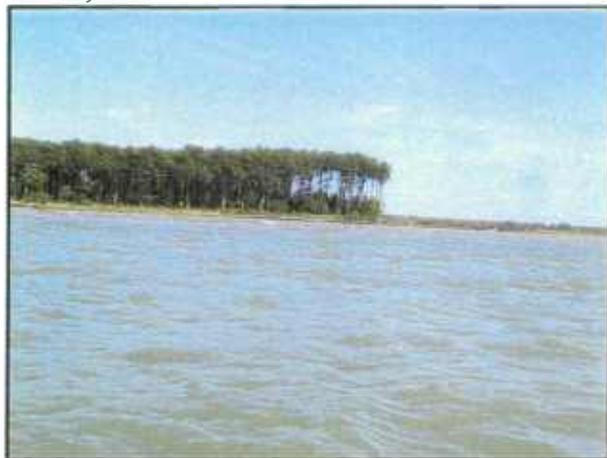
Photo 14. View from Bay side southwestern tip of island, facing east, of south end loblolly pine forested area, Great Blue Heron Rookery, and marsh on southern tip of island.
