**MARYLAND
PORT
ADMINISTRATION**

Poplar Island Environmental Restoration Project

2002 Crust Management Review

January 30, 2002 - November 13, 2002

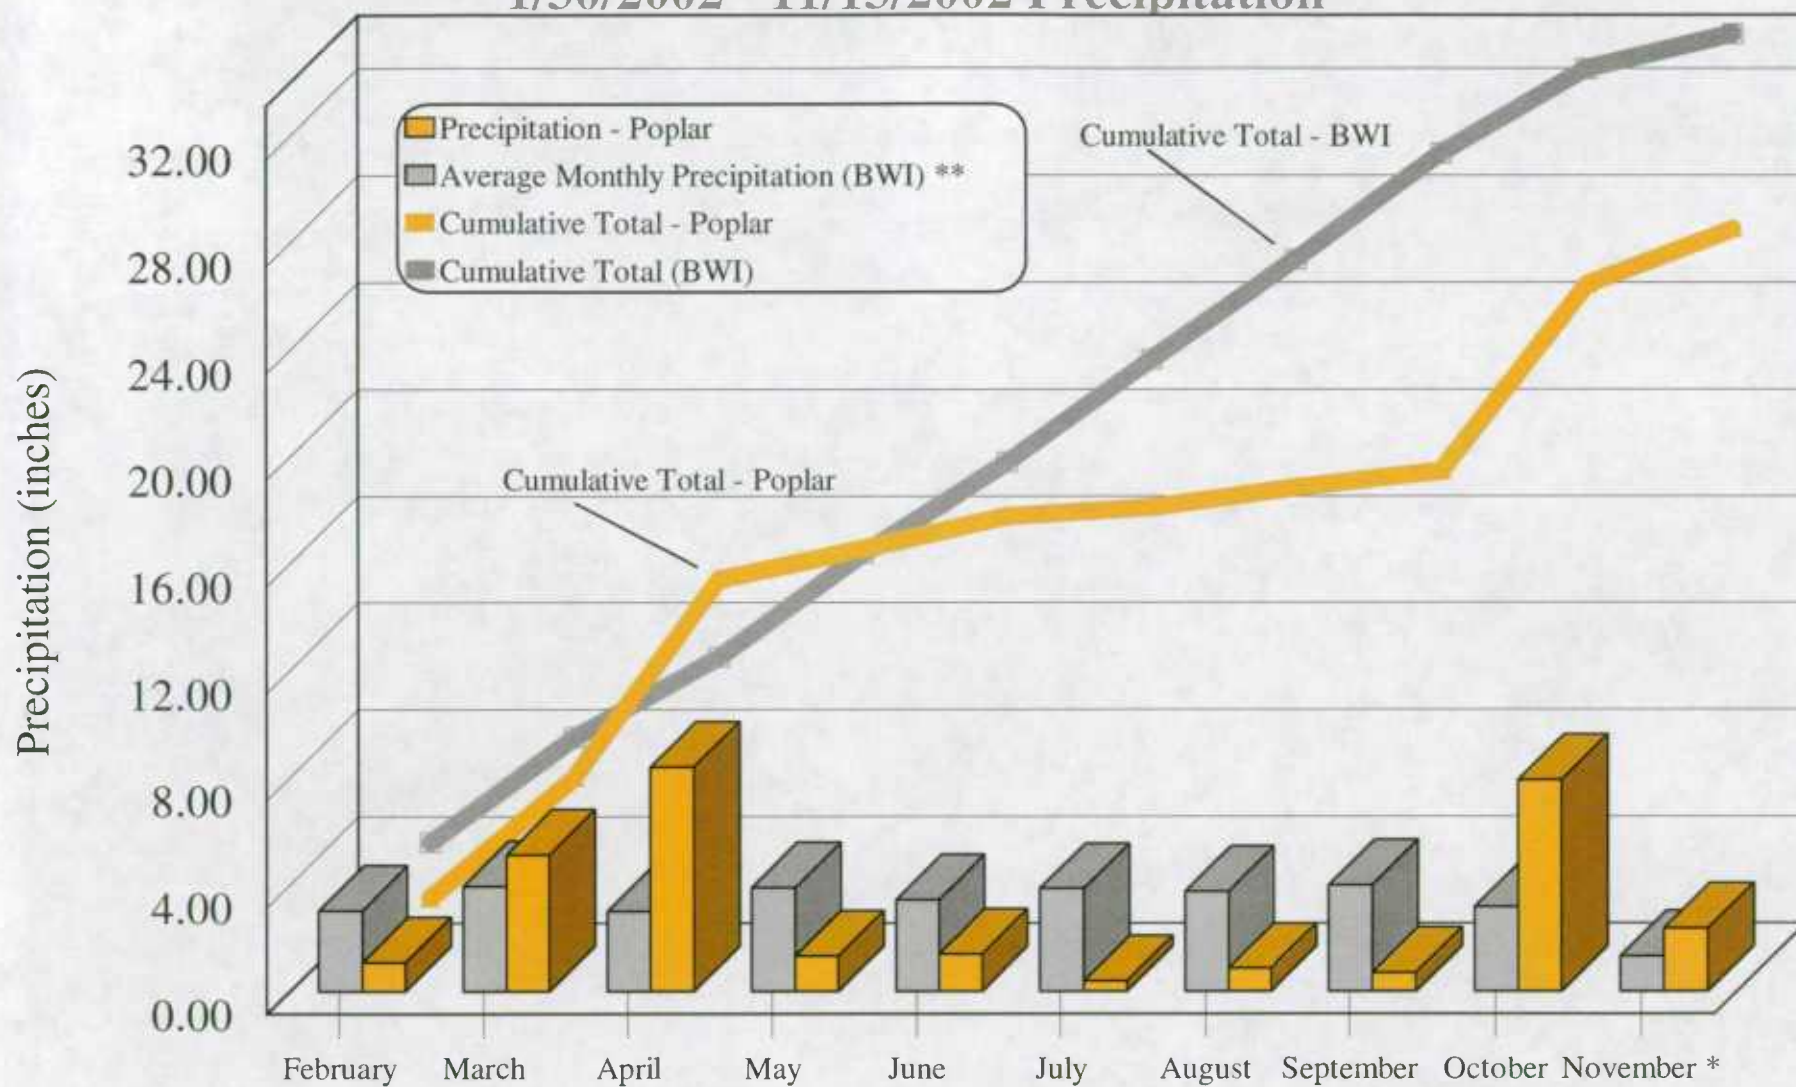
Figure IV-1

These dewatering efforts were augmented by the very dry summer of 2002. According to data collected by the National Climatic Data Center at the Baltimore-Washington International Airport (BWI), Poplar Island received 22% less precipitation than average (table IV-1, figure IV-1). The dry weather helped the dewatering effort.

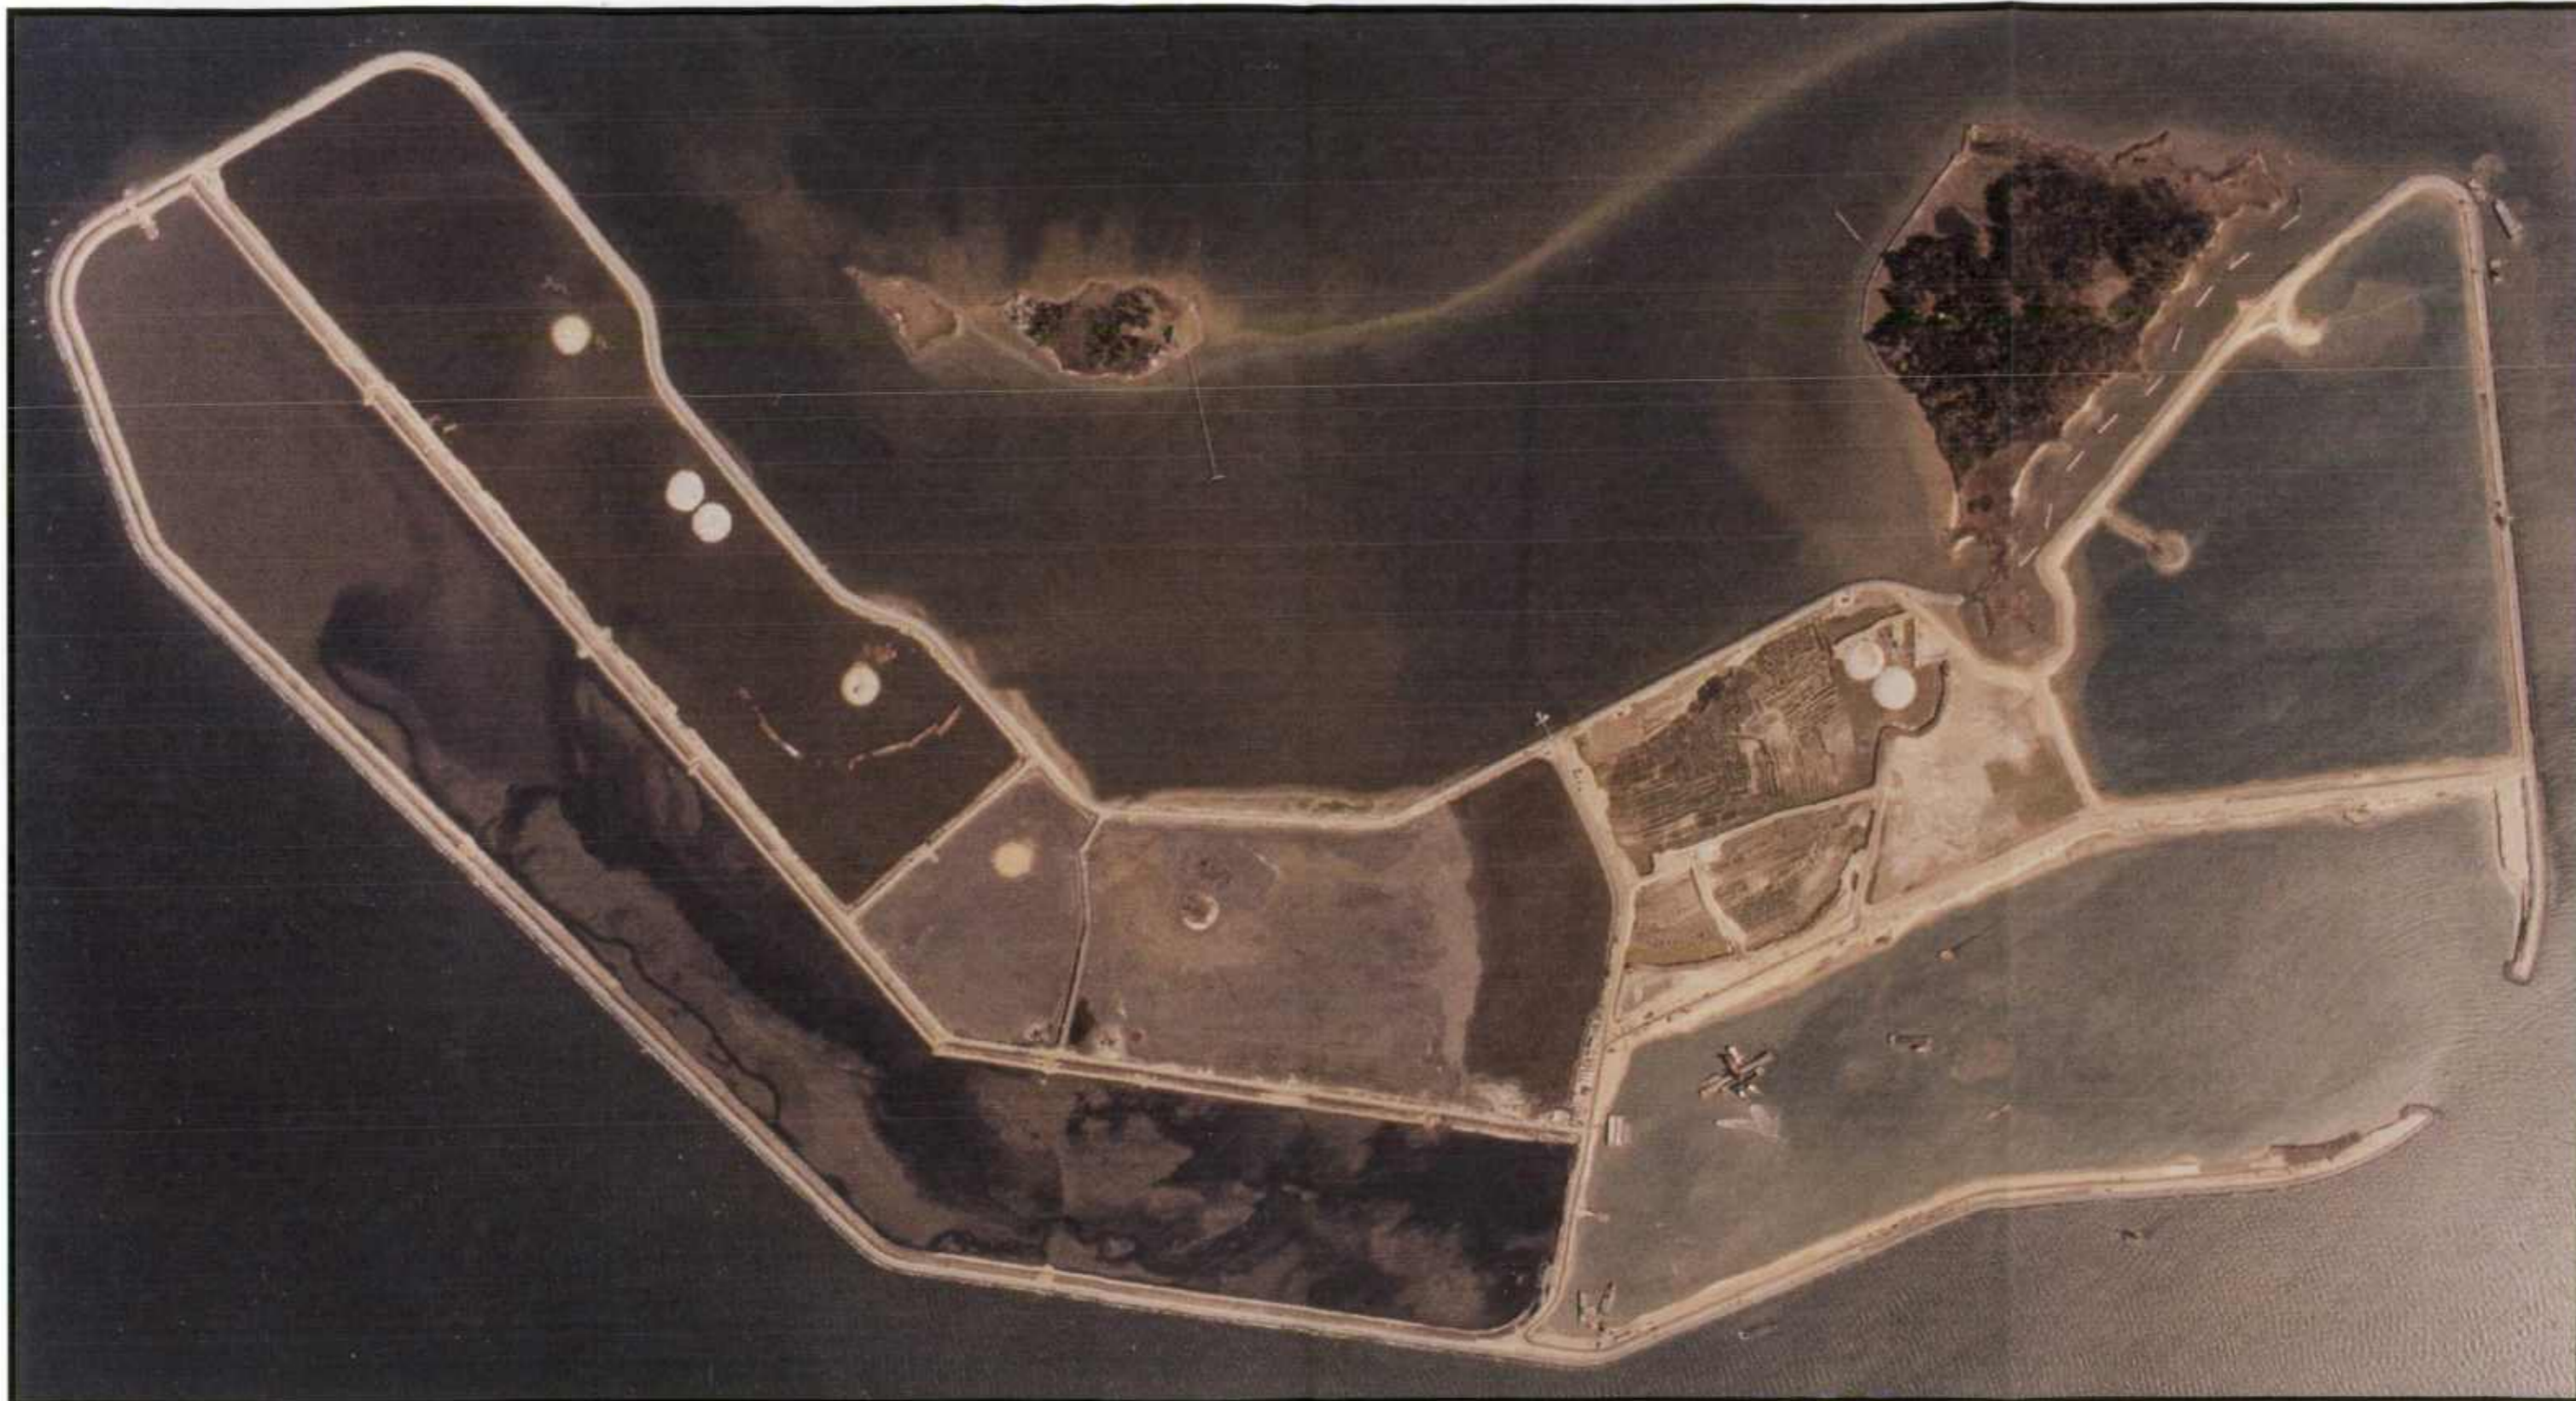
Figure IV-2

Approximately 6.2 mcy of dredged material was deposited in cell 2 during the 2001 – 2002 inflow season, 75% of the total dredged material volume received at Poplar Island. Inflow conditions are exhibited in the aerial photo taken in November 2001 (figure IV-2). In order to maximize long-term capacity in cell 2, crust management was performed in order to dewater the placed sediment. The 2002 Crust Management Season spanned roughly nine and a half months, from January 20, 2002 to November 13, 2002. During this time span, MES personnel were successful in creating 151,500 linear feet of trenches and depressions in cells 1, 2, 3D, and 3 (table IV-2). The aerial photo in figure IV-2 was taken in October 2002 – near the end of crust management season. The trenching pattern in cell 2 is easily discernable in the photo.

*Poplar Island Environmental Restoration Project
Aerial Photo: November 2001*

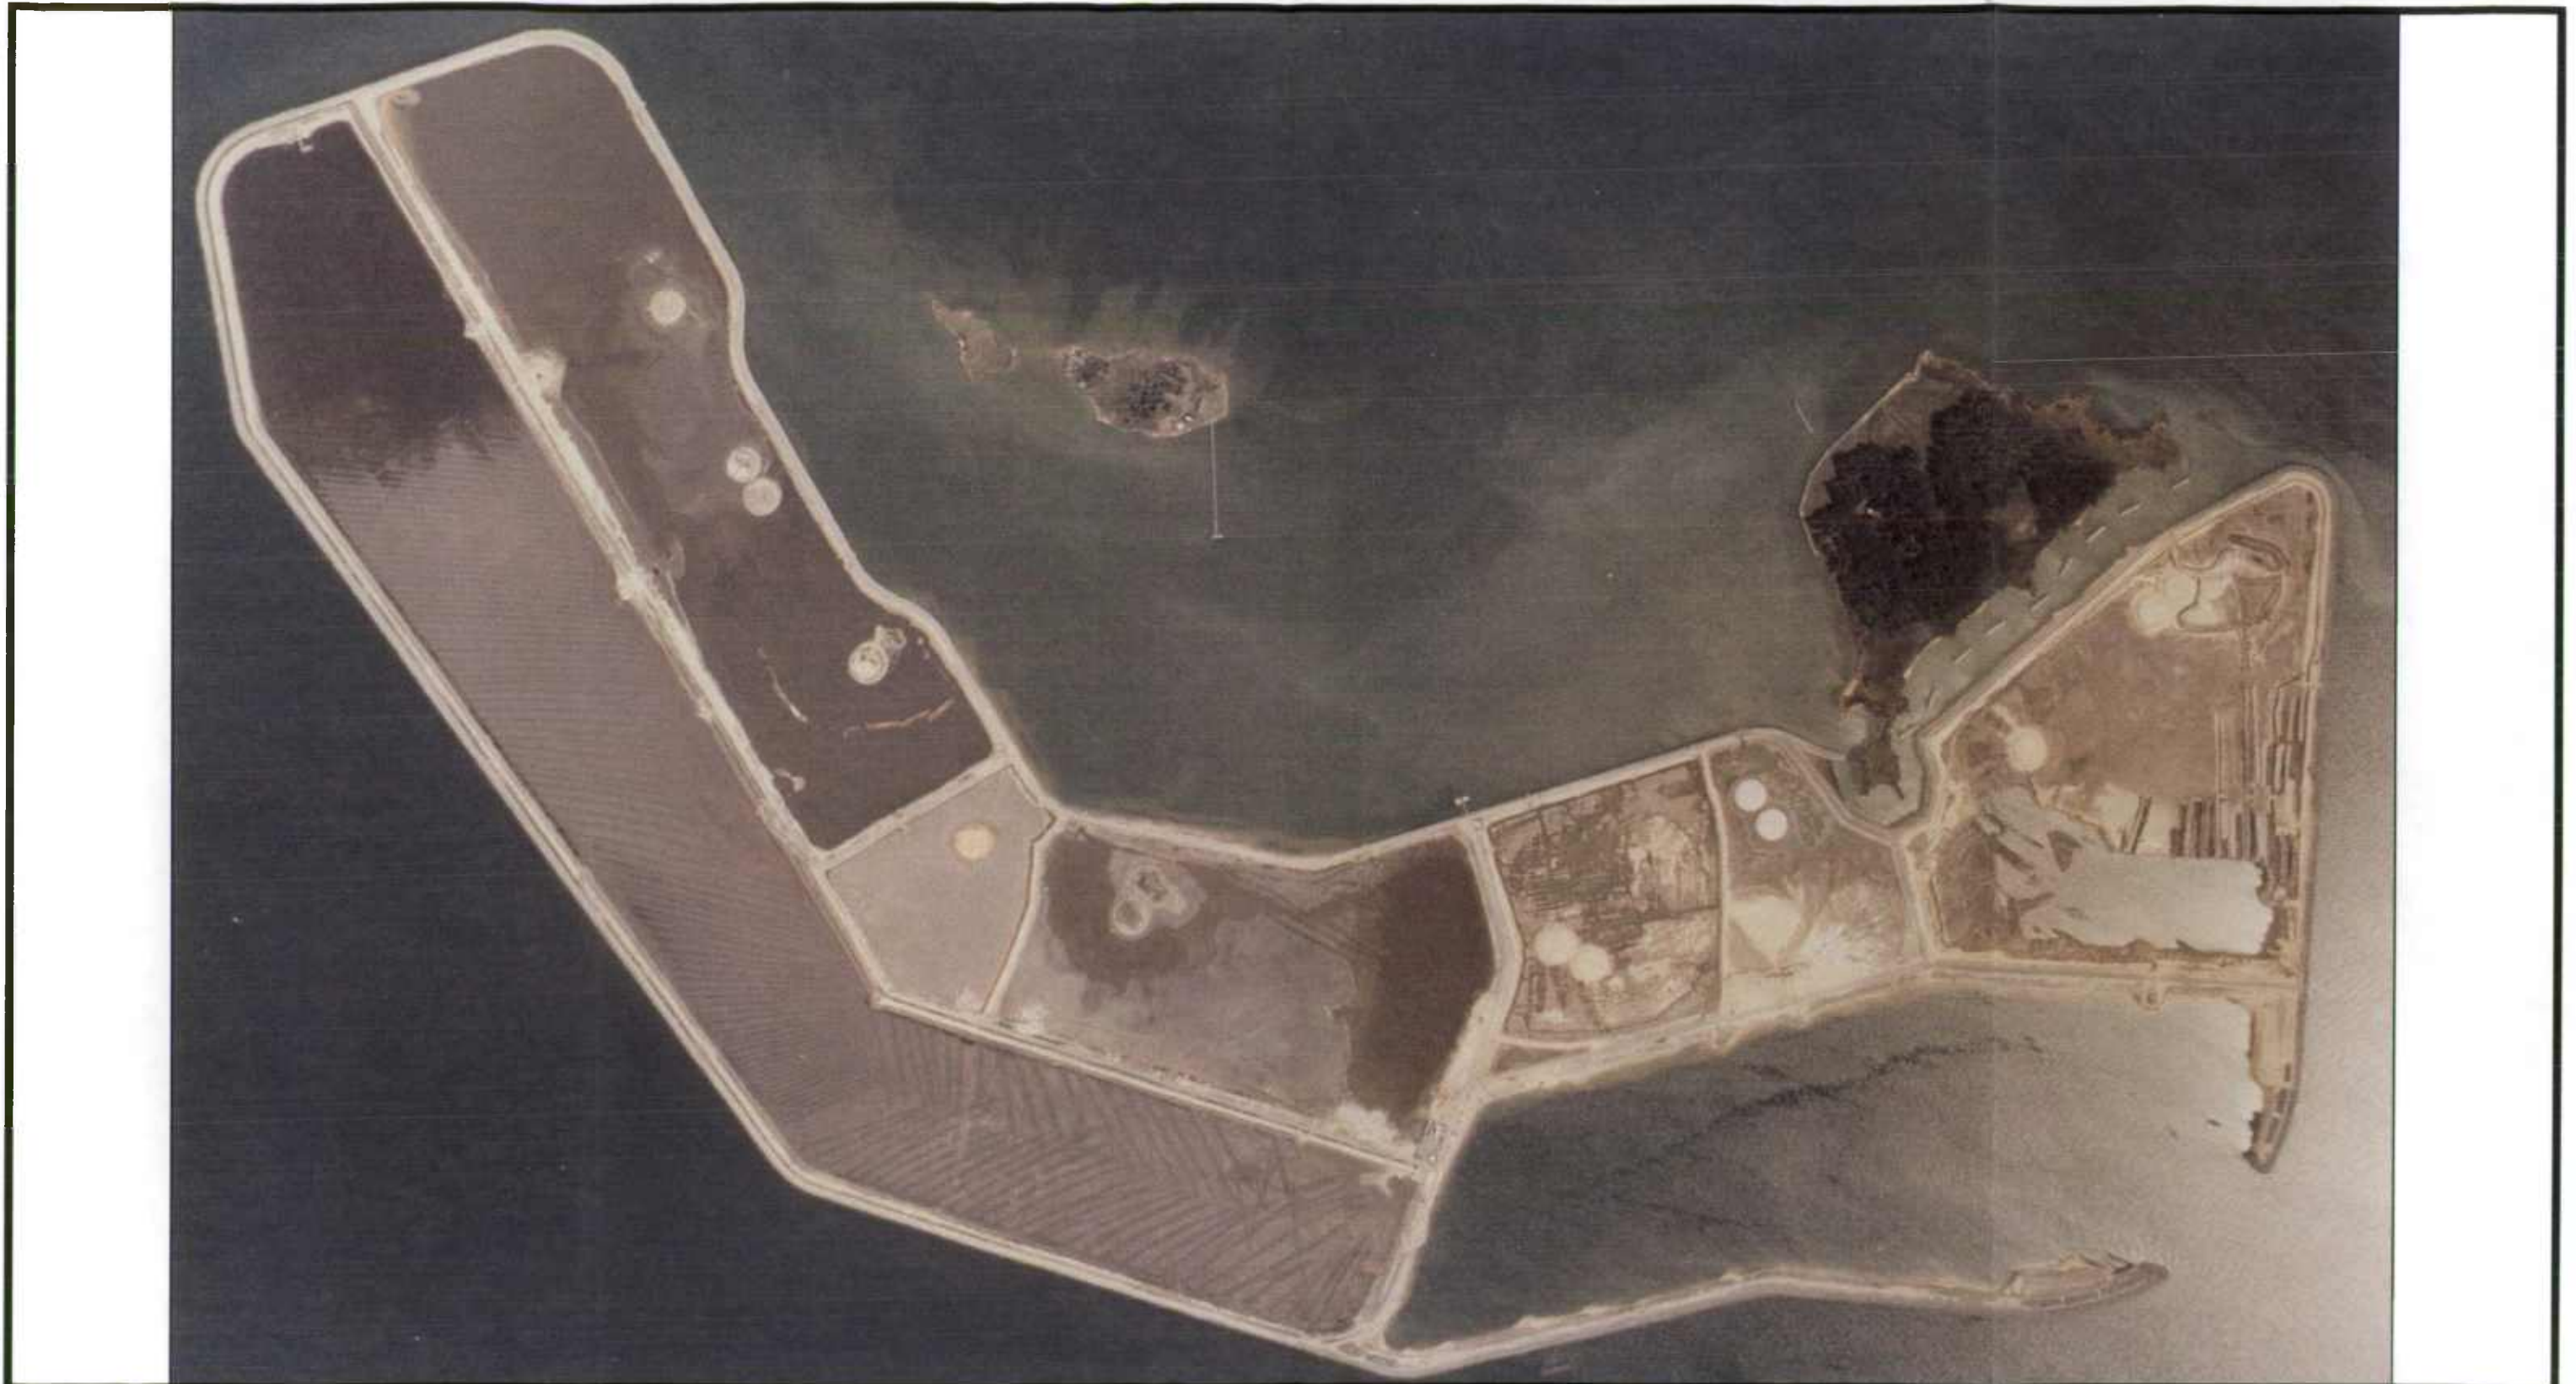
DRAWN BY: TMR	DATE: November 19, 2002
CHECKED BY: TMR	Figure IV-3
JOB NO.:	SHEET OF

*Poplar Island Environmental Restoration Project
Aerial Photo: October 2002*
