MARYLAND GEOLOGICAL SURVEY
Merryman Hall
The Johns Hopkins University
Baltimore, Maryland 21218
(301) 235-0771

COUNTIES (MD/PA) WASHINGTON/FULTON
M&D milestone no. 124 (128)
MHT-HSI no. WA-VI-025

FIELD SHEET: MASON & DIXON LINE, MARYLAND-PENNSYLVANIA BOUNDARY MARKER SURVEY

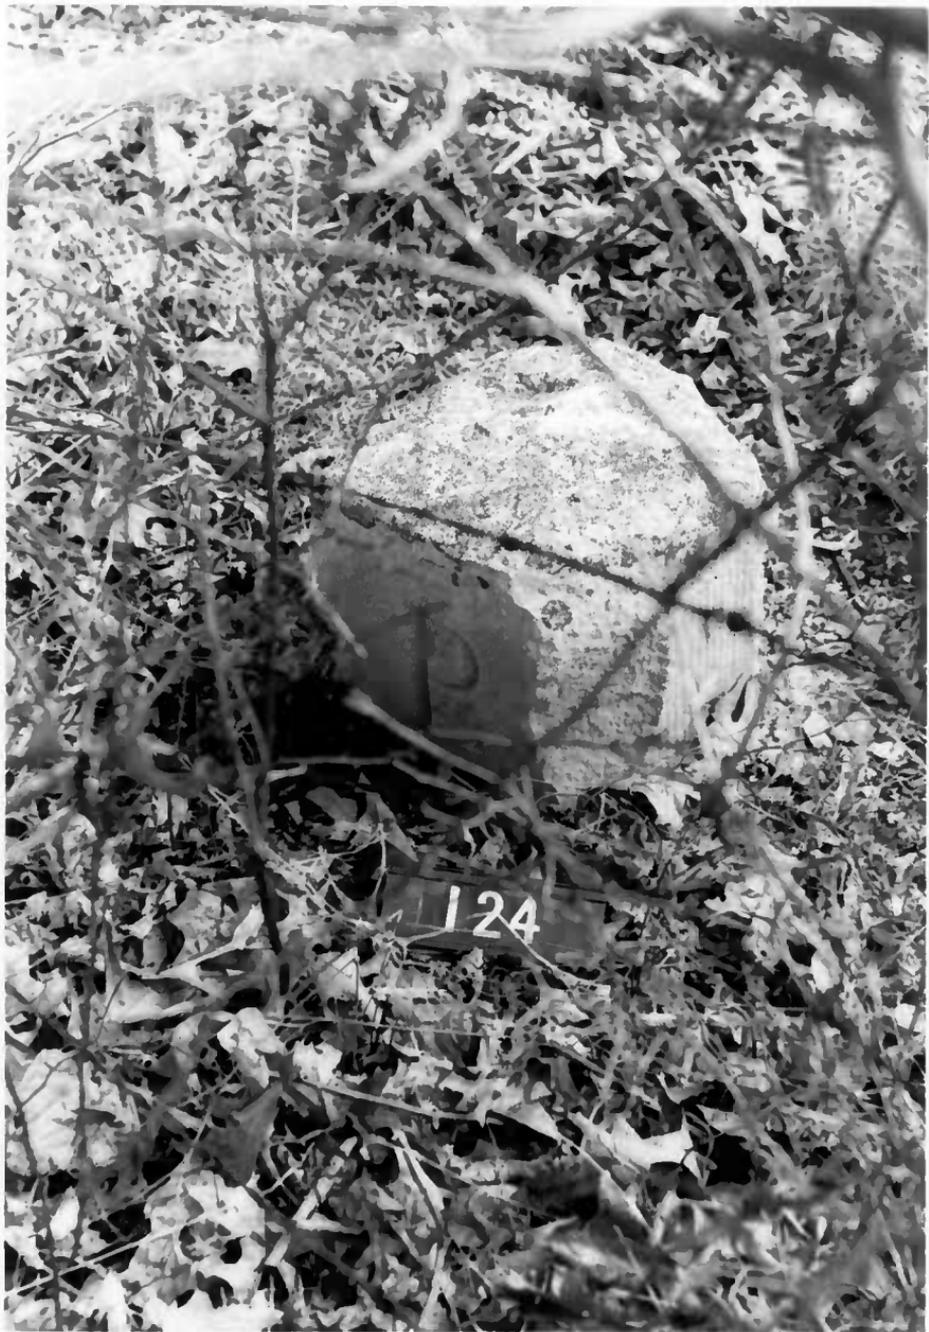
PHOTO: ALICE WILSON 3/24/87 (135.14.5)

N face (PA): 11" wide x 9 1/2" high; P & circle panel distinct; fluting & margins gone; chips all edges & corners; large chunk out of NW edge

W face: 11 1/2" wide x 10 1/2" high; about half of fluting, no margins remain; chips all edges & corners; huge chips NW & SW edges

MASON DIXON 22.5" - 145" MILESTONE 134 (128)
NEW SCENER (P. 1)

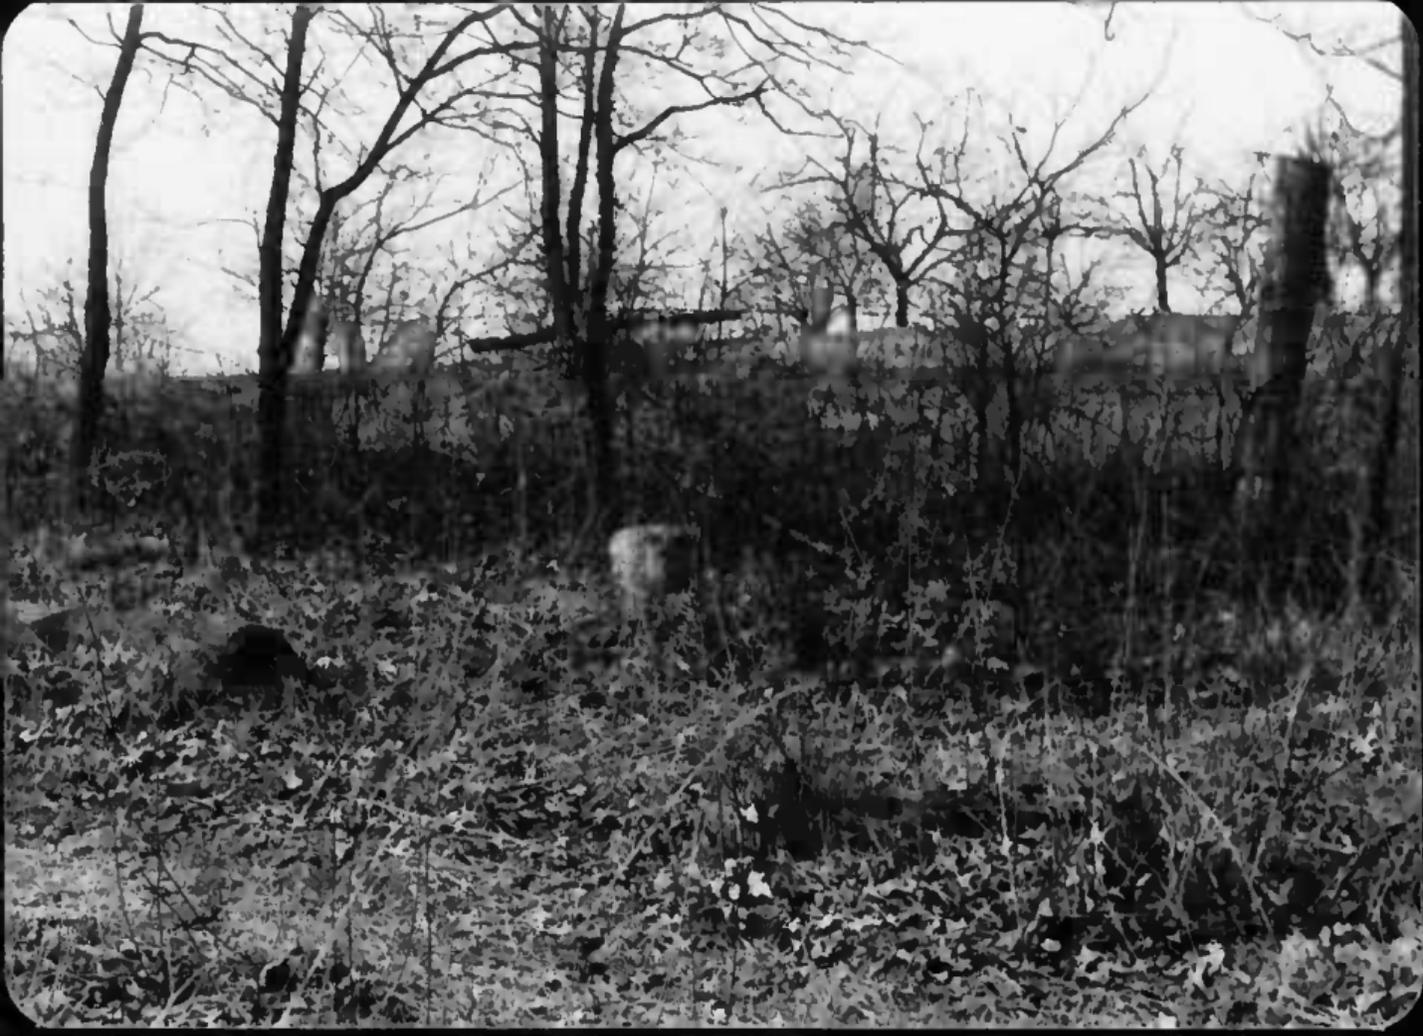
(1981.14.3)

MID WEST LINE; MILESTONE 124 (128)

VIEW NNW, LOOKING TOWARD STONE & ORCHARD

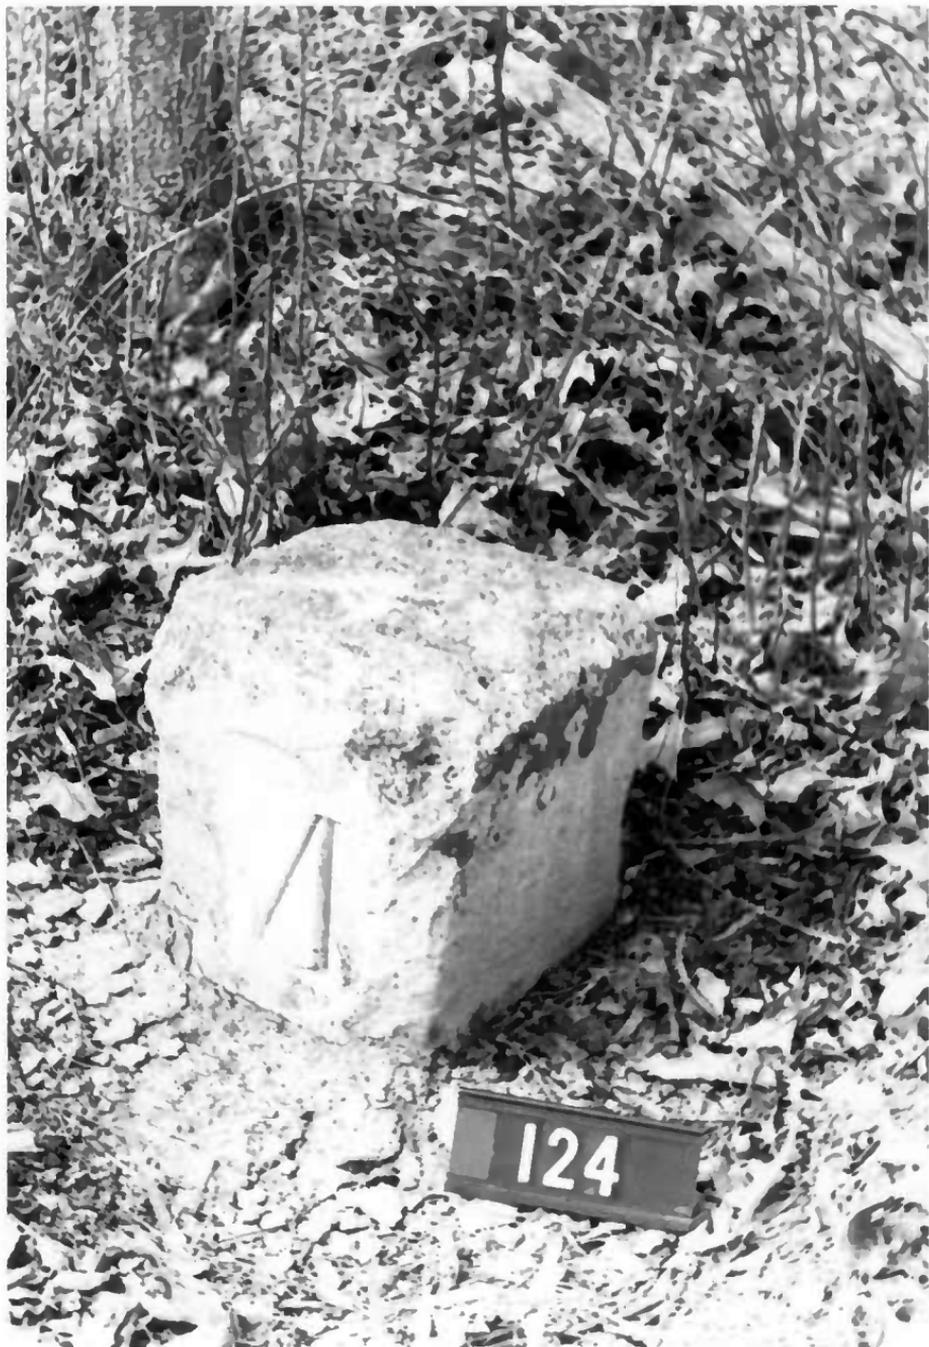
PHOTO ALICE MARTIN 1924 81 191 4 11

E face: 11 3/4" wide x 10" high; some fluting, no margins remain; chips all edges & corners; face weatherworn

S face (MD): 11 1/2" wide x 10 1/2" high; M & circle panel distinct, but huge chunk out of SW edge into M; fluting & margins gone; chips all edges & corners

MASON EDWIN WEST LINE MILESTONE (24, 128)
SE CORNER (10-7)
