INVENTORY FORM FOR STATE HISTORIC SITES SURVEY

HISTORIC Clover Hill Farm, McLuckie

AND/OR COMMON Part of Rocky Gap State Park

CLOVER HILL FARM, McLUCKIE
ALLEGANY COUNTY
MARYLAND
(DESCRIPTION, continued)

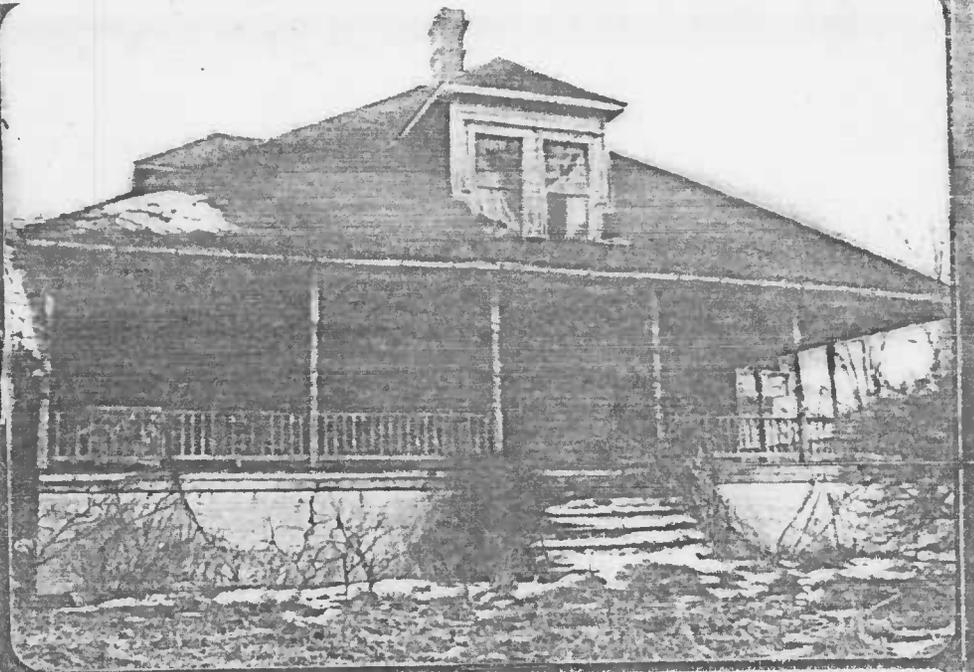
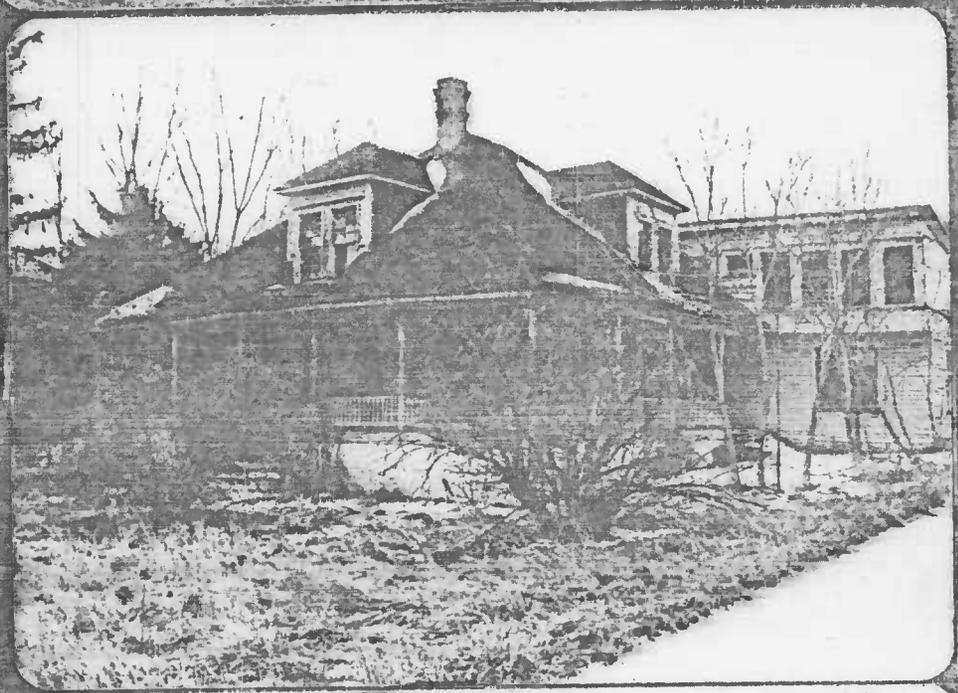
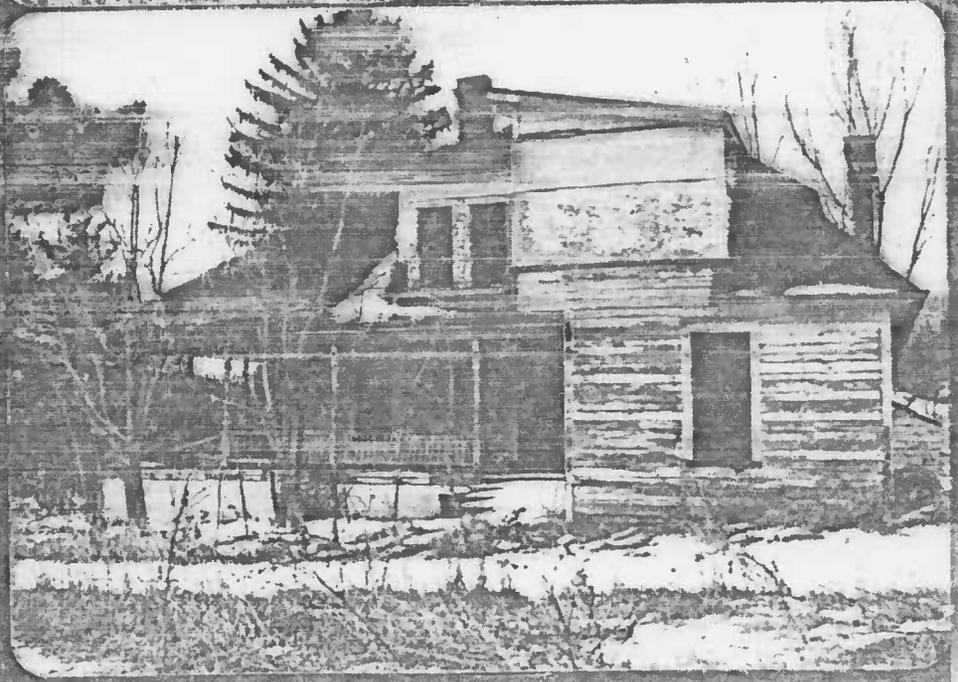
AK-III-C-068 Clover Hill Farm

The house is a one and a half story three bay bungaloid structure with a deep overhanging porch on three of its four sides. The roof is hipped and steeply pitched. A one story addition also with a hipped roof extends to the northeast from the rear corner of the house. A shed roof extension has been attached to the upper part of the wing giving it a second story. In each of the four slopes of the main section's roof is a hipped roof dormer with double six over two pane sash windows. The entire wall surface of the building is sheathed with german siding.

The main entrance is located in the center bay of the front elevation. It is trimmed similarly to the windows and has a four panel door beneath a single pane transom.

The porches which extend around the house are supported by turned posts and enclosed by a balustrade with turned balusters. The roof is sheathed with asphalt shingles and a central chimney of brick has several courses of decorative corbeling. A similar chimney is located at the rear of the house at the kitchen.

top - South Facade
center - South + East Facades
bottom - East Facade

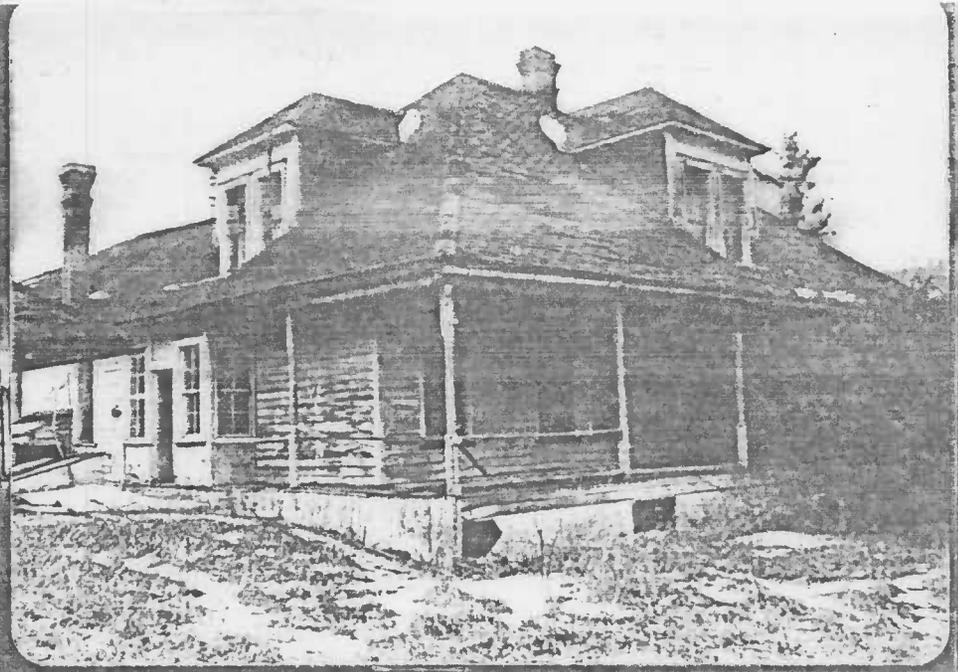
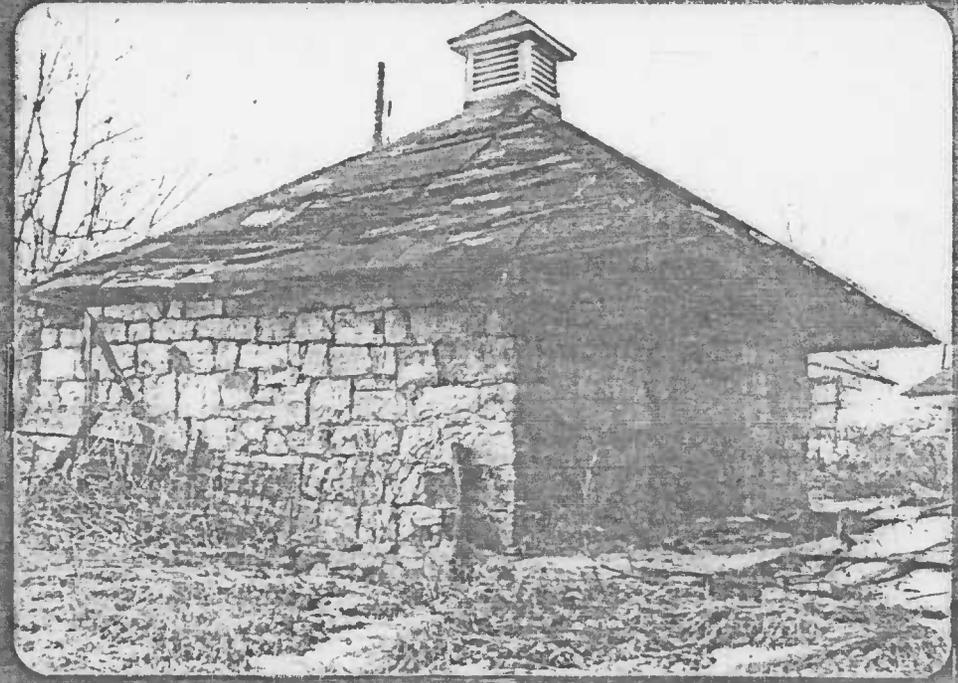
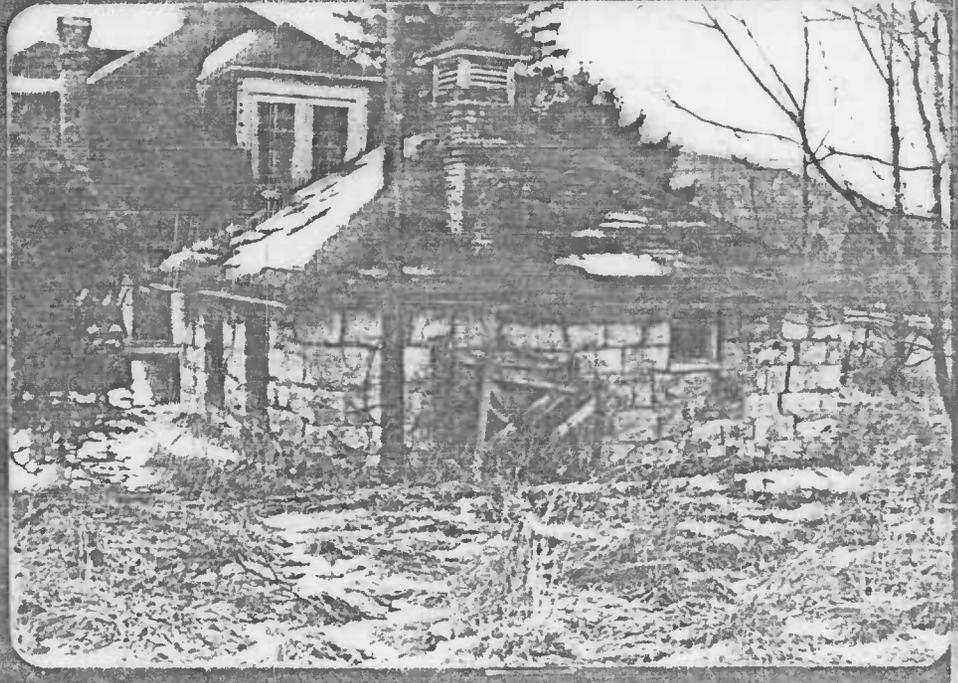
AL-III-C-068 Clover Hill Farm
top - North & West Facades
center - Dairy West and South Facades
bottom - " East and North Facades

To the rear of the farmhouse is a stone dairy and washhouse. It is located ten feet behind the rear wall of the farmhouse. It is constructed of quarry stone with one-foot, eight-inch thick walls. The structure has a hipped roof with a ventilator cupola. The structure has a two-room plan with a stone partition wall running down the center. There is no access between the two rooms. The eastern room has a brick flue that would have served an early twentieth century cast-iron stove. The western room has a concrete trough used for a dairy. The structure had a double entrance on the front and windows into the east room. The west room which contains the dairy had smaller windows for ventilation purposes. The dairy has the trough located on its west wall, constructed ^{of} with stone covered with concrete. The trough opening is about three-feet ^{wide} and runs the full-length of the stone structure. The ceiling of both sections ^{is} tongue and groove board painted white. The roof structure consists of eight rafters from each side of the building rising to the peak of the roof with braces at the middle on each side.

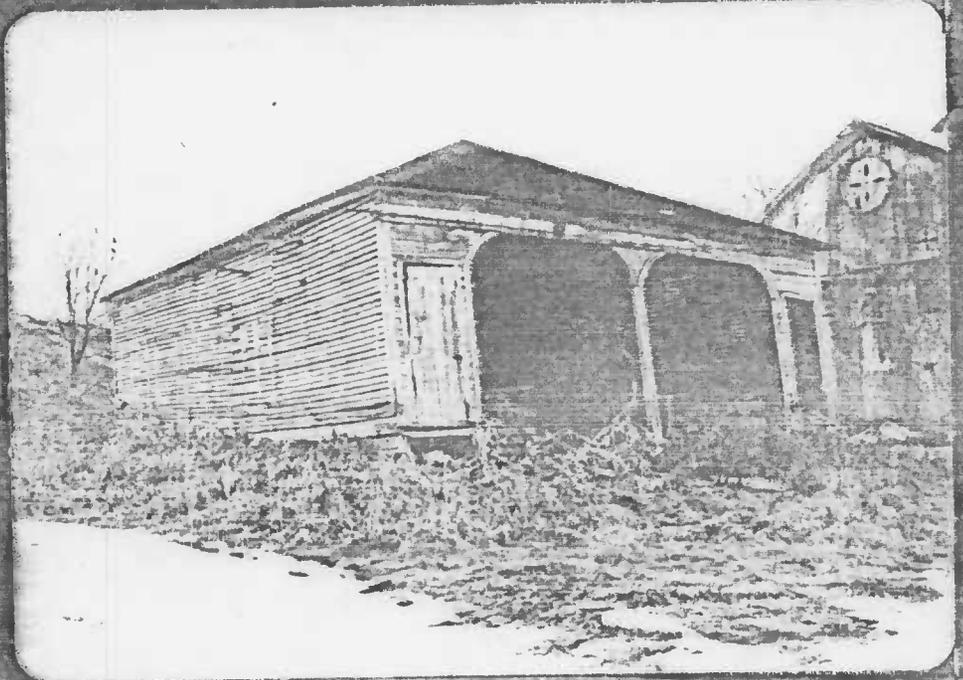
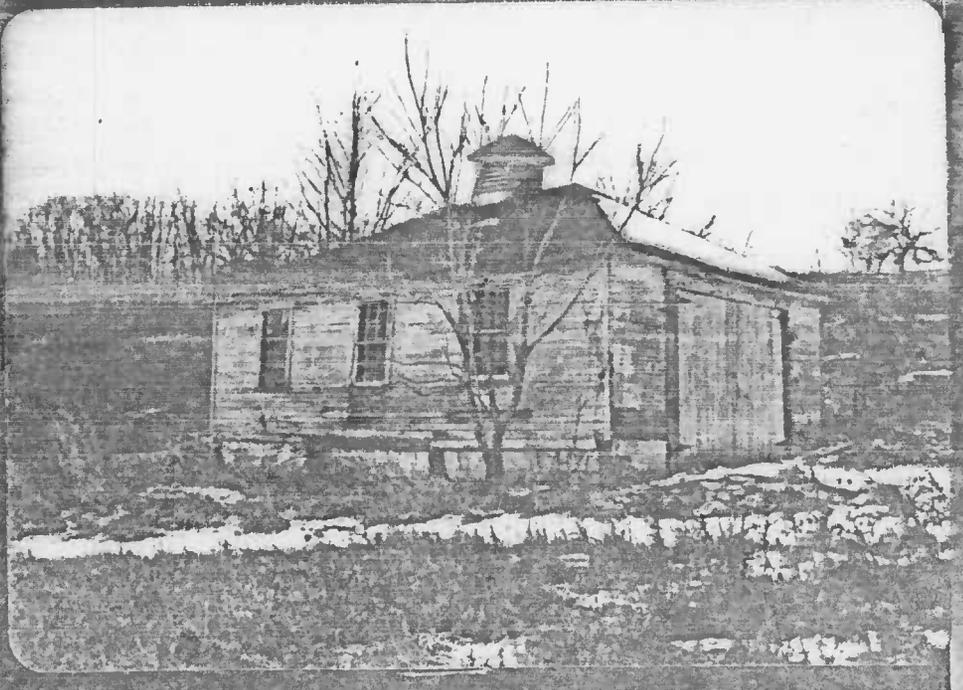
In the complex of farm buildings is a double-bay wagon shed/corncrib. The structure has a hipped roof covered in asphalt shingles. The north and south facades contained double wagon bays with a corncrib at the east and west ends of the structure. It is a frame structure that is covered in boards on the east and west ends set slightly apart for ventilation of the corncrib. The area on the north and south is covered in German siding.

Between the wagon shed-corncrib and the farmhouse is a frame garage. The garage has a hipped roof with a ventilator cupola that has a hipped roof. It is a frame structure covered in German siding. The garage door opening is double doors on the east facade. The other facades have two windows each.

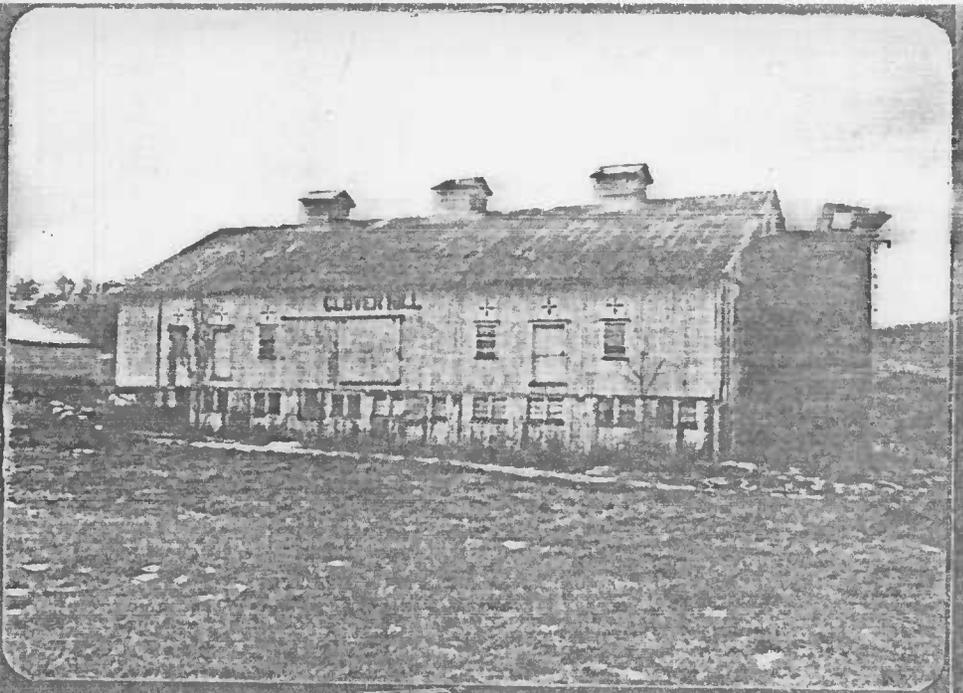
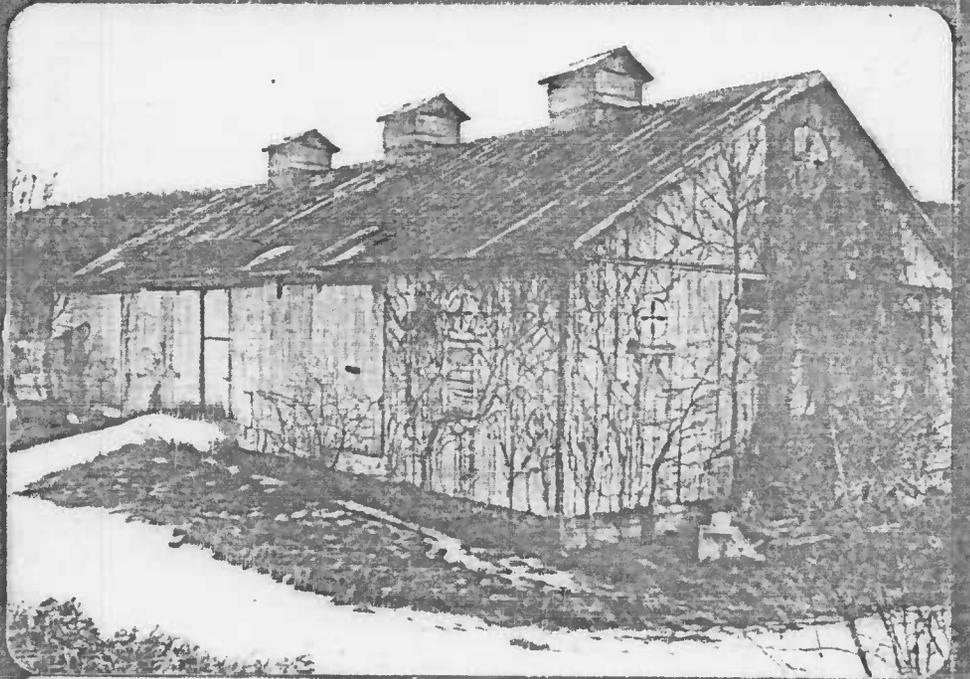
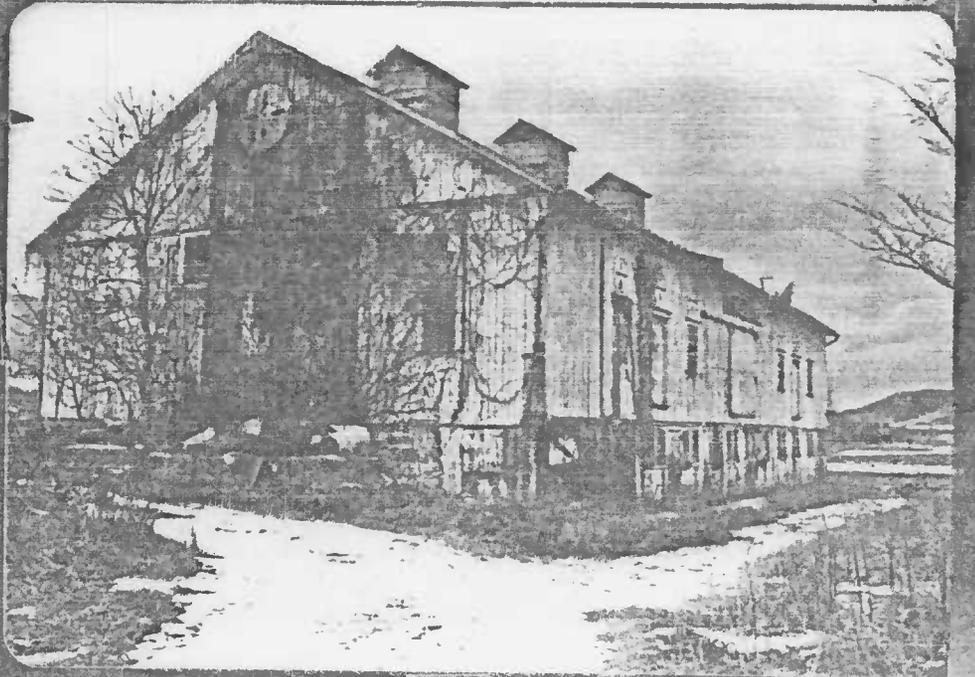
AL-III-C-068 - Clover Hill Farm
 top - Bank Barn South & East Facades
 center - " " North & West Facades
 bottom - " " South & West Facades

The bank barn at Clover Hill is a large ^{frame} structure with a stone foundation. The ^{facade is} ~~structure~~ located on the south facade and is enclosed in wood siding with numerous windows and door openings.

The main floor of the barn contained ^{rectangular} ventilator windows ^{with} ~~above~~ ^{located above them} ~~which were~~ circular decorative ventilators with a floral motif. The barn has a gable roof covered in sheet metal. The gable ends have similar ~~ventilator~~ windows with ventilator circles, with a large ventilator circle located in the gable. On the peak of the roof are three ventilator cupolas with gable rooves. At the east end of the barn is a pair of silos. A large one constructed of tile has a collapsed roof. The smaller one is a stave silo.

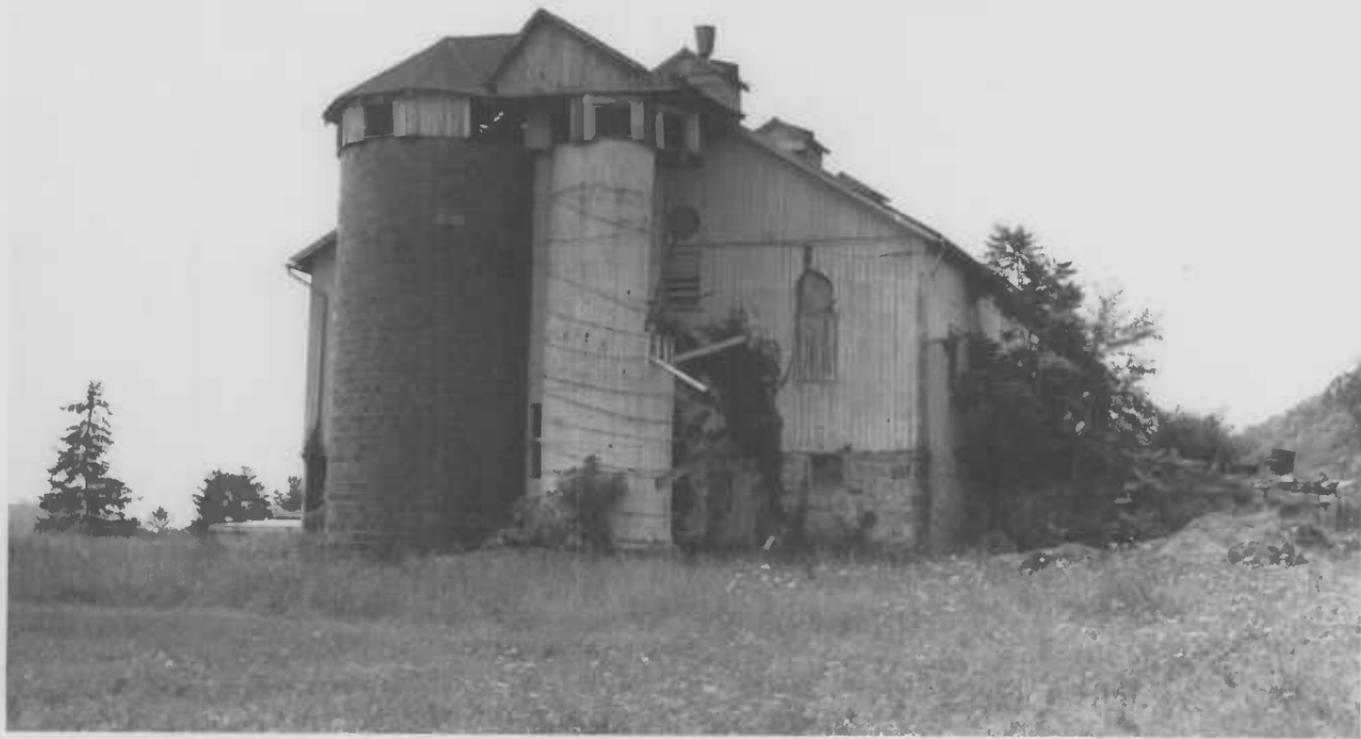
A-5

Northeast of the house are agricultural buildings and a barn. The barn is a large frame structure with decorative round ventilators cut in its walls. It also has three gable roofed ventilating towers in the roof. A modern milking barn has been added to one end. Two silos stand against the east end wall. One is of wood construction and the other is tile. A series of windows are present in a work area between the tops of the silos and their roofs. The barn roof is of standing seam sheet metal.

"Clover Hill Farm" - Barn

S.W. view

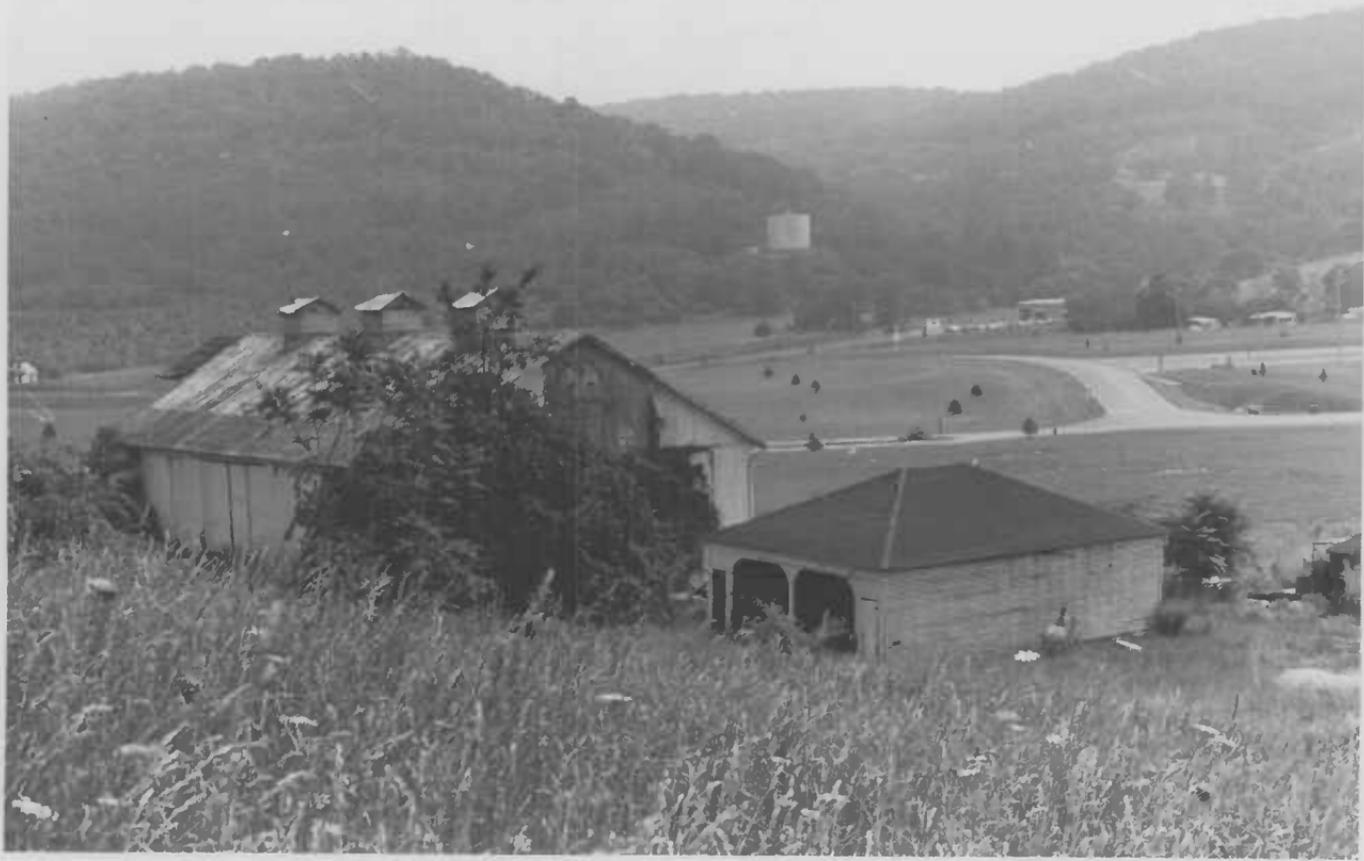
A-5

"Clover Hill Farm" - Barn

E view

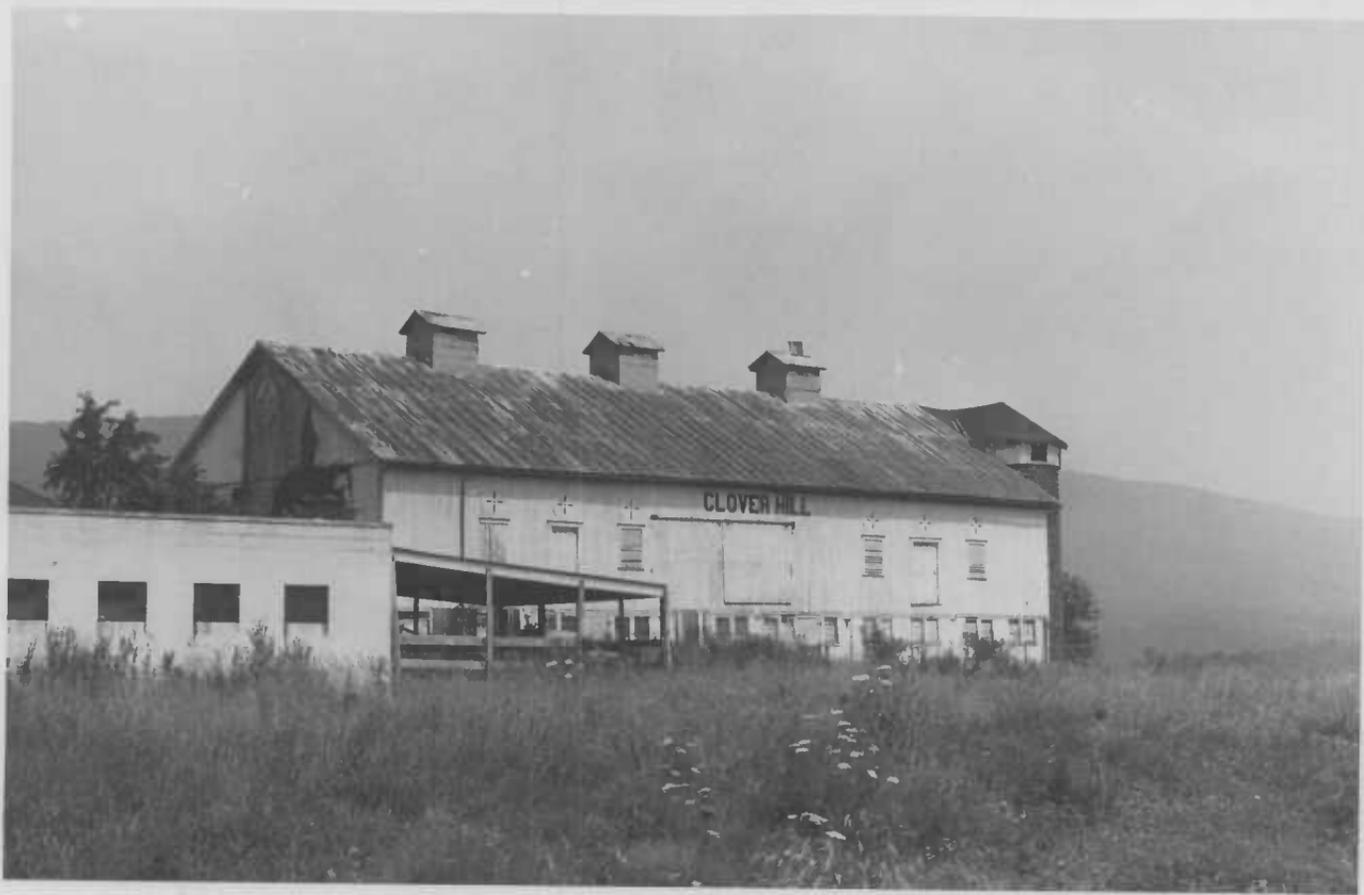
A-5

"Closest this Farm" barn

N view

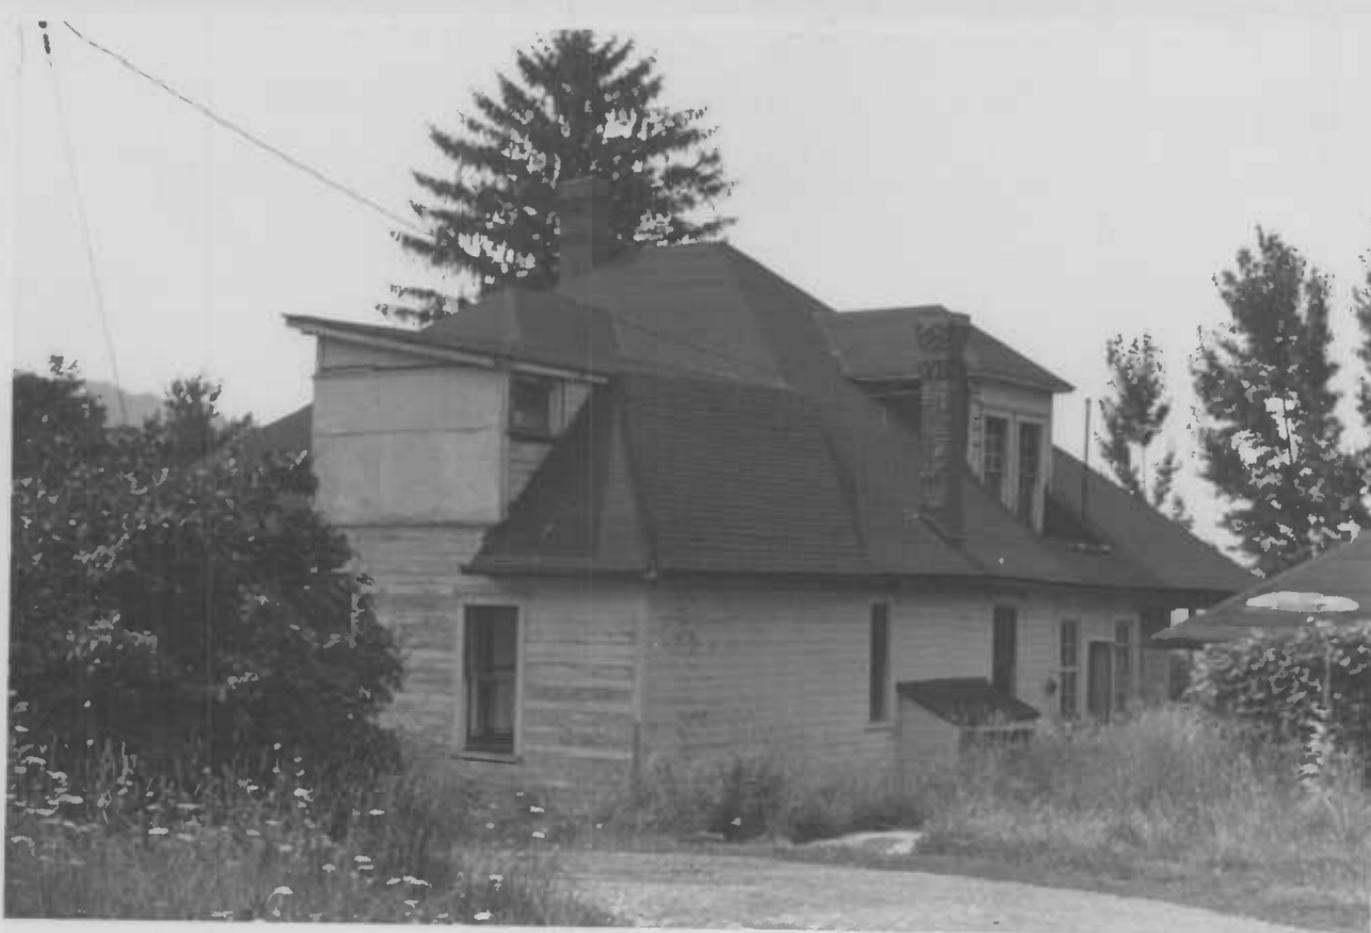
A-5

"Clover Hill Farm" - house

S. view

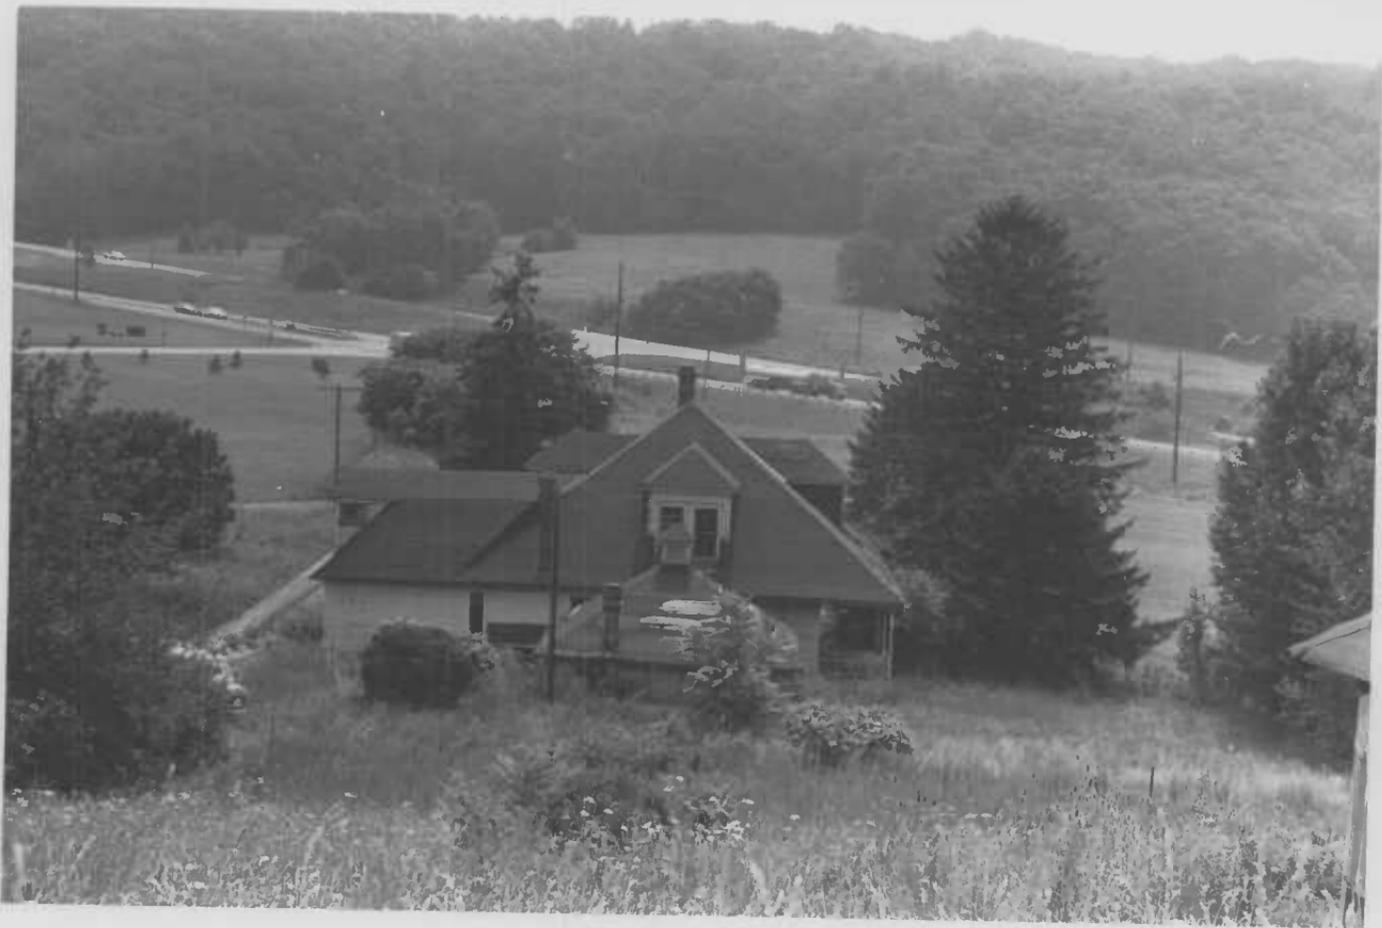
A-5

"Clover Hill Farm" - house

S.E. View

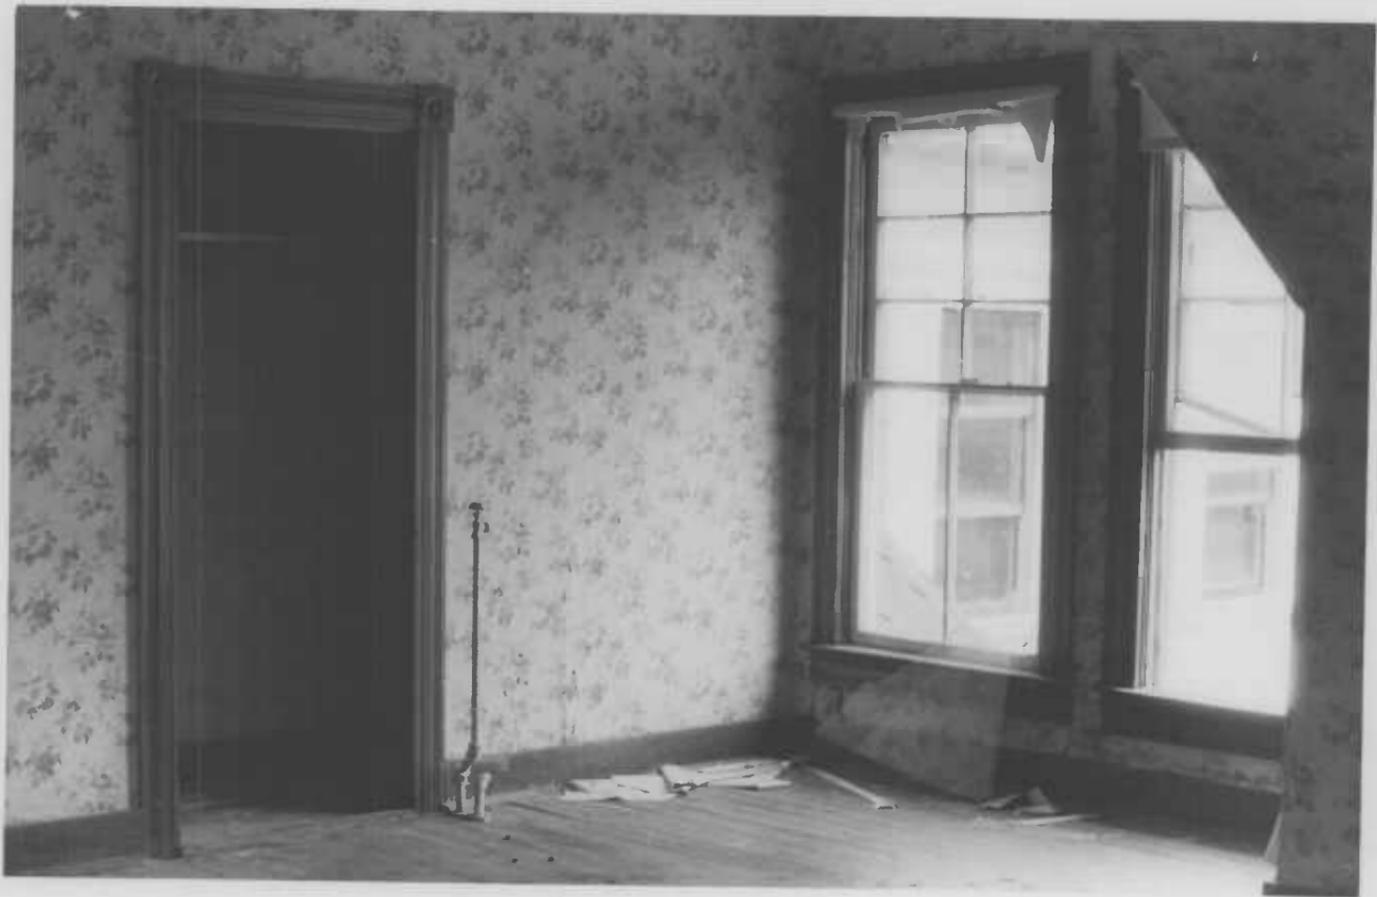
A-5

Large rooms at the second story are lit by the dormer windows. Their woodwork and trim is similar to that at the first story level.

2nd floor N Room

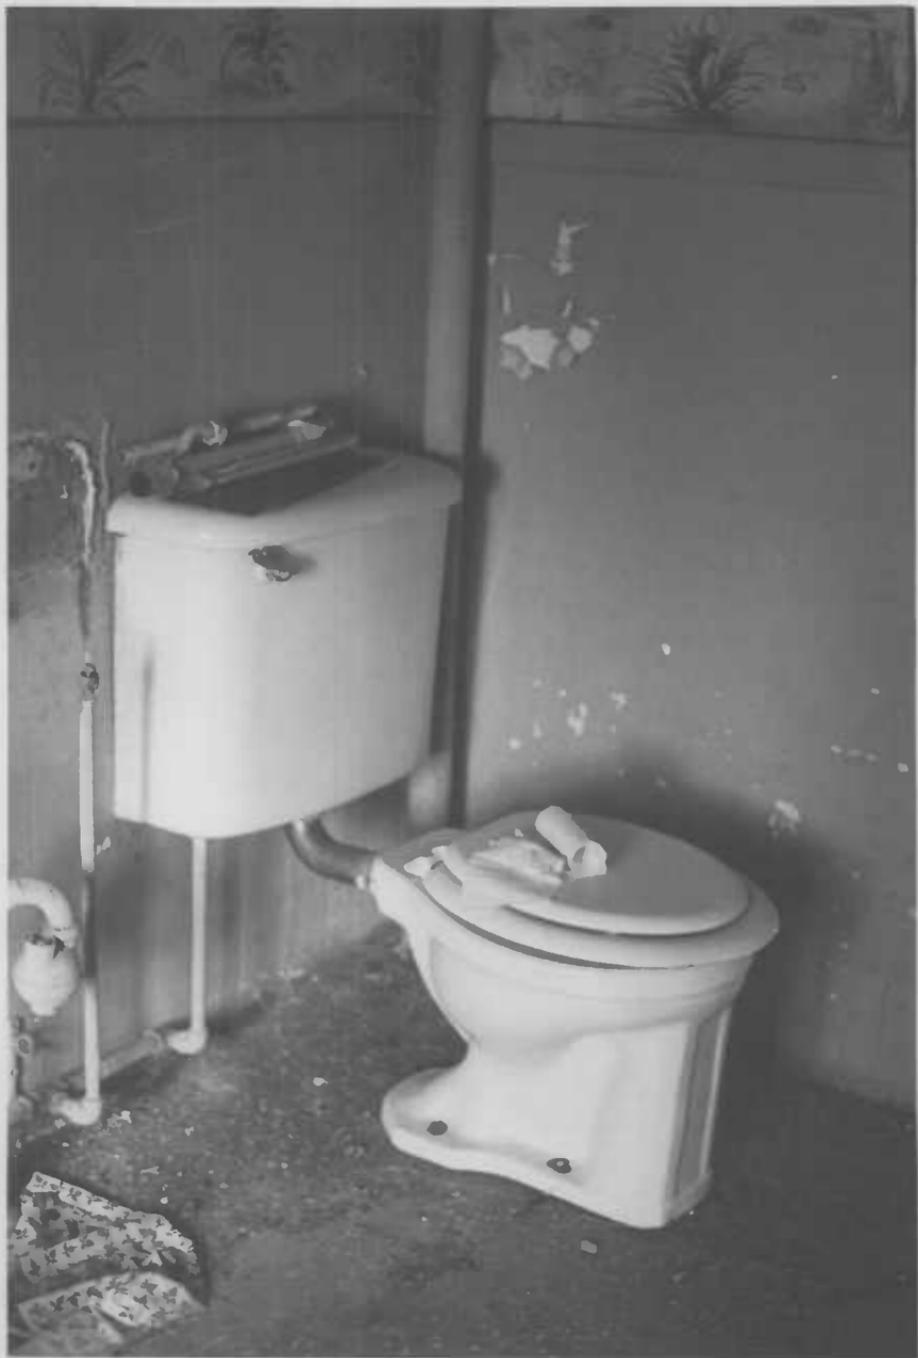
A-5

Behind the parlor is a large bathroom which retains early 20th century fixtures.

1st floor W. Room - bath

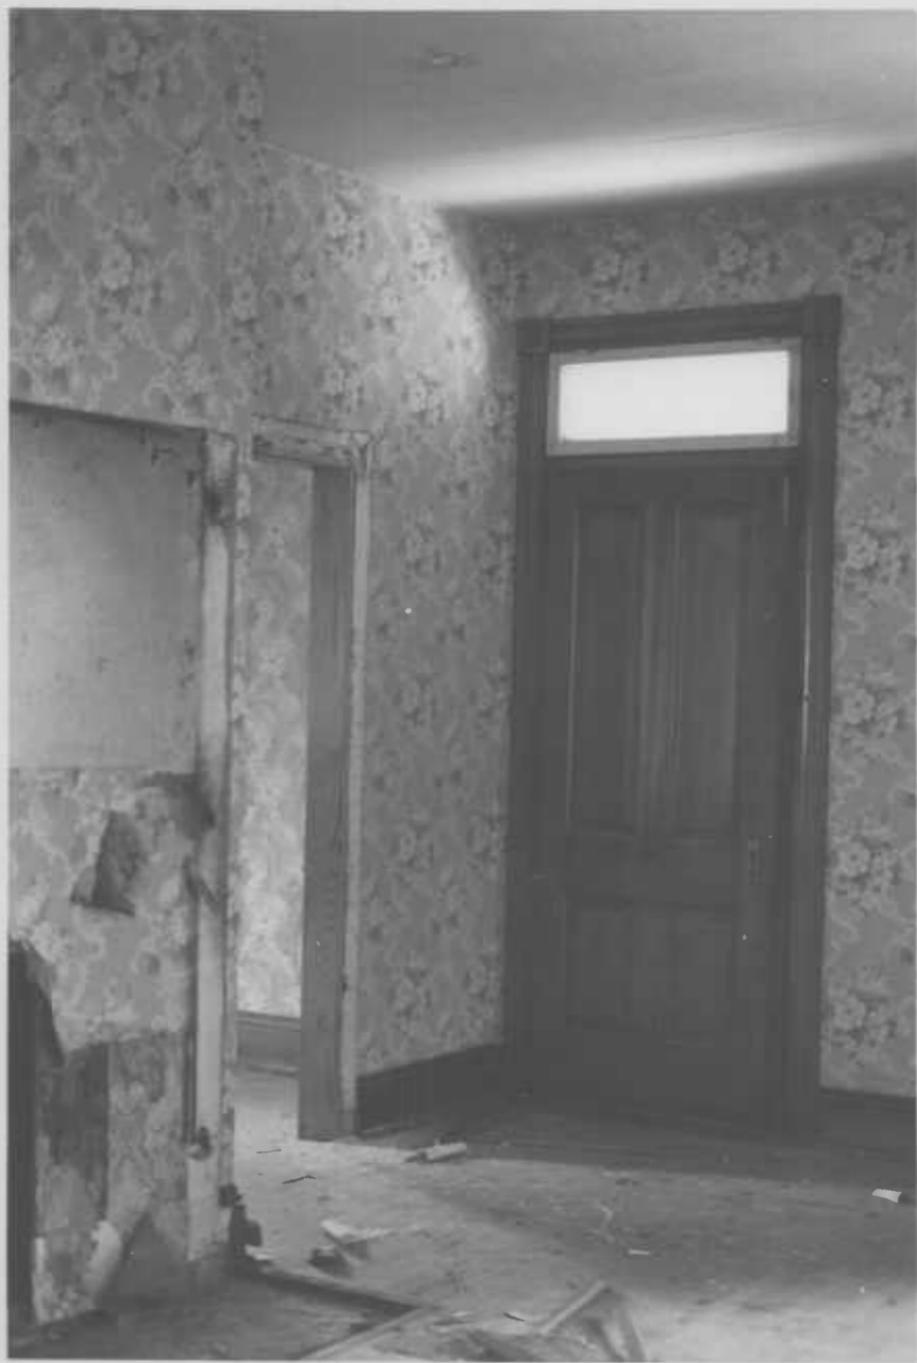
A-5

The interior of the house is divided into four rooms. The main entrance opens into the south room which is a parlor. It contained a fireplace along its interior wall. Recently the house was vandalized and the fireplace woodwork and trim was removed. Several door architraves were also taken. Remaining woodwork is pine with original painted wood graining. One architrave still in place has symmetrical molding and decorated corner blocks. The mantel piece is said to have been quite elaborate with a mirror above the fire place and numerous moldings.

1st floor S. room

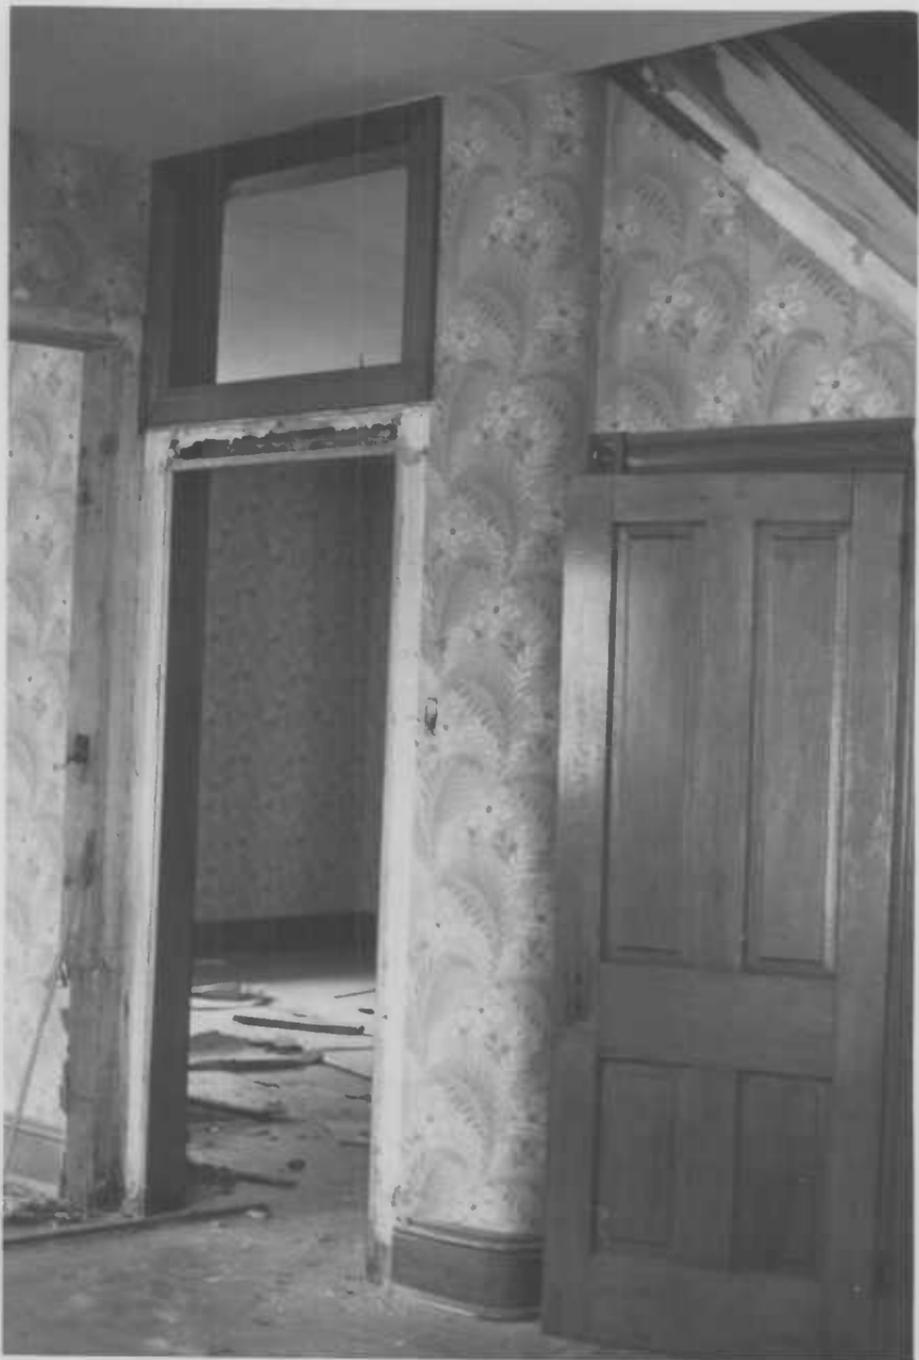
A-5

The main staircase is located in the north room. The hand rail, balustrade and trim have been removed. One notable feature in the stair room is a section of curved wall between a door frame and the back of the staircase.

1st Story, N. Room

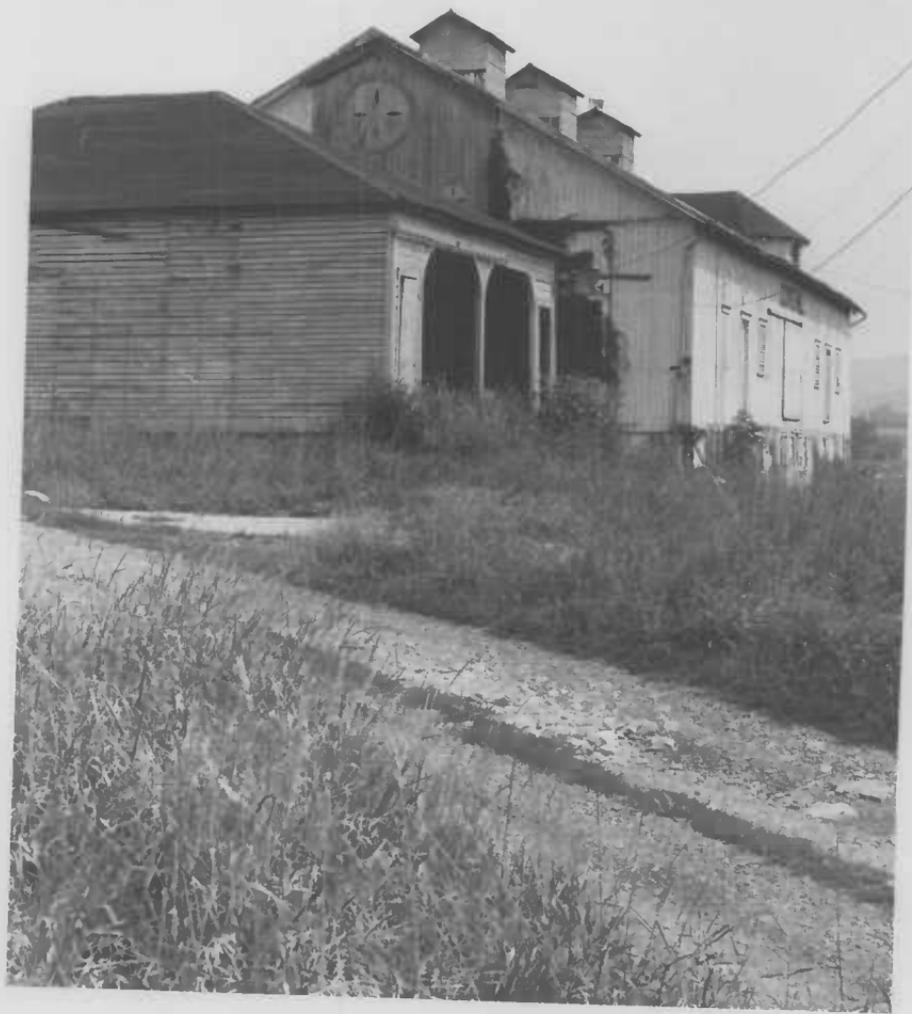
A.S

"Clover Hill Farm", barn

N.E. View

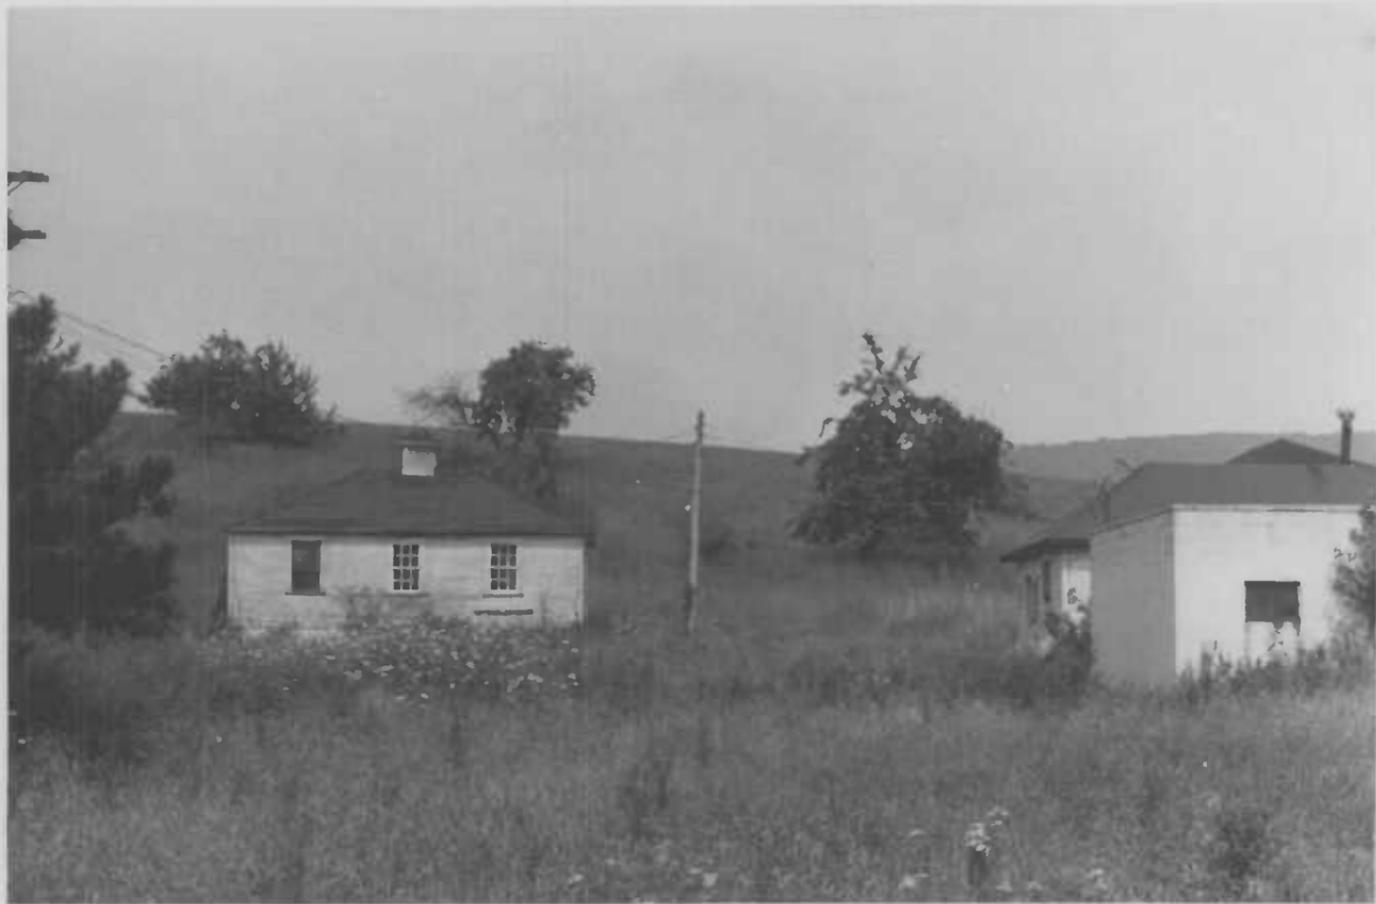
A-5

Near the barn is a frame wagon shed with a hipped roof. Other frame agricultural buildings are present including a chicken house and a milk house. Except for the barn all of the buildings in the complex have hipped roofs and appear to have been built following the pattern of the house. With the exception of the modern milking barn, all of the buildings appear to be contemporary and to have been built during the first quarter of the 20th century.

"Clow's Hill Farm" - outbuildings

N. View
