INVENTORY FORM FOR STATE HISTORIC SITES SURVEY

HISTORIC Clover Hill Farm, McLuckie

AND/OR COMMON Part of Rocky Gap State Park

CLOVER HILL FARM, McLUCKIE
ALLEGANY COUNTY
MARYLAND
(DESCRIPTION, continued)

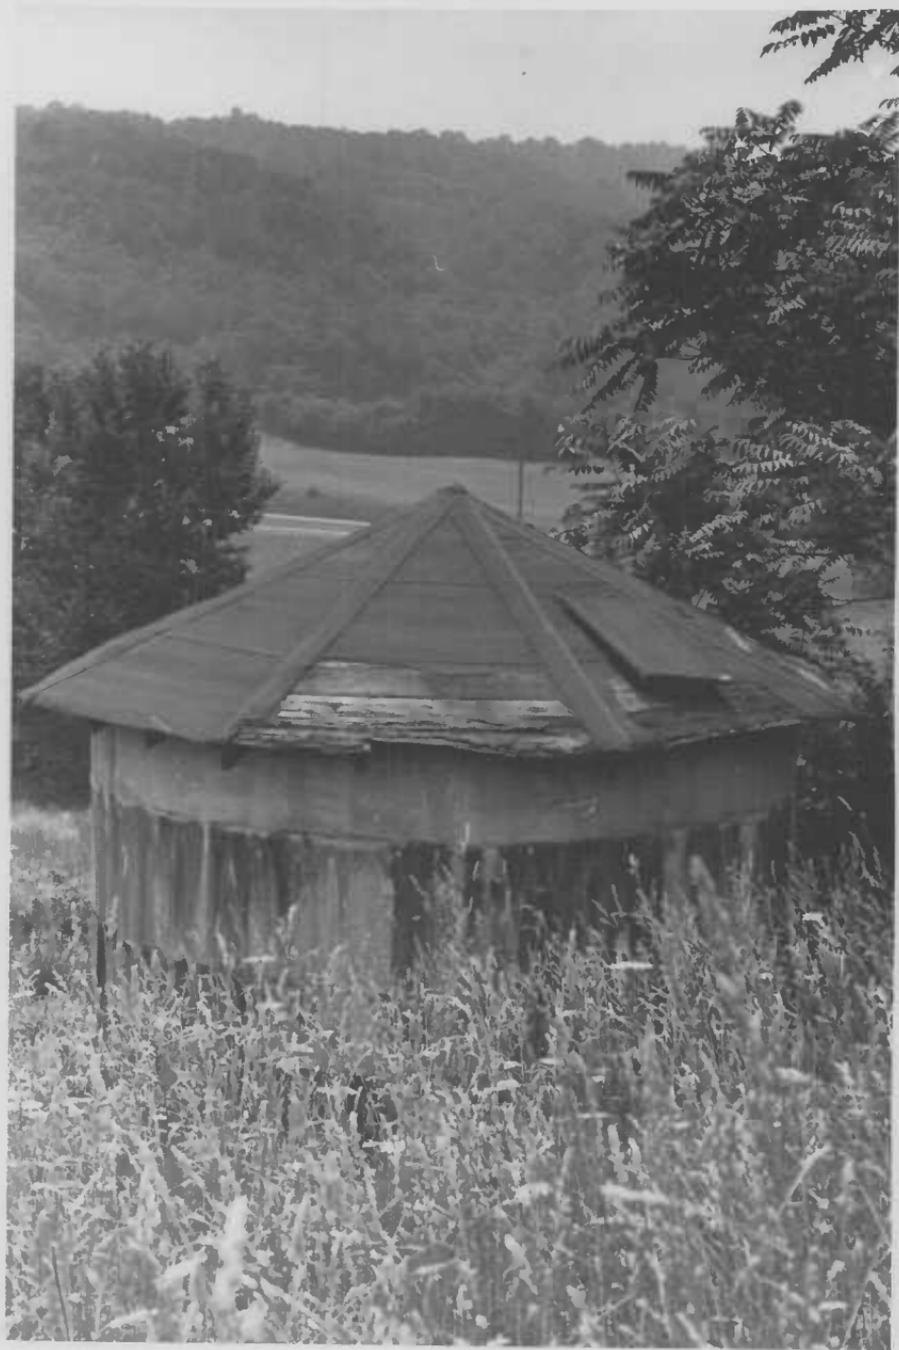
A-5

On a bluff west of the house is a round cast concrete cistern. It is fed from a stream which is located on the opposite side of US Route 40. The structure has a polygonal roof of wood sheathed with composition paper.

Cistern - SW view

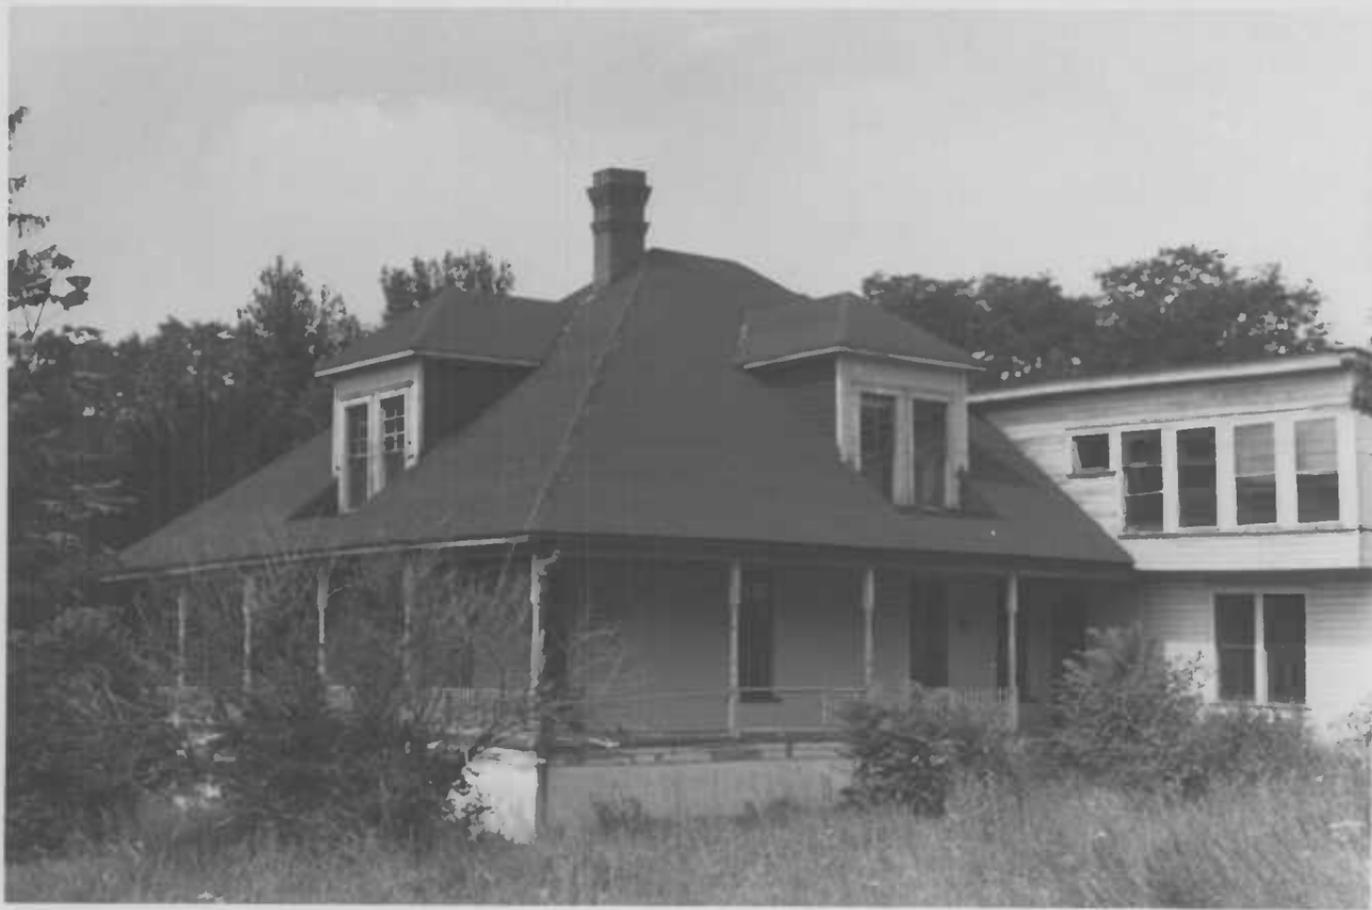
A-5-

"Clover Hill Farm" House

W. View
