AL-V-A-290

INVENTORY FORM FOR STATE HISTORIC SITES SURVEY

Robert Harvey Farm

North side Morgan Road

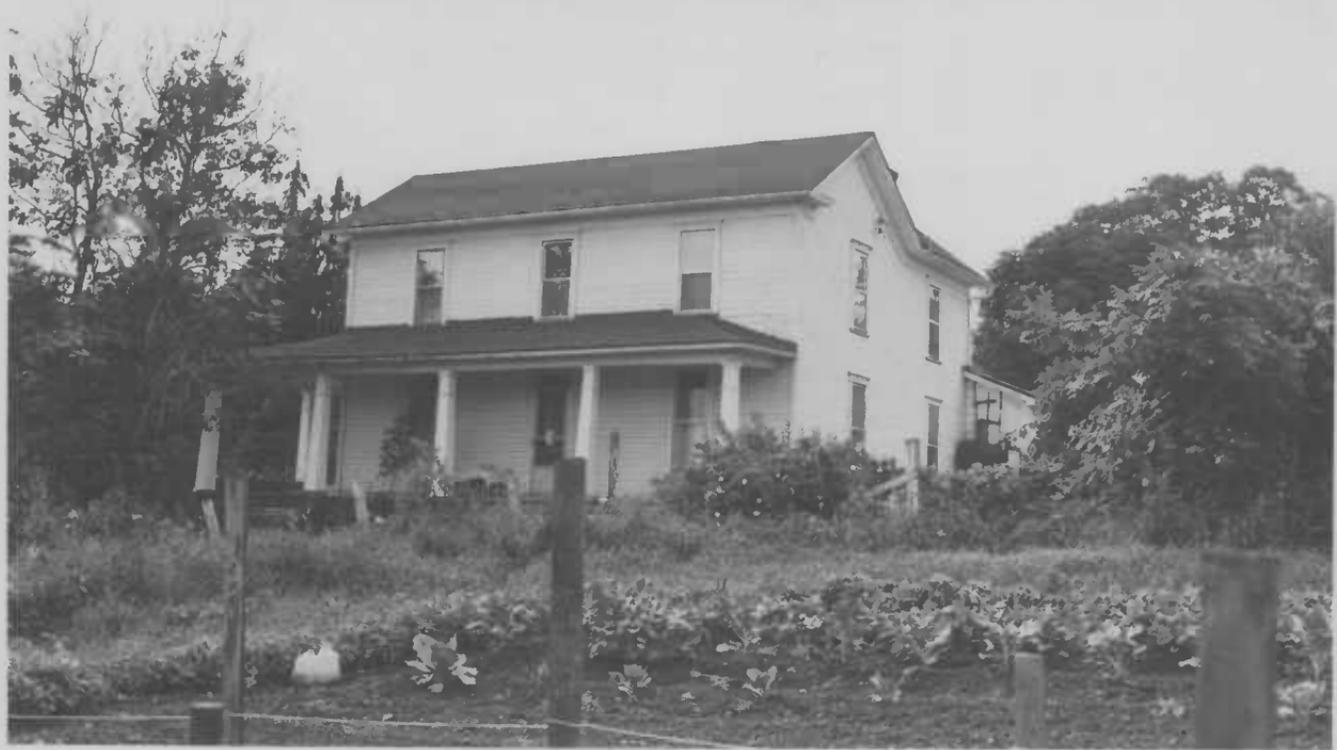
Farmhs. E elev.

The Robert Harvey Farm is located on the northern side of Morgan Road near Borden Shaft. The "L" shaped house is two stories tall, three bays wide on the facade (eastern elevation), and one bay deep. The frame walls are covered with a unique double german siding. Each board resembles two boards of narrow german siding. The house rests on a high rubblestone foundation. The gabled roof is covered with asphalt shingles. A one story frame addition, also covered with double german siding, abuts the western elevation of the rear wing.

A wrap around veranda covers the facade, southern, and eastern elevations of the main block and the southern elevation of the rear wing. The hip roof of the veranda is supported by eleven tapered square wooden posts which are capped. Windows are 1/1 sash surmounted by drip mouldings. Ground floor windows of the facade are tall. An entrance in the center of the facade has a one light transom and a door of one light and three panels with original porcelain hardware. The entrance is surmounted by drip moulding. An interior brick chimney is located on the western elevation of the rear wing.

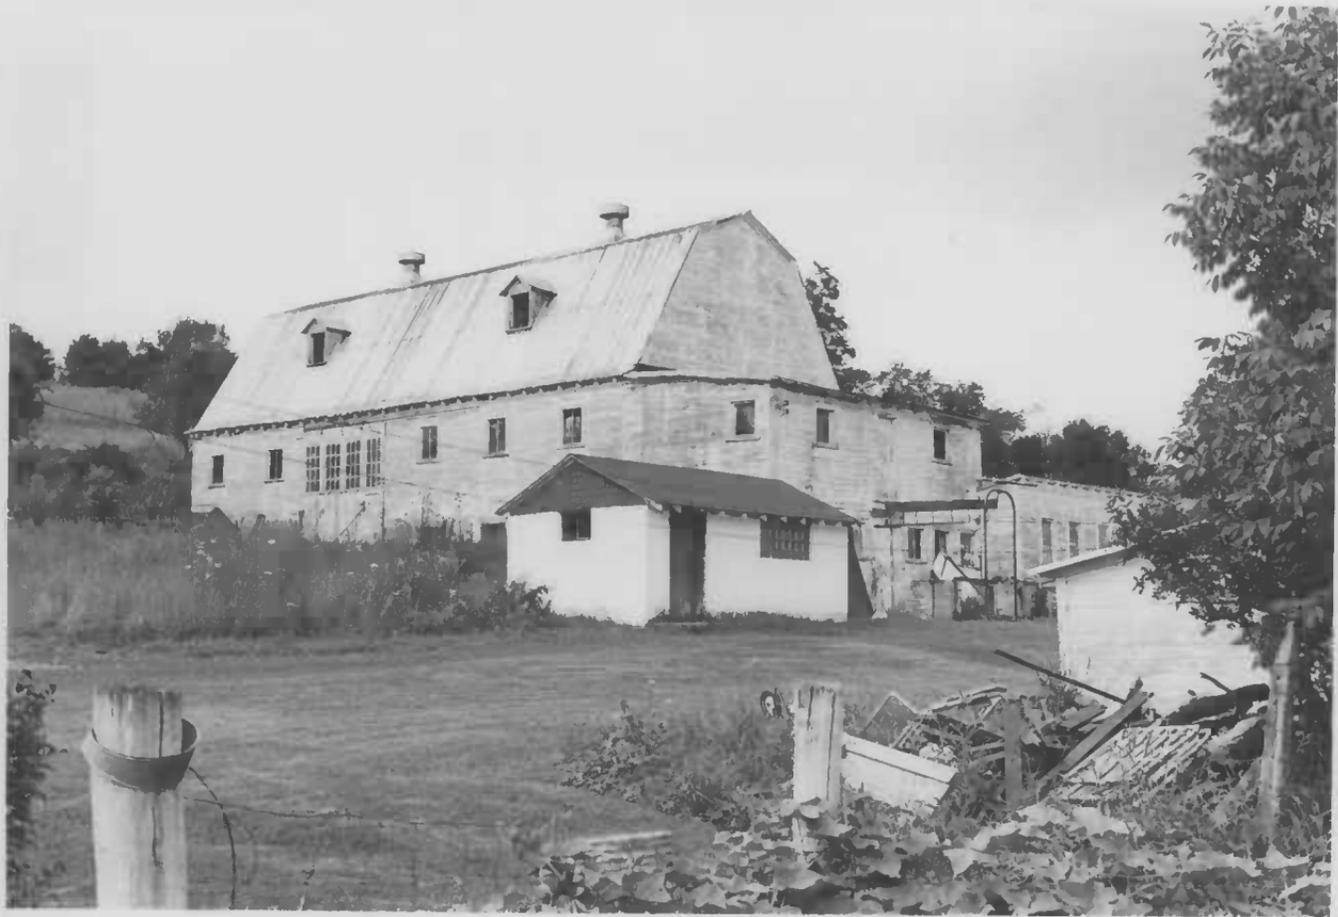
AL-V-A-290
Robert Harvey Farm
Allegany Co., MD
David A. Dorsey 8/81
Barn - S elev.

A barn located to the north of the farm house was built over a small log barn. The frame barn is covered with german siding. It rests on a high foundation of poured cement. The gambrel roof is covered with corrugated metal. Two gabled dormer ventilators are on each side of the barn. Two hinged doors on the southern elevation open on metal runners. Each door has two windows of twelve lights each. Windows are of two lights each and are fixed in place. A shed roofed addition and connecting coops, all covered with german siding, are on the eastern elevation of the barn.
